# **GEO-ENVIRONMENTAL AUDIT**

## **PHASE 4 Validation**

**28 War Office Road  
Bamford  
Rochdale  
OL11 5HH**

Author: Daniel Slattery  
Client: Tiberius Properties NW Ltd.  
Reference: rep-tjba-JM-28 war office rd-Phs4ENV validation-210126.docx

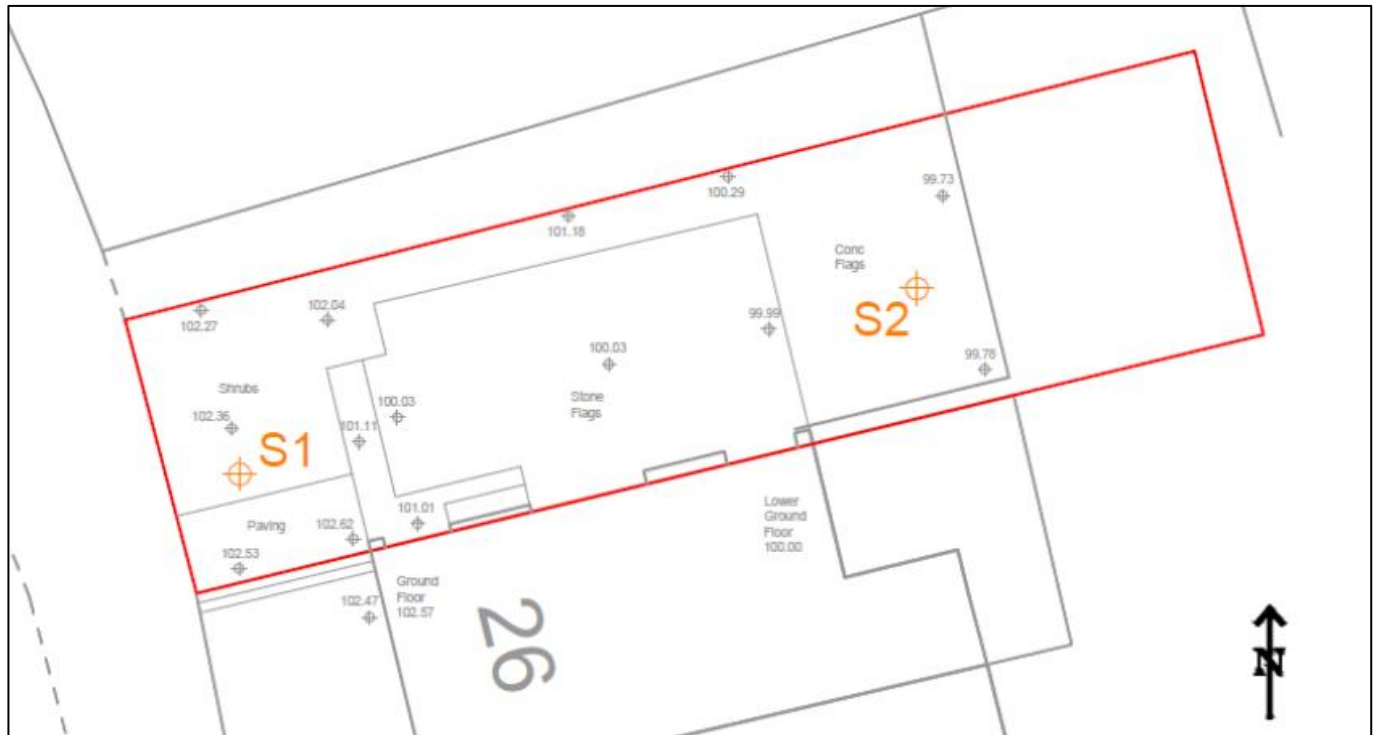
Two soil samples were taken as part of the original assessment (S1-2). S1 was taken to the small front garden area, and S2 to the lower rear garden area, refer to site plan excerpt below:

Soil sample S1 of the upper front side adjacent to the road proved to be mildly contaminated with lead, and was proposed to require remediation in this area.

Sample S2 of the lower rear garden area was free from contamination above residential threshold values. No remedial measures were considered to be necessary in this area. Much of the area was garden area previously, and apart from minor landscaping, removal of trees, and creation of a new patio area, the proposed garden required only minor reprofiling/re-seeding.

The as-built site layout now comprised the driveway to the front area adjacent to the highway. Due to this the pollutant linkage with regards to minor lead contamination in this area, is now considered to be mitigated by pathway removal owing to the introduction of a permanent hardstanding.

Minor contaminated area to the front is now considered to be mitigated by the introduction of permanent hardstanding.
