# Former Heywood Stores, Heywood

Phase 2 Environmental Site Investigation

323173 R02(01)

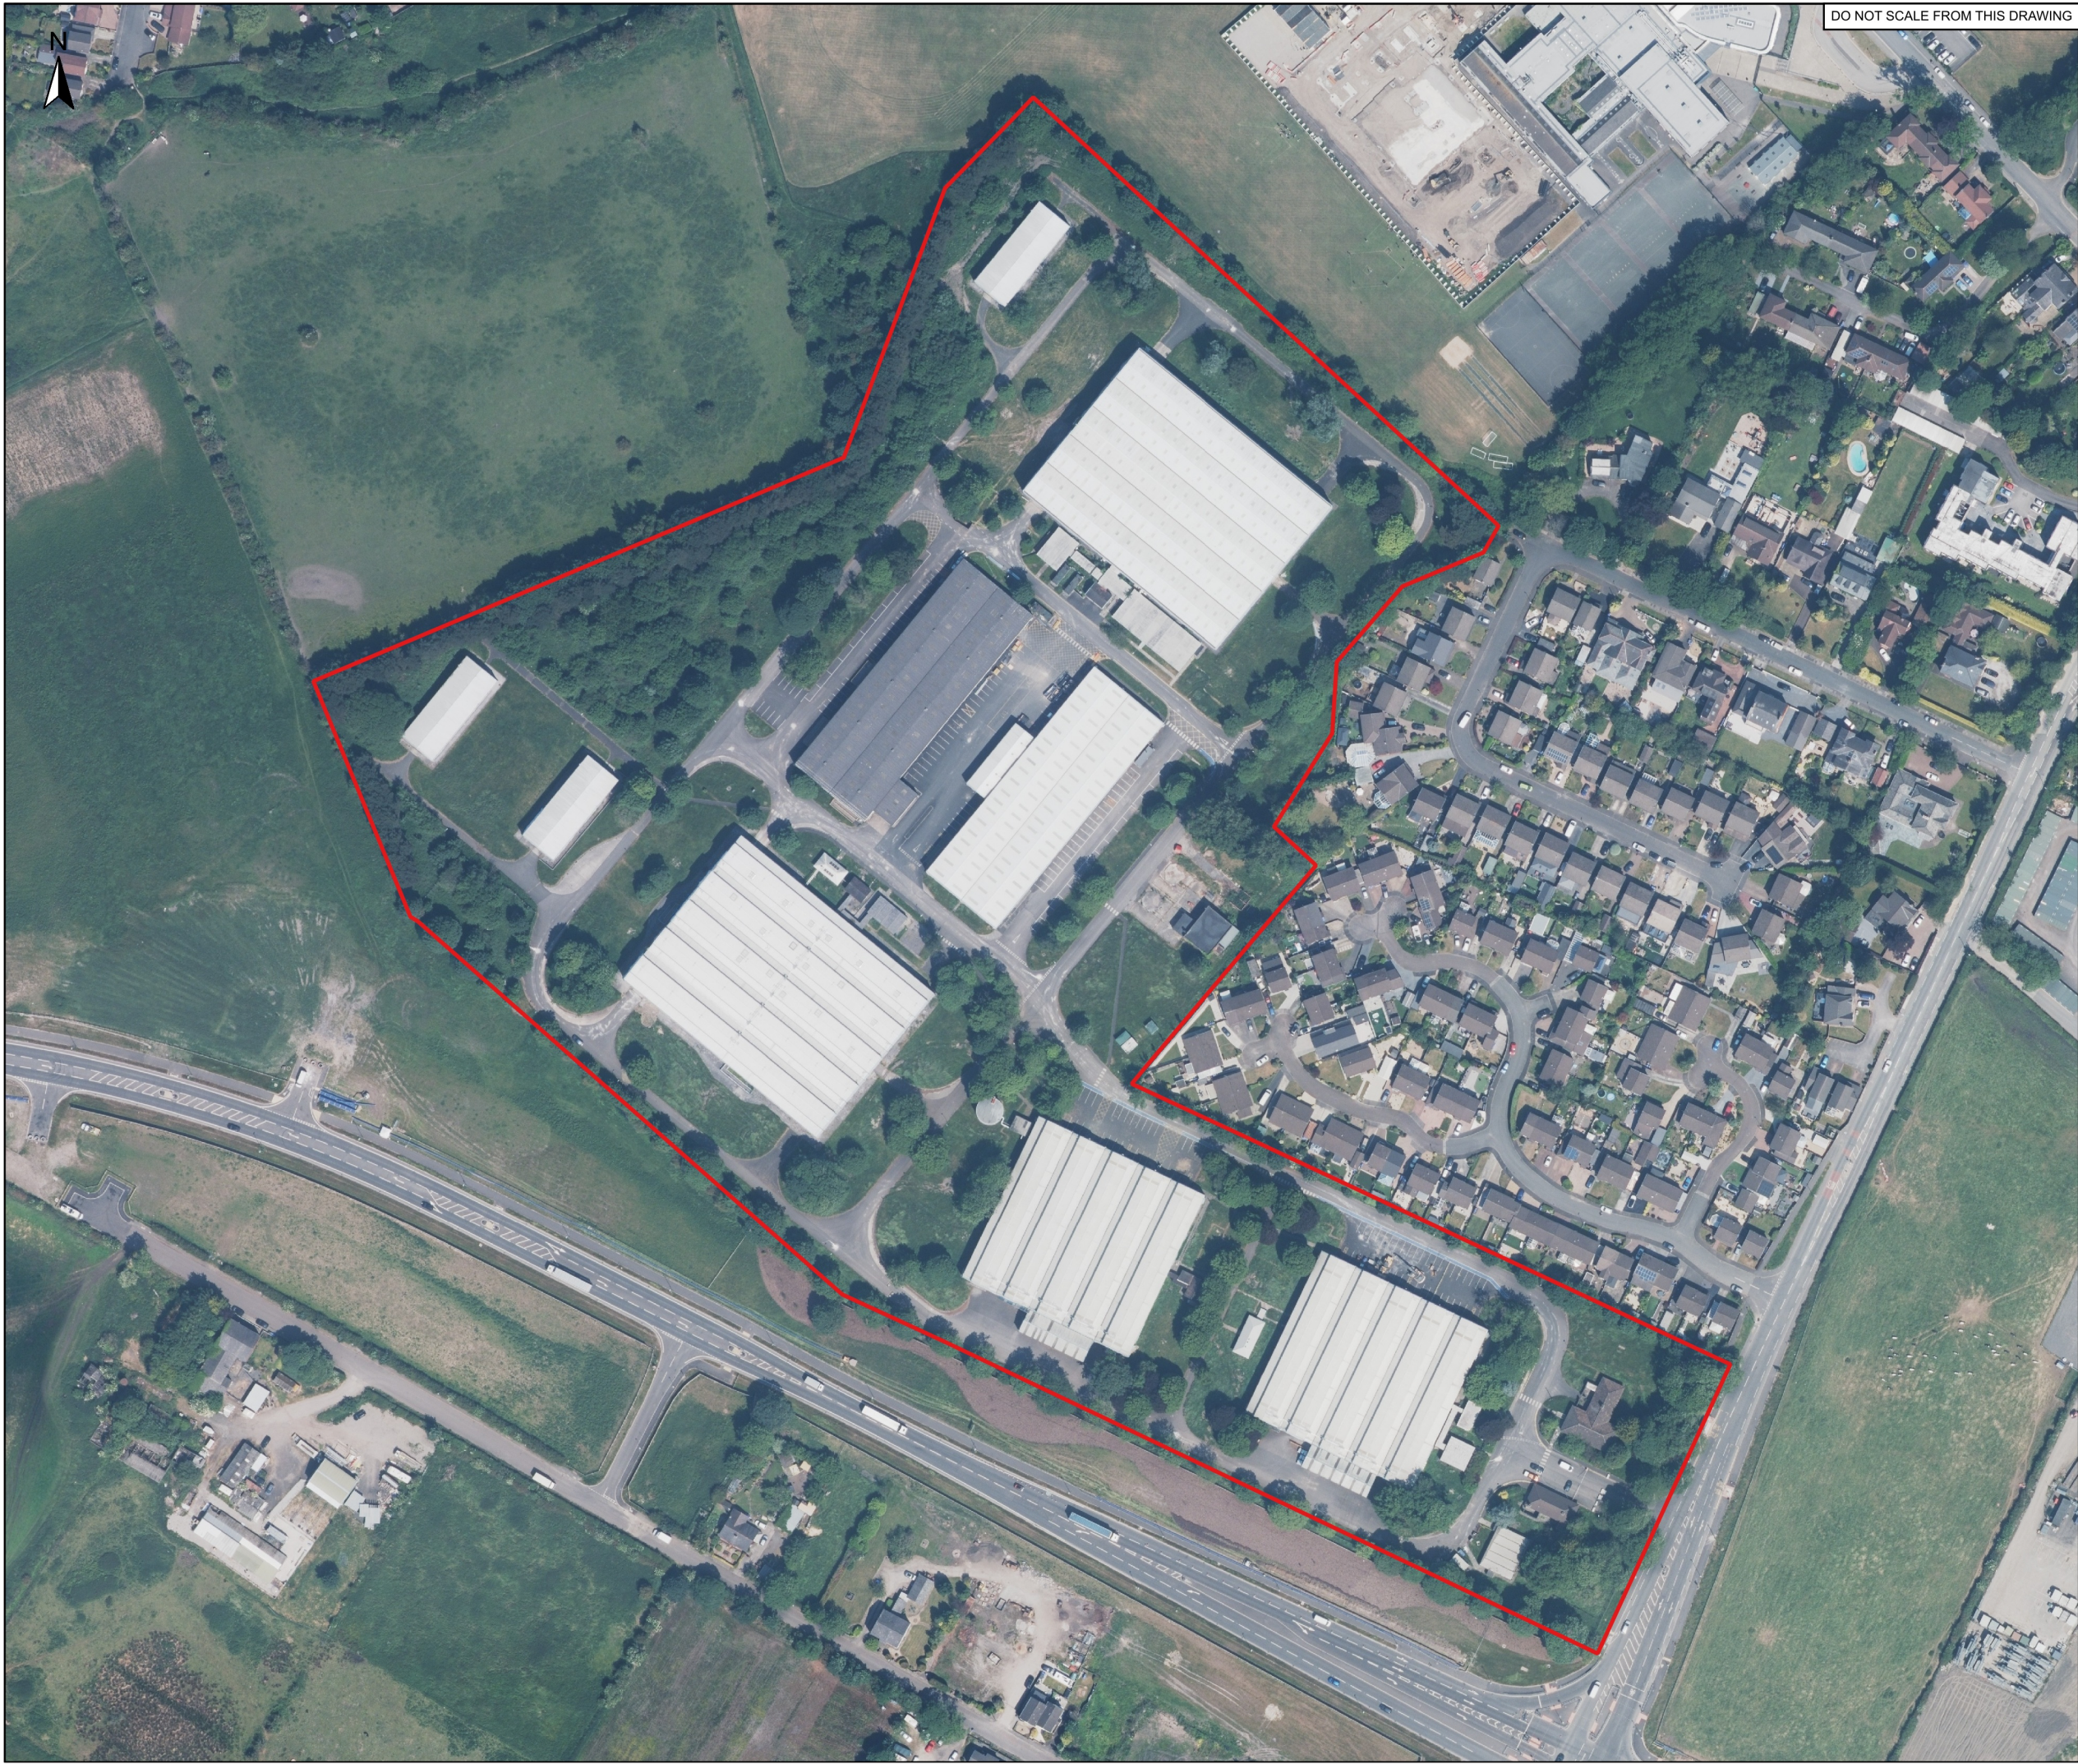
**Figure 2    SITE LAYOUT PLAN**

The site boundary and current site layout are shown on **Figure 2**. The site covers an area of approximately 11.19 hectares. It is currently unoccupied following recent demolition works on the former warehouses. The site is roughly “L shaped” and now comprises former road ways and slabs associated with the former structures.

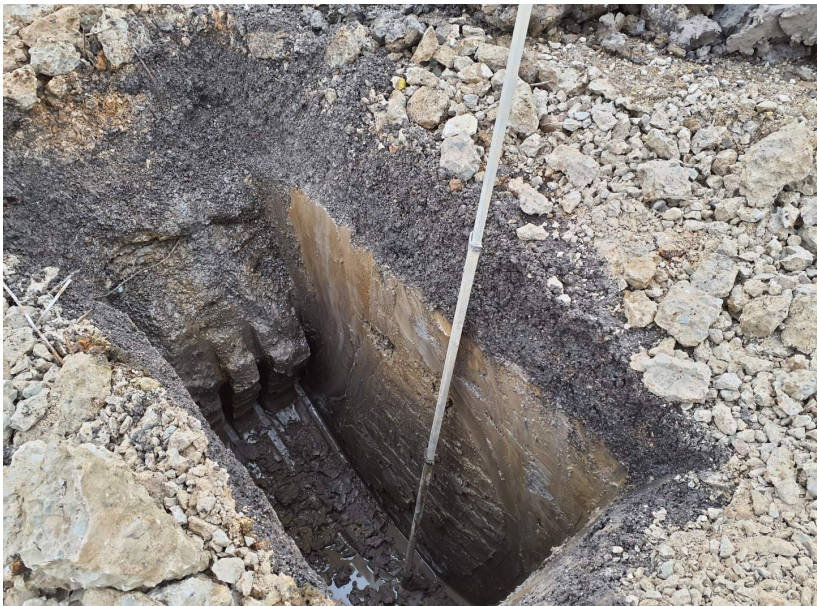
| <b>1</b> | 6.11.2025 | |

| <b>Description:</b><br>Ground conditions in TP201 | | |

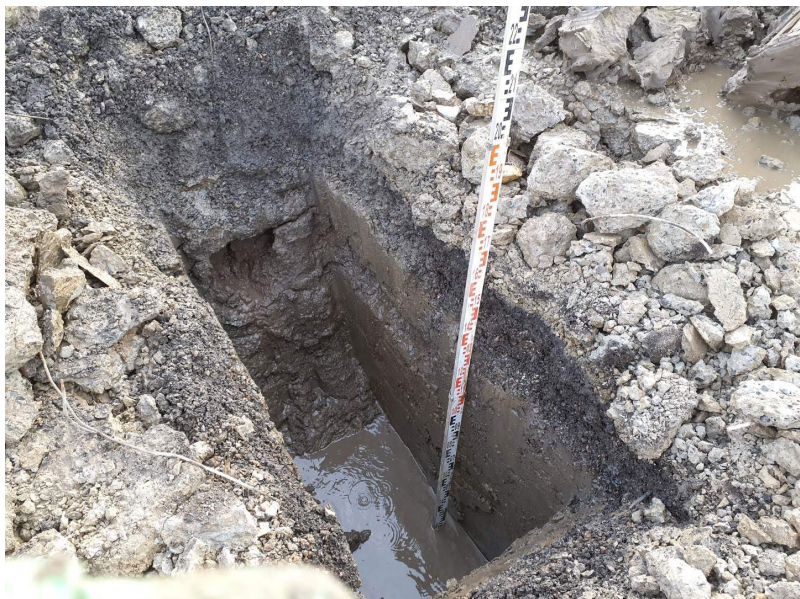
| 2 | 6.11.2025 | |

| <b>Description:</b><br>Ground conditions in TP202 | | |

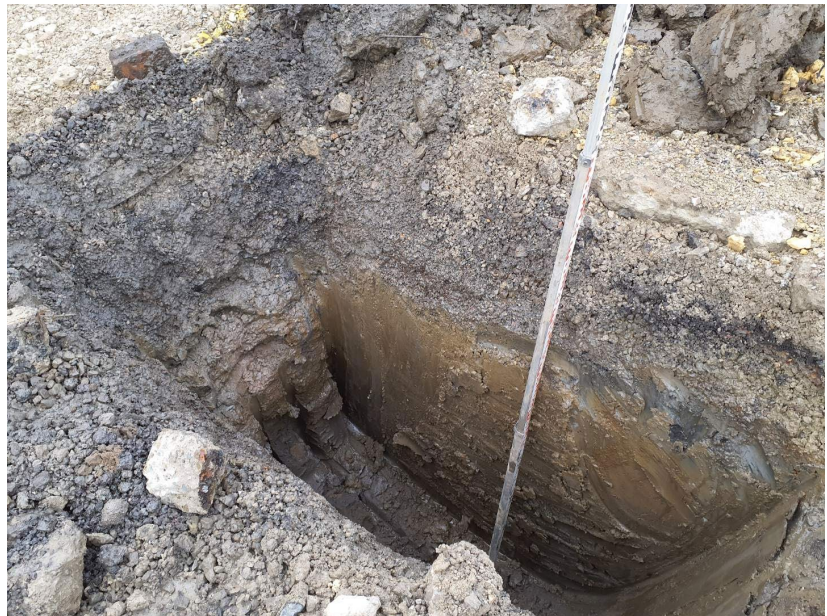
| <b>Photo No.</b><br>3 | <b>Date:</b><br>6.11.2025 | |

| <b>Description:</b><br>Ground conditions in TP204 | | |

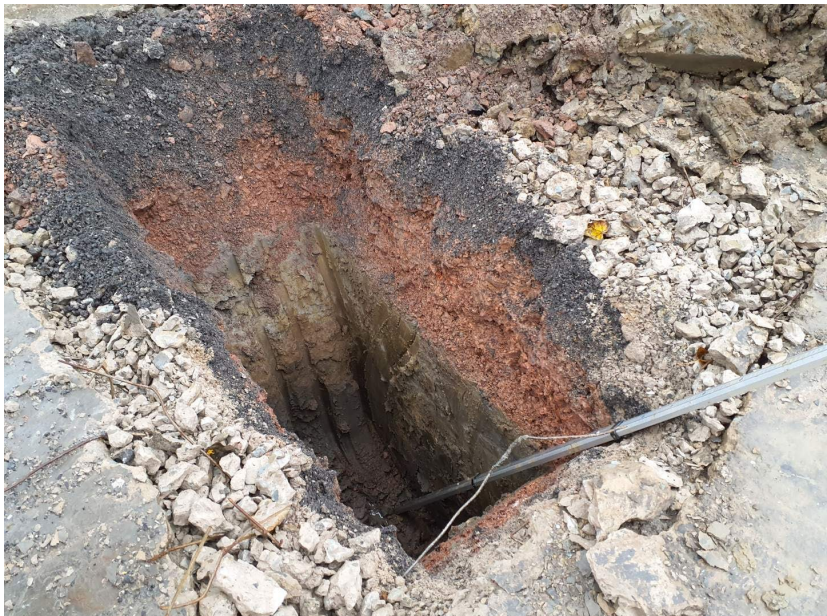
| <b>Photo No.</b><br><b>4</b> | <b>Date:</b><br>6.11.2025 | |

| <b>Description:</b><br>Ground conditions in TP207 | | |

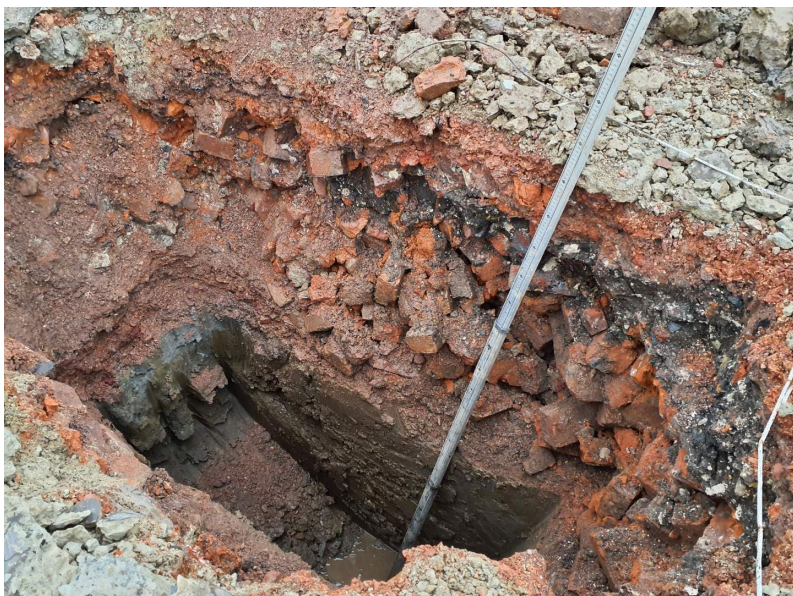
| <b>Photo No.</b><br><b>6</b> | <b>Date:</b><br>4.11.2025 | |

A summary of the soil testing completed during the investigation is provided above in Table 4 with results are presented in **Appendix E**. Screening for asbestos containing materials was completed on 27 samples, with results confirming detections of asbestos cement in TP204, and chrysotile loose fibres in the sample of made ground from TP210. Further analysis of the asbestos identified a % w/w of 0.006%.

| <b>Description:</b><br>Ground conditions in TP210 | | |

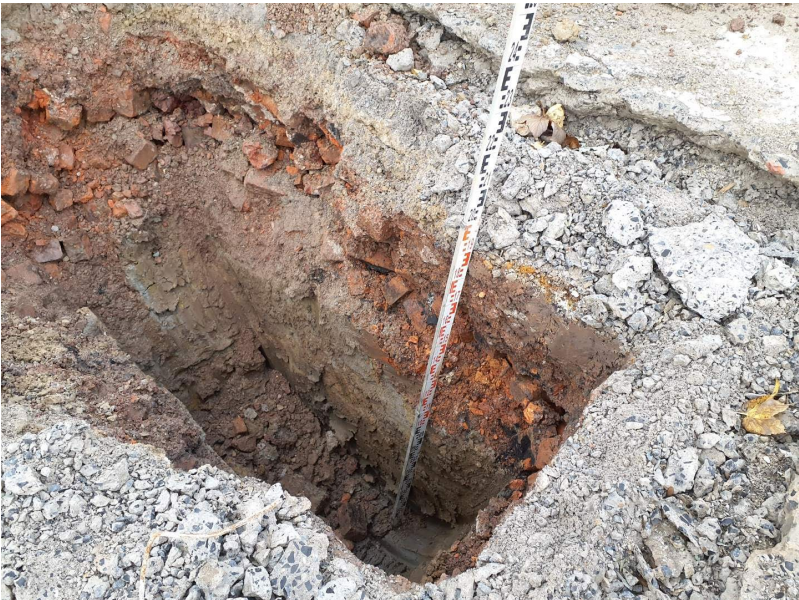
| <b>Photo No.</b><br>7 | <b>Date:</b><br>5.11.2025 | |

| <b>Description:</b><br>Ground conditions in TP214 | | |

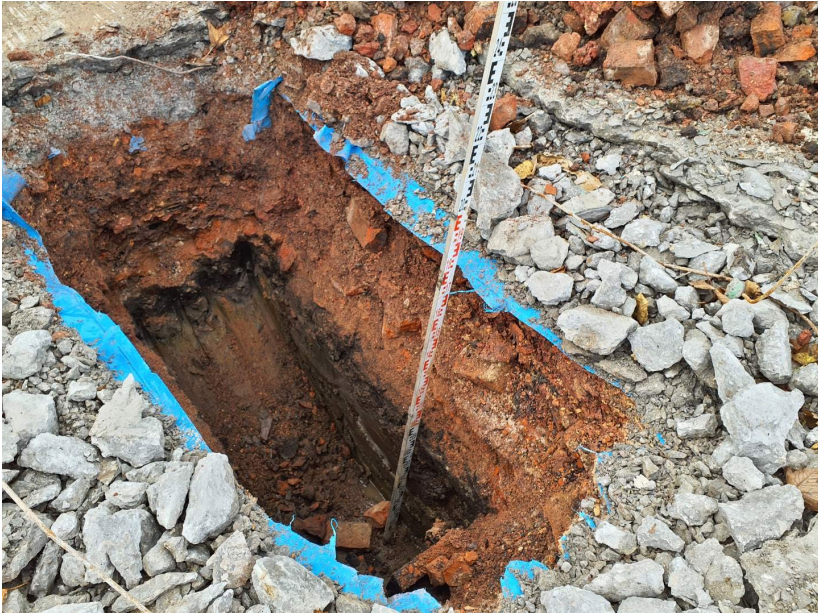
| <b>Photo No.</b><br>8 | <b>Date:</b><br>5.11.2025 | |

During the intrusive works, olfactory evidence of contamination was noted in two trial pits (TP215 and TP216), described as an organic odour, and was associated with the silt horizon between the made ground and clay soils.

| <b>Description:</b><br>Ground conditions in TP216 | | |

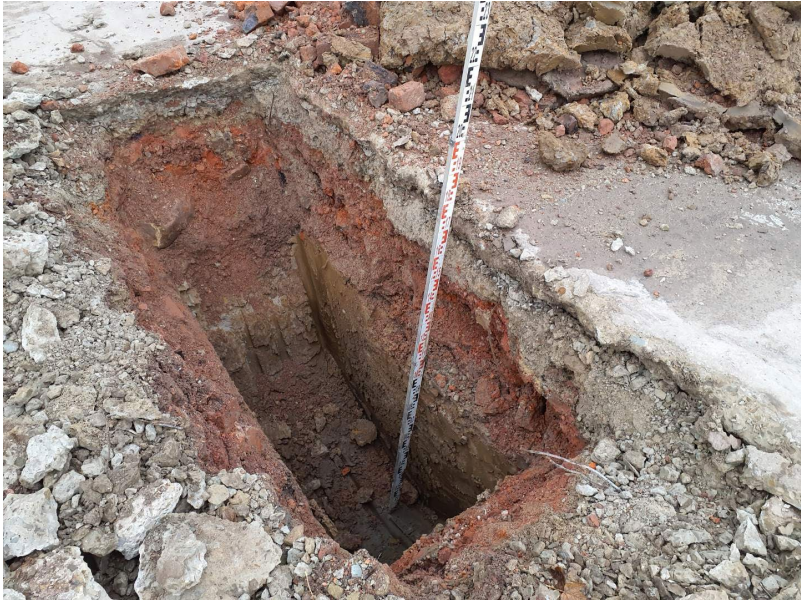
| 9 | 5.11.2025 | |

| Ground conditions in TP218 | | |

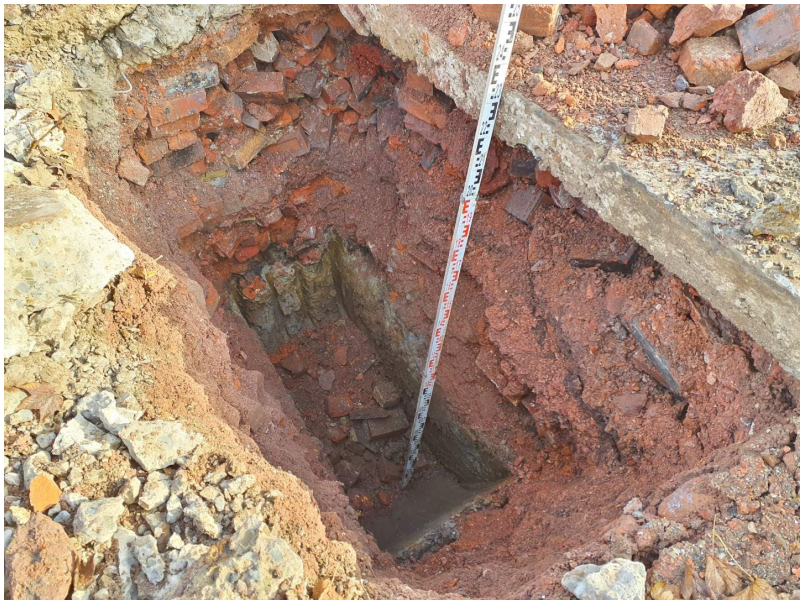
| <b>Photo No.</b><br><b>10</b> | <b>Date:</b><br>6.11.2025 | |

| <b>Description:</b><br>Ground conditions in TP221 | | |
