# PHASE I AND II GEOENVIRONMENTAL SITE ASSESSMENT

| Site: | Hareshill Road, South Heywood |
| References: | 18-435-R1-3 |
| Client: | Northstone |

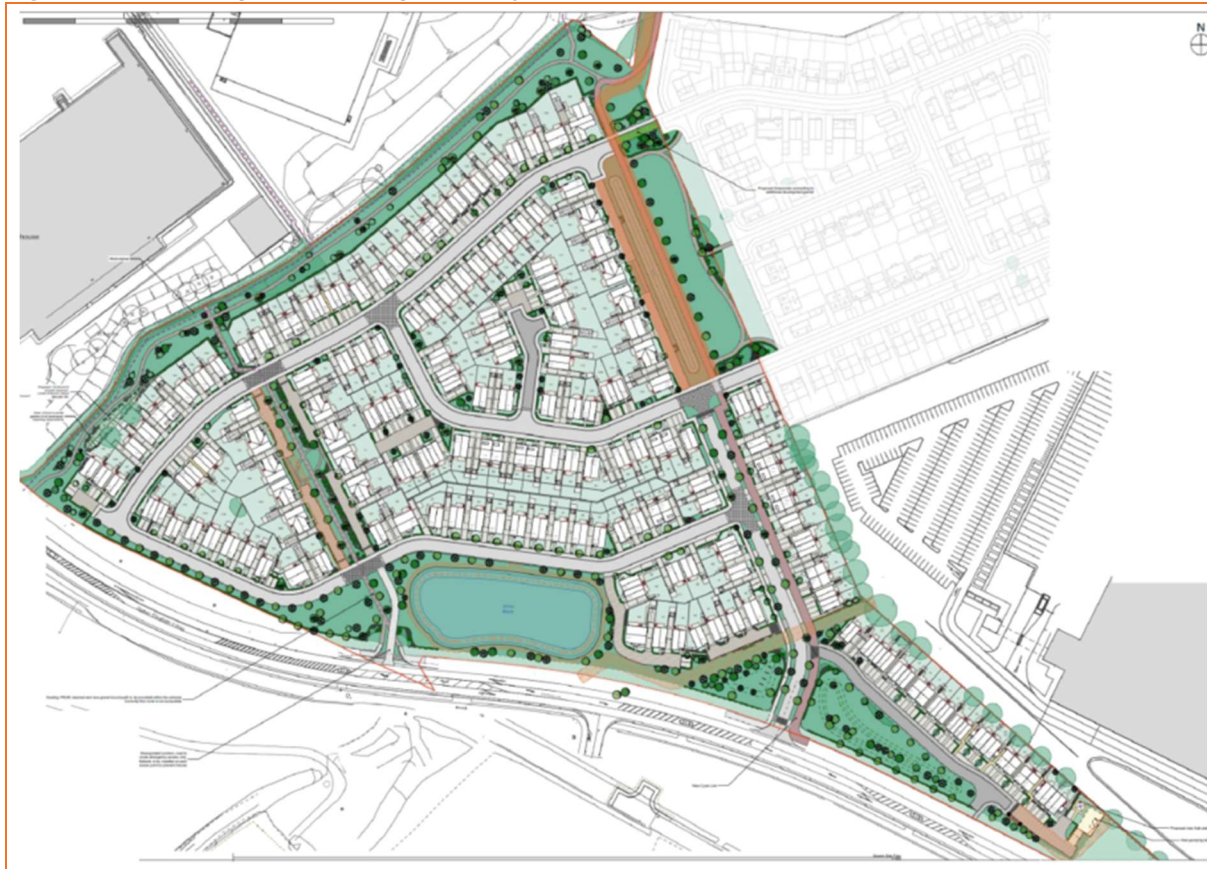
Figure 1.1 Proposed Development Layout

| <b>Proposed Development</b> | Northstone intends to construct a low-rise residential development with associated gardens, estate roads and infrastructure. |

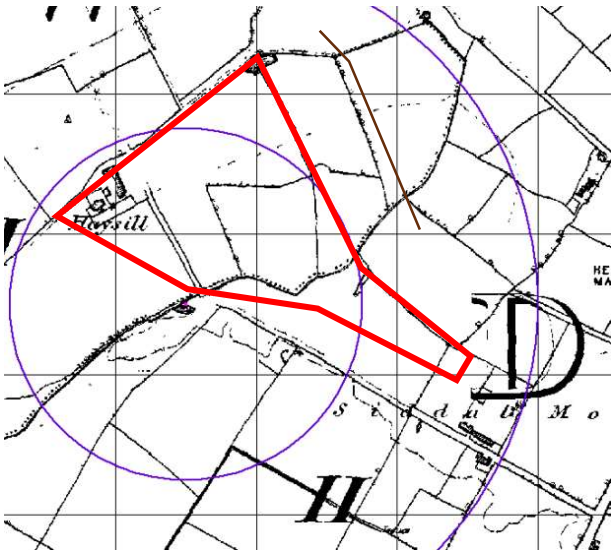
| MAP EDITION | HISTORICAL LAND USE | HISTORICAL MAP EXCERPT |
|---|---|---|
| 1848<br>1:10,560 | <p>The majority of the site is recorded as undeveloped agricultural land with Harehill farm located in the west of the site.</p> <p>A pond is recorded at the northern tip of the site.</p> | |

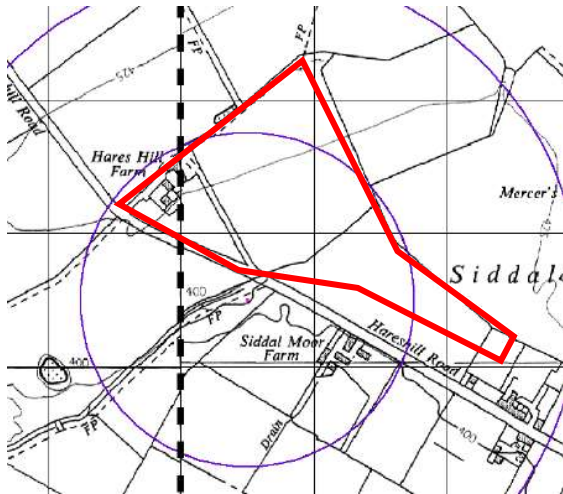
| MAP EDITION | HISTORICAL LAND USE | HISTORICAL MAP EXCERPT |
|---|---|---|
| <p>1965<br/>1:10,000</p> | <p>No significant changes are recorded to the subject site. The pond adjacent to the northern boundary is no longer recorded.</p> | |

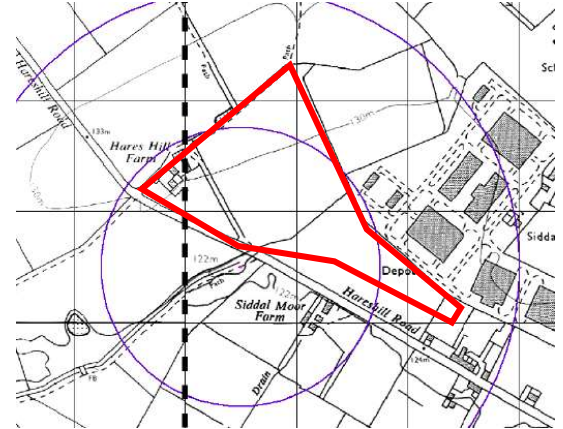
| MAP EDITION | HISTORICAL LAND USE | HISTORICAL MAP EXCERPT |
|---|---|---|
| <p>1974-77<br/>1:10,000</p> | <p>No significant changes are recorded to the subject site.</p> | |

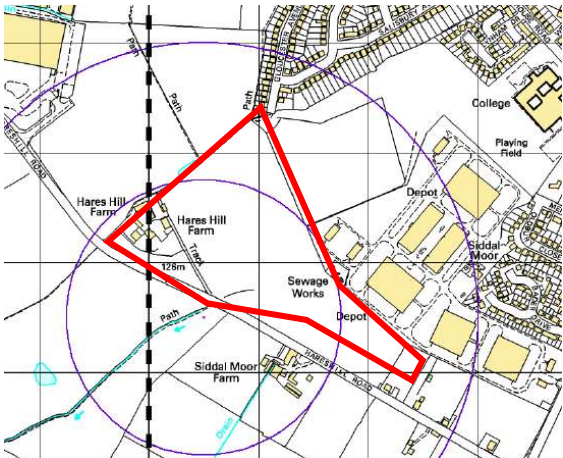
| MAP EDITION | HISTORICAL LAND USE | HISTORICAL MAP EXCERPT |
|---|---|---|
| <p>1999<br/>1:10,000</p> | <p>A field boundary in the south of the site is no longer present.</p> | |

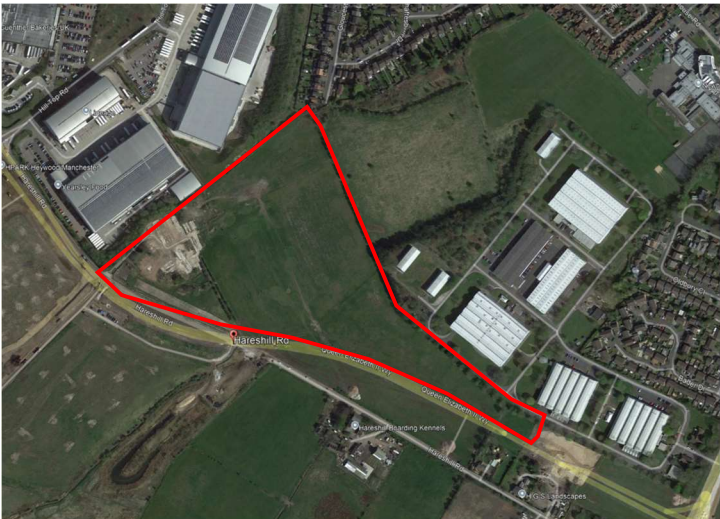
| MAP EDITION | HISTORICAL LAND USE | HISTORICAL MAP EXCERPT |
|---|---|---|
| <p>April 2021<br/>Google Earth Aerial Imagery</p> | <p>The farm buildings in the west of the site have been demolished.</p> | |

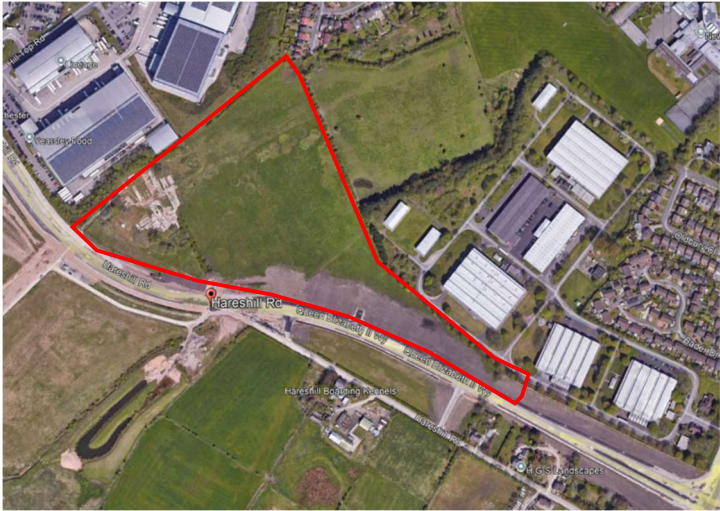
| MAP EDITION | HISTORICAL LAND USE | HISTORICAL MAP EXCERPT |
|---|---|---|
| <p>April 2022</p> <p>Google Earth Aerial Imagery</p> | <p>Ground workings are shown in the south of the site associated with the construction of the new link road to the south.</p> | |

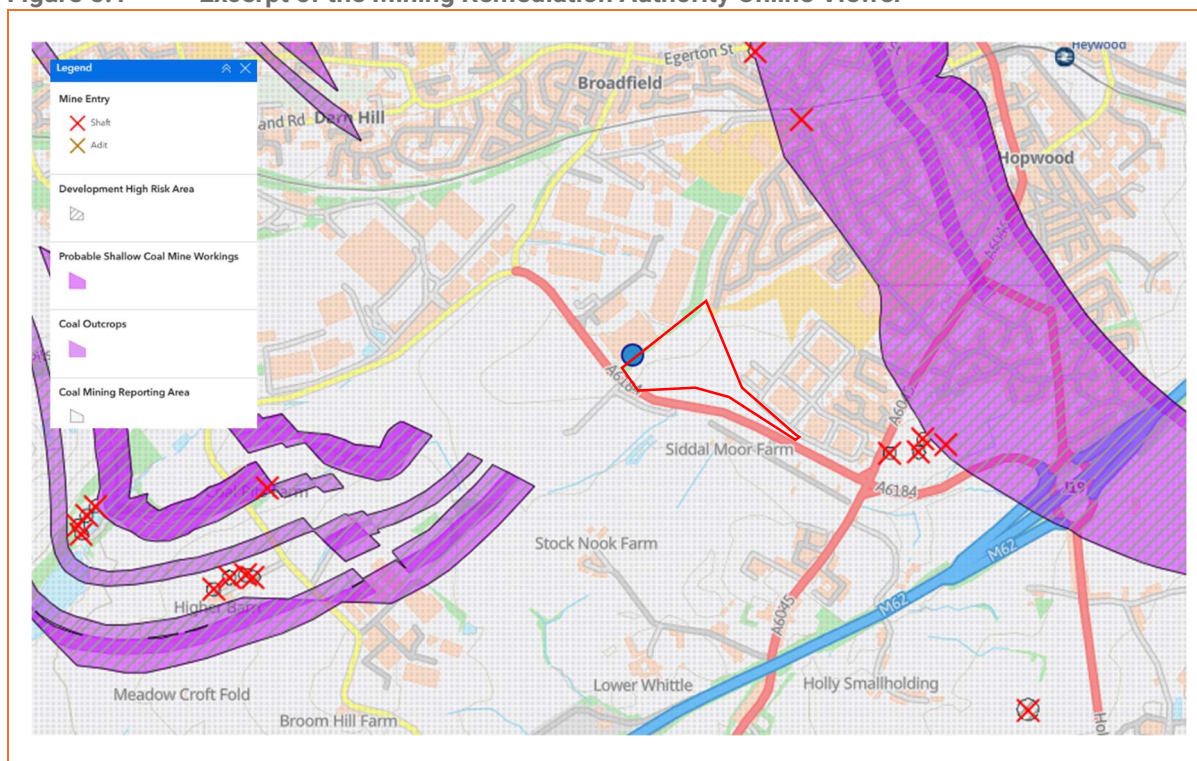
Figure 5.1 Excerpt of the Mining Remediation Authority Online Viewer

As the site is within an area affected by coal mining E3P has obtained a Consultant Coal Mining Report for the site (ref: 51002103708001.)

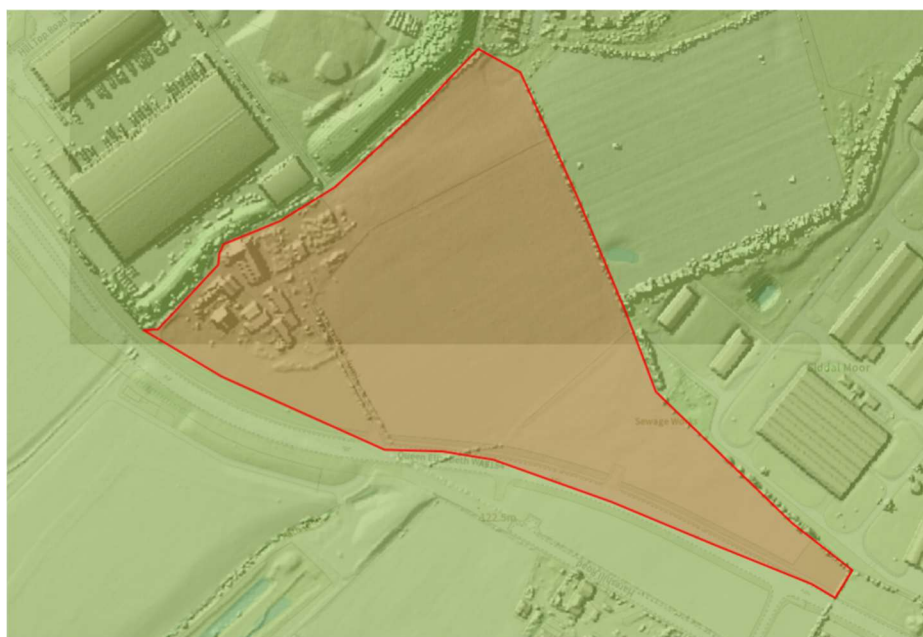
**Figure 6.1** Surface Lidar Data

With the exception of the development Hares Hill Farm, the site has undergone no significant historical development and the land broadly represents natural landform.

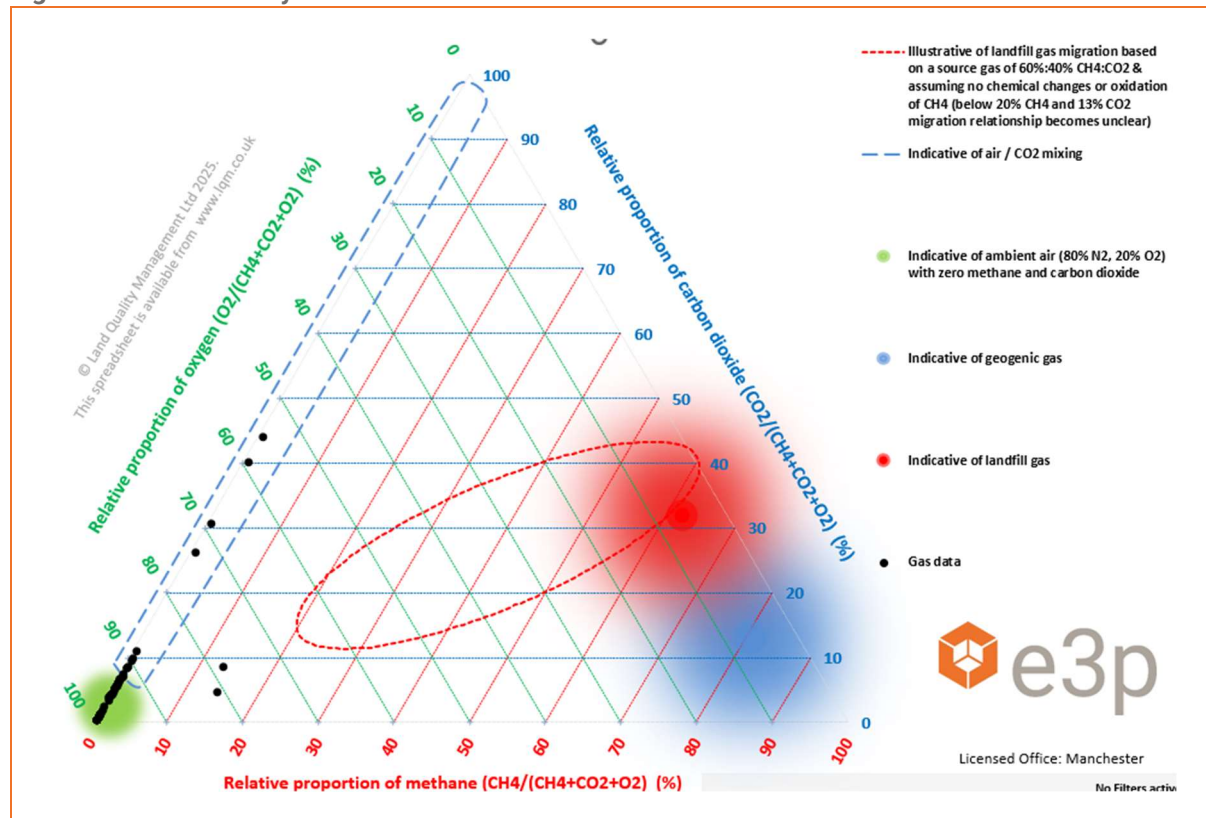
Figure 10.1 Ternary Gas Plot

The ternary gas plot suggests that the ground gas concentrations are indicative of ambient air and air/ $CO_2$  mixing, therefore there is considered to be a low risk.

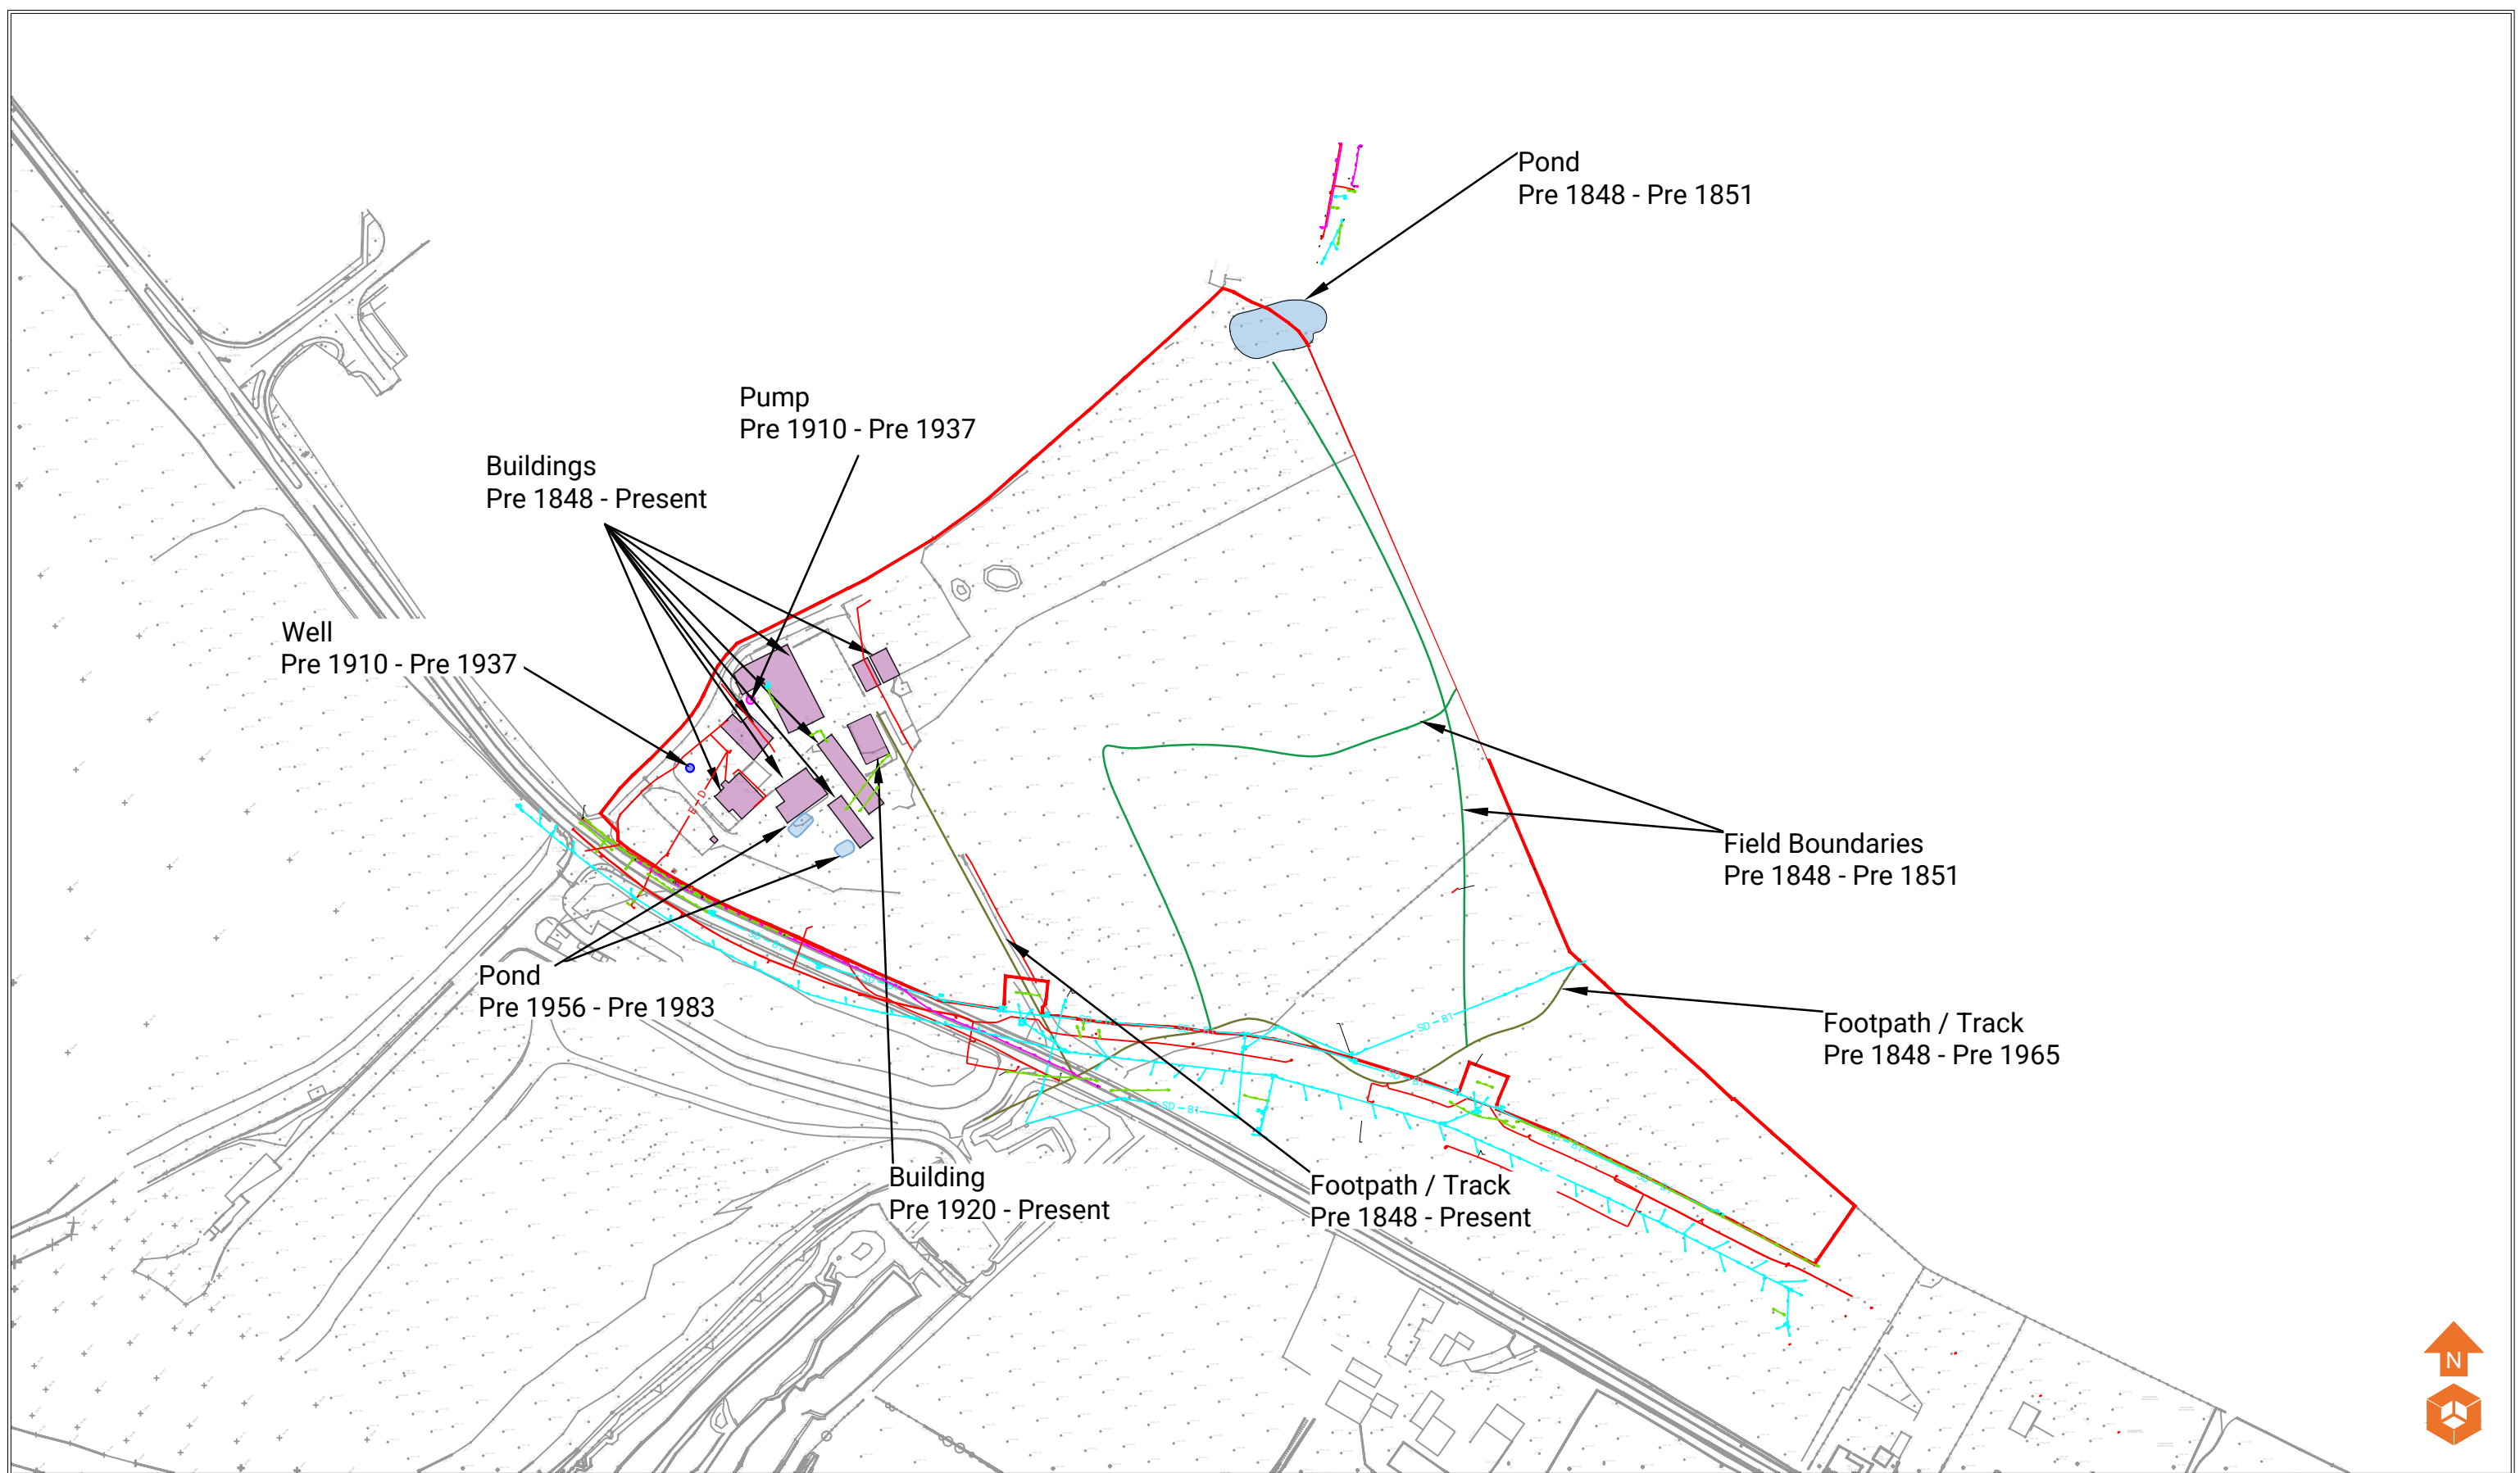
Historical Features Plan

Historical Features

- Embankment
- Ruin
- Well
- Pump
- Field Boundary
- Footpath / Track

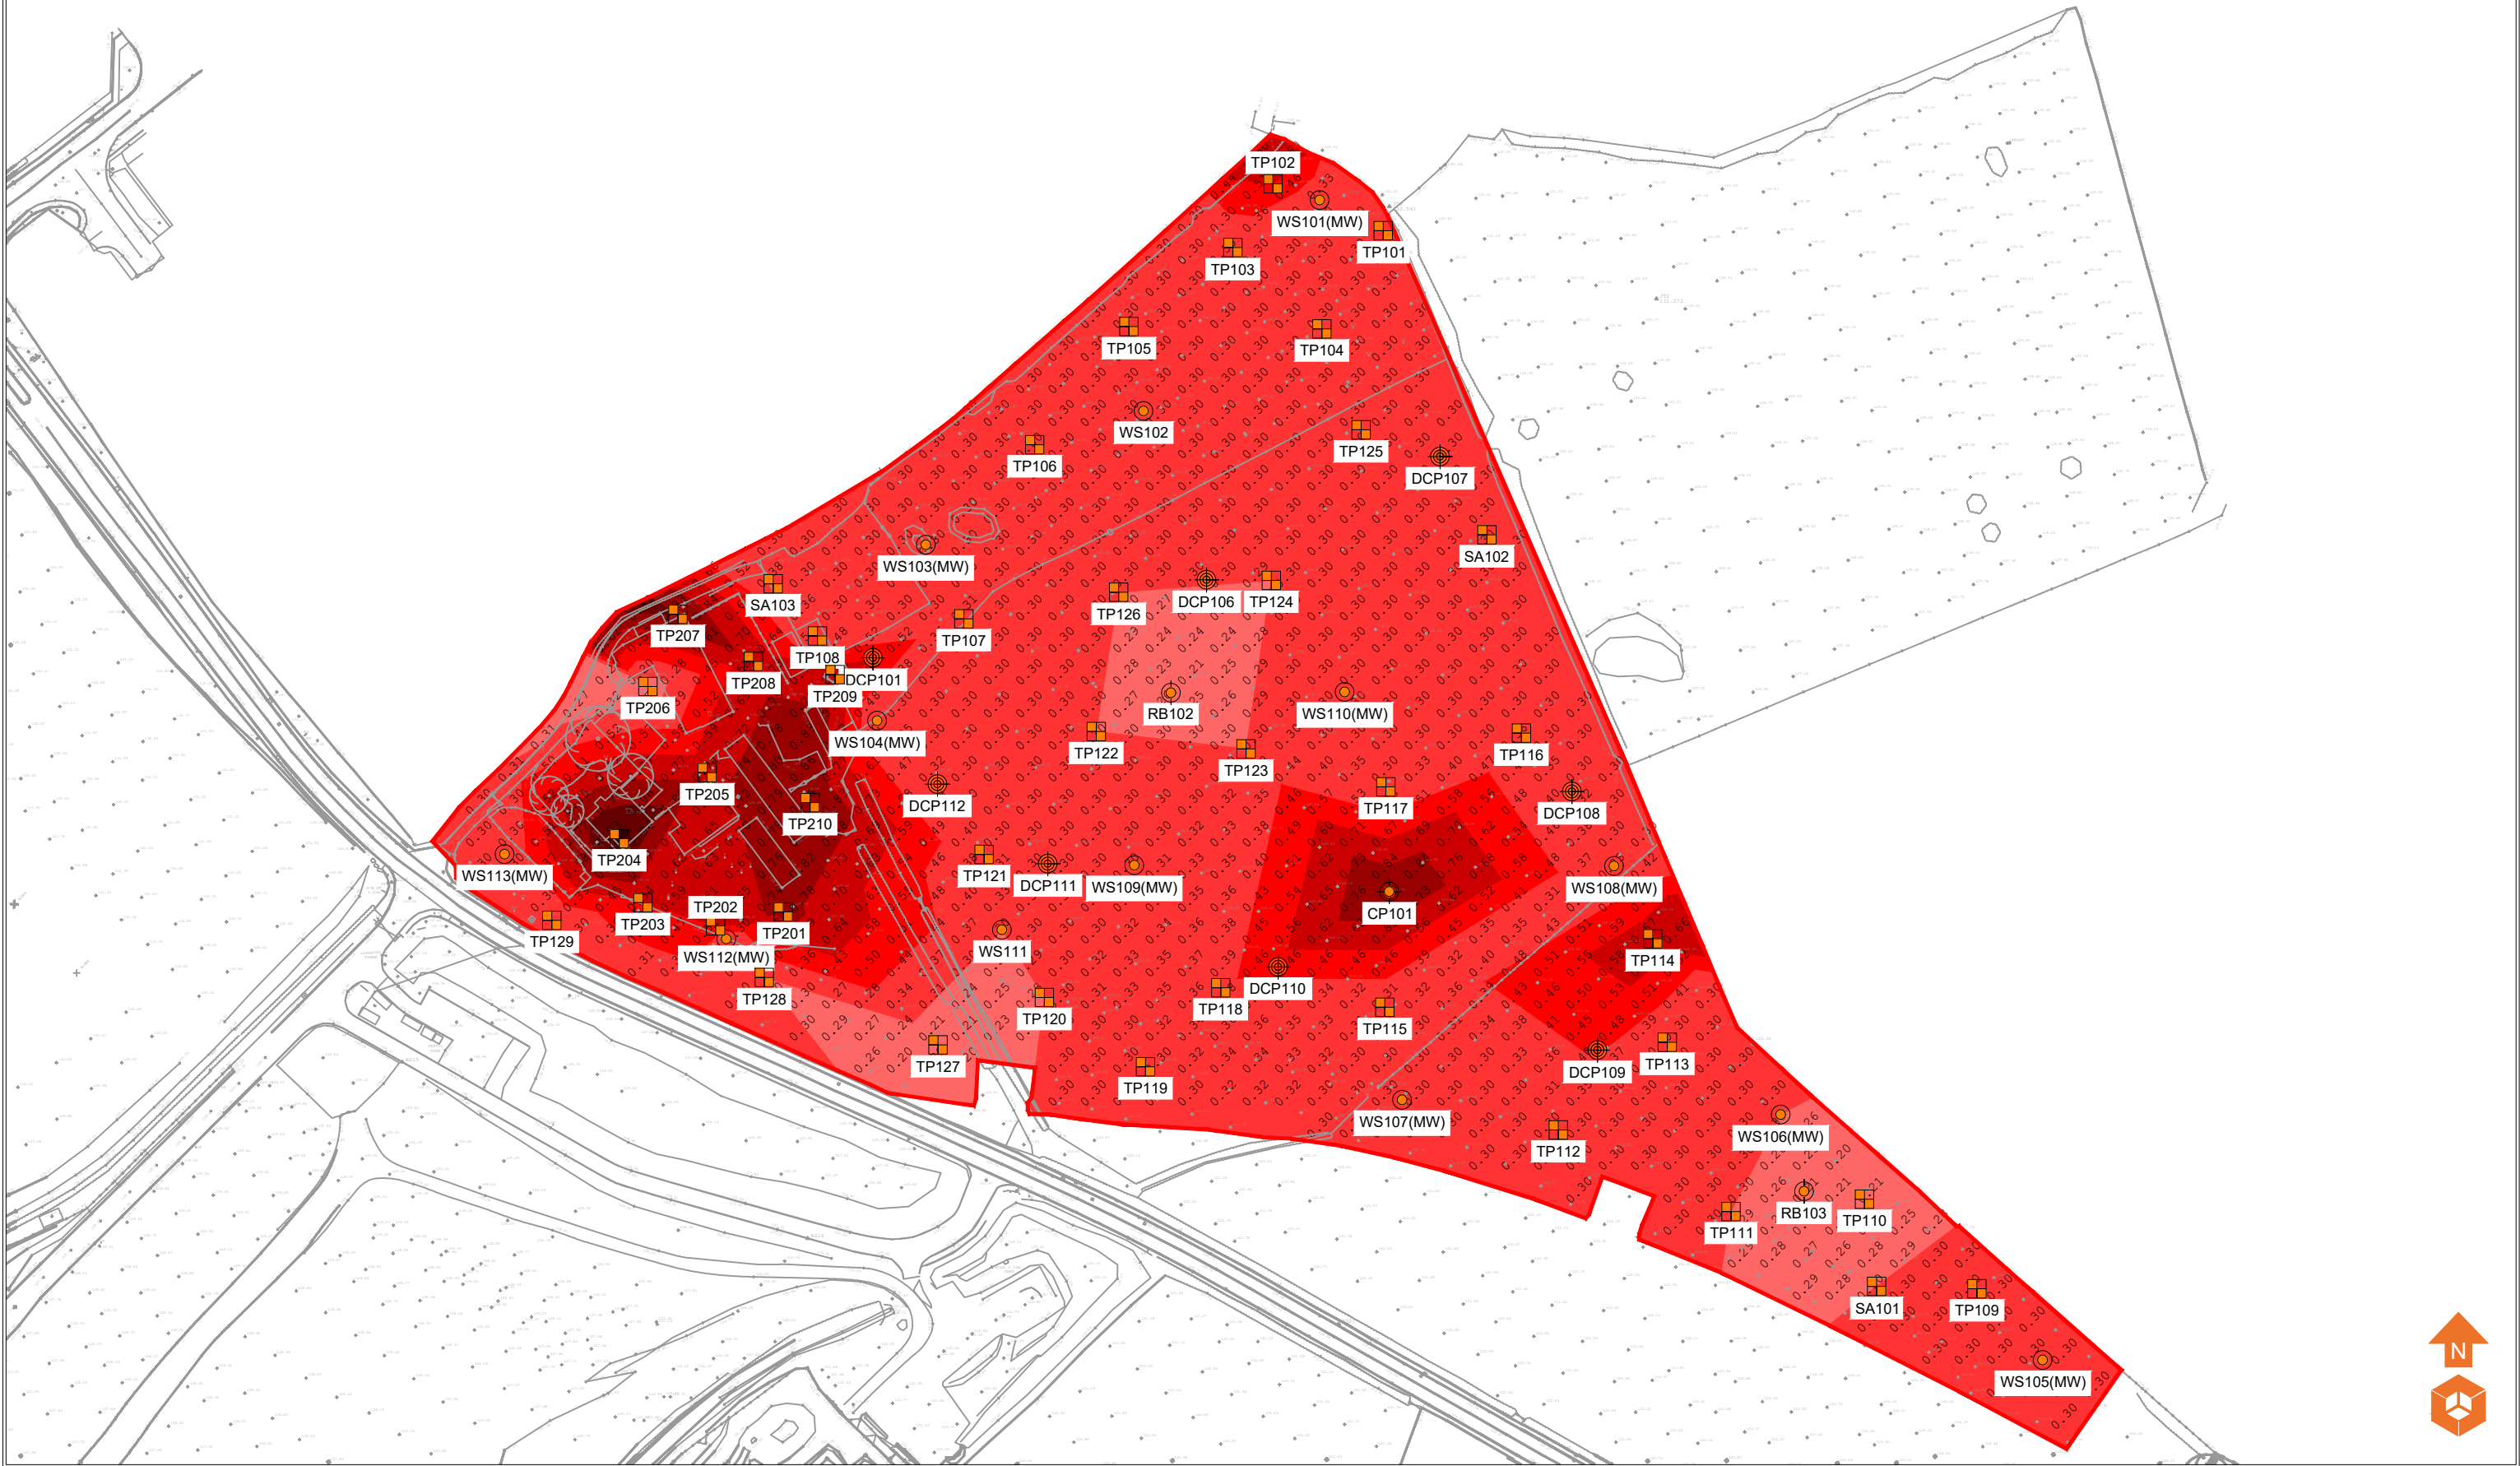
- Made Ground Depth (m)**
- Depth of Made Ground 0.00 - 0.14m
  - Depth of Made Ground 0.15 - 0.29m
  - Depth of Made Ground 0.30 - 0.44m
  - Depth of Made Ground 0.45 - 0.59m
  - Depth of Made Ground 0.60 - 0.74m
  - Depth of Made Ground 0.75 - 0.89m
  - Depth of Made Ground >0.90m

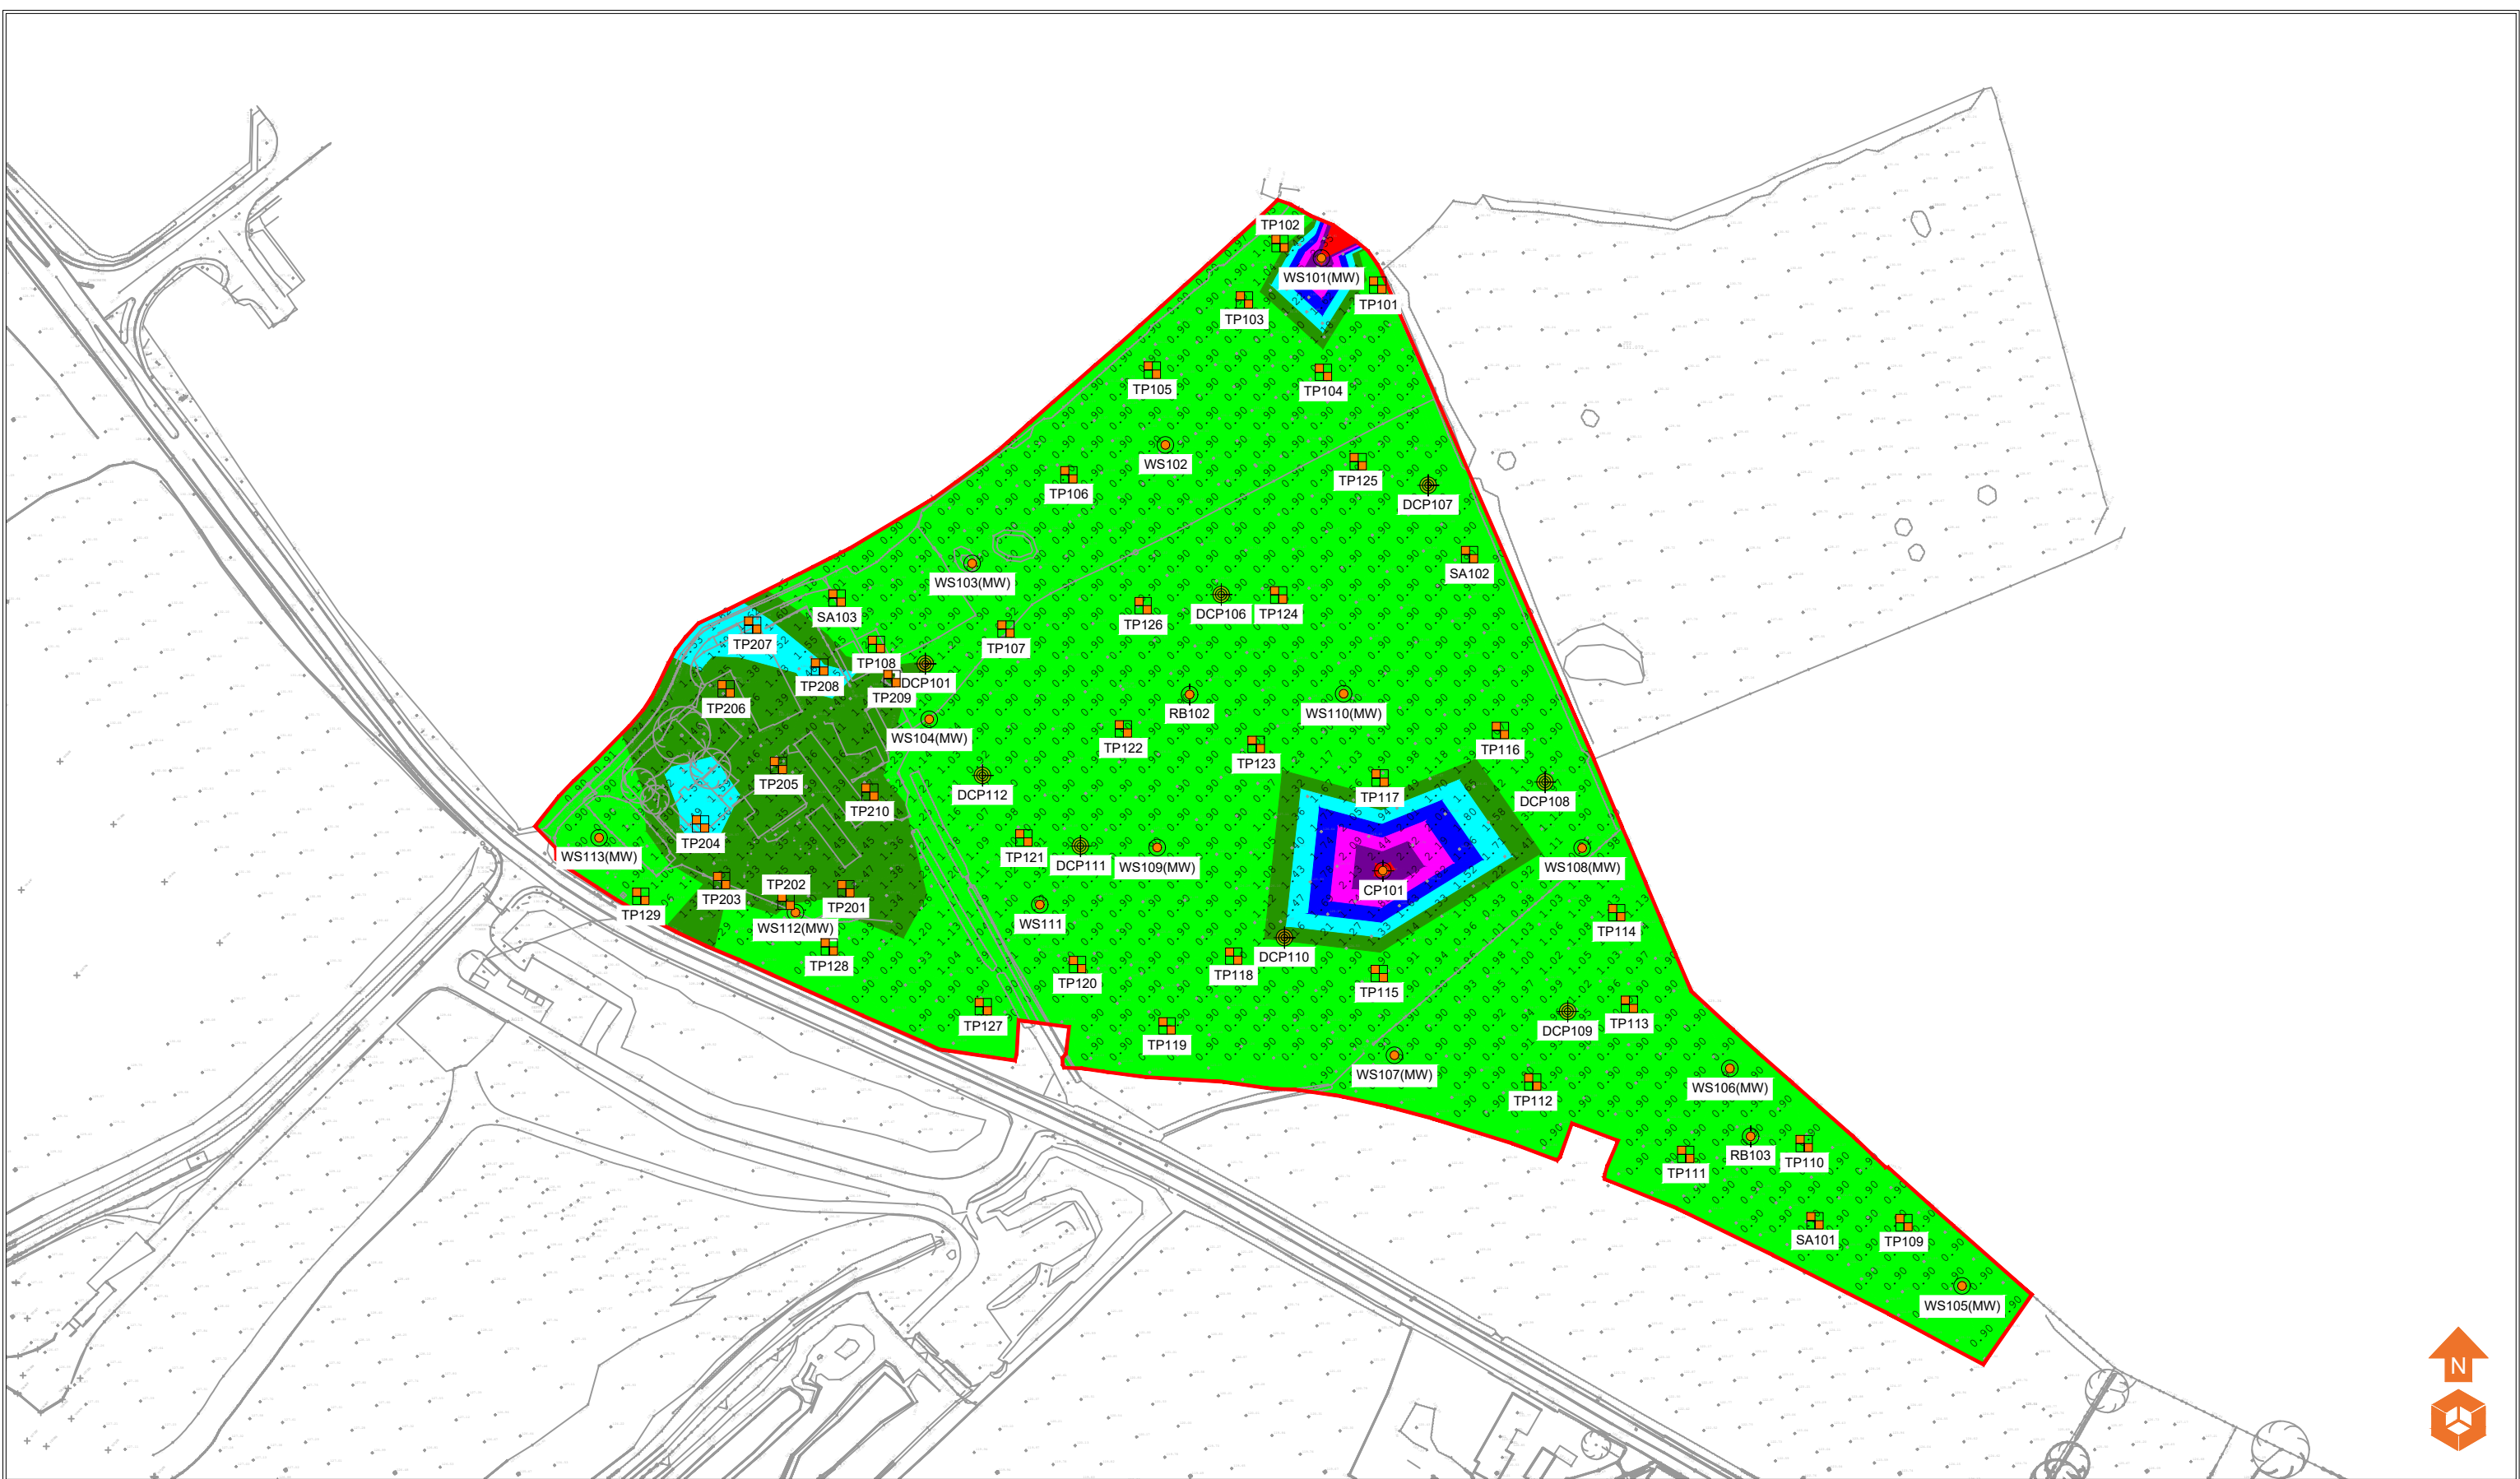
- Shallow Spread Footings**
- Depth to Founding Strata 0.00 - 1.24m
  - Depth to Founding Strata 1.25 - 1.49m
- Mass Trench Fill Footings**
- Depth to Founding Strata 1.50 - 1.74m
  - Depth to Founding Strata 1.75 - 1.99m
  - Depth to Founding Strata 2.00 - 2.24m
- Engineered Footings**
- Depth to Founding Strata 2.25 - 2.49m
  - Depth to Founding Strata >2.50m

| <b>Foundation Options</b> | <p>Based on existing data and given the predominantly cohesive ground conditions, it is considered that the majority of the proposed dwellings could be constructed using traditional spread footings bearing in the firm to stiff Clay at a depth from 1.00 m to 1.50 m below current ground levels.</p> <p>Where deeper variable soft natural clays, or loose sand and gravels are identified, dependent on development levels, plots may require locally deepened to Mass Trench Fill. Alternatively, it is recommended that Ground Improvement by VSC be considered to ensure a safe and uniform ABP for a doubly reinforced strip foundation bearing within the treated sub-stratum.</p> <p>In the location of soft clays, plots will require a driven pile foundation due the incompatibility with VSC.</p> <p>It is recommended that at working drawing stage, a foundation schedule is prepared for the development taking account of the physical change of natural clay soils and the current/proposed locations of trees.</p> |

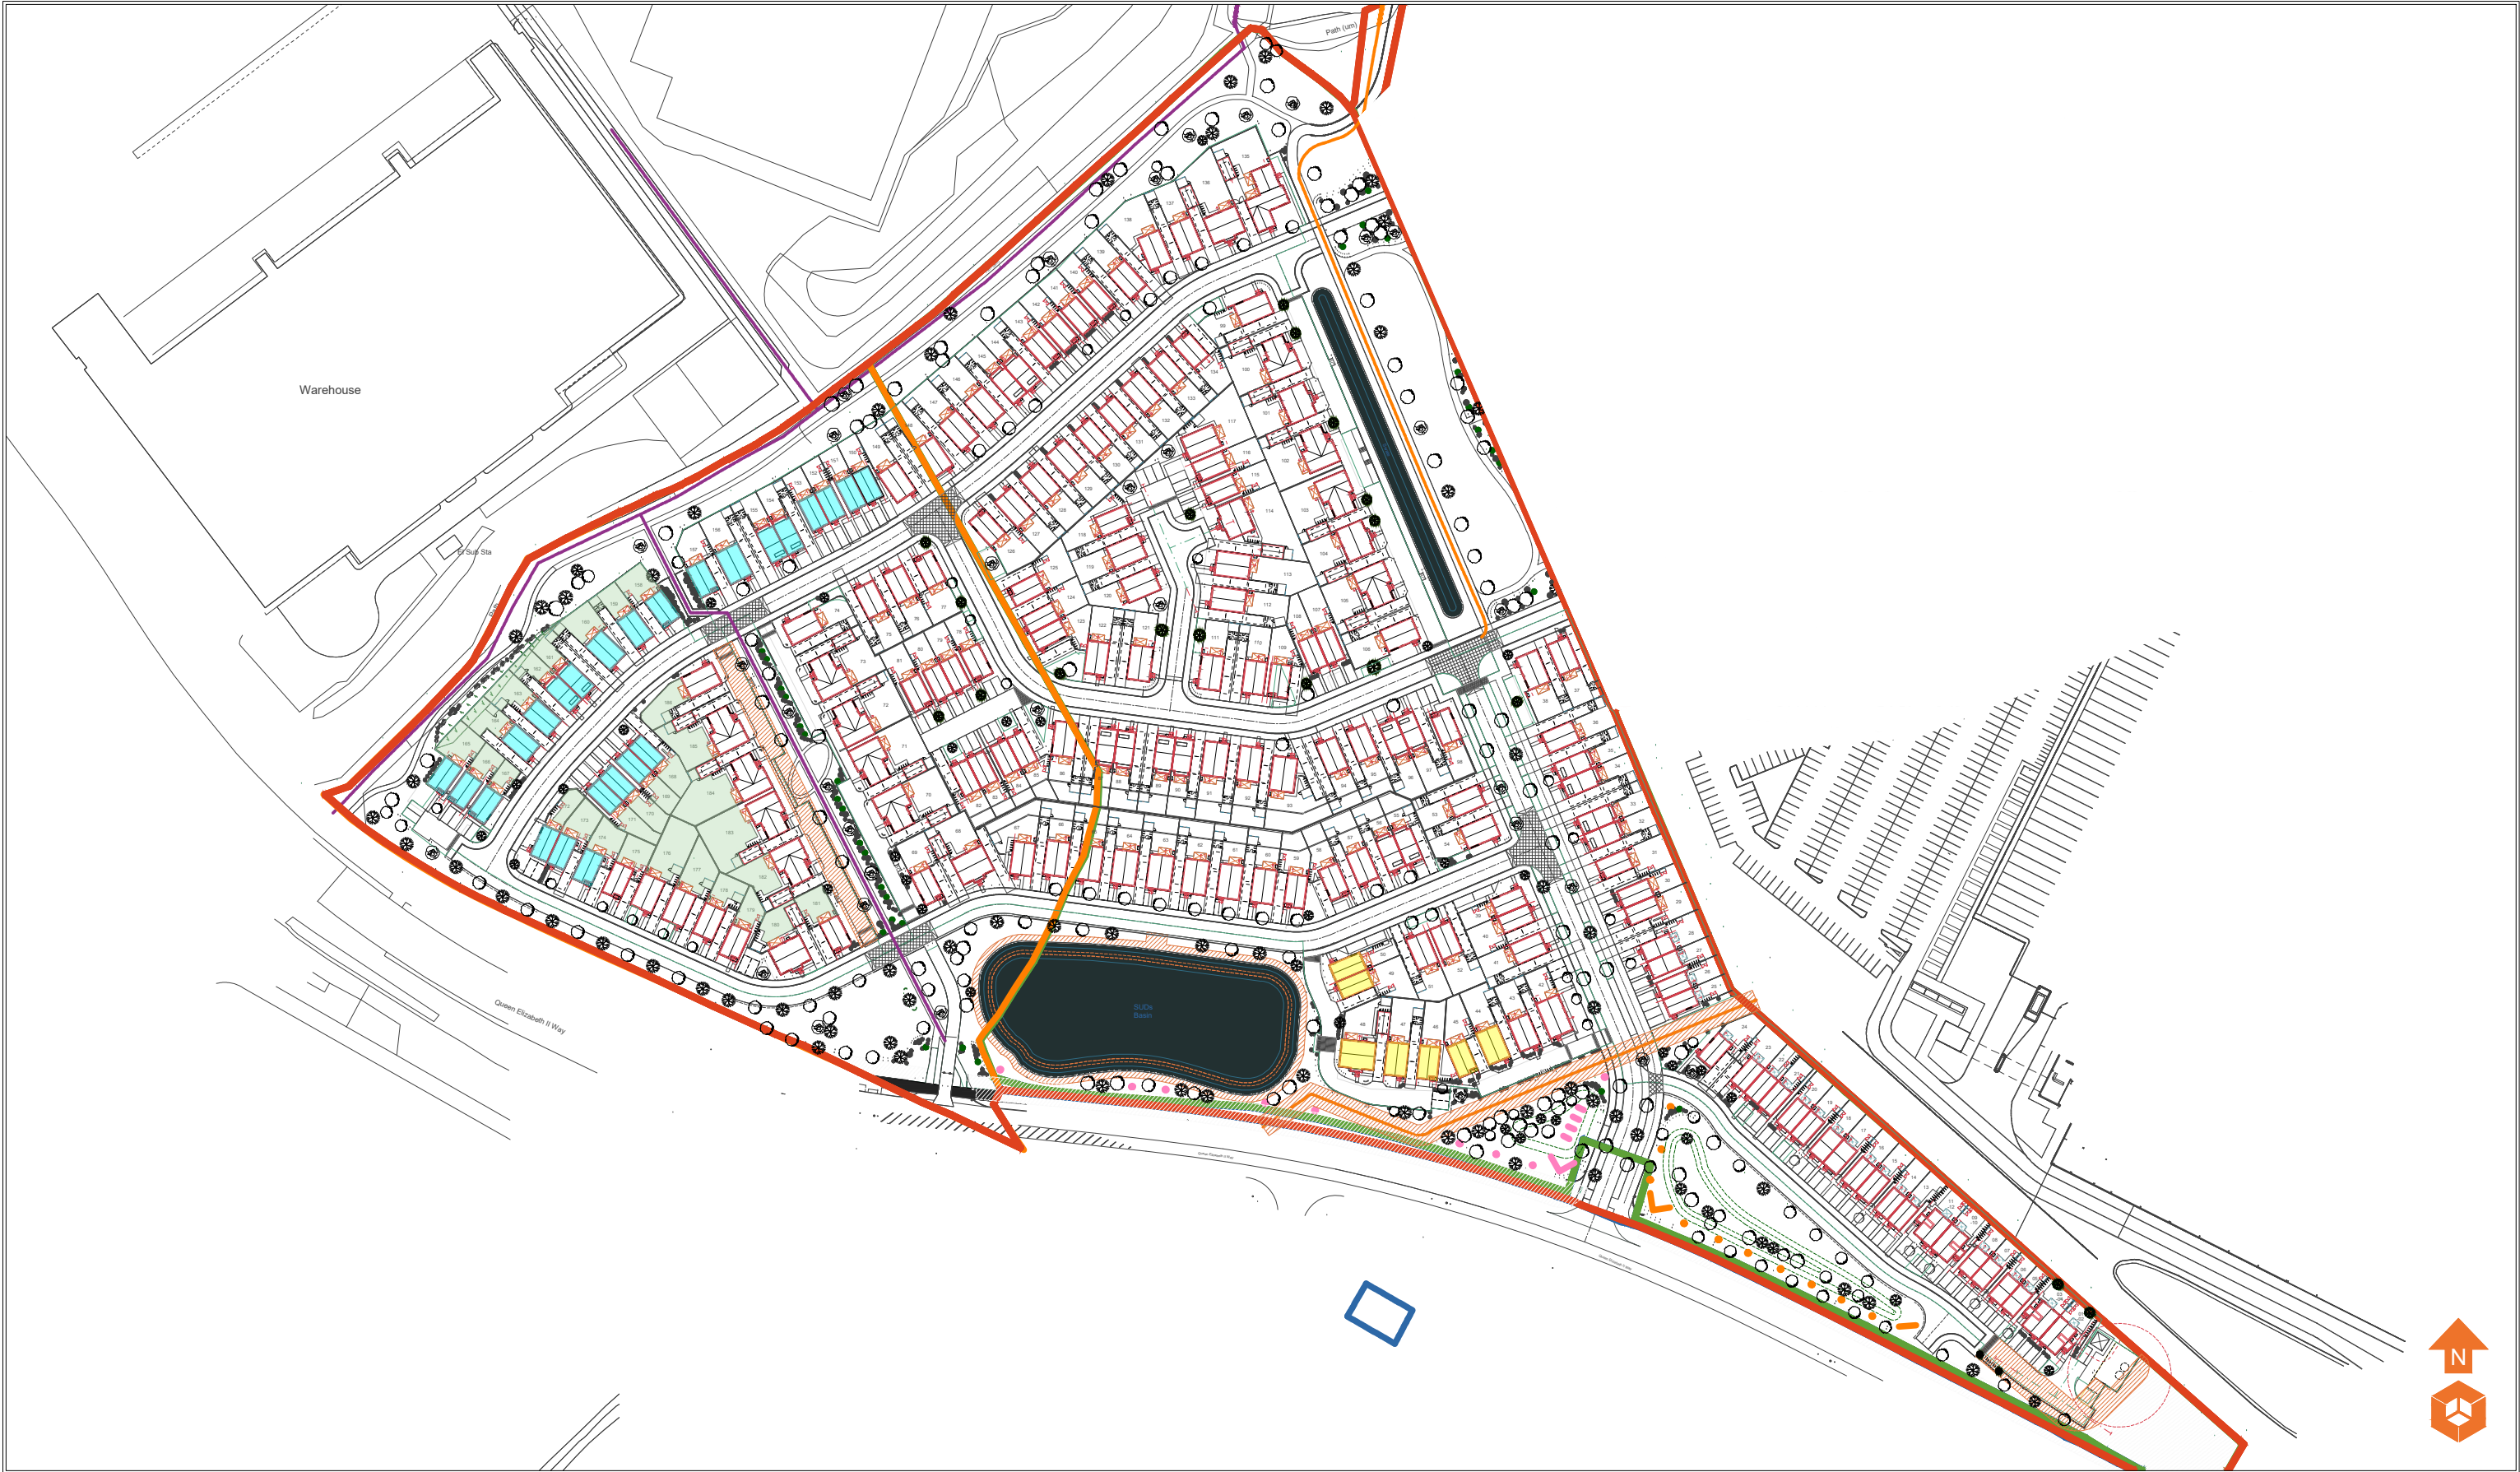
- Key
- Plots Requiring 600mm Clean Cover System
  - Plots Requiring Basic Radon Protection Measures
  - Plots Requiring Precautionary CS2 Measures

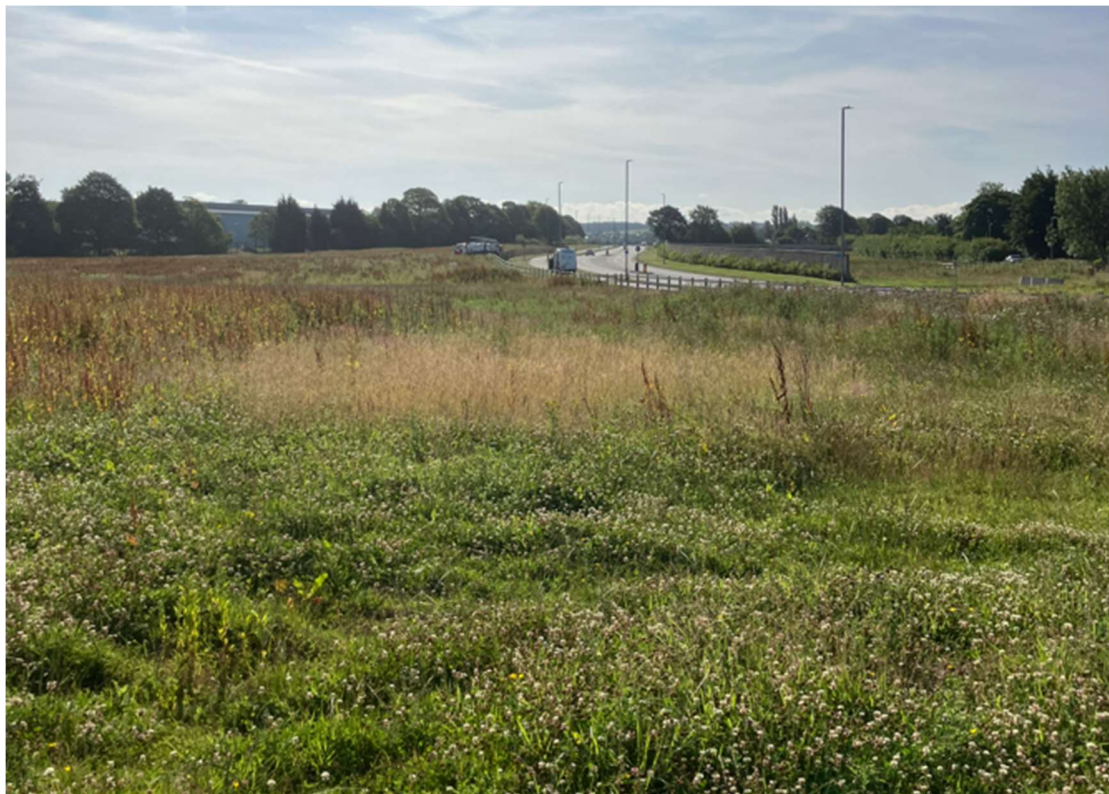
**PLATE 1 – VIEW FROM WEST TO SOUTHEAST**
