# PHASE I AND II GEOENVIRONMENTAL SITE ASSESSMENT

| Site: | Hareshill Road, South Heywood |
| References: | 18-435-R1-3 |
| Client: | Northstone |

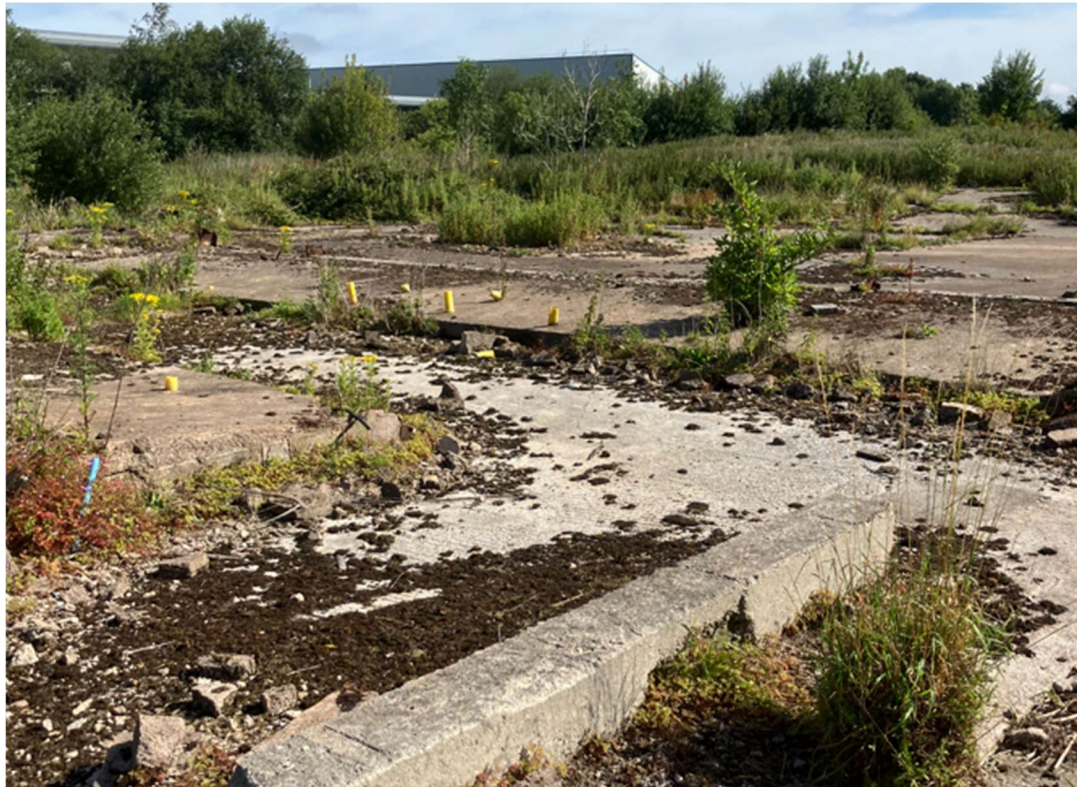
#### PLATE 5 – REMNANT SLABS AND WALLS AT FORMER HARES HILL FARM

- ✦ Given the predominantly undeveloped nature of the site, it is likely there will be limited Made Ground fill deposits and obstructions. Existing buildings have been demolished to ground level, however, all relict foundations and sub-surface structures will require grubbing out before the proposed development's construction.

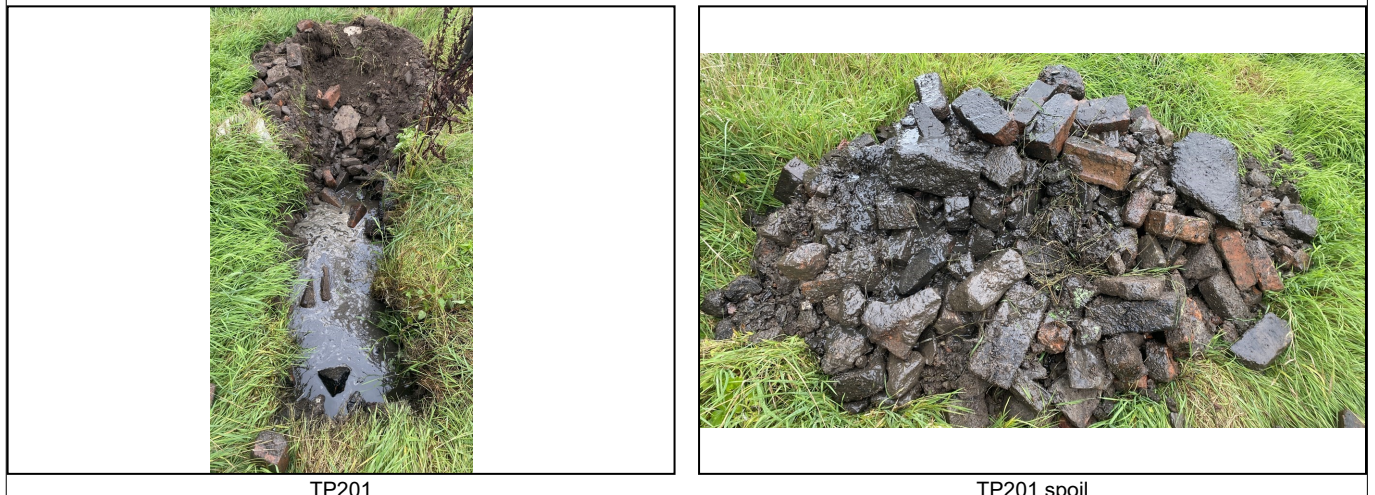
TP201

TP201 spoil

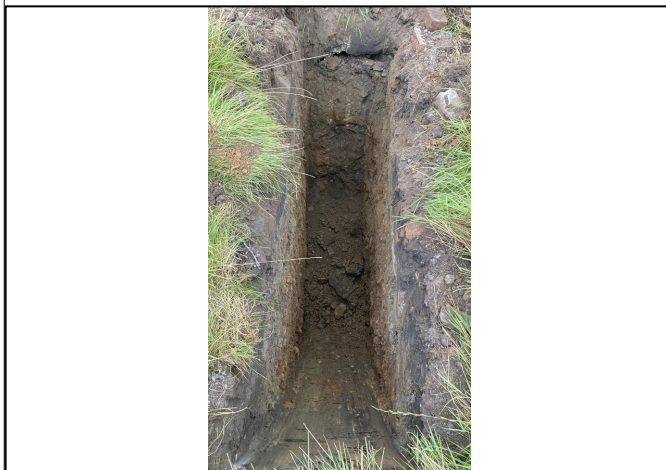
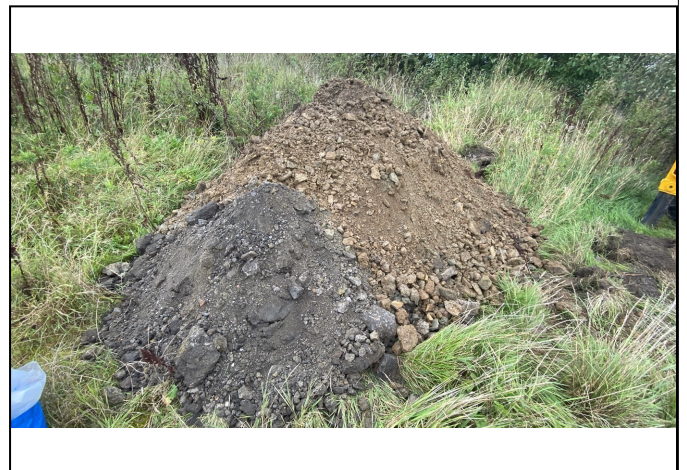
TP202

TP202 spoil

Remarks: 1. Complete. 2. Water strike encountered at 2.80 m bgl as minor ingress.

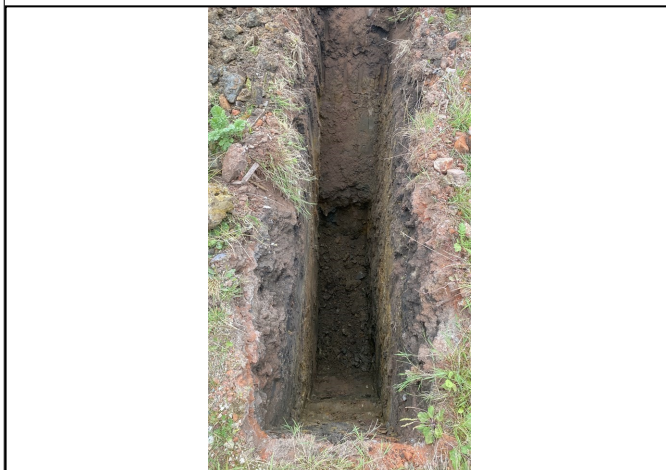
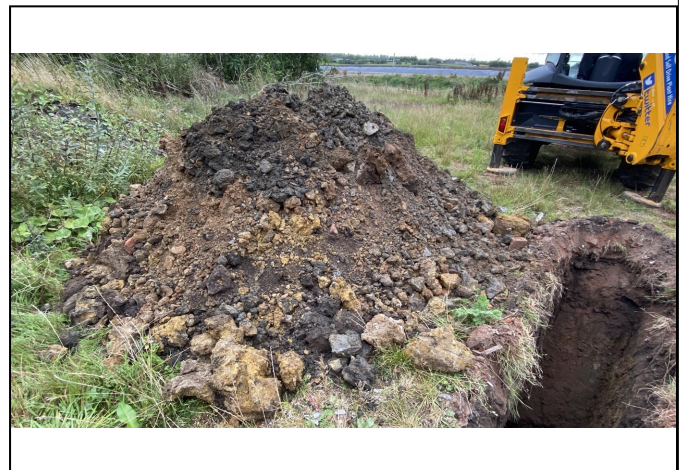
TP204

TP204 spoil

Remarks: 1. Complete.

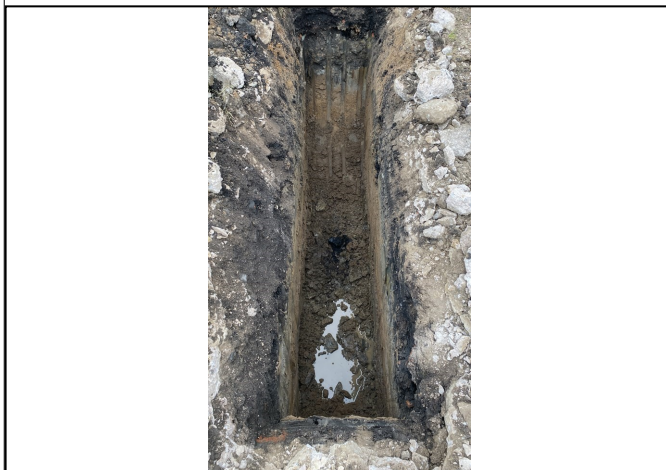
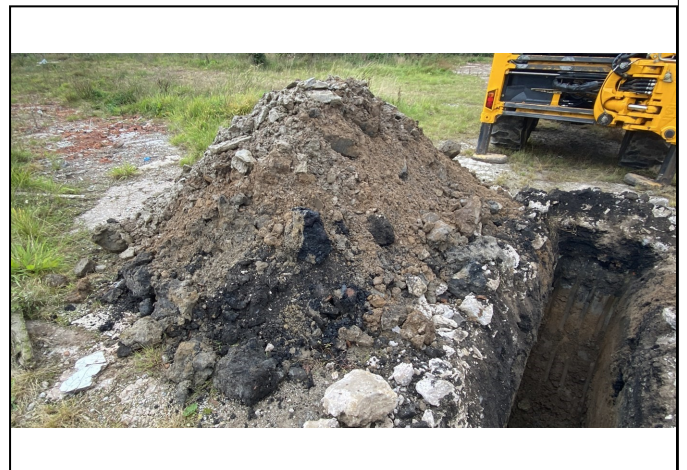
TP205

TP205 spoil

Remarks: 1. Complete. 2. Water strike encountered at 2.40 m bgl.

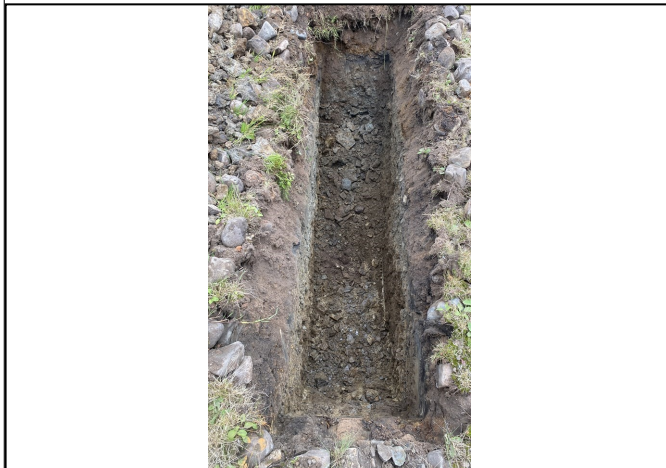
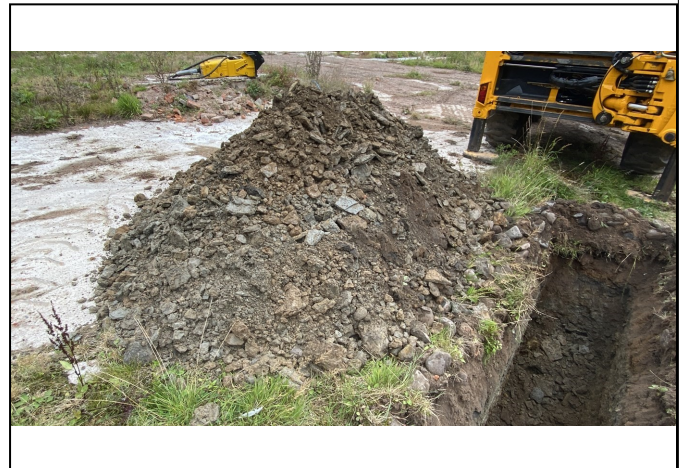
TP206

TP206 spoil

Remarks: 1. Complete. 2. Water strike encountered at 1.50 m bgl.

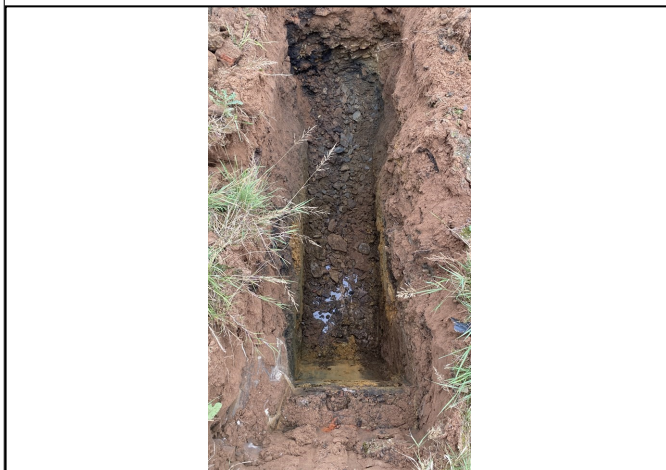
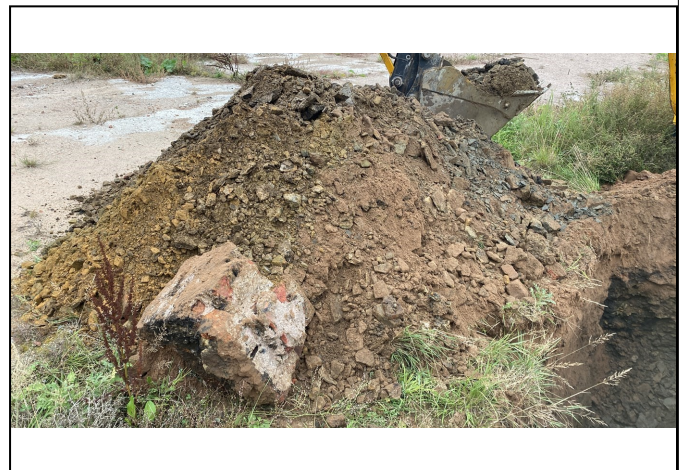
TP207

TP207 spoil

Remarks: 1. Complete. 2. Water strike encountered at 2.00 m bgl.

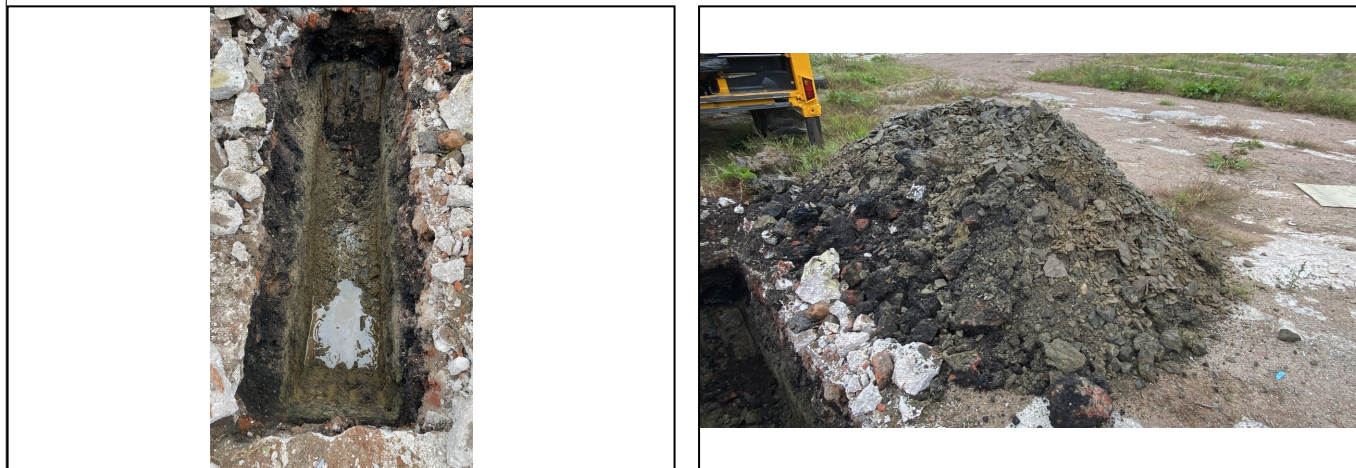
TP208

TP208 spoil

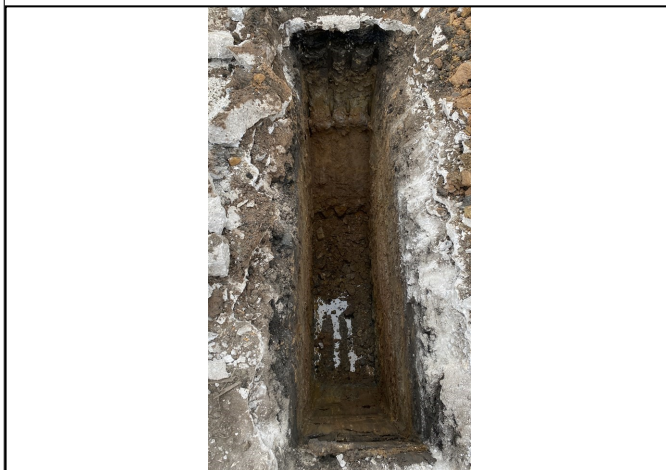
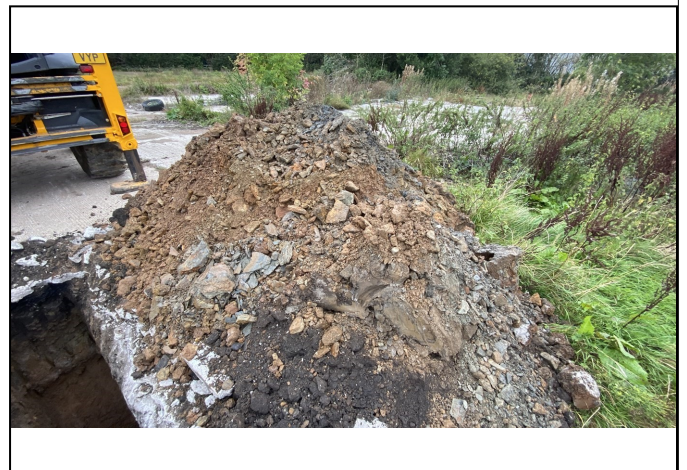
TP209

TP209 spoil

Remarks: 1. Complete. 2. Water seepage at 2.40m bgl.

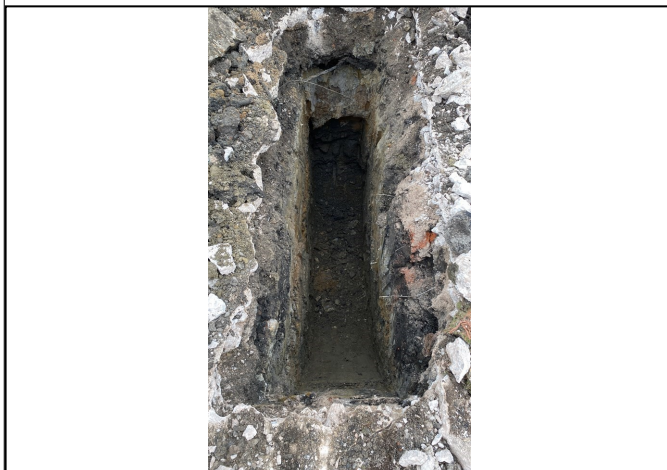
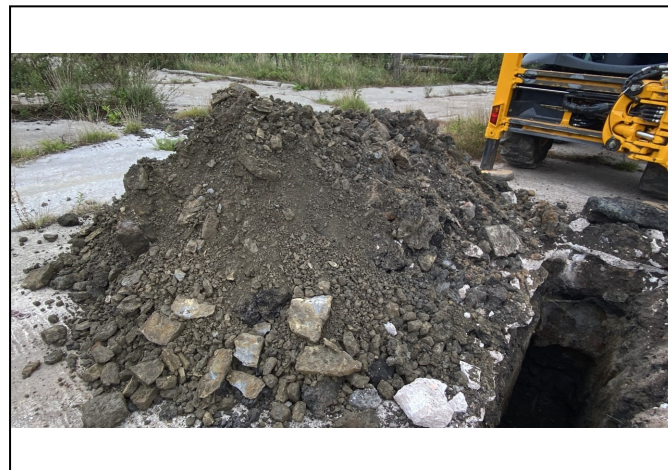
TP210

TP210 spoil

Remarks: 1. Complete.

Stability: Stable.

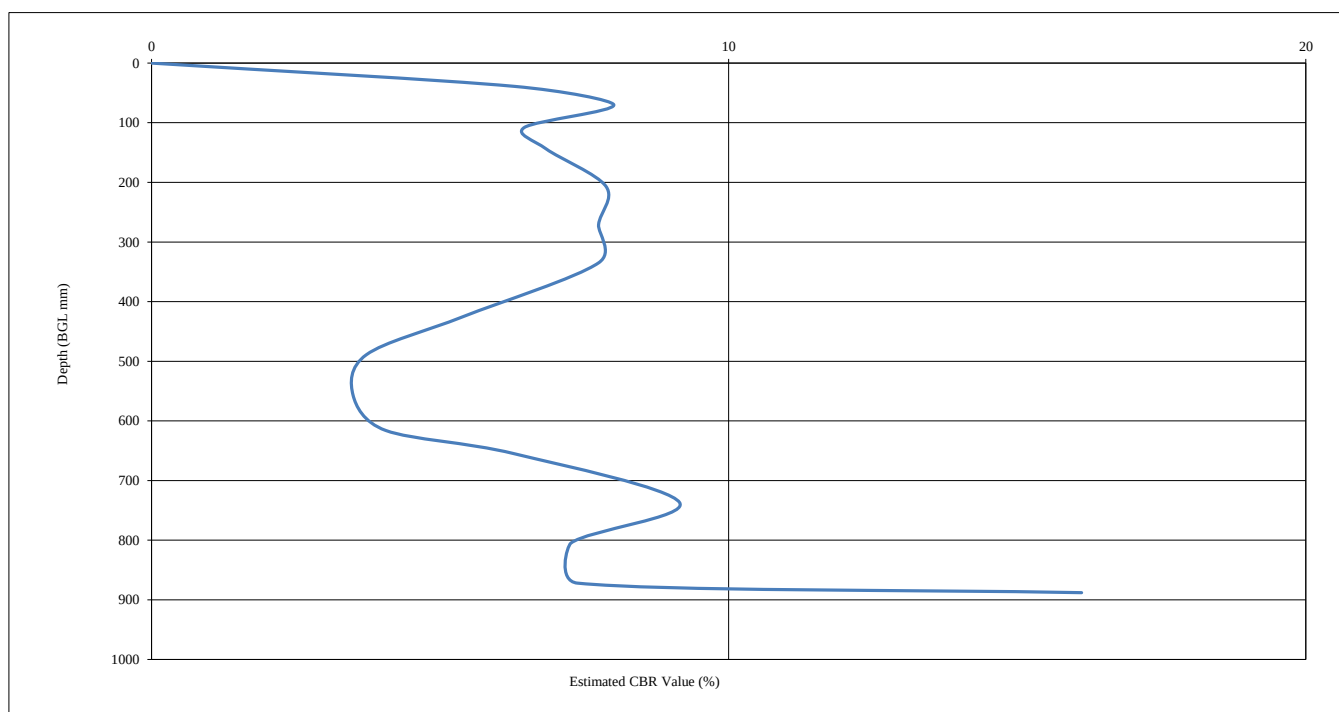
#### Estimated California Bearing Ratio Graph

| Start Depth (mm) BGL | Finish Depth (mm) BGL | No. of Blows | Blows Per Layer | DCP mm/Blows | Ave Estimated Layer (CBR %) |
| 0 | 335 | 10 | 10 | 33.50 | 7.38 |

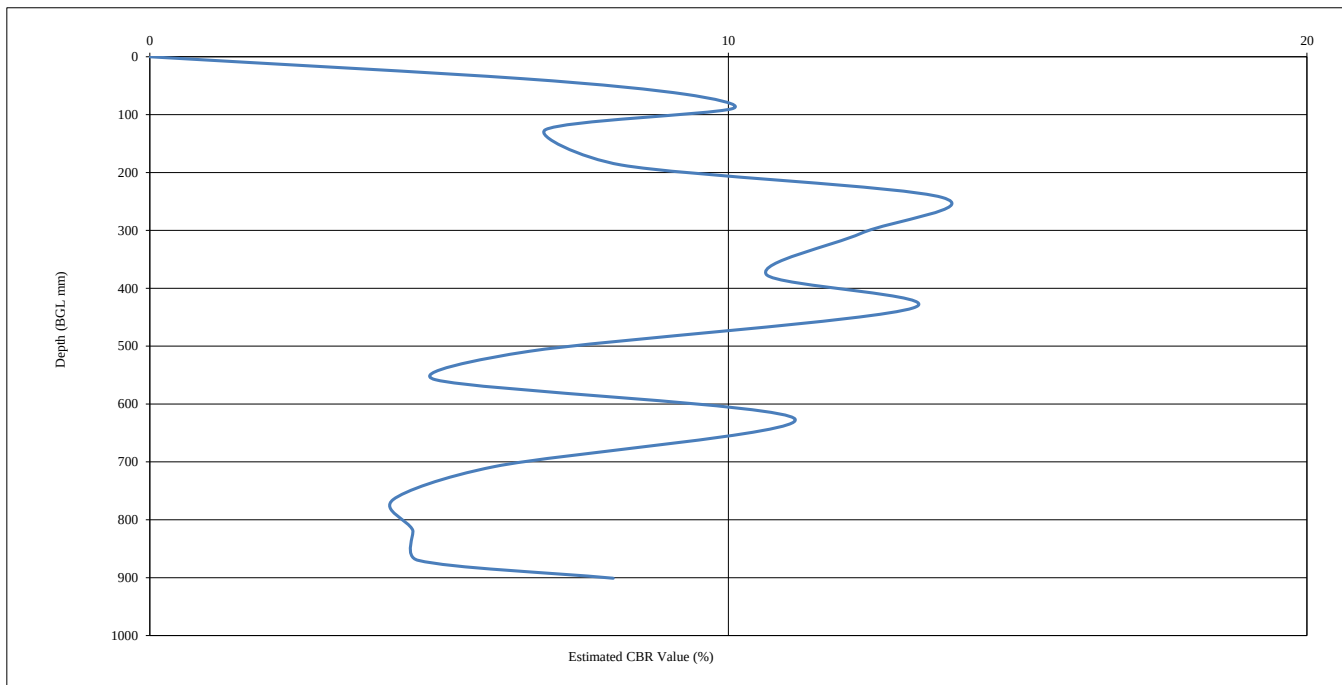
## Estimated California Bearing Ratio Graph

| Start Depth (mm) BGL | Finish Depth (mm) BGL | No. of Blows | Blows Per Layer | DCP mm/Blows | Ave Estimated Layer (CBR %) |
| 0 | 243 | 9 | 9 | 27.00 | 9.27 |

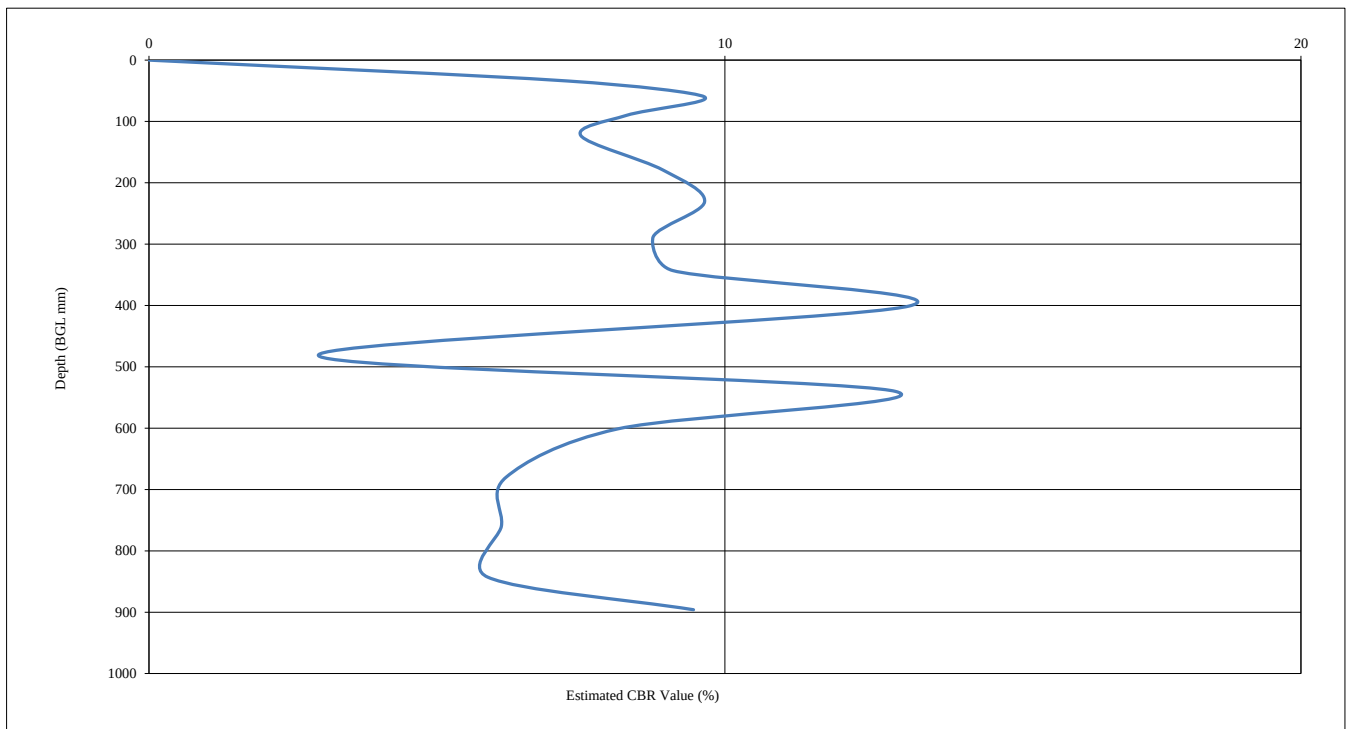
## Estimated California Bearing Ratio Graph

| Start Depth (mm) BGL | Finish Depth (mm) BGL | No. of Blows | Blows Per Layer | DCP mm/Blows | Ave Estimated Layer (CBR %) |
| 0 | 343 | 12 | 12 | 28.58 | 8.73 |

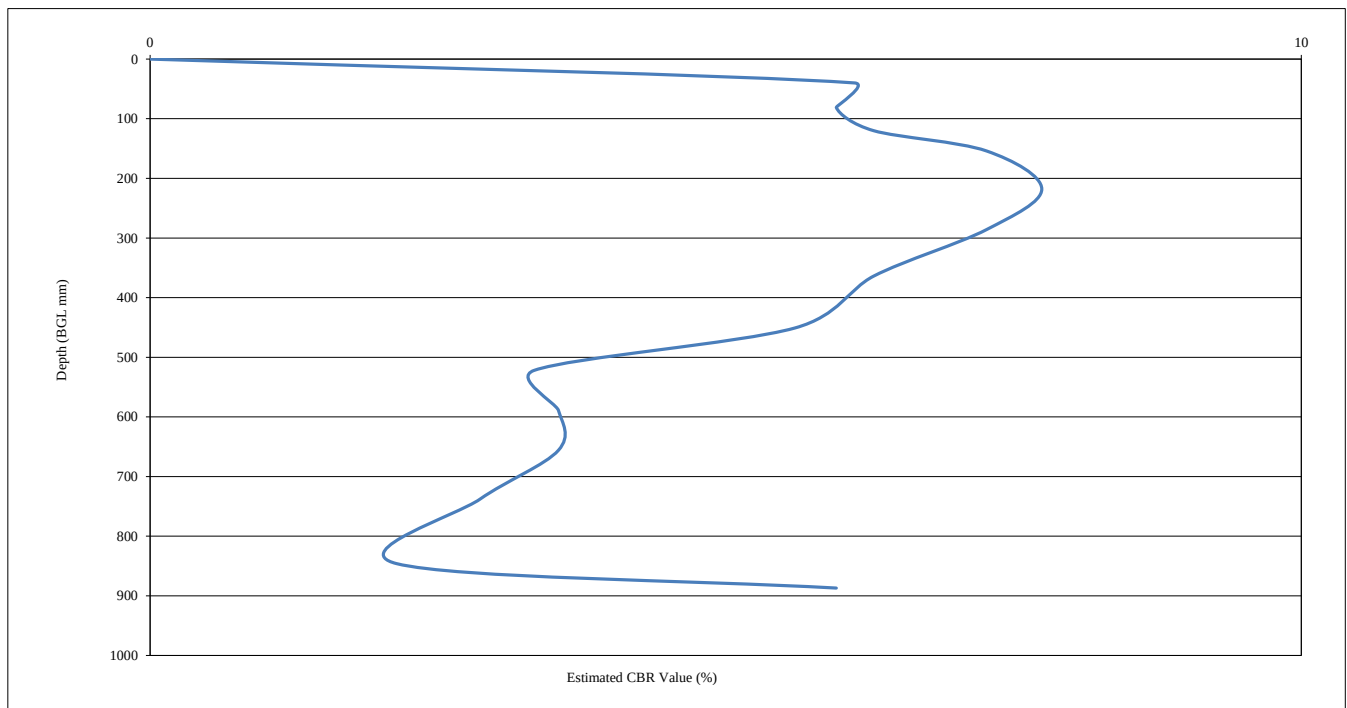
## Estimated California Bearing Ratio Graph

| Start Depth (mm) BGL | Finish Depth (mm) BGL | No. of Blows | Blows Per Layer | DCP mm/Blows | Ave Estimated Layer (CBR %) |
| 0 | 154 | 4 | 4 | 38.50 | 6.37 |

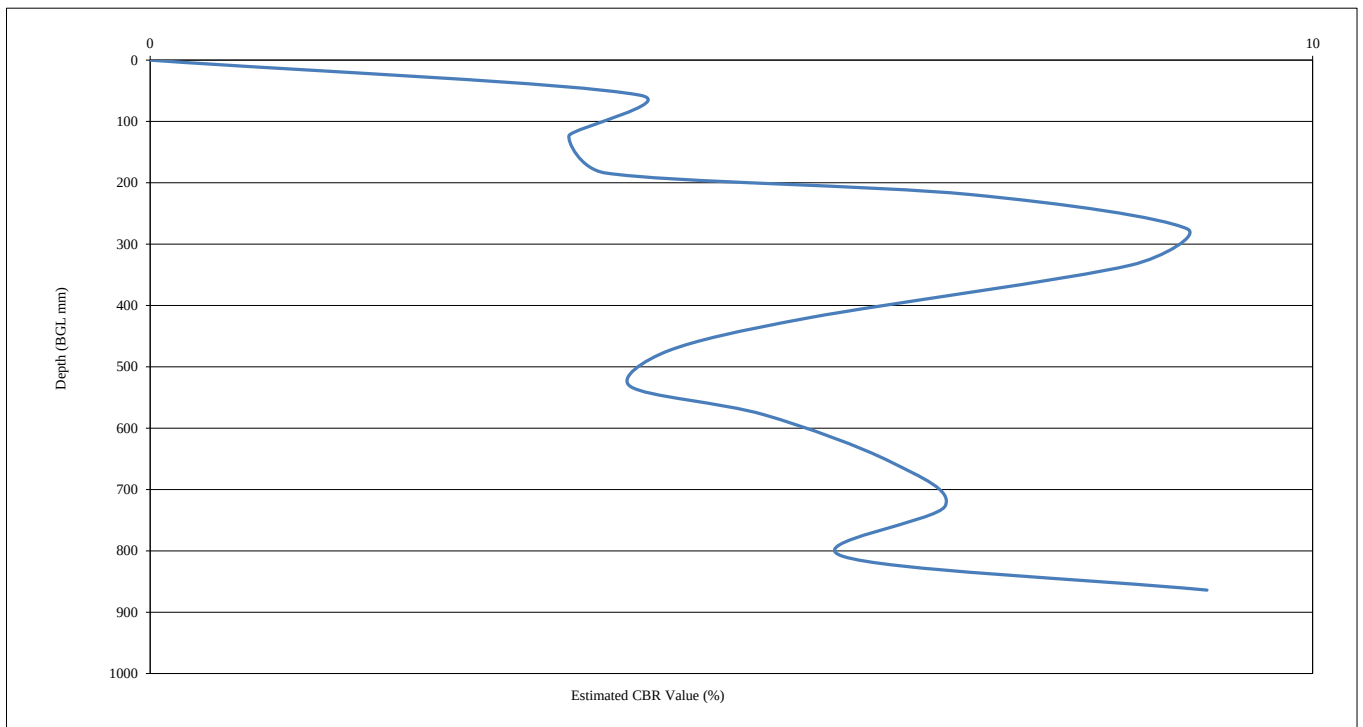
## Estimated California Bearing Ratio Graph

| Start Depth (mm) BGL | Finish Depth (mm) BGL | No. of Blows | Blows Per Layer | DCP mm/Blows | Ave Estimated Layer (CBR %) |
| 0 | 184 | 3 | 3 | 61.33 | 3.89 |
