Report No: C795/RS-Rev 2  
Date: March 2026

**REMEDIATION STRATEGY**  
**for land off**  
**WATERFOLD LANE, HEYWOOD, BURY,**  
**LANCASHIRE**

Prepared for  
**JHA Pulmann Ltd**

Prepared by  
G&M Consulting Ltd, The Chestnuts, Brackenhill Road, Haxey, Doncaster DN9 2LR

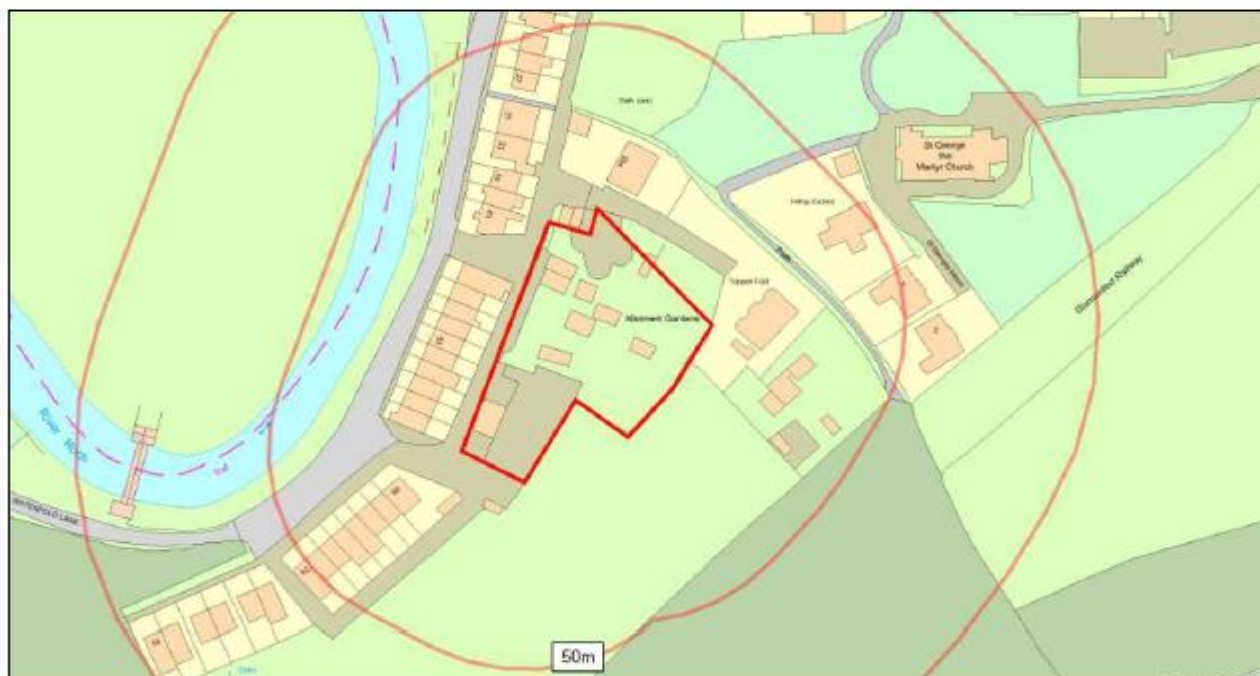
**Figure A:** Site Location Plan. Red is approximate site boundary and pink are 50m and 100m buffers.  
Extract from Envirocheck report (Appendix C).

The area shown within the red site boundary on Figure A below, will be referred to throughout this document as 'the site'.

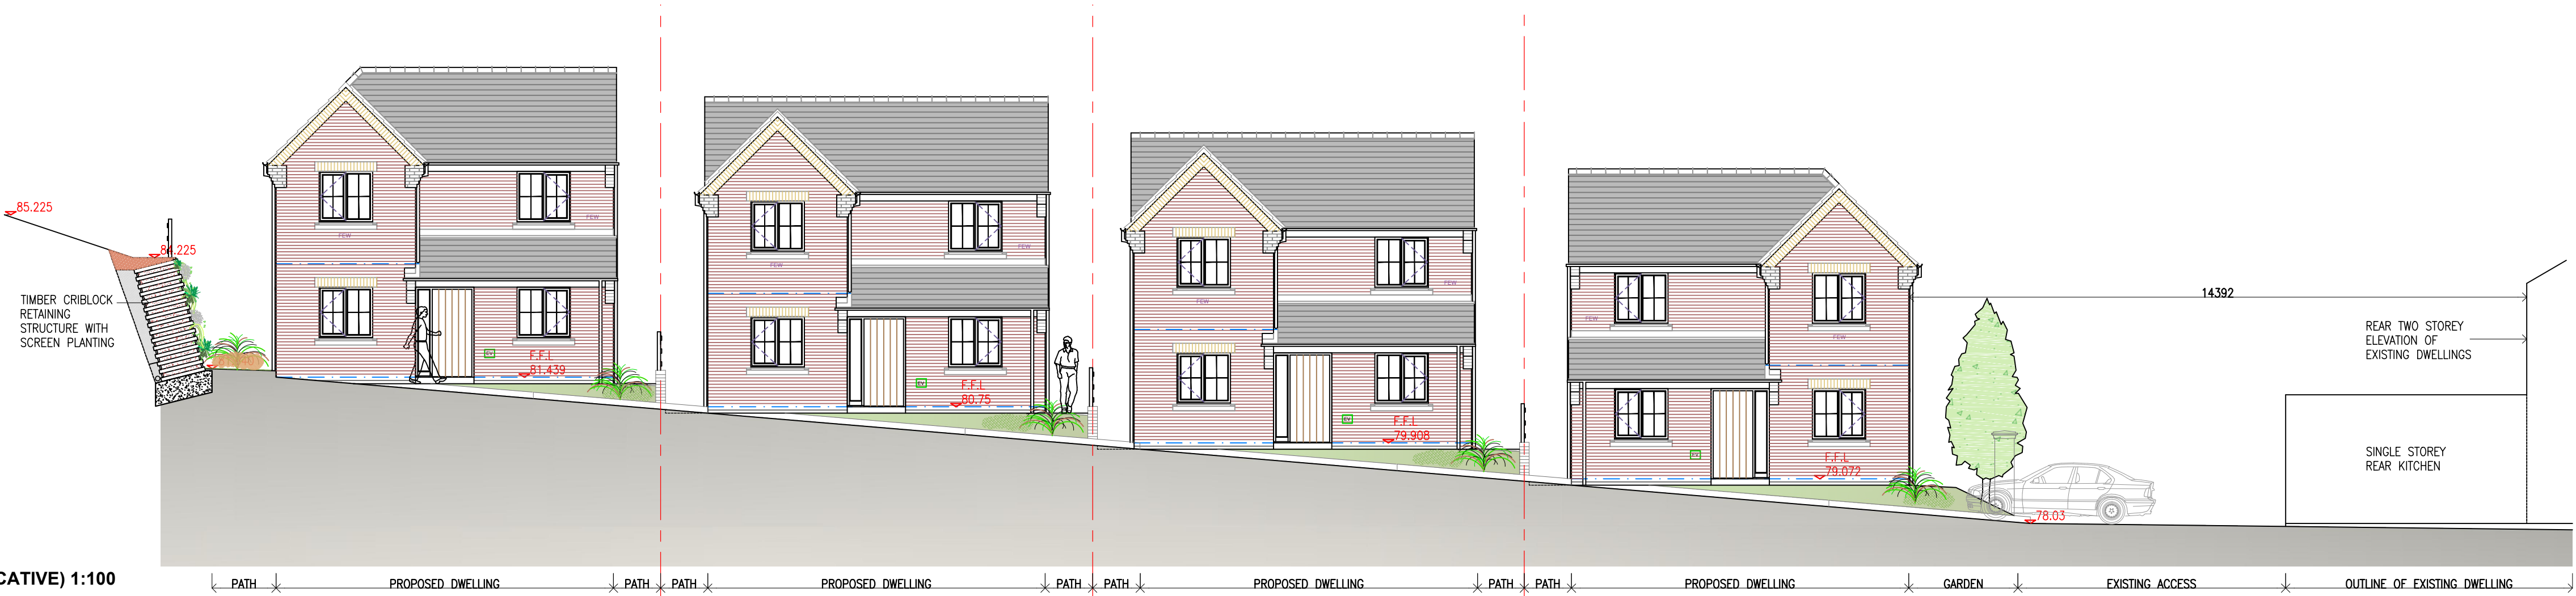
PROPOSED SITE SECTION (INDICATIVE) 1:100

The development comprises five detached residential dwellings, with associated areas of hardstand parking and private gardens, the layout of which is shown on Drawing No M20-12-14 Rev 02, dated January 2020, prepared by Pulmann Associates, a copy of which is presented in Appendix A of this report.

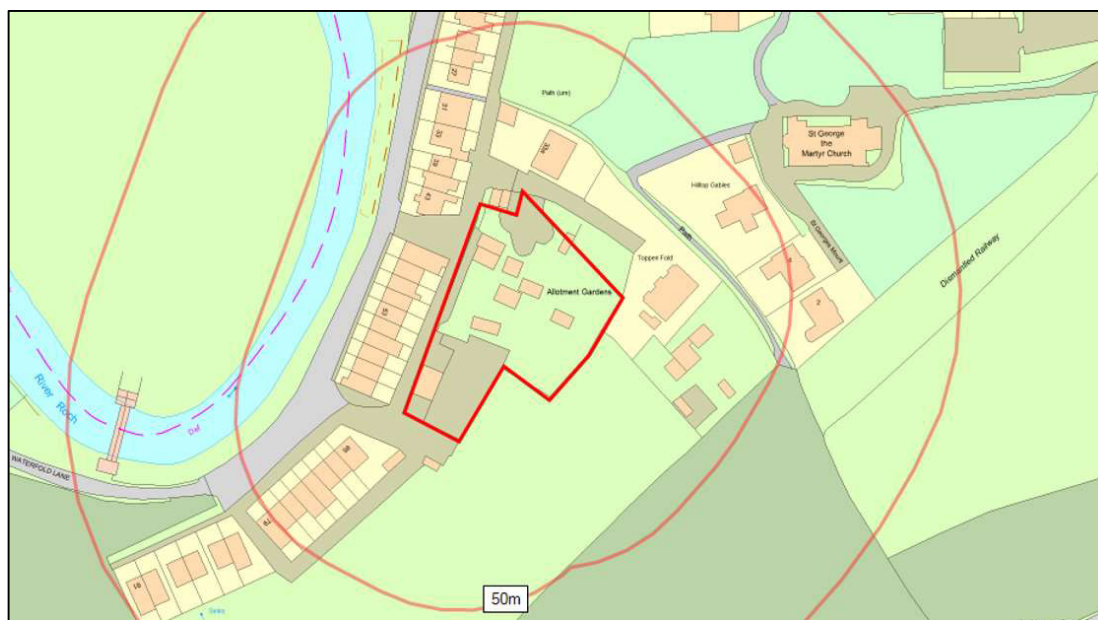
**Figure A:** Site Location Plan. Red is approximate site boundary and pink are 50m and 100m buffers.  
Extract from Envirocheck report (Appendix C).

The site is located east of Waterfold Lane, to the rear of terraced housing dated from the 1860s. Waterfold Lane is accessed from the A58 Bury New Rd to the north.

The area shown within the red site boundary on Figure A below, will be referred to throughout this document as 'the site'.

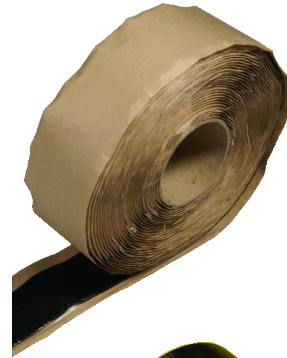
A butyl modified reinforced double sided bitumen tape, 1.5mm thick, designed to form a gas tight gasket. Excellent adhesion and tolerance to damp conditions.

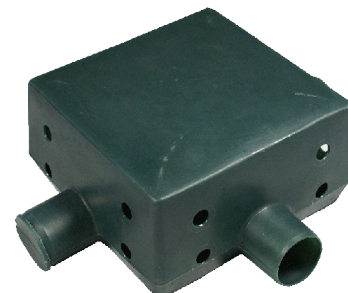
### Radon Sump Units

The Radoncare Sump and Cavity Gas Vent System is manufactured by a rotational moulding process from heavy duty polyethylene. The sump is constructed with a solid roof and base and is provided with 40mm diameter holes in the walls. Spigots for 100mm pipe connections are provided at each end of the sump, but are blanked off with knock outs to allow choice of direction for extract pipe. The cavity gas vent comes with a detachable polyethylene cap, which can be easily removed if an extraction system has to be attached.

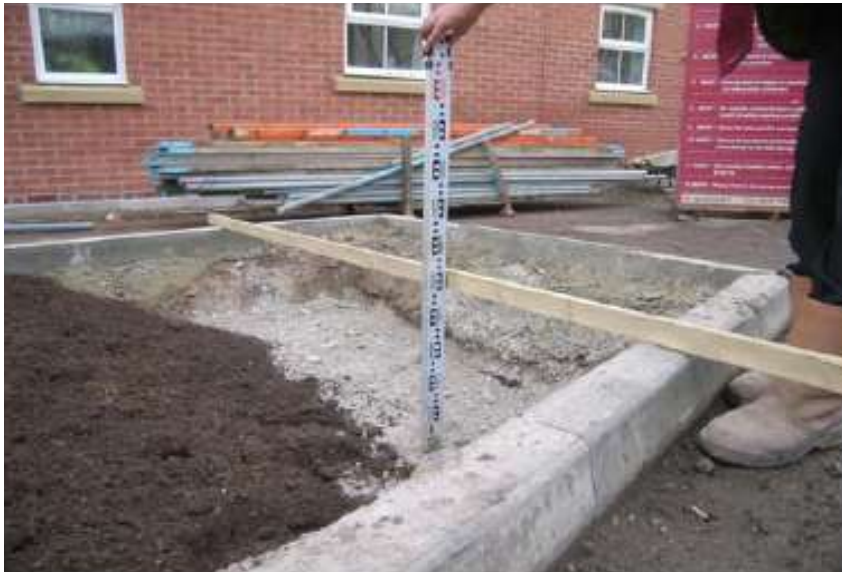
Photograph 1:  
Depth check of inert  
cover within area of  
public open space.  
Physical break layer  
and topsoil visible.

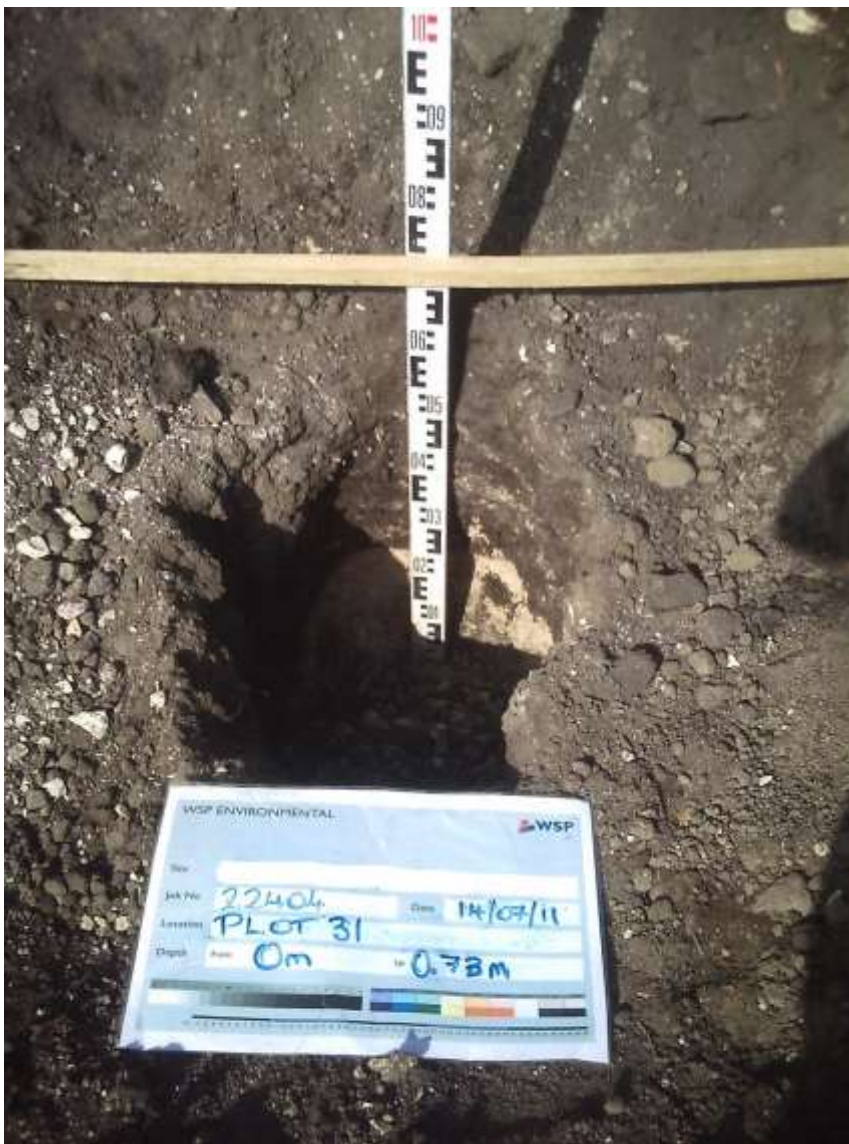
Photograph 2:  
Depth check of inert  
cover with Site &  
Location Information  
Board.

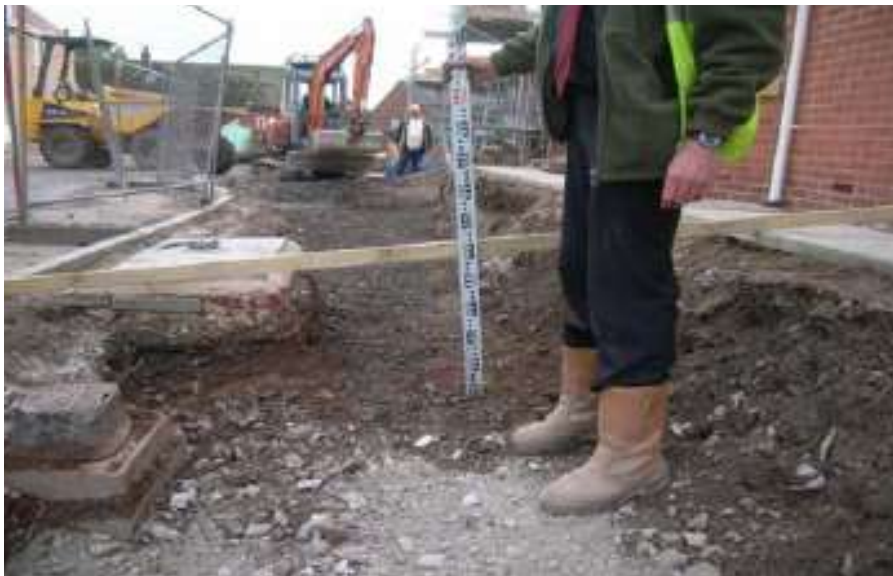
Photograph 3:  
Depth check of inert cover within areas of front gardens.

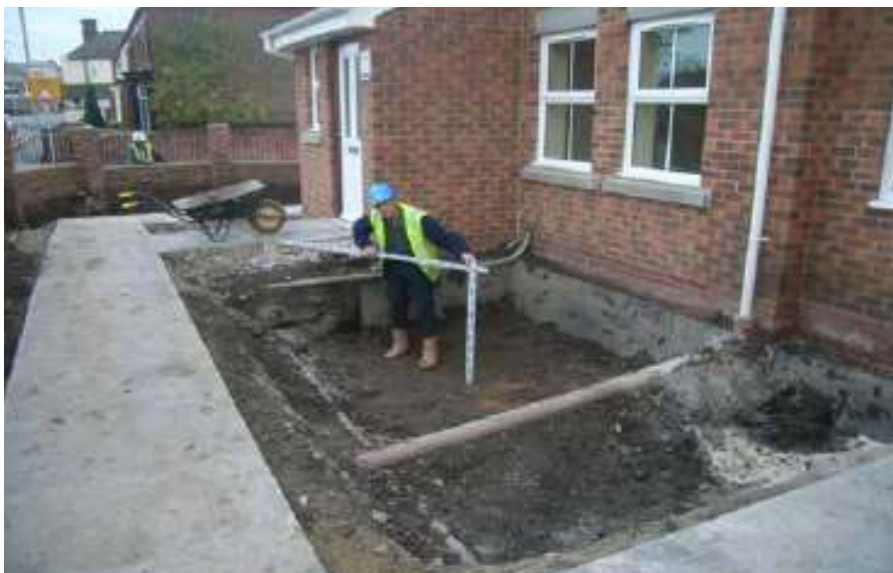
Photograph 4:  
Depth check of inert cover within areas of front gardens.

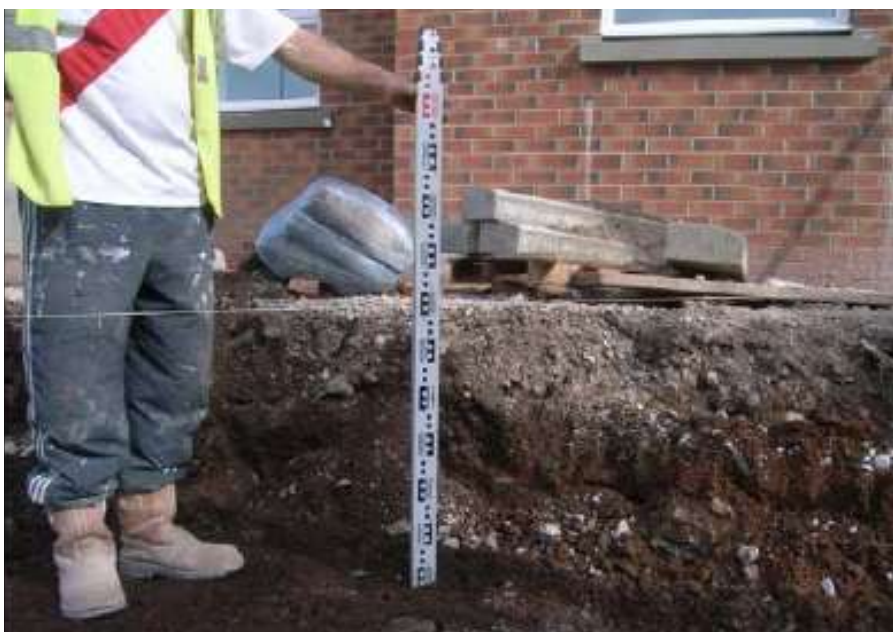
Photograph 5:  
Depth check of inert cover within rear gardens. Taut string line spans across excavation.

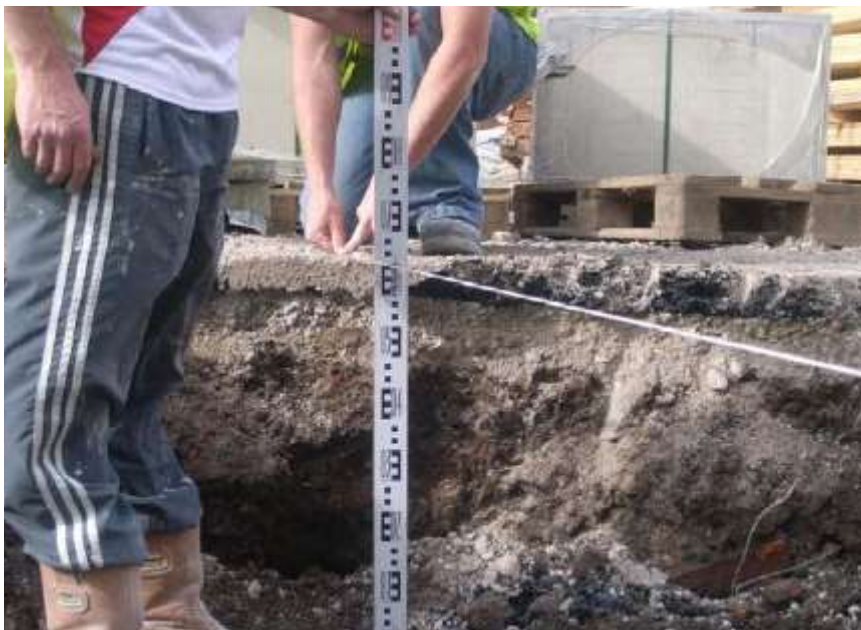
Photograph 6:  
Depth check of inert  
cover within rear  
gardens. Taut string  
line spans across  
excavation.

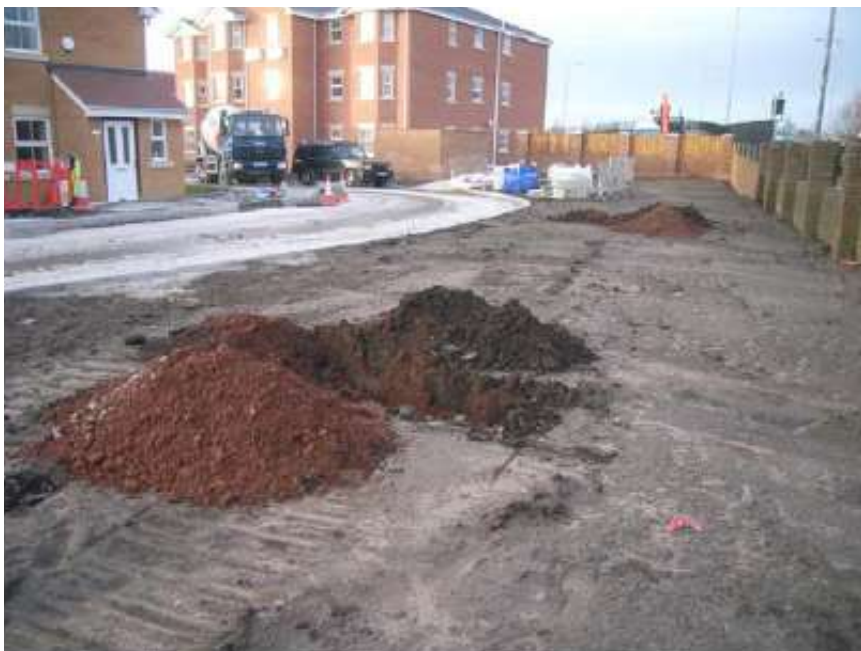
Photograph 7:  
Shows the spatial  
location of the  
verification pit.

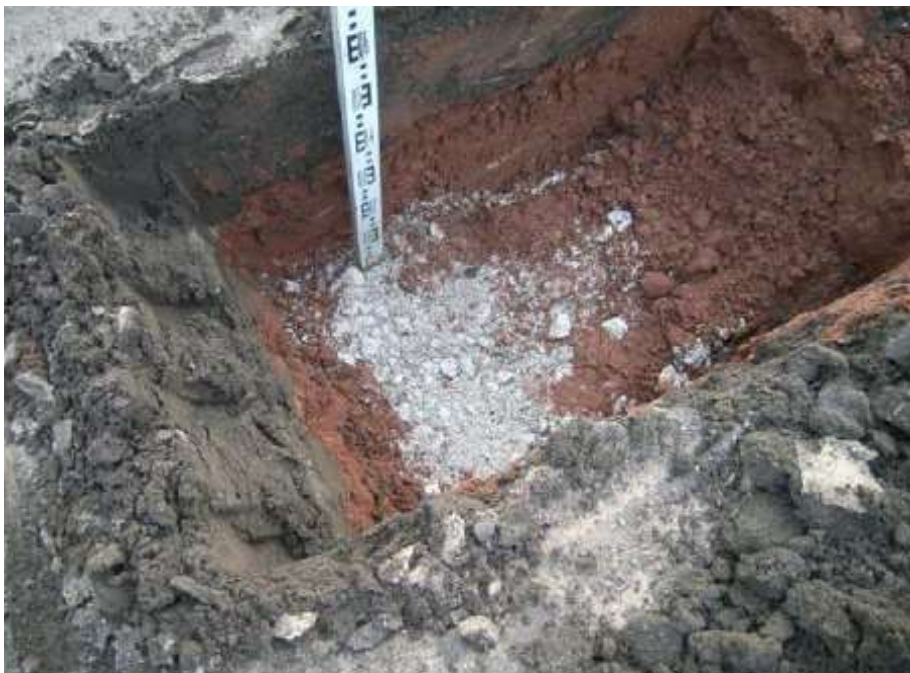
Photograph 8:  
Excavation within  
public open space  
and verification pit  
showing the presence  
of a remediation  
break layer at the  
base, a crushed  
sandstone inert fill  
overlain by topsoil.

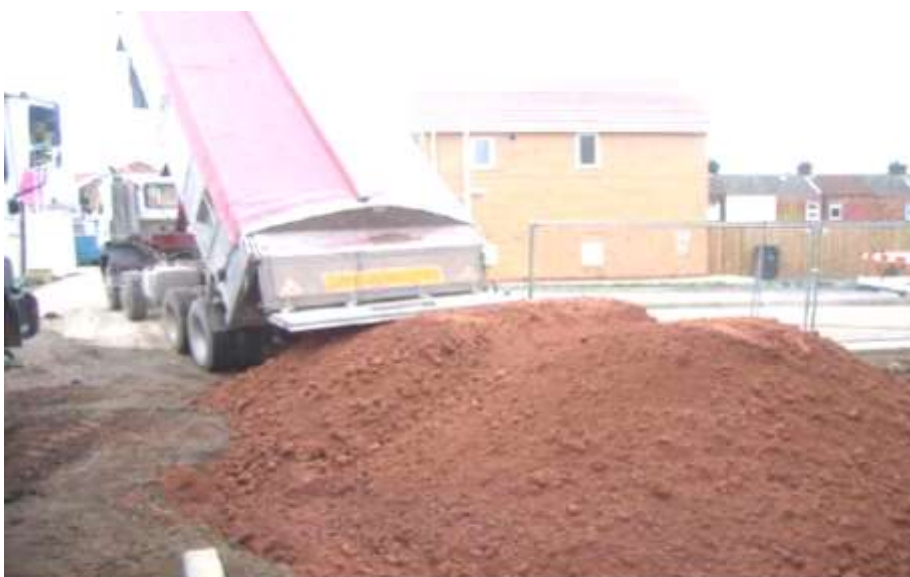
Photograph 9:  
Inert crushed  
sandstone being  
delivered. The spatial  
area of the  
remediation can be  
observed from these  
photographs (old  
terrace housing).

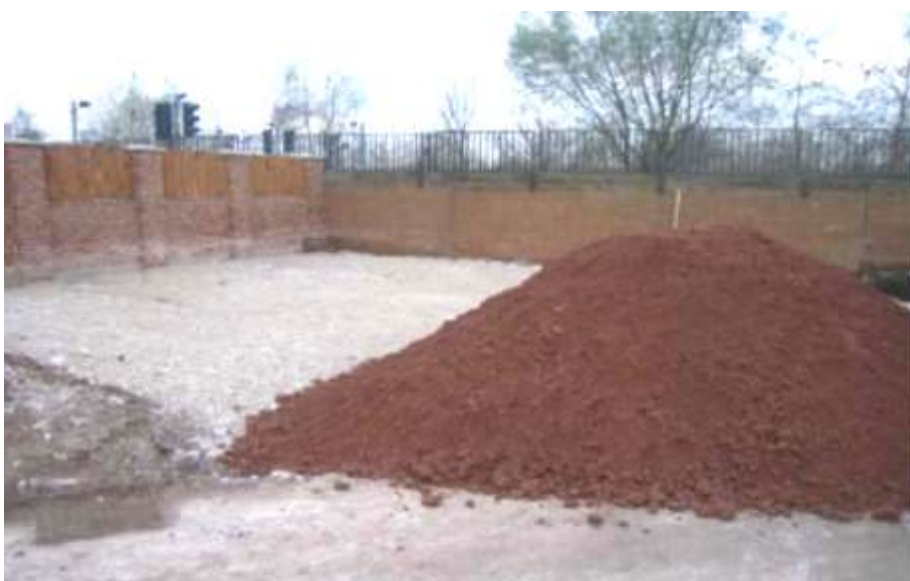
Photograph 10: Inert  
crushed sandstone  
being delivered with  
visible remediation  
break layer. The  
spatial area of the  
remediation can be  
observed from these  
photographs (traffic  
lights).

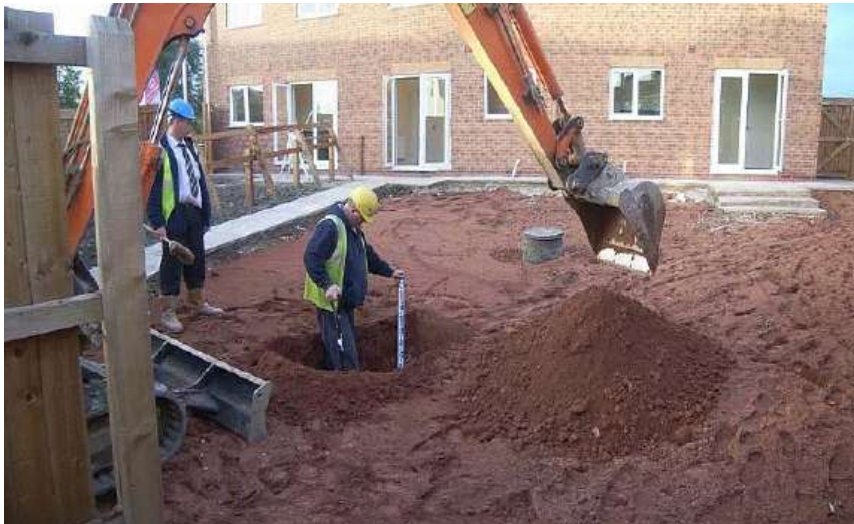
Photograph 11:  
Shows the remediation of the rear garden, with a significant depth (1.0m) of inert cover. This photograph has been stitched to form a panoramic photograph and hence there is slight distortion

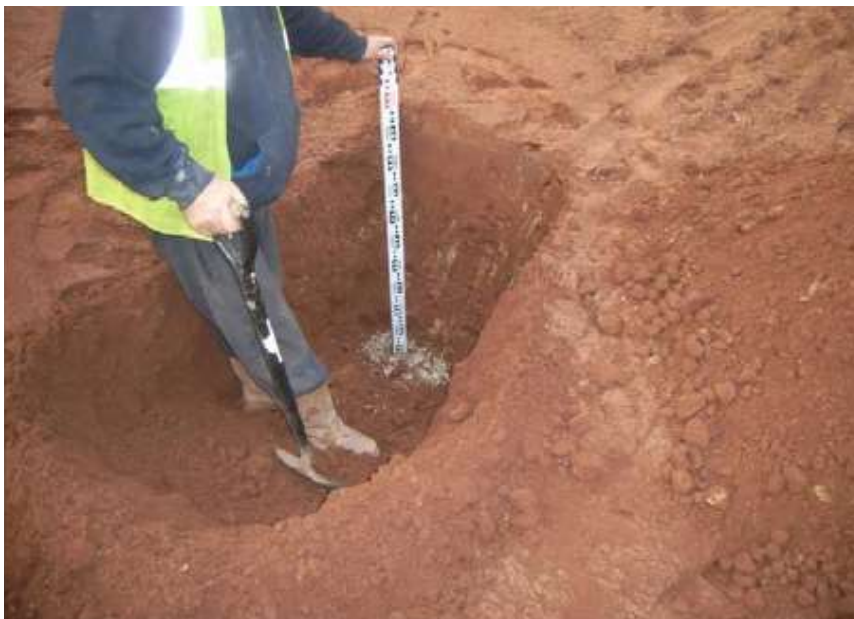
Photograph 12:  
Shows the remediation of the rear garden, with a significant depth (1.0m) of inert cover. Remediation break layer visible at the base of the excavation.
