# CALLIARD'S MILL, SMITHY BRIDGE, OL15 8HW

## Preliminary Bat Roost Assessment and Nocturnal Bat Report

*October 2025*

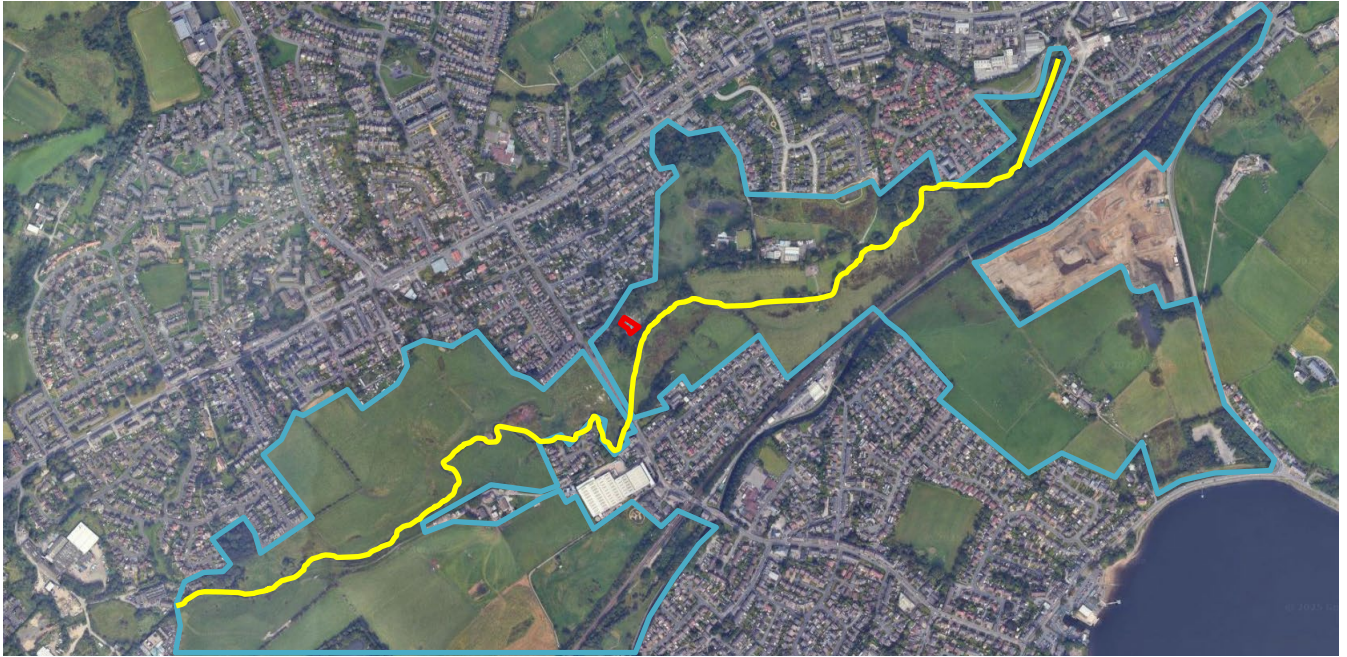
Figure 1.2.2 Site Location and habitat connectivity.

- Red dot indicates site location.
- Yellow lines indicate linear features connecting areas of optimal habitat.
- Blue areas indicate areas of optimal habitat for roosting and foraging.

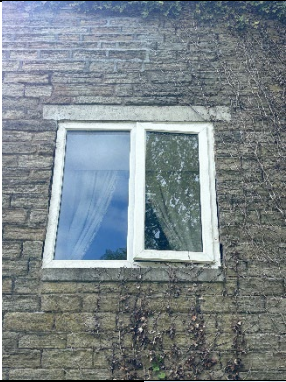
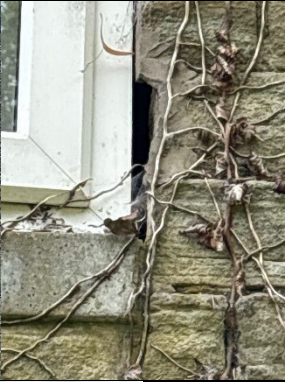
| Description | Photograph | |
|---|---|---|
| TN1 | | |

3.2.4. On the upper floor of the southwestern aspect, six windows run from left to right. The second window from the right has missing brick between the exterior brickwork and the window frame, particularly in the bottom right corner, which creates a PRF for crevice dwelling bat species such as common pipistrelle (TN1).

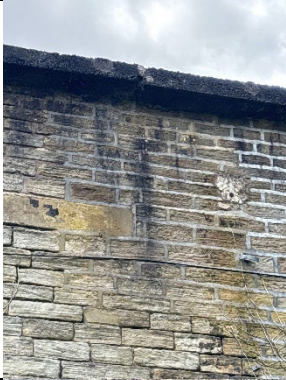
| Description | Photograph | |
|---|---|---|
| TN2 | | |

- 3.2.9. A crack in the eave is causing a split in the overhang which may provide a crevice PRF (TN2).
- 3.2.10. Overall, the ivy cover on the left-hand side is restricting visibility and making identification of further roosting features difficult. A few small PRFs were identified across the remainder of the aspect which would be suitable for small numbers of crevice dwelling bat species such as common pipistrelle.

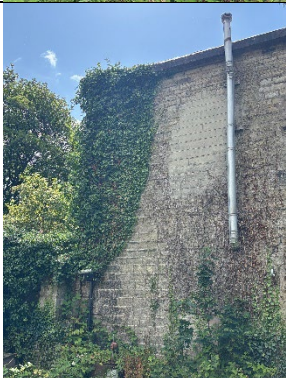
| Description | Photograph | |
|---|---|---|
| TN4 | | |

- 3.2.7. On the far left of the southwest aspect is an area of extensive ivy growth, which has caused crumbling sealant underneath the concrete eave creating PRFs for crevice dwelling bat species (TN4). The ivy may also conceal further PRFs however given the limited extent of the other PRFs on the building it is thought these will be limited and suitable for only small numbers or individual crevice dwelling bats.

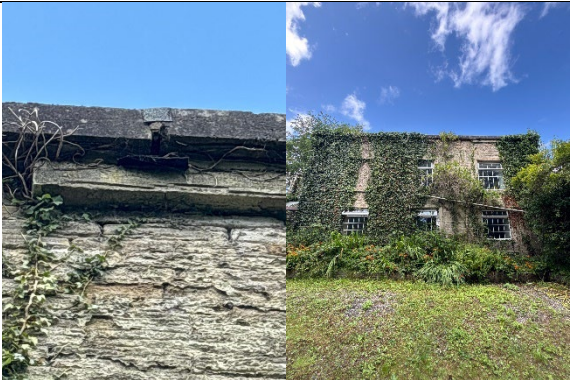
| TN5 | |

- 3.2.11. This elevation is extensively covered in ivy, limiting visibility. A crack was seen in the eave on the right-hand side of the building however it could not be determined how deep it was therefore this was classed as a PRF as it may provide suitable roosting conditions for crevice dwelling species (TN5).
- 3.2.12. Overall, these features present potential roosting opportunities and the restricted visibility due to the ivy may mean more are concealed beneath.

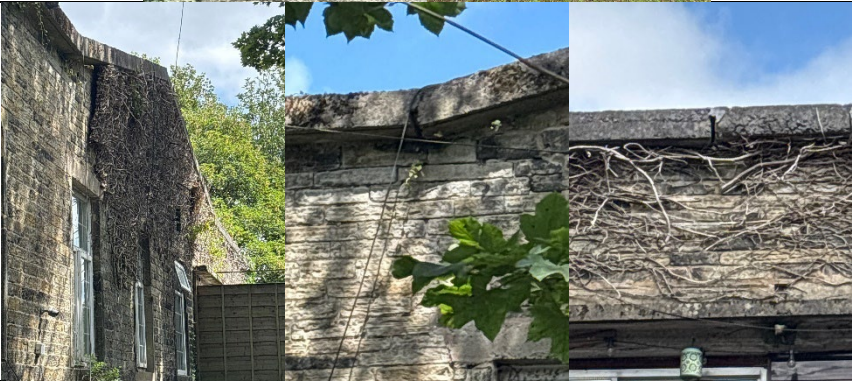
| TN6 | |

- 3.2.13. A large patch of dead ivy is pulling away from the building, creating a potential crevice feature between the brickwork and dead root. Several splits were noted within the overhang and daylight was visible through the split to the east but not through the split on the western side, suggesting variable depth (TN6).
- 3.2.14. Overall, the building itself does not create significant PRFs however the dead ivy provides a crevice feature for potential roosting.

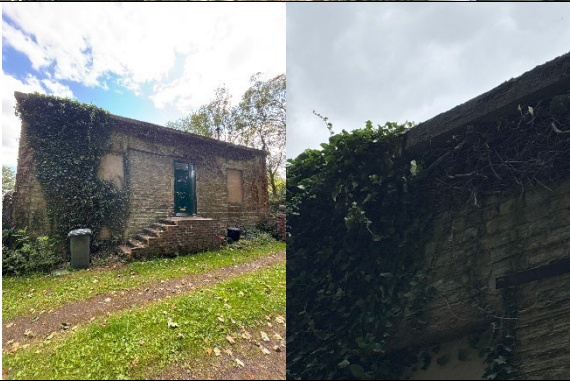
| TN7 | |

- 3.2.15. The southeastern aspect exhibits gaps within the overhang and ivy covers the left-hand side of the aspect; however, no definitive PRFs were identified (TN7).

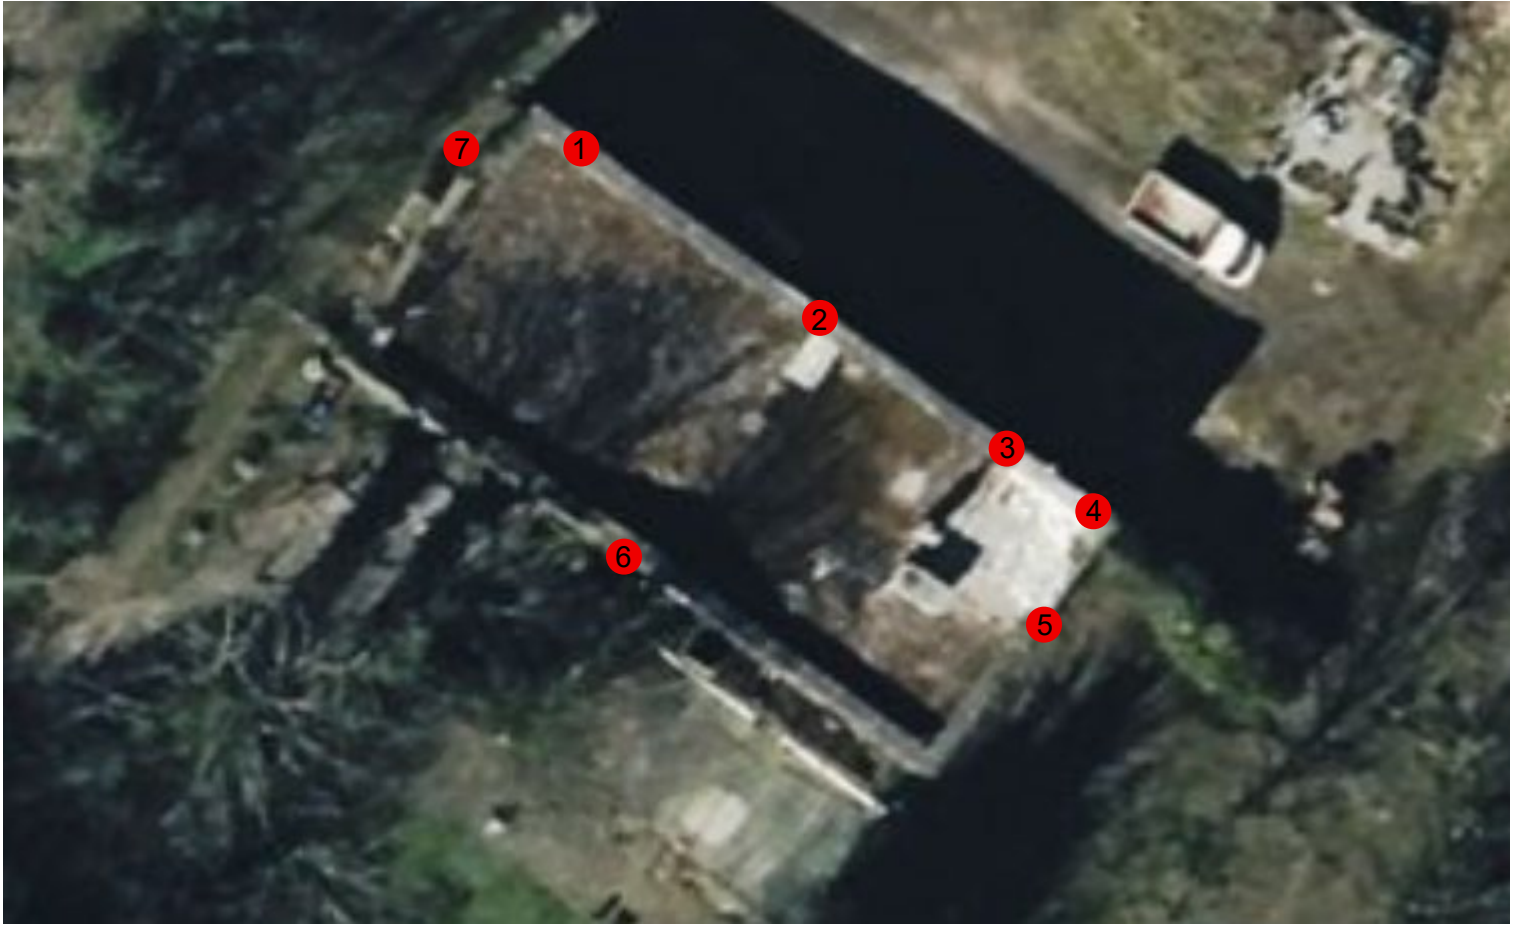
*Target Note Map*

3.2.3. Each potential roosting feature (PRF) is described below and assigned a target note (TN), photographs of the features can be found in the appendix with locations plotted on a target note map.

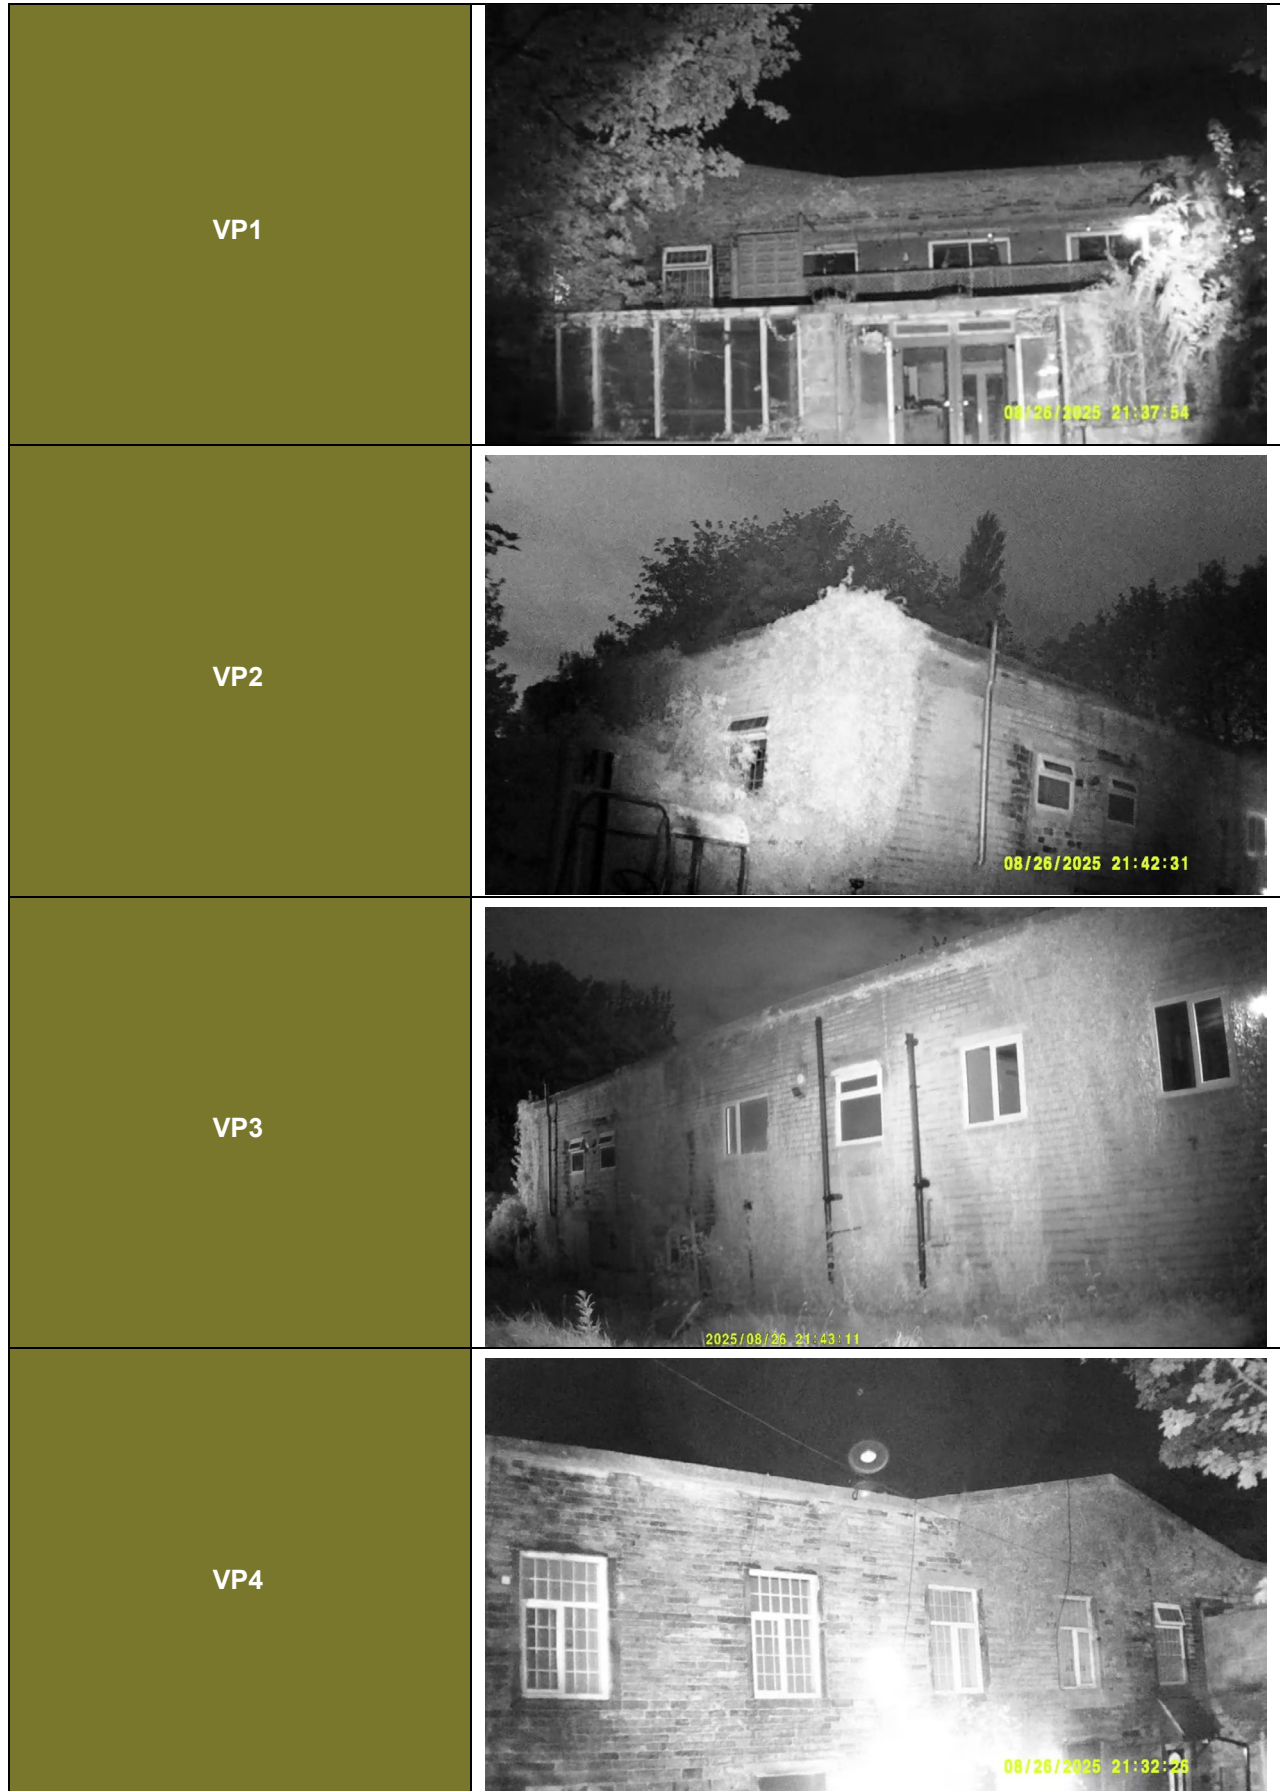
*Dark point screenshots from the survey*

- 4.1.3. No emergences were recorded across any of the VPs, footage from the infrared cameras was reviewed and areas around the ivy were specifically rereviewed to ensure no roosts had been concealed.

- 4.1.4. The dark point camera screenshots from the survey showing the field of view of each camera can be found in the appendix.
