## Preliminary Roost Assessment

24A Baron Street, Rochdale, OL16 1SJ

Change of use from storage units to 7 self-contained apartments.

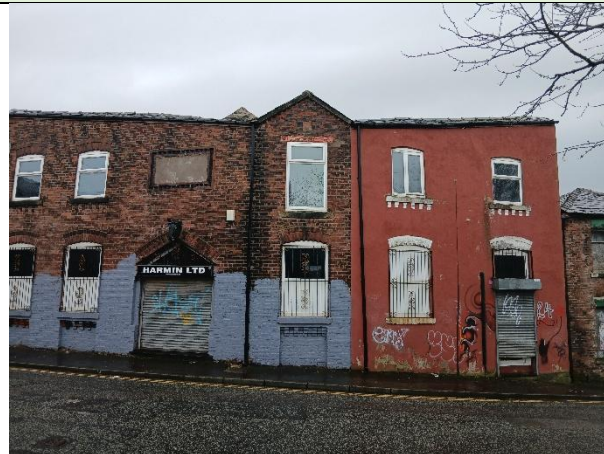
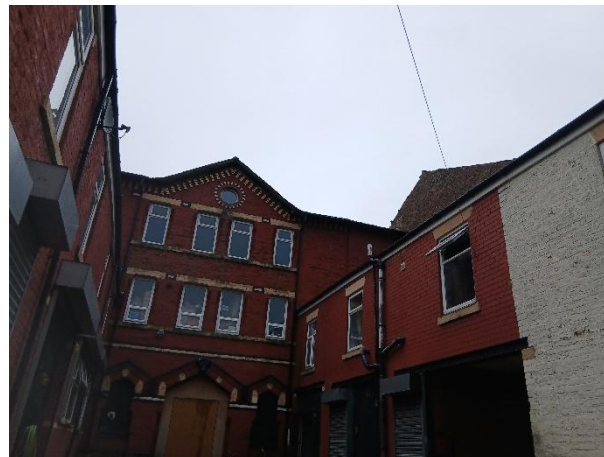
| Field Survey Results | | | |
|---|---|---|---|
| <p><i>Summary</i></p> <p>B1 is a part two-storey, part three-storey “U-shaped” building with an enclosed courtyard to the rear and is of red brick construction. The roof is pitched and clad with slate tiles. Internally, there is no enclosed roof void; the rooms incorporate open ceilings with timber rafters and sarking felt exposed. The building is subject to change of use and the following: removal of roller shutters and their replacement with uPVC windows and new surrounding brickwork, the removal of sections of uPVC fascia boards to expose sandstone heads, and the replacement of broken or lifted roof tiles.</p> <p>The building has <b>low habitat value</b>.</p> | | | <p><b>B1: Northeast elevation</b></p> <p><b>B1: Rear view from courtyard</b></p> |

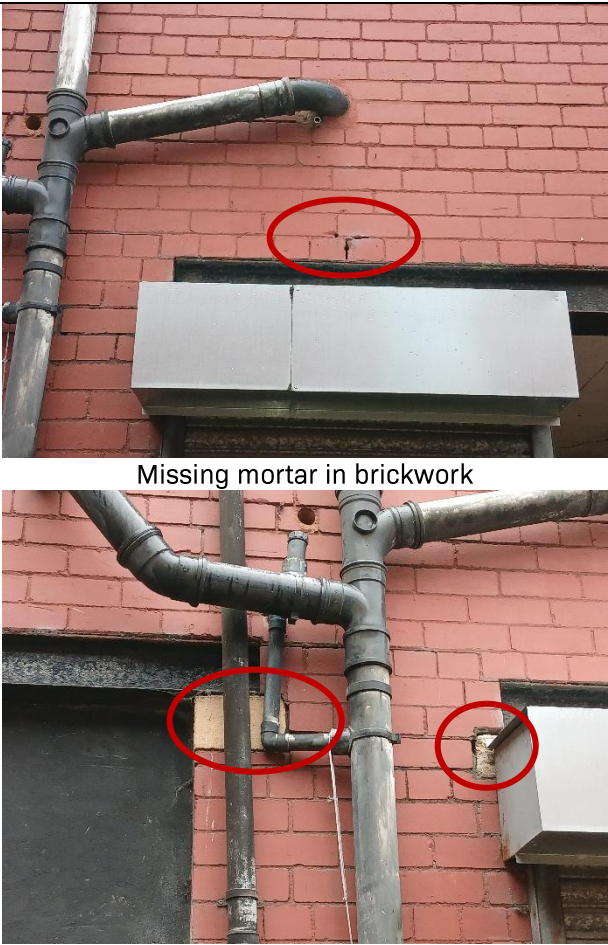
| Walls | Predominantly red brick, with part of northwest and northeast elevations painted. Part of southeast and northeast elevations rendered. | <p>The walls are generally in good condition, with localised weathering, cracks and missing mortar on the northwest elevation bricks and sills. These features are suitable for individual crevice-dwelling bats.</p> <p>There are gaps behind the roller shutter boxes on the southeast elevation, however these do not provide access to the internal of the building and are considered negligible for bats.</p> | <p>Missing mortar in brickwork</p> <p>Gaps in sills and brickwork</p> |

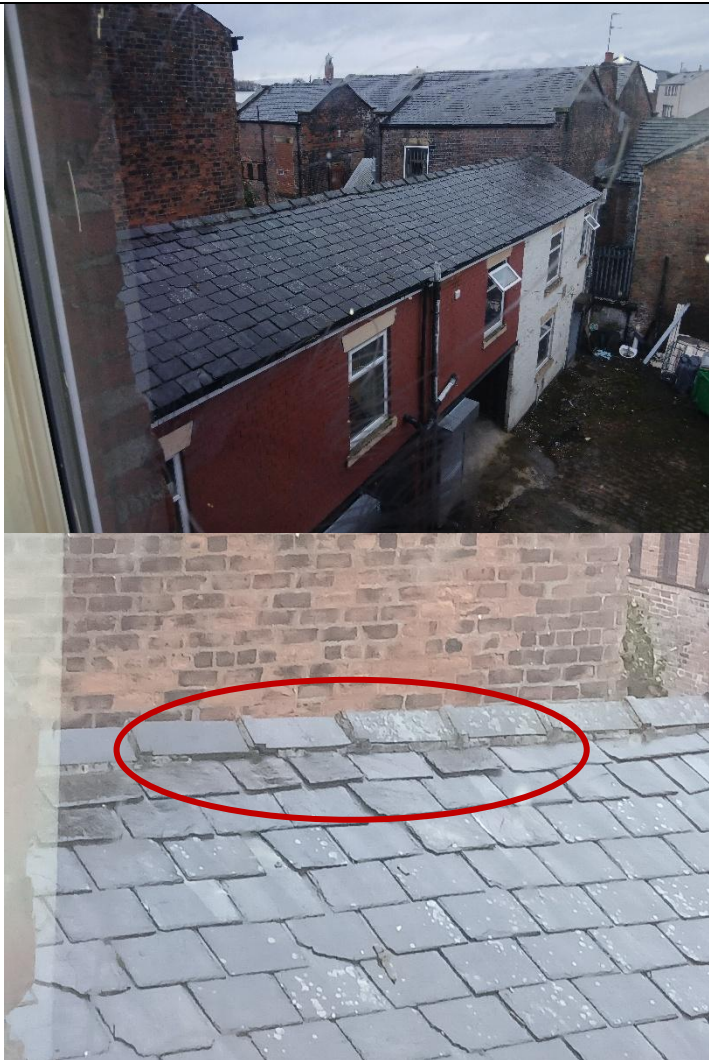
| Roof | Slate | <p>The roof is pitched and clad in slate tiles with a slate-covered ridge. The roof is generally in good condition across all elevations. There are localised sections of missing mortar along the length of the ridge line across all elevations. Displacement of individual slate tiles was observed in places, with tiles slipped, lifted or broken.</p> <p>The space under the tiles and under the roof ridge are areas which are suitable to support individual crevice-dwelling bats.</p> <p>No evidence of bats found but recent rain would wash this away externally.</p> | <p>Roof of south east elevation of B1 showing missing mortar and slipped/lifted/broken tiles</p> |

| <b>Impacts, Recommendations and Enhancements</b> | |
|---|---|
| <i>Foreseen Impacts</i> | <p><b>Roosting habitat</b><br/>The proposed development will involve the removal of roller shutters and their replacement with uPVC windows and new surrounding brickwork, the removal of sections of uPVC fascia boards to expose sandstone heads, and the replacement of broken or lifted roof tiles. This could result in the destruction of any bat roosts present and could cause disturbance, death or injury to bats.</p> <p><b>Foraging and commuting habitat</b><br/>The proposed development will not result in the removal of any habitats which could be used by foraging or commuting bats.</p> <p><b>Artificial lighting</b><br/>No new lighting will be installed as a result of the proposed development.</p> |

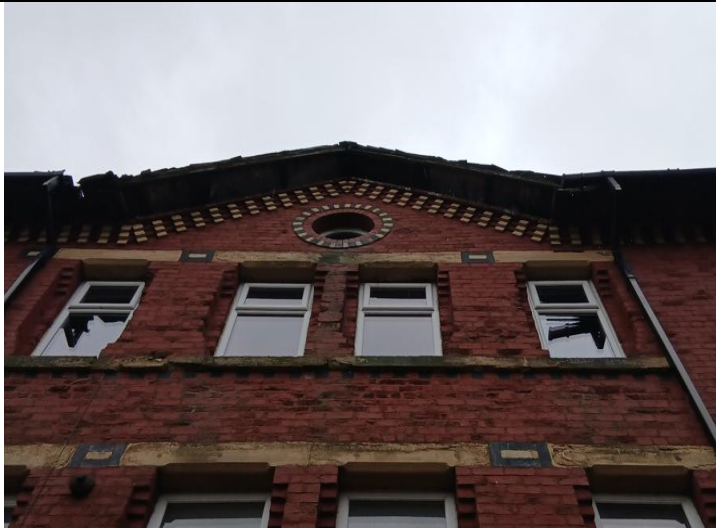
| Eaves | Open, overhanging | <p>The eaves are open with a slight overhang. The timber eaves are shallow and exposed underneath with no soffit present. They are generally in good condition,</p> | |

| | with no soffit present | with no gaps or cavities observed. They do not provide access into the internal roof structure. Therefore, they are not suitable for crevice-dwelling bats. | |

Eaves along the southeast elevation

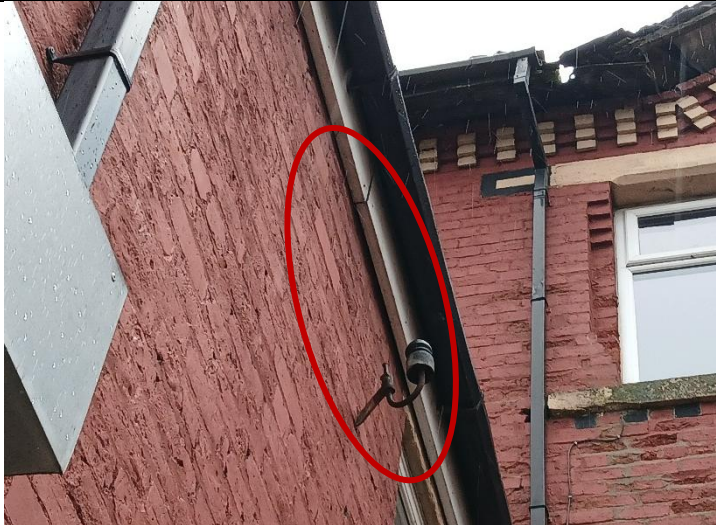
| Barge boards/fascia boards | Timber and uPVC | Most of the fascia is of timber construction, with sections of the original timber replaced by uPVC fascia boards. There are gaps along the fascia particularly along the southeast elevation. These gaps are suitable for individual/low numbers of crevice-dwelling bats. | |

Gaps are present along the uPVC fascia boards

| | <p><b>No works to the property that may block or remove potential roosting features should be carried out until the required surveys have been completed. Undertaking such work beforehand could unlawfully affect bats if present and may compromise the validity of the surveys and hinder the planning application process.</b></p> <p>One bat emergence/re-entry surveys are required on B1 during the active bat season (May – September) to confirm presence/likely-absence of bats roosting in or on the building.<br/>This survey visits should be completed during the optimal survey period mid-May to August inclusive.<br/>Sub-optimal: early May and September. Would require greater justification of timing e.g., weather conditions, known local bat activity.<br/>Four surveyors are required to provide full coverage of the building's elevations to look for emerging/re-entering bats. An infrared camera should also be employed as part of the survey to see where any specific roost locations are located.<br/>If any bat roosts are confirmed from this survey schedule, a bat licence would be required to demolish the buildings as it would involve the destruction of roosts. This is applied for with the help of a class 2 licensed bat ecologist after planning permission is granted, but before commencement of works.</p> <p><b>Foraging and commuting habitat</b><br/>No further surveys are required.</p> <p><b>Artificial lighting</b><br/>None required.</p> |

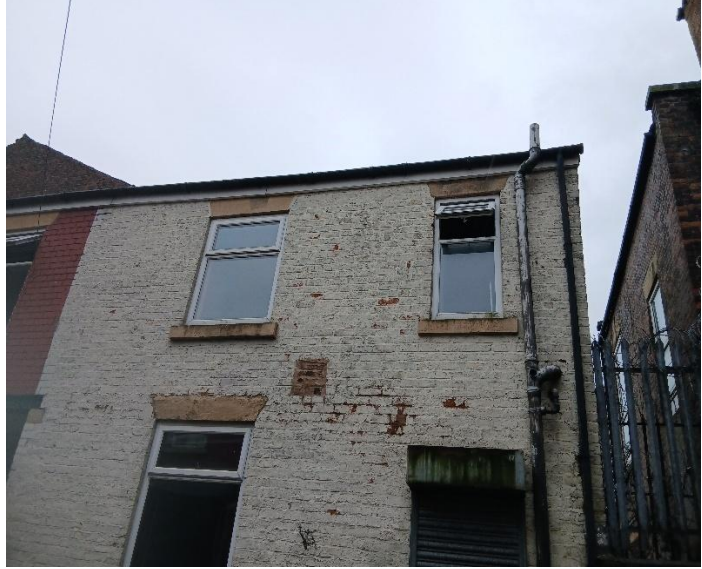
| Window/doors frames and lintels | uPVC | <p>The windows are uPVC across all elevations with sandstone lintels and sills. The windows are tightly sealed with no visible gaps and no suitability for bats identified.</p> | <p>Tight fitting uPVC windows with sanstone sills</p> |

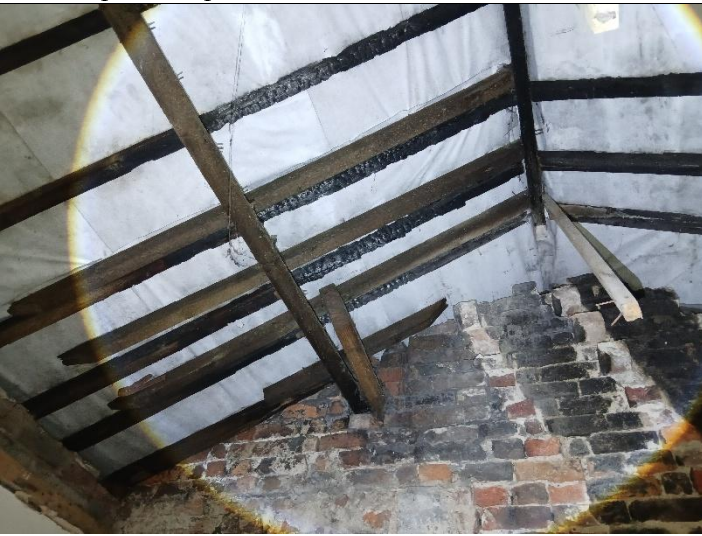
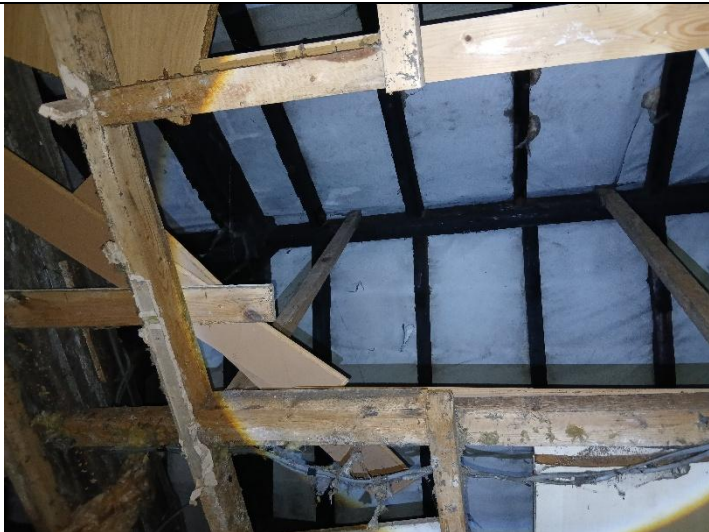
| Internal voids | Timber rafters and ridge beam, sarking felt, brick walls. Open floor to ridge. | <p>Internally, the first-floor rooms of the two-storey sections and the second-floor room of the three-storey section do not contain a loft or enclosed roof void. Instead, the rooms have open ceilings, with the underside of the pitched slate roof directly visible. The roof structure comprises exposed timber rafters, with sarking felt present beneath the slate covering and brick gable walls forming the roof apex.</p> <p>The internal roof structure shows evidence of historic alteration, including redundant and truncated timber, indicating that the building may previously have incorporated a ceiling or enclosed roof void, which has since been removed. As a result, there are no enclosed or sheltered roof spaces present within the building.</p> <p>The rafters, ridge beam and sarking felt were observed to be in good condition, with no visible gaps or features that would provide access into concealed voids. The rooms are well lit, with high levels of daylight entering</p> | |

| | | <p>via windows, resulting in an open and exposed internal environment.</p> <p>No evidence of bats was found.</p> | <p>Internal of B1 showing room with open ceiling</p> |
