Preliminary Roost Assessment

Sheepbank Farm, Littleborough

Reference: 82-065-R1-1

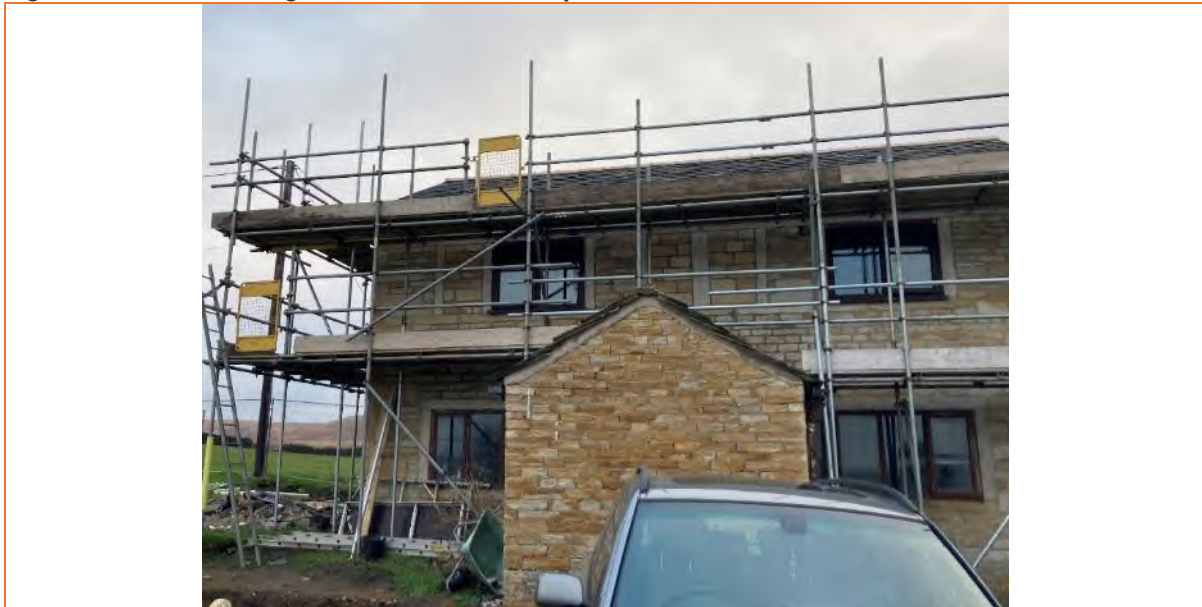
Figure 2 Showing B1's southwestern aspect

The building comprised a vacant two-storey main building with two one-storey annexes to the southwest and northeast, with a gabled slate-pitched roof on the main building and the southwest annex. A single-slanted slate roof was present on the northeast annex. The building was constructed out of stone and mortar.

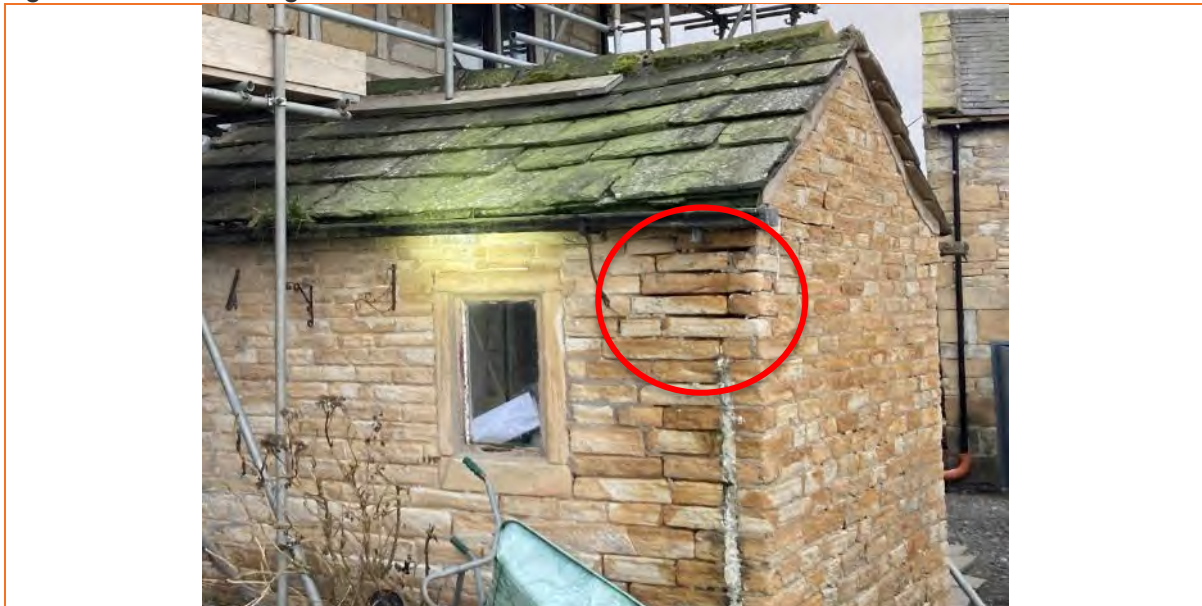
Figure 3 Showing PRF1

Externally, the main building appeared to have been repointed and therefore was in good condition with no cracks or missing mortar visible during the survey. There were crevices within the brickwork on the southwestern annex which may provide roosting opportunities for bats (PRF1). However, these features will only support bats on an occasional basis rather than regularly, due to their depth and likely fluctuation in temperature.

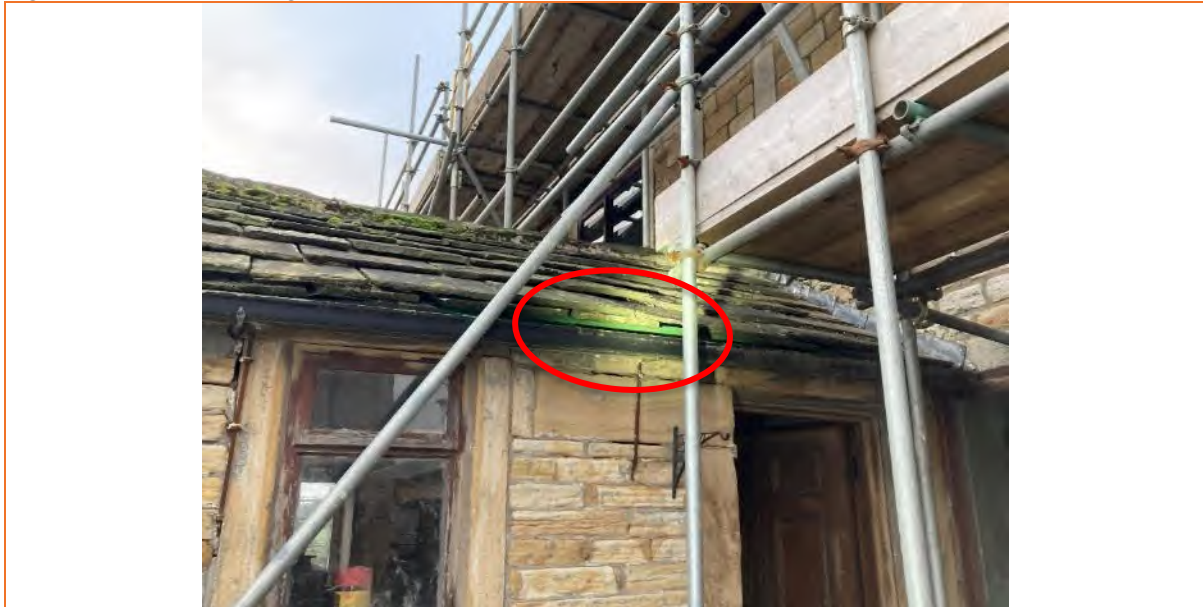
Figure 4 Showing PRF2

The slate roof appeared to have been recently installed on the main building, as such it appeared to be in good condition, with no broken or lifted tiles noted during the survey which could support roosting bats. However, the slate roofs on both annexes did not appear to be recently installed. Missing and lifted tiles were present on the southwestern annex roof which are likely to support a small number of bats on an occasional basis (PRF2). In addition, gaps were identified between the roof and stonework on the northeastern annexe which are likely to support a small number of bats on a more regular basis because they are more sheltered from external conditions (PRF3).

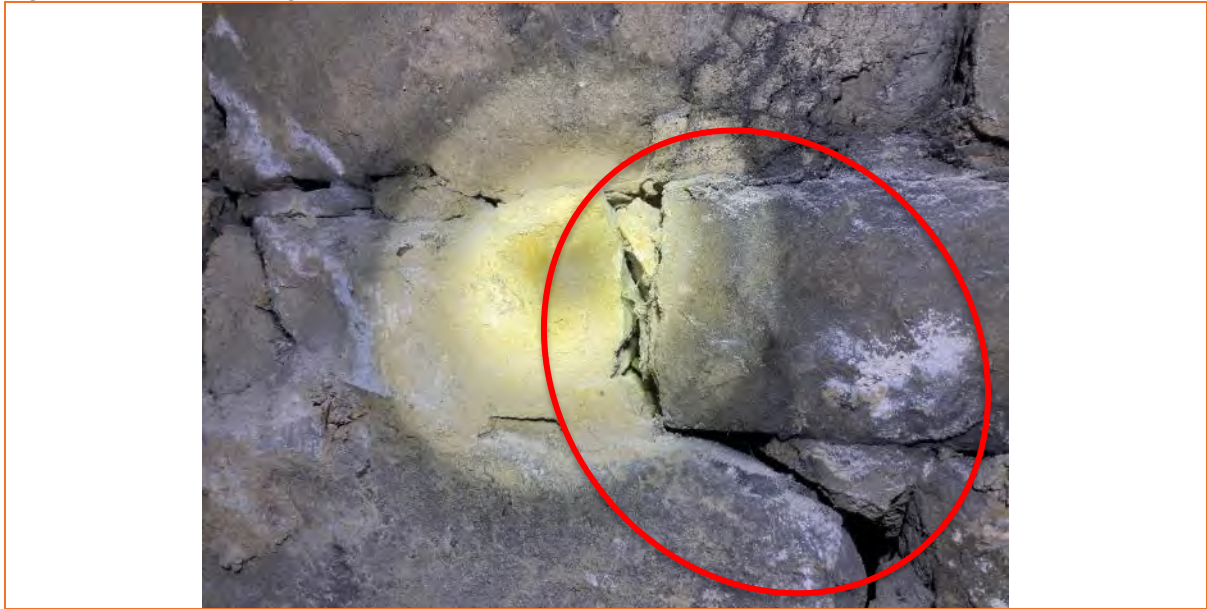
Figure 6 **Showing PRF4**

Internally, on the upper floor, numerous crevices between the stonework were noted and were especially evident where the corners of the wall joined. Crevices were identified on the internal southern wall at varying heights (PRF4); on the southwestern and northeastern walls where the joists met with the floor (PRF5); in the northeastern, southeastern, and southwestern corners between the brickwork (PRF6, PRF7, and PRF8 respectively); and on the northern wall surrounding supporting beams (PRF9). These crevices are likely to support bats on a more regular basis and the deeper cavities have the potential to support hibernating bats as they provide a cool, stable, and damp environment for winter torpor and hibernation.

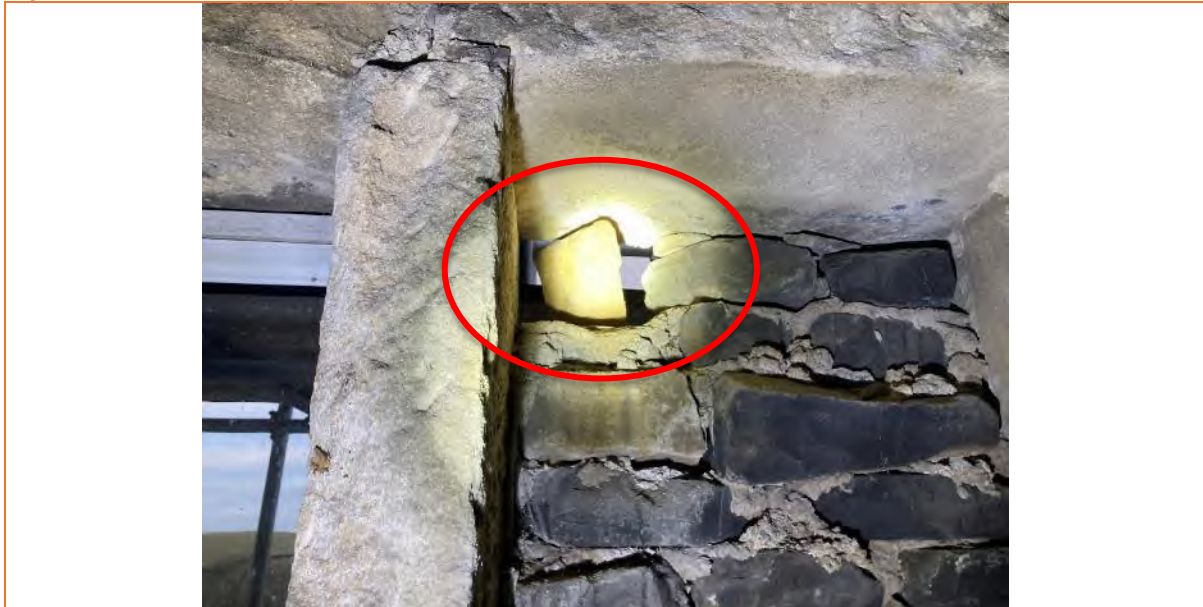
Figure 12 Showing AP1

Furthermore, on the upper floor, numerous crevices in the stonework surrounding the windows and brickwork and window ledges on the southwestern (AP1) and northeastern (AP2) aspects were identified, providing access internally for roosting bats.

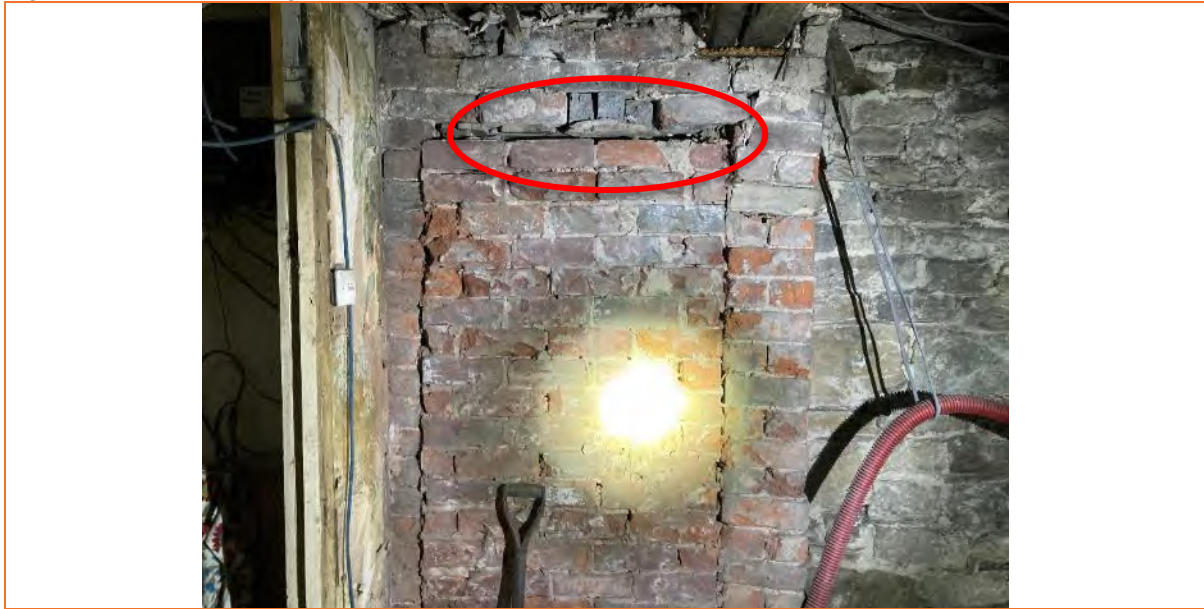
Figure 14 Showing PRF10

On the ground floor, a gap in the brickwork was noted within the internal wall opposite the staircase at a height of approximately 1.5 m (PRF10). The gap was too deep to inspect fully but is anticipated to support bats on a regular basis. Additionally, crevices were identified under the stairs (PRF11) and within the chimney (PRF12) on the northern wall and within the brickwork at varying heights in the room to the south (PRF13). These features are likely to support bats on a regular basis and may support hibernating bats.

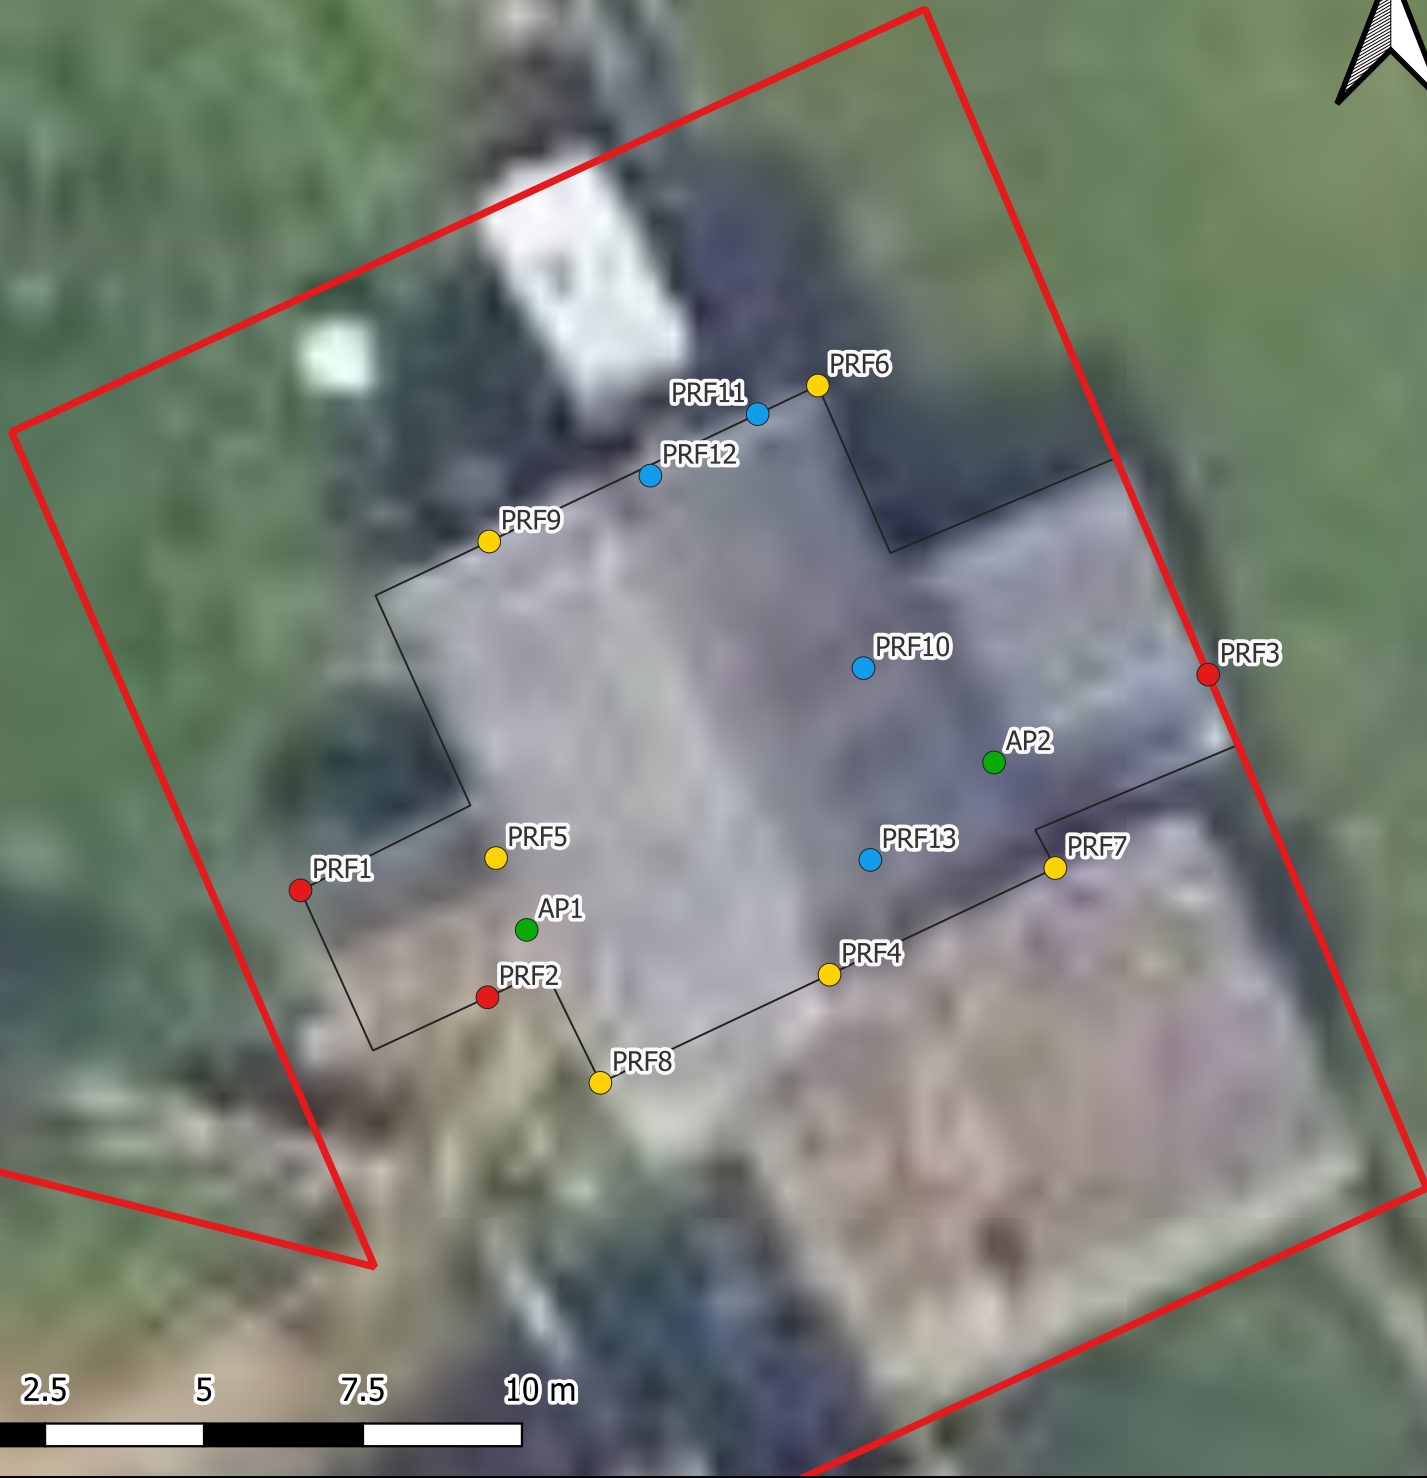
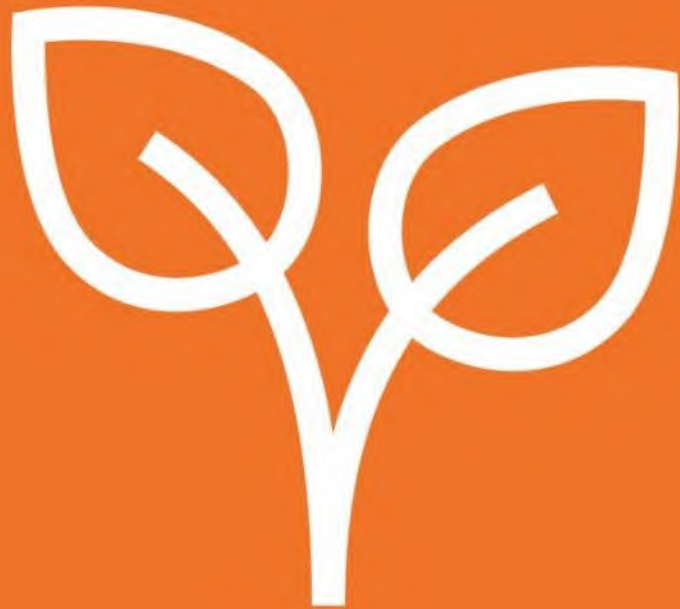
**APPENDIX I
PRELIMINARY ROOST
ASSESSMENT PLAN**

A Preliminary Roost Assessment (PRA) was undertaken on B1 on-site. No other buildings were present within the site boundary. Please see Appendix I for the Preliminary Roost Assessment Plan which details the location of the access points (APs) and potential roost features (PRFs).
