# **GEO-ENVIRONMENTAL AUDIT**

## **PHASE 1 PRELIMINARY RISK ASSESSMENT**

**KEN MILLS HOUSE  
NEW STREET  
SHAWCLOUGH  
ROCHDALE  
OL12 6NS**

Author: Daniel Slattery  
Client: B&L Homes Ltd  
Reference: rep-tjba-B&L-new st-Phs1Env-020326.docx

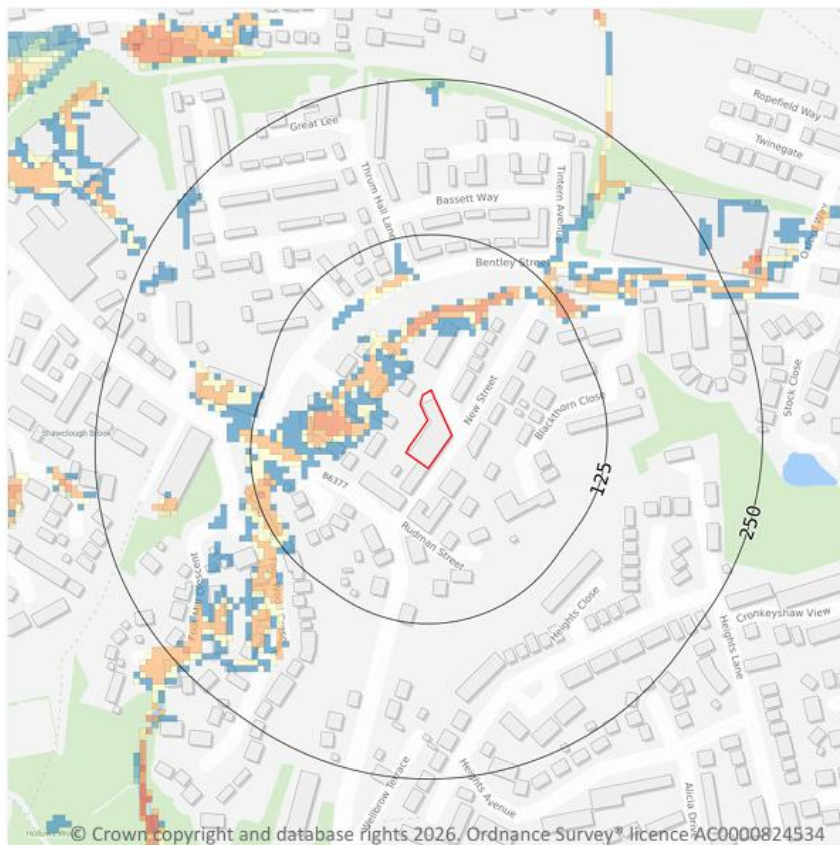
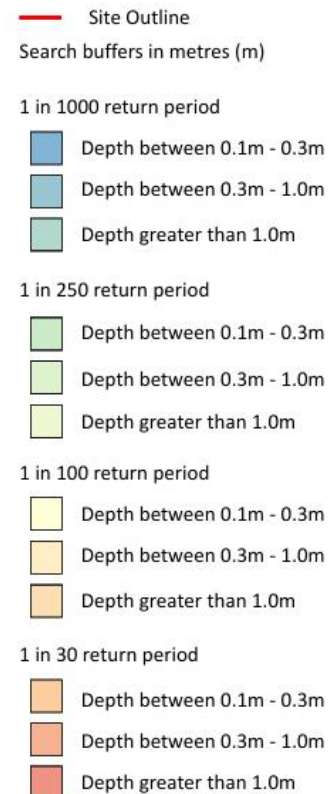
## 8 Surface water flooding

### 8.1 Surface water flooding

Highest risk on site

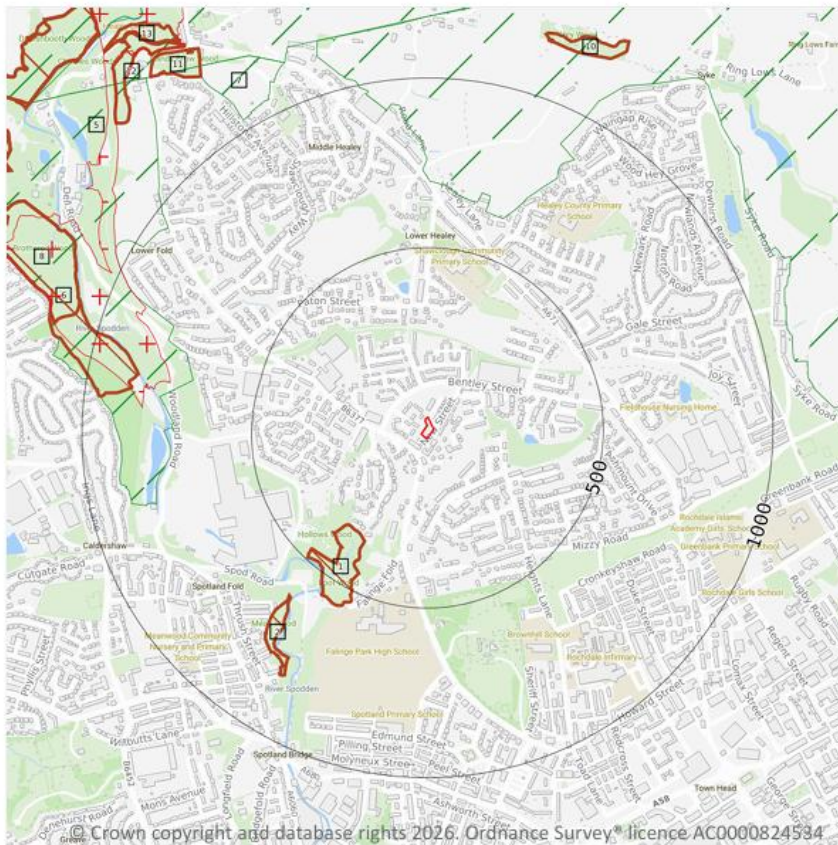
## 10 Environmental designations

- Site Outline
- Search buffers in metres (m)
- + Local Nature Reserves (LNR)
- ▨ Designated Ancient Woodland
- ▨ Green Belt

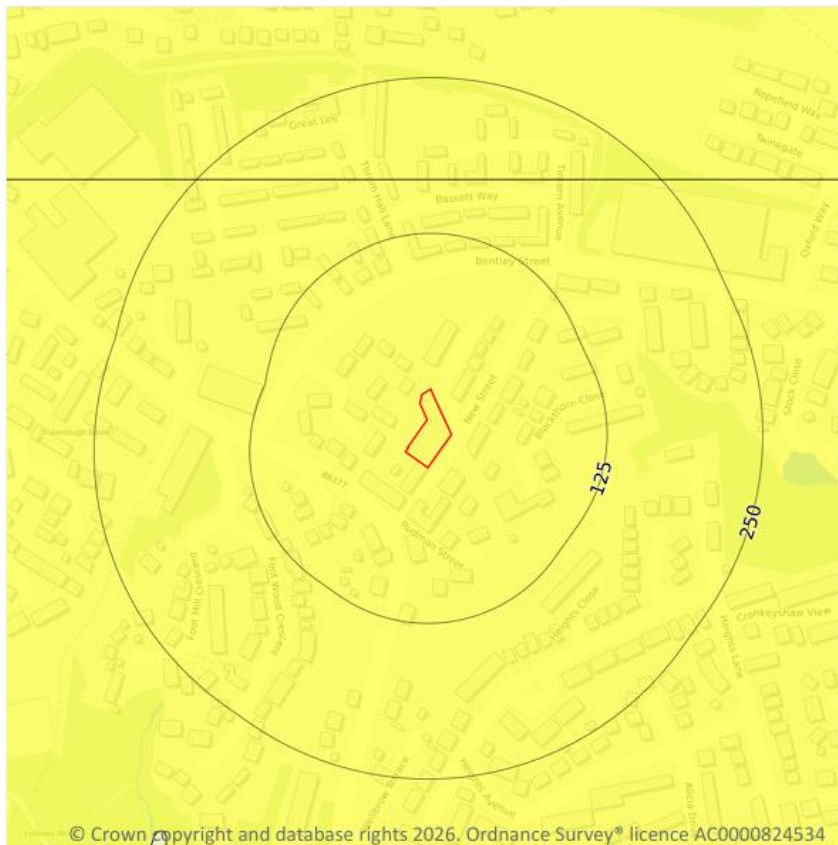
## Natural ground subsidence - Collapsible deposits

The potential hazard presented by natural deposits that could collapse when a load (such as a building) is placed on them or they become saturated with water.
