## Preliminary Ecological Appraisal and Roost Assessment

The Church Inn, Castle Hill Road, Rochdale, Bury, Greater Manchester, BL9 6UH

“The conversion of a public house/restaurant to an office with associated parking and landscaping.”

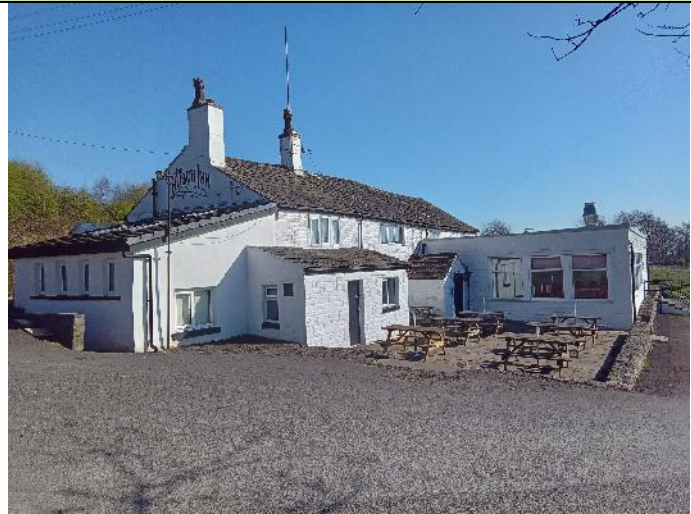
| <p><i>Summary</i></p> <p>B1 is a double-storey rendered stone and brick-built vacant restaurant building with a pitched and gabled roof clad in stone and concrete roof tiles. Sections of the roof are flat and clad in corrugated metal and bitumen. The building will undergo a full re-roof as part of the proposed works. Gaps were recorded along the majority of the main roof stone tiles, which could support moderate numbers of crevice-dwelling species, or provide ingress opportunities to void-dwelling species into the internal loft voids. The building is unlikely to support a hibernation roost but could support a maternity roost. The building has <b>high roost value</b>.</p> | | | |

| <i>Recommendations</i> | <p><b><u>Roosting habitat:</u></b></p> <p><b>B1: Three bat emergence surveys are required during the active bat season (optimal May to August, suboptimal September) to confirm presence or likely absence of a bat roost in the building.</b> At least two of the surveys should be completed during the optimal survey period mid-May to August inclusive and surveys should be spread at least three weeks apart. Infra-red cameras should be used as an aid. Five surveyors are required to provide full coverage of the building.</p> <p><b>If bat roosts are confirmed in the building an EPSL application to Natural England will be required.</b> The EPSL application requires that surveys have been undertaken within the most recent active bat season and planning permission must have been granted and all relevant wildlife-related conditions have been discharged prior to submission.</p> <p><b>B2:</b> In the unlikely event that a bat or evidence of bats is discovered during the development all work must stop, and a bat-licensed ecologist contacted for further advice.</p> <p><b>Trees:</b> In the event of future tree felling or pruning, a separate Ground Level Tree Assessment (GLTA) survey should be undertaken to assess impacts.</p> |

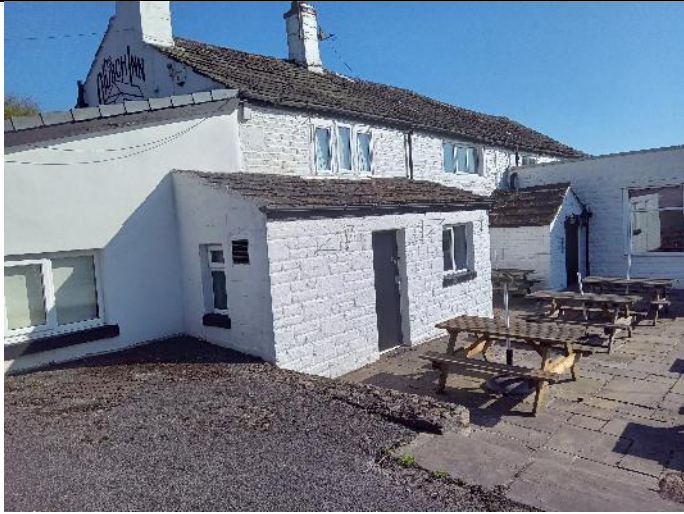
| Walls | Rendered or painted | <p><b>Condition/description:</b></p> <p>No suitable crevices or cavities were recorded along the supporting walls, which were found to be intact and in very good condition.</p> <p><b>Suitability/access/evidence of bats:</b></p> <p>No suitable features or evidence were recorded.</p> | |

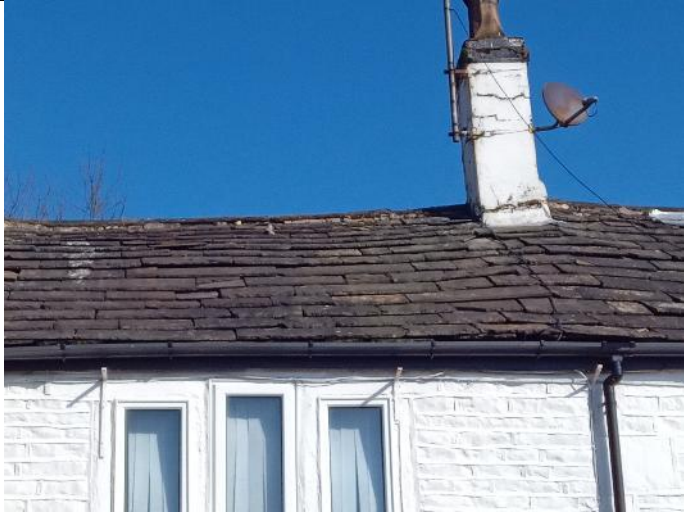
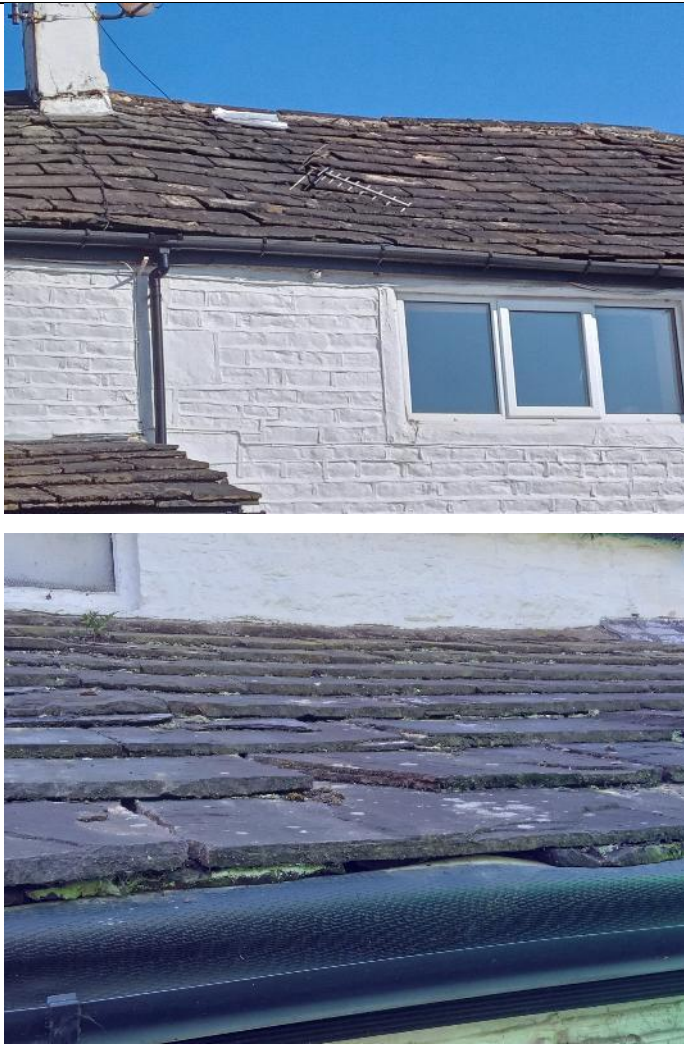
| Roof | Stone | <p><b>Condition/description:</b></p> <p>Gaps between the roof tiles were recorded along both the north and south elevations, and along the roof verges of the east and west gables.</p> <p><b>Suitability/access/evidence of bats:</b></p> <p>Space under tiles could accommodate crevice-dwelling bat ingress with roosting opportunities between the roof tiles, and ingress points along the main roof structure and along the roof verges of the east and west gables. Could support moderate numbers of crevice-dwelling</p> | |

| | | <p>species. Gaps could also support void-dwelling species ingress into the loft voids.</p> | |

| B2 - description | Photographs |
|---|---|
| <p><i>Foreseen Impacts</i></p> | <p><b><u>Roosting habitat:</u></b></p> <p><b>B1:</b> The proposed development will result in a full re-roof and internal reconfiguration of this building. This could result in the destruction of any bat roosts present and could cause disturbance, death, or injury to bats.</p> <p><b>B2:</b> Bats are very unlikely to be roosting within this building and as such, there are not anticipated to be any impacts on bats as a result of its removal.</p> <p><b>Trees:</b> The on-site trees were not subject to inspection, as none are scheduled to be removed, as part of the proposed works.</p> |

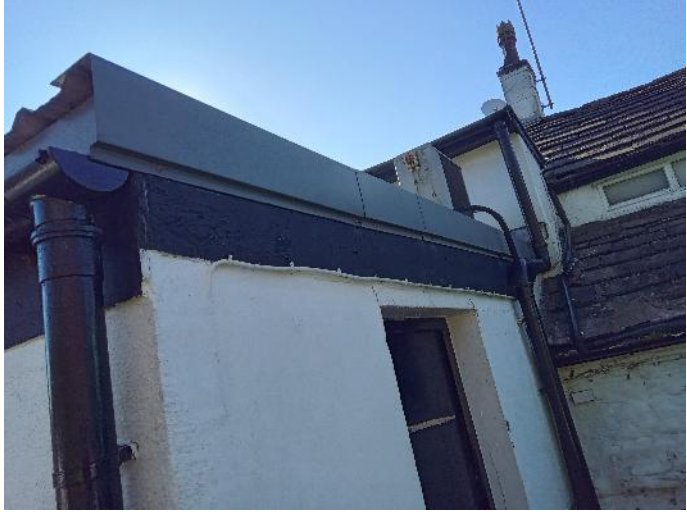
| Eaves | Overhanging<br>with flat roof<br>bordered by<br>metallic<br>fascias | <p><b>Condition/description:</b><br/>Appear intact.</p> <p><b>Suitability/access/evidence of bats:</b><br/>No suitable features or evidence were recorded.</p> | |

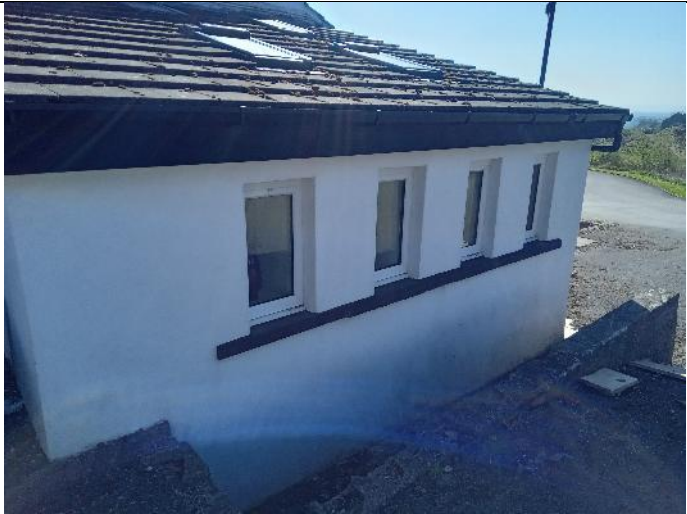
| Window/ door<br>frames | uPVC or<br>wooden | <p><b>Condition/description:</b><br/>Appear tight fitting.</p> <p><b>Suitability/access/evidence of bats:</b><br/>No suitable features or evidence were recorded.</p> | |

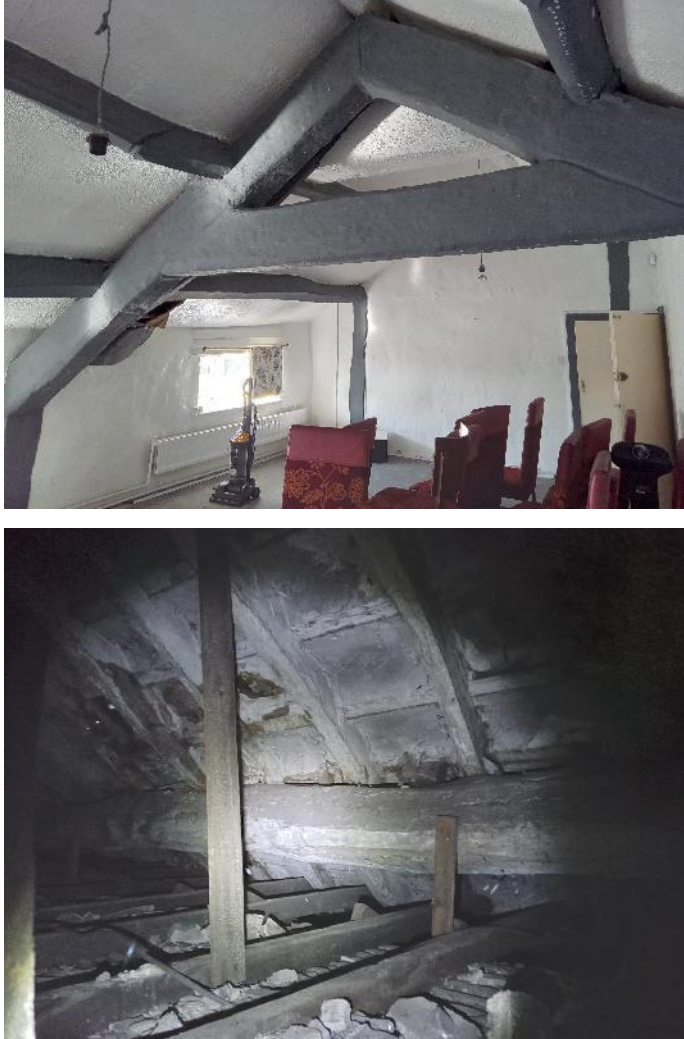
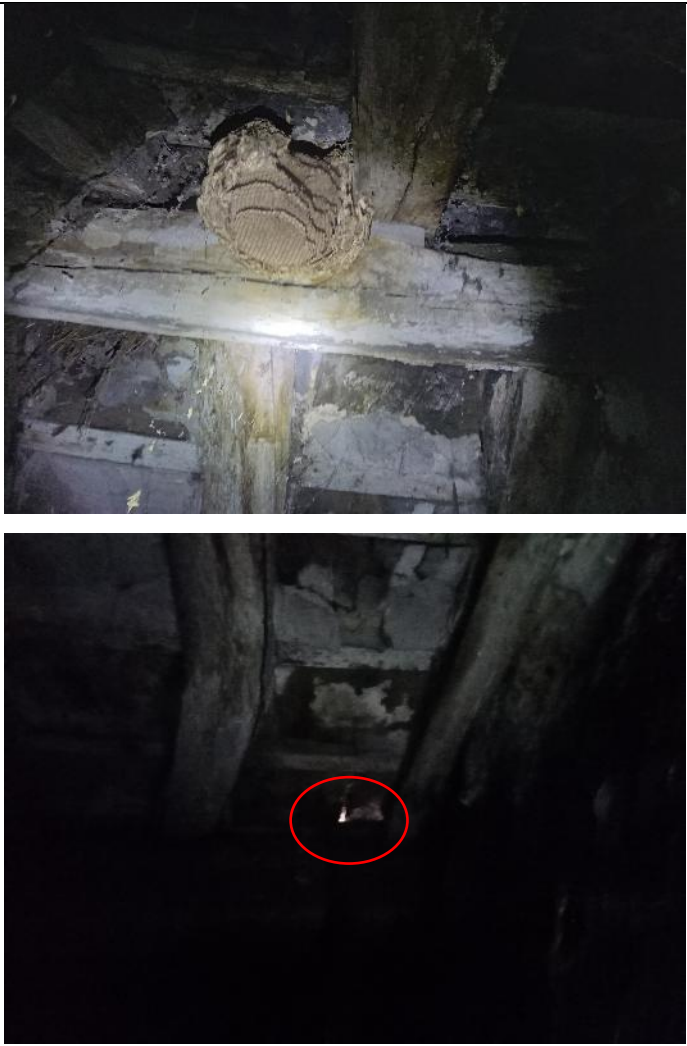
| Internal voids | Timber rafters and ridge beam. Open floor to ridge. Unlined. | <p><b>Condition/description:</b></p> <p>The east-most section of the main roof structure of the building has a vaulted ceiling, however, two loft hatches are present, centrally and west of the building. The west-most loft hatch could not be opened as it is sealed shut, however, the centre-most loft void is described, below.</p> <p>Internally space measure approximately ~4m long, ~2m wide, floor to ridge height ~1m. The roof structure is unlined, and there is light ingress in places, where tiles have gaps. The void is suitable for void-dwelling species, though no droppings were recorded. A hornet's nest is located within the space. Bat droppings could be concealed between the roof tiles.</p> <ul style="list-style-type: none"> <li>❖ Temperature reading: 11.0°C</li> <li>❖ Humidity readings: 50.8%</li> </ul> <p><b>Suitability/access/evidence of bats:</b></p> <p>No evidence was recorded, but evidence could be concealed deeper within the roof structure.</p> | |

One of the loft space voids within B1 was sealed shut and unopenable, thus could not be internally inspected. However, this is not considered to be a significant limitation as the recommended bat emergence surveys should record any roosts within the building, after completion.

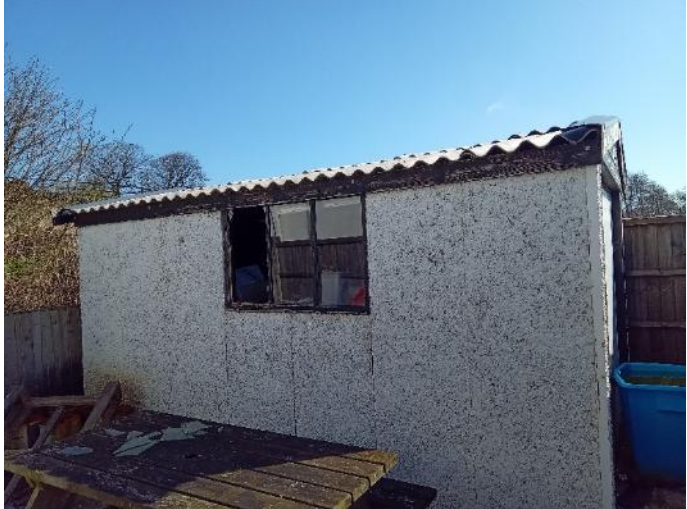
| B2 - description | Photographs |
|---|---|
| <p><i>Summary</i></p> <p>B2 is a pebble-dash rendered small outbuilding with a pitched roof clad in asbestos. Given a lack of suitable features or evidence recorded along the exterior/interior of the building, the building has <b>negligible roost value</b>.</p> | |
