## **Project**

**Project Name:** LITTLEBOROUGH HOLLINGWORTH RD  
**Project Date:** 06/11/2025  
**Inspection Standard:** MSCC5 Sewers & Drainage GB (SRM5 Scoring)

## Section Inspection - 06/11/2025 - 02X

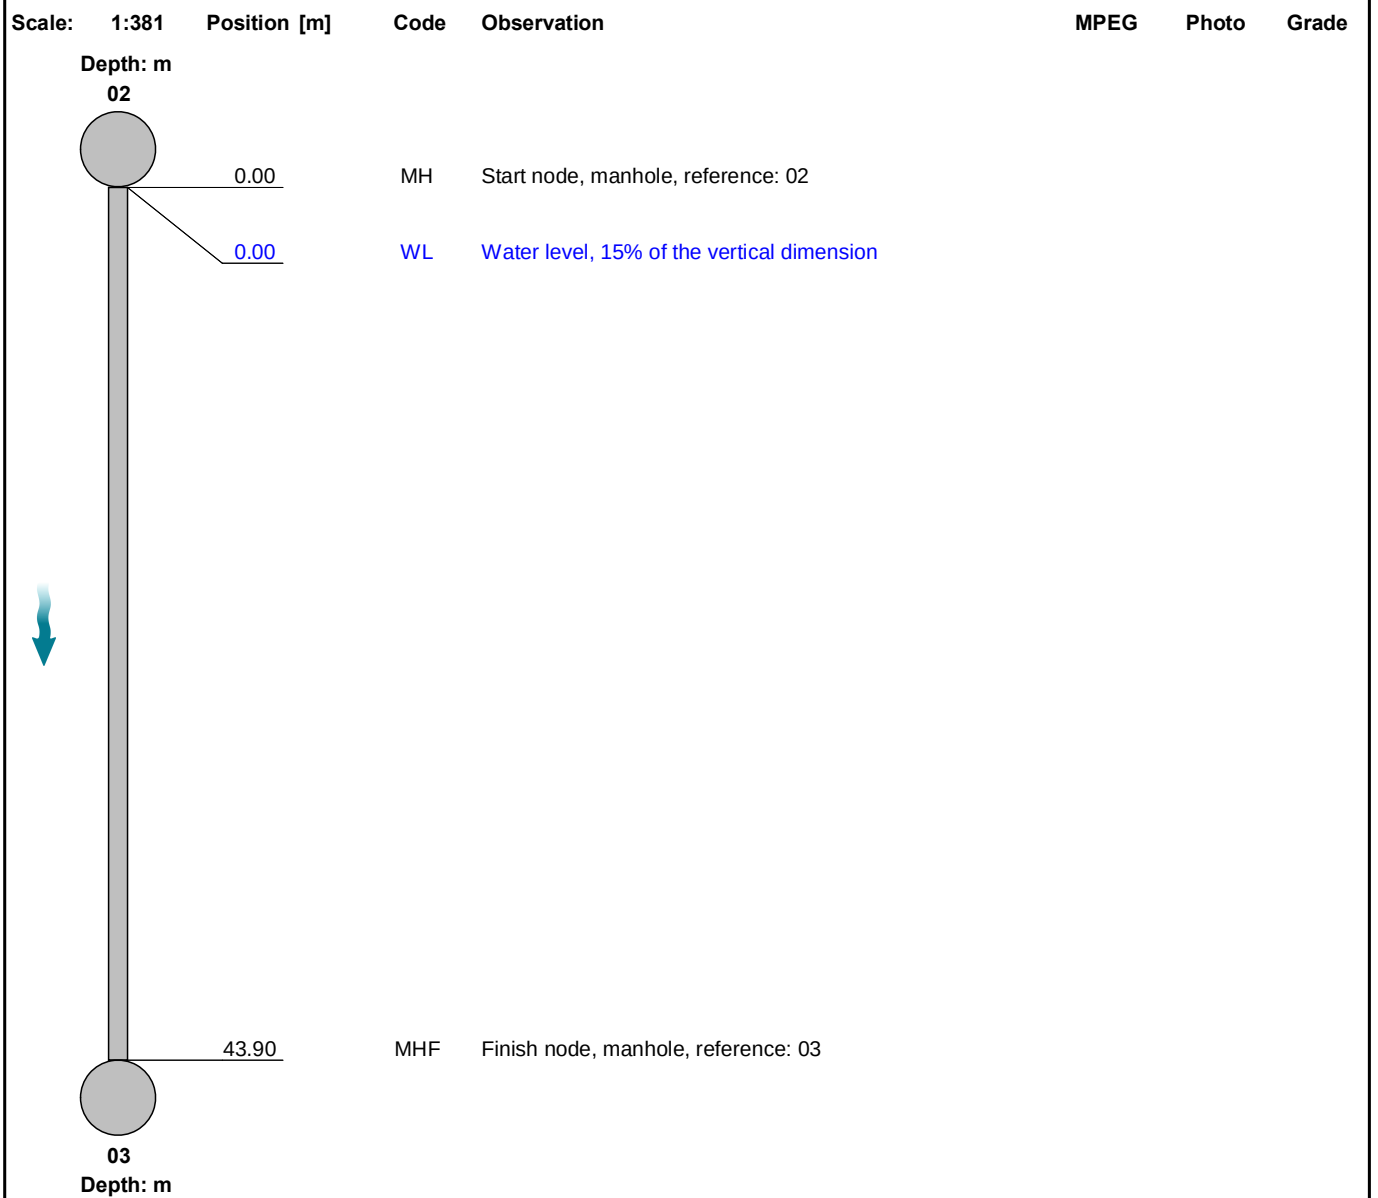
| No. | m+ | Code | Observation |
|---|---|---|---|
| 1 | 0.00 | MH | Start node, manhole, reference: 02 |
| 2 | 0.00 | WL | Water level, 15% of the vertical dimension |
| 3 | 43.90 | MHF | Finish node, manhole, reference: 03 |

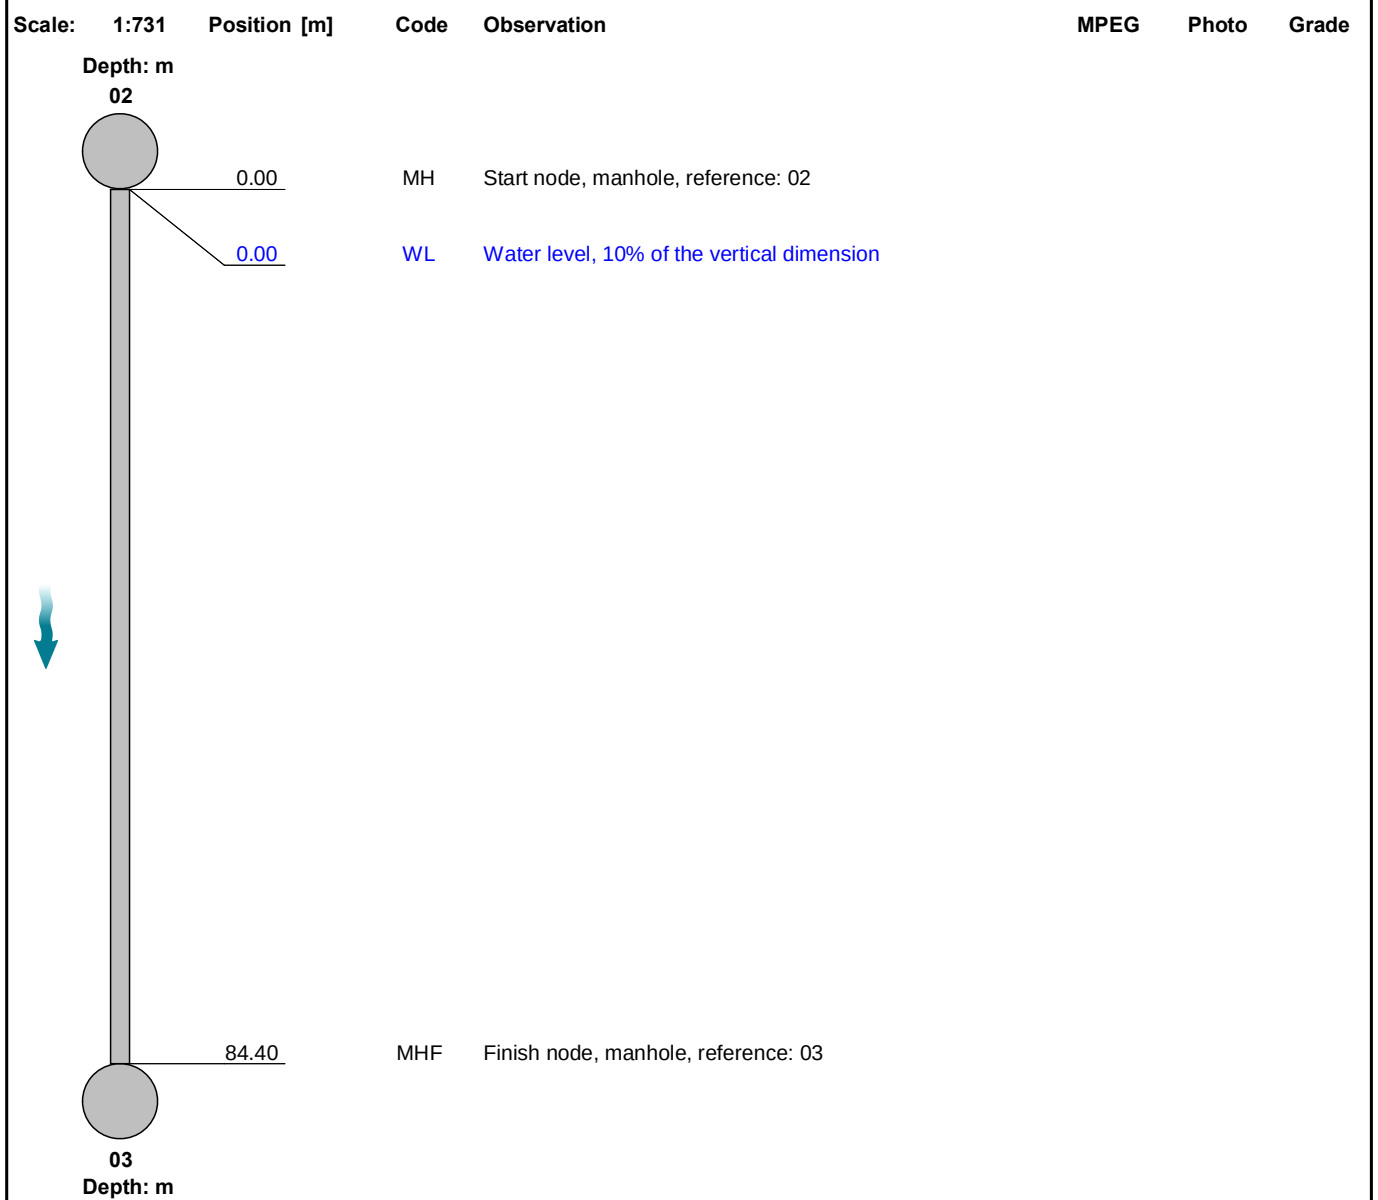
## Section Inspection - 06/11/2025 - 02X

| No. | m+ | Code | Observation |
|---|---|---|---|
| 1 | 0.00 | MH | Start node, manhole, reference: 02 |
| 2 | 0.00 | WL | Water level, 10% of the vertical dimension |
| 3 | 84.40 | MHF | Finish node, manhole, reference: 03 |

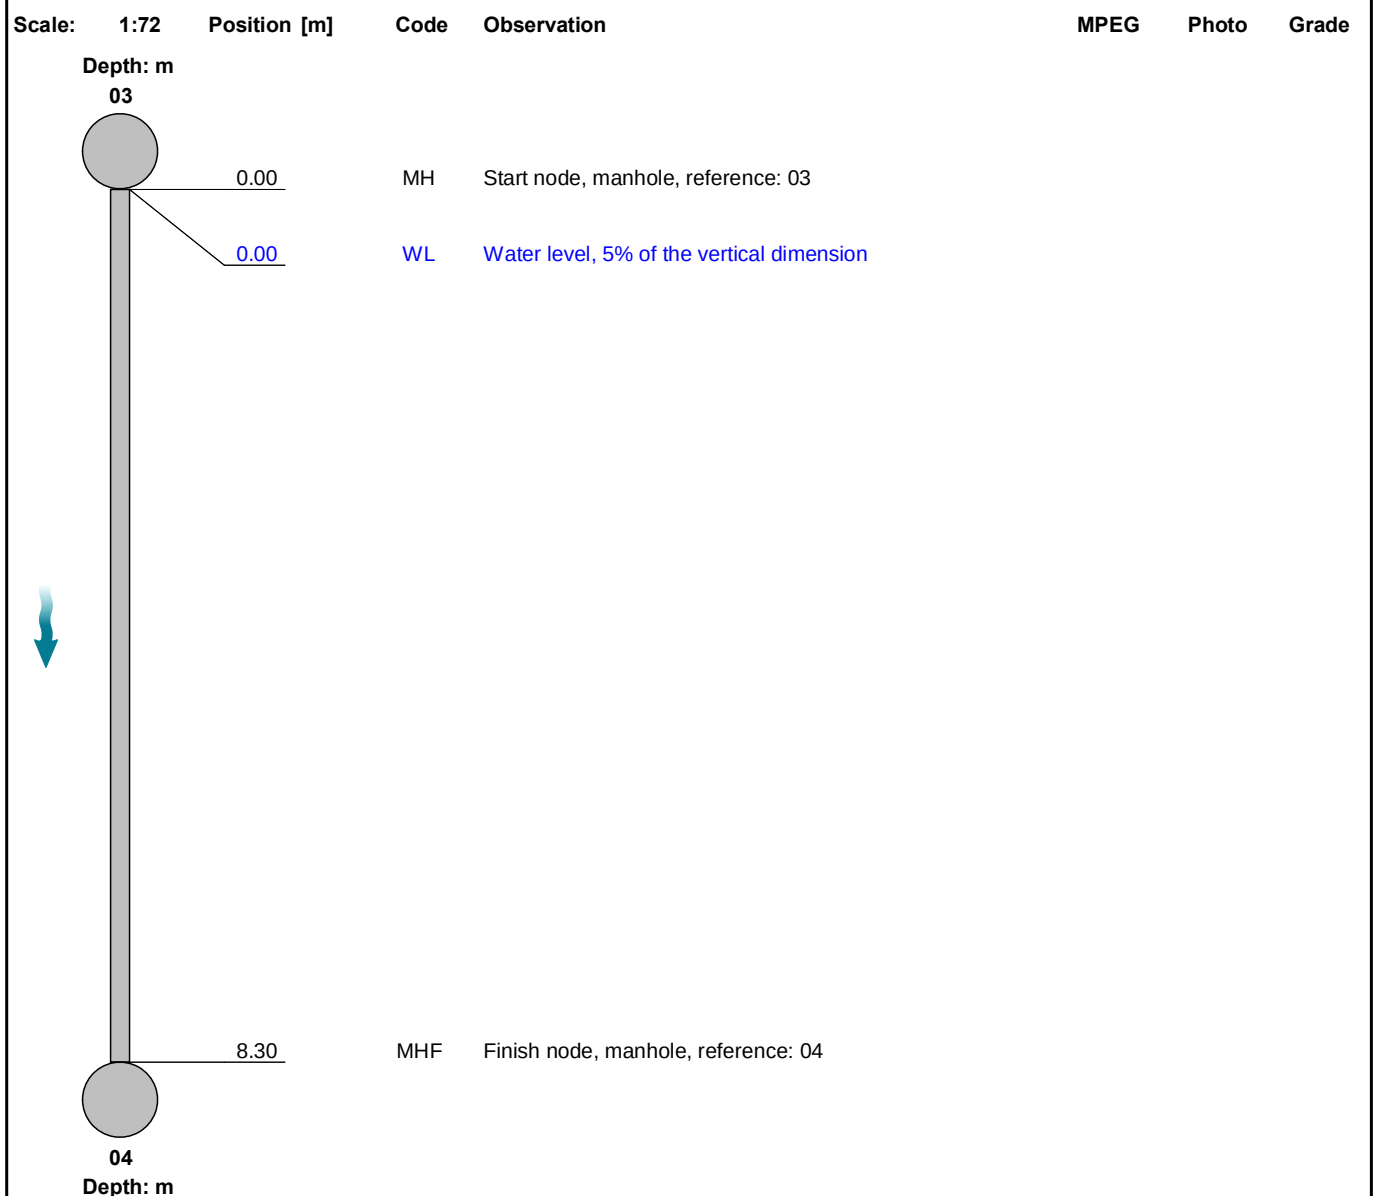
## Section Inspection - 06/11/2025 - 03X

| No. | m+ | Code | Observation |
|---|---|---|---|
| 1 | 0.00 | MH | Start node, manhole, reference: 03 |
| 2 | 0.00 | WL | Water level, 5% of the vertical dimension |
| 3 | 8.30 | MHF | Finish node, manhole, reference: 04 |

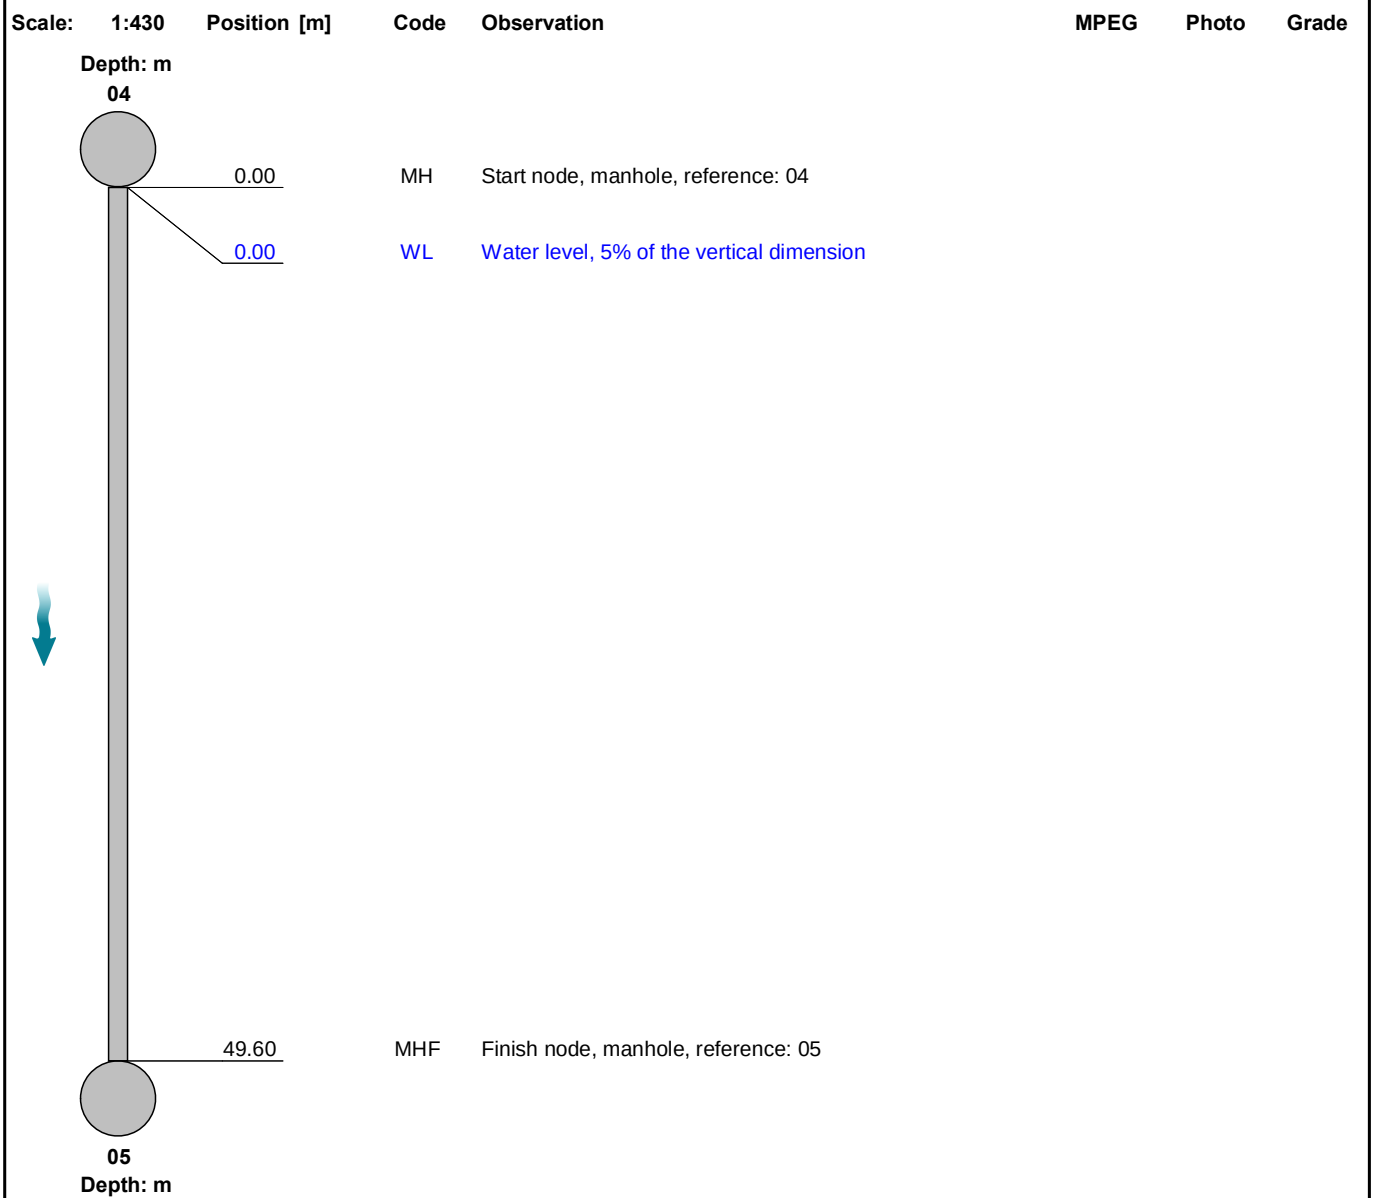
## Section Inspection - 06/11/2025 - 04X

| No. | m+ | Code | Observation |
|---|---|---|---|
| 1 | 0.00 | MH | Start node, manhole, reference: 04 |
| 2 | 0.00 | WL | Water level, 5% of the vertical dimension |
| 3 | 49.60 | MHF | Finish node, manhole, reference: 05 |

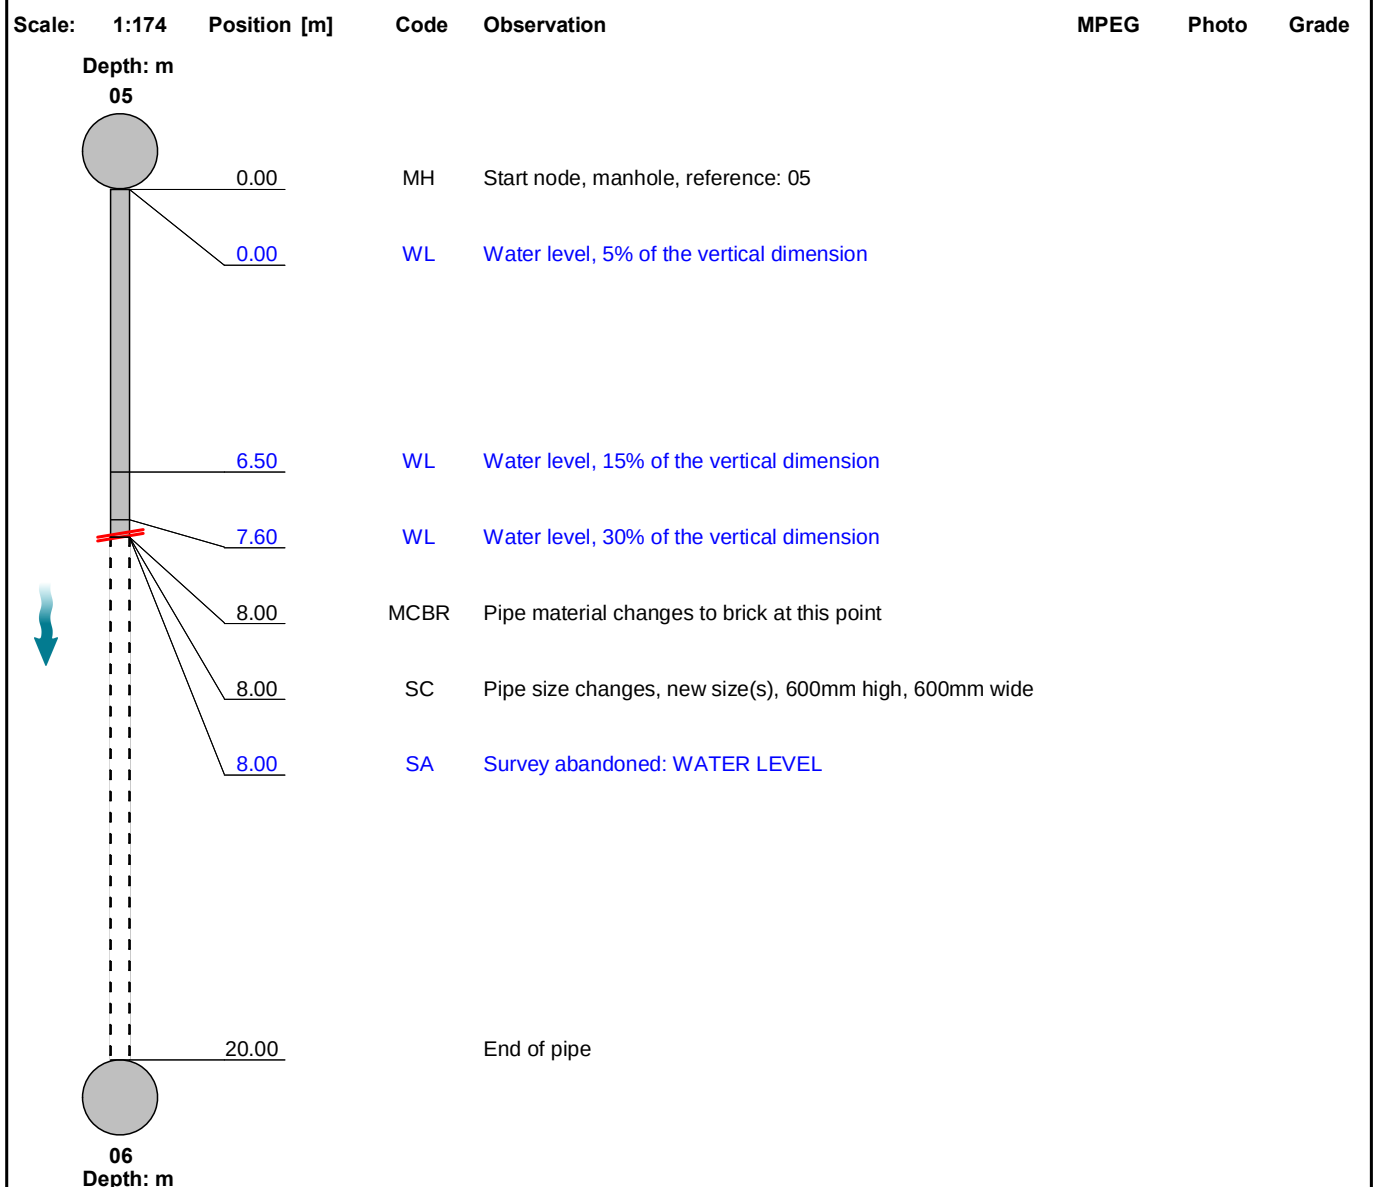
## Section Inspection - 06/11/2025 - 05X

| No. | m+ | Code | Observation |
|---|---|---|---|
| 2 | 0.00 | WL | Water level, 5% of the vertical dimension |
| 3 | 6.50 | WL | Water level, 15% of the vertical dimension |
| 4 | 7.60 | WL | Water level, 30% of the vertical dimension |
| 5 | 8.00 | MCBR | Pipe material changes to brick at this point |
| 6 | 8.00 | SC | Pipe size changes, new size(s), 600mm high, 600mm wide |
| 7 | 8.00 | SA | Survey abandoned |

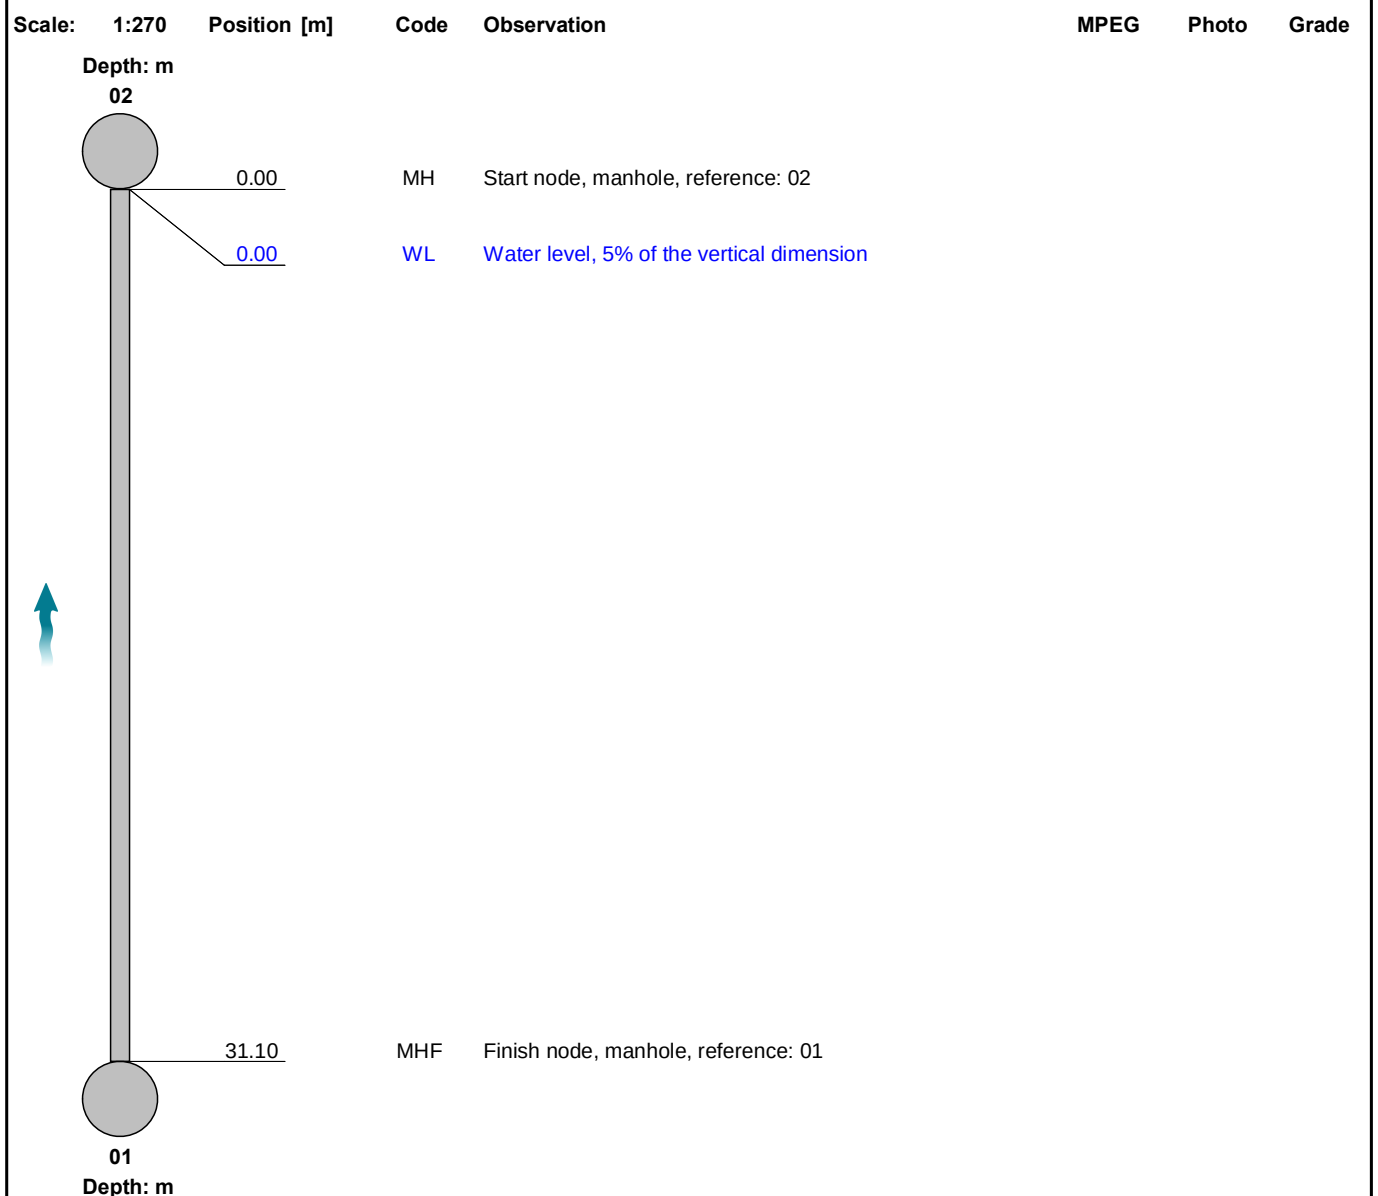
## Section Inspection - 11/11/2025 - 01X

| No. | m+ | Code | Observation |
|---|---|---|---|
| 1 | 0.00 | MH | Start node, manhole, reference: 02 |
| 2 | 0.00 | WL | Water level, 5% of the vertical dimension |
| 3 | 31.10 | MHF | Finish node, manhole, reference: 01 |
