# Preliminary Ecological Appraisal and Roost Assessment

Standrings, Bagslate Moor Road, Rochdale, Greater Manchester, OL11 5XT

This report is prepared to inform a planning application with the Rochford District Council. The proposal is described as:  
The construction of 1no. dwelling, with vehicular garaging, parking, new access and associated landscaping [Unsubmitted].

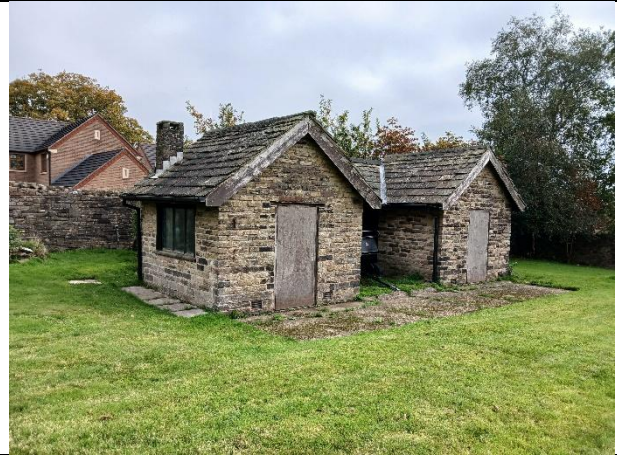
| <b>B1 Building description</b> | | | <b>Photographs</b> |
|---|---|---|---|
| <p><i>Summary</i></p> <p>B1 is a small single storey outbuilding that was historically used as a changing room for tennis courts present within the wider site ownership. The roof has slate tiles, and the walls are stone. There are numerous lifted and missing tiles, with missing mortar present along multiple roof ridges and terminal tile edges. Therefore, the structure presents suitable bat roosting and access features for crevice dwelling bat species. There is no internal loft void. The building will be demolished entirely. The building has <b>high habitat value</b> for roosting bats and may be suitable to support a maternity roost of crevice dwelling bats.</p> | | | |

| <p><i>Foreseen Impacts</i></p> | <p><b>Roosting habitat [Buildings]</b><br/>The proposed development will result in the demolition of this building. This could result in the destruction of any bat roosts present and could cause disturbance, death or injury to bats.</p> <p><b>Roosting habitat [Trees]</b><br/>At this stage it has not been confirmed whether T22 will be retained or felled to facilitate the development. The feature present on T22 (cavity) was not possible to fully inspect from ground level. Therefore, a close-up inspection of the PRFs identified from ground-level will be required to determine their suitability for bats (i.e. PRF-I or PRF-M).</p> <p><b>Foraging and commuting habitat</b><br/>The proposed development will result in the loss of small areas of scattered scrub and modified grassland within the vegetated garden but given their low value and the presence of more extensive areas of foraging and commuting habitat in the locality, this is likely to be inconsequential for bats.</p> <p><b>Artificial lighting</b><br/>The proposed development may lead to an increase in the amount of current lighting of surrounding habitats or the retained building without mitigation. This may disturb commuting bats.</p> |
| <p><i>Recommendations</i></p> | <p><b>Roosting habitat [Buildings]</b></p> <p><b>No works to the property that may block or remove potential roosting features should be carried out until the required surveys have been completed. Undertaking such work beforehand could unlawfully affect bats if present and may compromise the validity of the surveys and hinder the planning application process.</b></p> <p><b>Three</b> bat emergence/re-entry surveys are required on B1 during the active bat season (May – September) to confirm presence/likely-absence of bats roosting in or on the building.<br/>These survey visits should be completed during the optimal survey period mid-May to August inclusive. The survey visits should be at least three weeks apart.<br/>Sub-optimal: early May and September. Would require greater justification of timing e.g., weather conditions, known local bat activity.</p> <p>One of the surveys could be a dawn re-entry survey, or all three can be at dusk if supported by night vision aids (NVA).<br/><b>Four</b> surveyors are required to provide full coverage of the building's elevations to look for emerging/re-entering bats. An infrared camera should also be employed as part of the survey to see where any specific roost locations are located.<br/>Lighting mitigation may be required based on the outcome of the night bat survey(s).<br/>If any bat roosts are confirmed from this survey schedule, a bat licence would be required to demolish the buildings as it would involve the destruction of roosts. This is applied for with the help of a class 2 licensed bat ecologist after planning permission is granted, but before commencement of works.</p> |

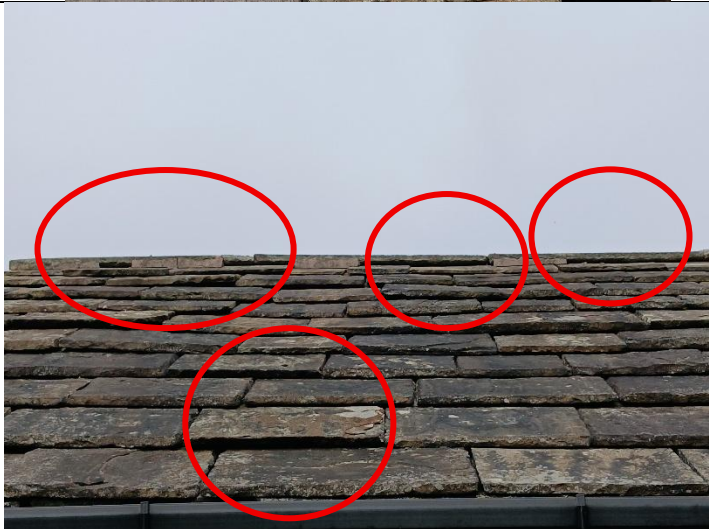
| Roof | Slate | <p><b>Condition/description</b><br/>Cross-hipped gabled roof, cat slide central to the two gables. Raised tiles present throughout.</p> <p><b>Suitability/access/evidence of bats</b><br/>Space under tiles could accommodate crevice dwelling bats and provide access into an internal space within the roof structure. Due to the amount of missing mortar present along the ridge tiles this is suitable to support maternity roosts of crevice dwelling bats. No evidence found but recent and current rain would wash this away externally.</p> | |

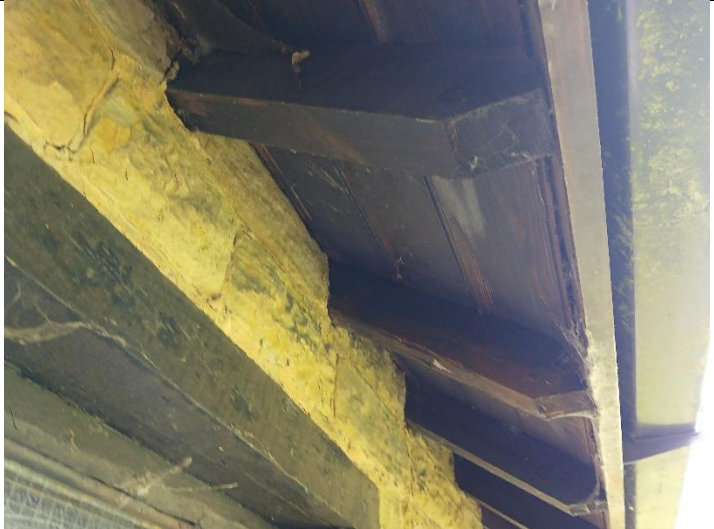
| Eaves | Overhanging | <p><b>Condition/description</b><br/>No gaps were present along the wall tops or under the eaves.</p> <p><b>Suitability/access/evidence of bats</b><br/>No suitable access for void dwelling or crevice dwelling bat species. No evidence found but recent and current rain would wash this away externally.</p> | |

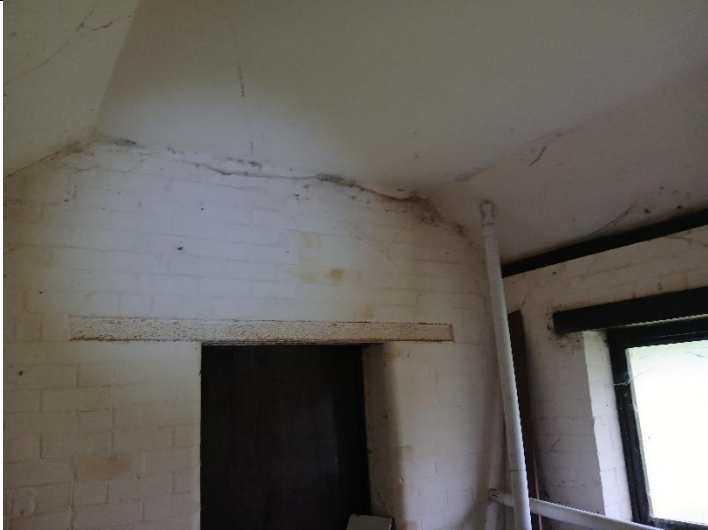
| Internal voids | N/A | <p><b>Condition/description</b><br/>No internal loft space present</p> <p><b>Suitability/access/evidence of bats</b><br/>No suitable roosting features for void dwelling or crevice dwelling bat species. No evidence internally.</p> | |

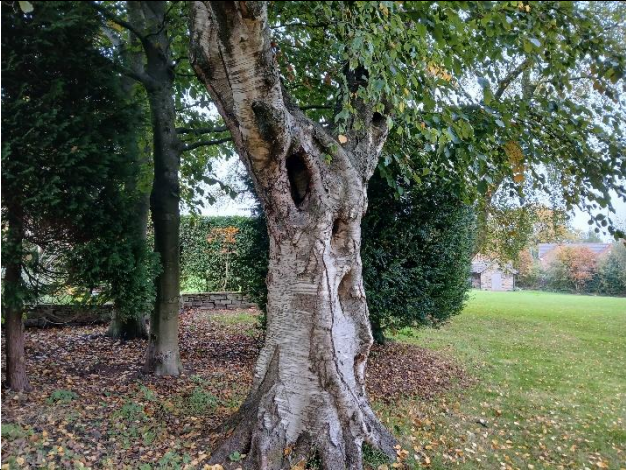
| T22 description | | | Photographs |
|---|---|---|---|
| <p><i>Summary</i></p> <p>All the trees within the development area were surveyed, only T22 was found to have features suitable for roosting bats. T22 is a mature cherry tree located within the western area of the garden (SD 87007 13803). The tree has a DBH ~45cm and a height of approx. 18m.</p> <p>Features identified on T22 during the survey are detailed below.</p> | | | |

| | <p><b>Roosting habitat [Trees]</b><br/> A close-up inspection of the PRFs on T22 identified from ground-level will be required to determine their suitability for bats (i.e. PRF-I or PRF-M). This will either involve a tree climbing team or a MEWP to access the features and should be carried out by a class 2 licenced ecologist. The inspection will involve a detailed inspection of all features using a torch and endoscope. Following this inspection, the features will then be re-classified based on their suitability for roosting bats. Depending on the results of the close-up inspection further surveys may be required to determine bat presence/likely-absence or a recommendation to remove the trees under a precautionary working method statement.</p> <p><b>Foraging and commuting habitat</b><br/> No further surveys are required.</p> <p><b>Artificial lighting</b><br/> A low impact lighting strategy will be adopted for the site during post-development which outlines the areas of the site that will be retained as dark corridors. Parameters can be found on the Bat Conservation Trust website:<br/> <a href="https://www.bats.org.uk/our-work/buildings-planning-and-development/lighting">https://www.bats.org.uk/our-work/buildings-planning-and-development/lighting</a></p> <p><b>Suggested biodiversity enhancements</b><br/> Enhancements are dependent on the outcome of further surveys.</p> |

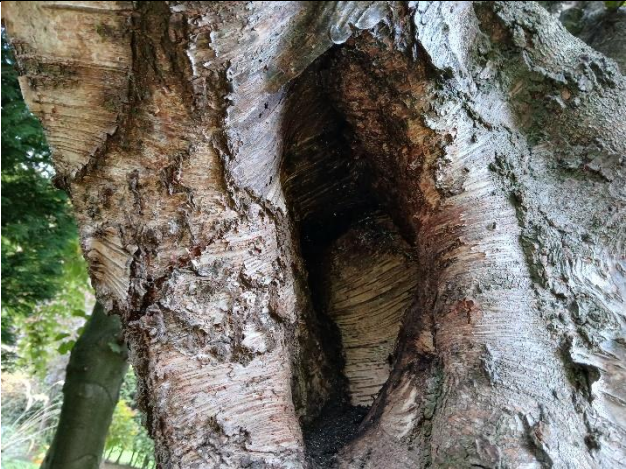
| T22 description | | | Photographs |
|---|---|---|---|
| PRF-1 | Cavity | <p>Cavity located approximately 2m from ground level on western aspect of stem (south facing). Feature measures approximately 35cm height by 25cm width. Whilst a ladder was used for a visual inspection, revealing a 6cm x 2cm crack which could lead to an additional cavity, the cavity was too high to fully inspect from ground level, and as such the depth of the crack and potential additional cavity could not be determined. Therefore, the feature requires further investigation (i.e. <b>FAR</b>) to determine its suitability for roosting bats.</p> <p>At the time of the site visit the cavity was dry and there was no evidence of bats observed.</p> | |

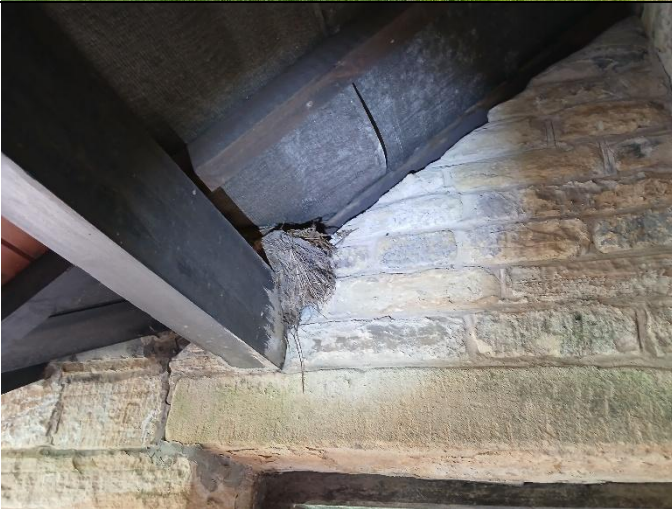
| <p><i>Summary of Survey Findings</i></p> | <p><b>Buildings</b><br/> A nest was located along the western elevation of B1 under the eaves. The nest is consistent with house martin; it was not occupied at the time of the site visit.</p> <p><b>Trees and vegetation</b><br/> No bird nests were identified within the scrub, tree line, trees or hedges on-site, however they all offer nesting opportunities and nest-building resources for birds.</p> <p><b>Barn owls</b><br/> The site does not appear to provide any suitable nesting sites for barn owls.</p> <p><b>Overwintering birds</b><br/> Due to the small size of the site and the extent and type of the habitats recorded, the site not considered suitable to support a significant assemblage of protected and/or notable birds.</p> |

Figure 6: Bird nest found under the eaves on the western elevation of B1

| <i>Recommendations</i> | <p><b>Buildings/trees</b><br/>The demolitions of B1 and removal of any vegetation should be undertaken outside the period 1st March to 31st August. If this timeframe cannot be avoided, a close inspection of the vegetation should be undertaken immediately, by a qualified ecologist, prior to the commencement of work. All active nests will need to be retained until the young have fledged.</p> <p>Precautions should be taken with machinery and noise levels when working close to any retained nests so as not to disturb any nearby nesting birds during construction works. At least a 3-5m buffer should be created between any machinery and active nests until the young have fledged.</p> <p><b>Barn owls</b><br/>None required.</p> <p><b>Overwintering birds</b><br/>None required.</p> <p><b>Suggested biodiversity enhancements</b><br/>The installation of a minimum of three bird boxes on mature trees around the site boundaries or within the structure of the new building to provide additional nesting habitat for birds e.g.<br/>Schwegler No 17 Swift Nest Box (buildings)<br/>Schwegler 1SP Sparrow Terrace (buildings)<br/>Schwegler 1B Nest Boxes (trees)<br/>Schwegler 2H Robin Boxes (trees)<br/>Woodstone Nest Box (buildings or trees)<br/>Or a similar alternative brand.<br/>Tree boxes should be positioned approximately 3m above ground level where they will be sheltered from prevailing wind, rain and strong sunlight. Small-hole boxes are best placed approximately 1-3m above ground on an area of the tree trunk where foliage will not obscure the entrance hole.</p> |

| | <p>Swift and sparrow boxes should be positioned at the eaves of a building and can be incorporated into the fabric of the building during construction.</p> <p>House martins are colonial nesters, so it is recommended to install multiple artificial cup nests in pairs, to encourage re-colonisation. The artificial nests should be placed on a sheltered side of the building (north or east facing), at least 2m above the ground. As the development is proposing the construction of a residential dwelling it is recommended to instal a droppings board approx. 2 meters below the nest to catch droppings and minimise the impact of the nests on the homeowners.</p> |

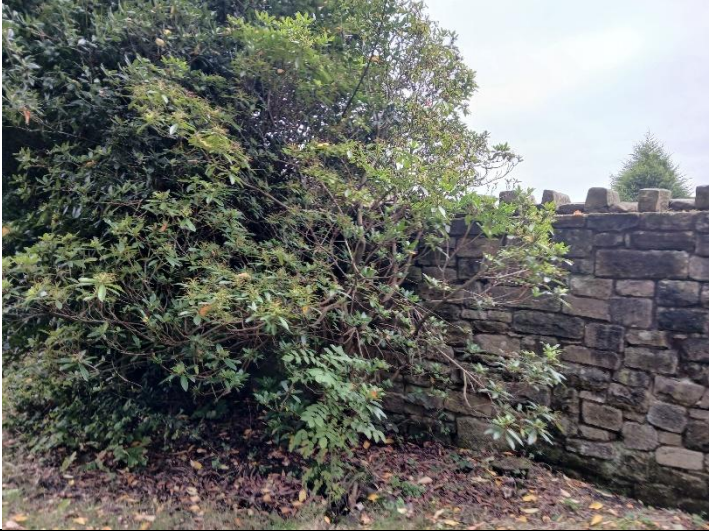
| <i>Summary of Survey Findings</i> | Himalayan balsam and Rhododendron were identified on the site which area listed as an invasive, non-native species under Schedule 9 of the Wildlife and Countryside Act 1981. |

| | | <p>Figure 16: Rhododendron present along the southern boundary line</p> |

| <i>Recommendations</i> | <p>The following measures should be implemented to control and/or eradicate Himalayan balsam from the site:</p> <ul style="list-style-type: none"> <li>• Himalayan balsam removal should be undertaken between April and June, prior to seeding.</li> <li>• Pull the plant up by grasping the base of the stem and giving a steady gentle pull to bring up roots.</li> <li>• Dispose of Himalayan balsam in line with appropriate controlled waste measures or by leaving it in a pile to compost down (this stops the balsam re-growing from the roots or the nodules on the stem).</li> <li>• Ensure biosecurity measures are in place and clean boots, clothing and vehicle tyres before leaving site.</li> </ul> <p>Rhododendron present within the garden along the southern boundary is unlikely to be impacted by the construction, due to the site being situated within an area of urban gardens continued on-site management should reduce the risk of any spread into the neighbouring gold course. Making the risk of release into wild environments minimal.</p> |

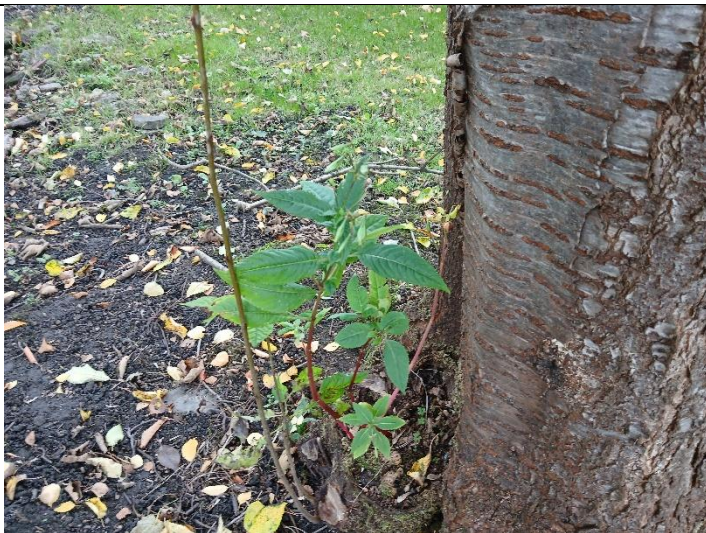
Figure 17: Himalayan balsam present amongst the trees in the western section of garden
