**Riverside Drive, Rochdale**

**Phase 2 Geo-Environmental Investigation, Risk Assessment and  
Remediation Strategy**

Job Number  
**LKC251054**

Report Date  
**May 2026**

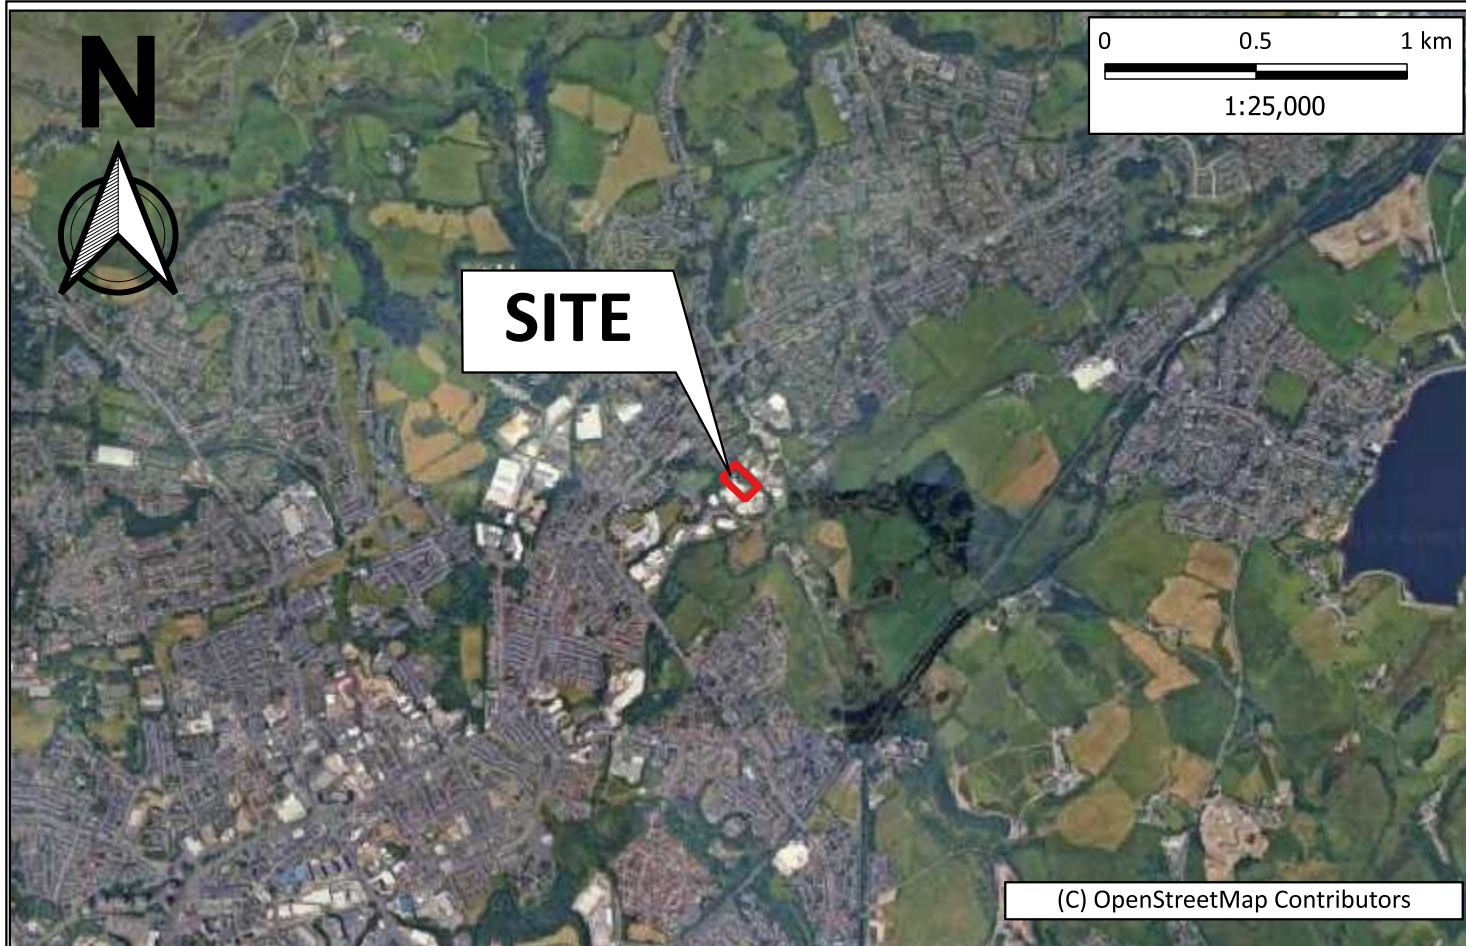
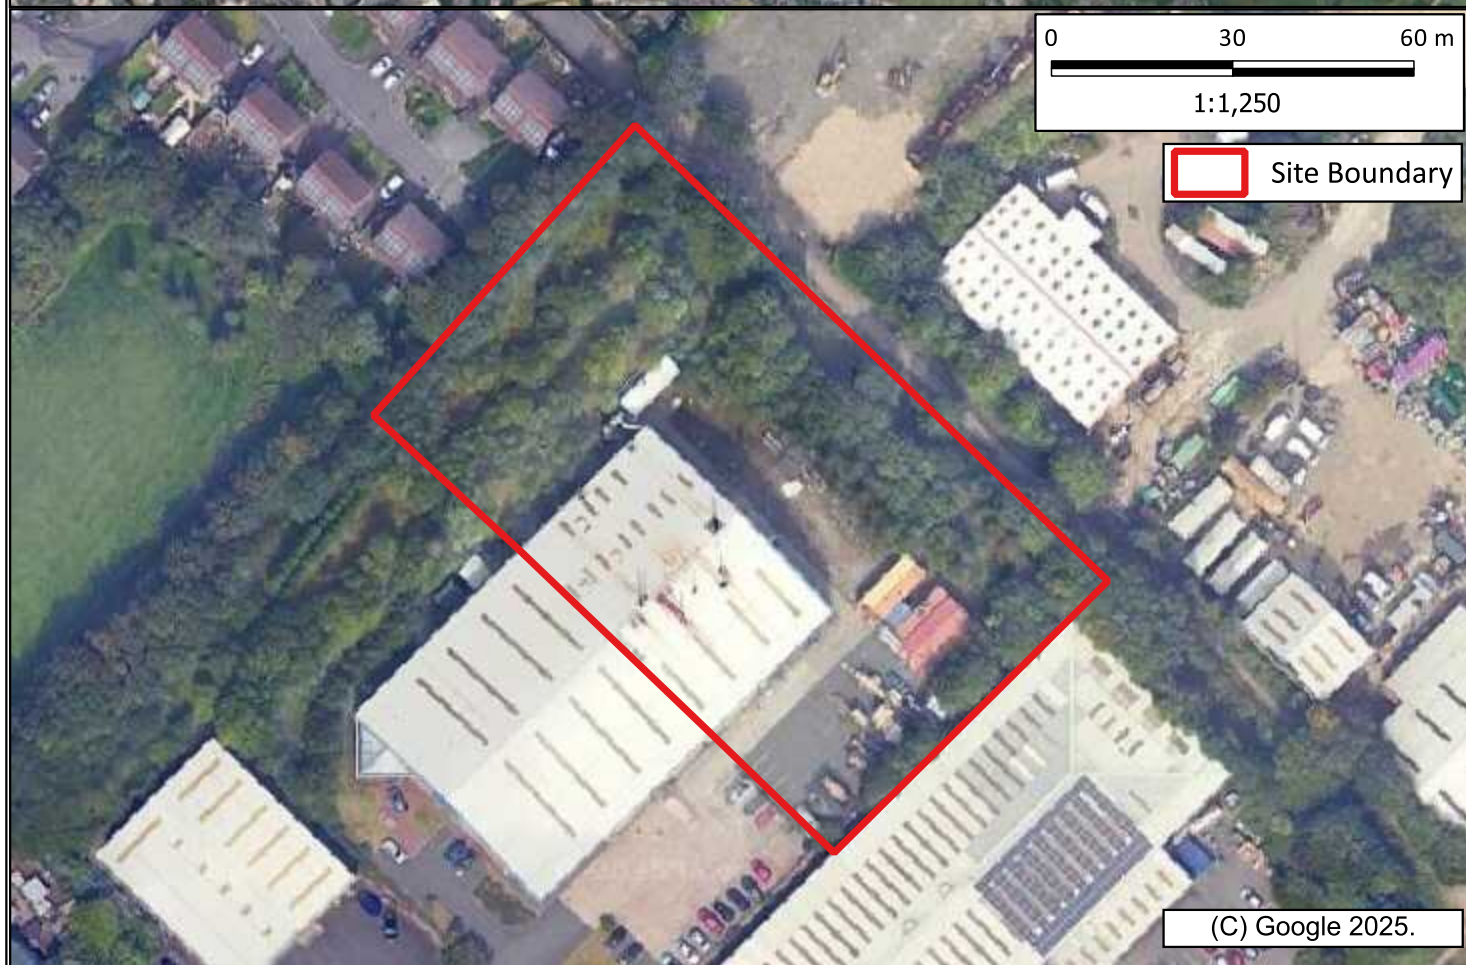
| Client:<br><br>Fothergill Coated Fabrics Ltd | | | | Title:<br><br>Site Location &<br>Boundary Plan | | <br><br>LK CONSULT | |
| Site:<br><br>Riverside Drive, Rochdale | | | | Scale (see scale bar):<br><br>1:25,000      &<br>1:1250 @ A4 | | | |
