## Invasive plant species management plan

| SITE | Land to the west of New Street,<br>Littleborough, OL15 8HW |
| REPORT REFERENCE | JK24-0499-IPSMP-28012026 |

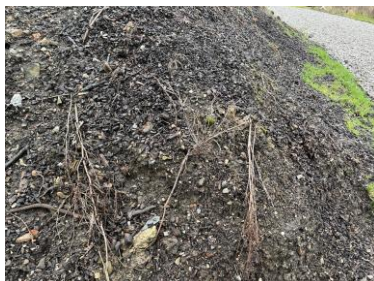
| Japanese Knotweed | |
|---|---|
| JK2 | |

| Location reference number | Location (includes proximity to boundary) | Proximity to built structures or hard-landscaped areas (m) | Area and size of infestation<br><i>Scales -</i><br><i>Very small: 1m<sup>2</sup> or less</i><br><i>Small: 1m<sup>2</sup> to 4m<sup>2</sup></i><br><i>Medium: 4m<sup>2</sup> to 25m<sup>2</sup></i><br><i>Large: 25m<sup>2</sup> to 100m<sup>2</sup></i><br><i>Extensive: greater than 100m<sup>2</sup></i> | Height of growth | Description of growth (includes maturity and condition) | Notes |
|---|---|---|---|---|---|---|
| JK2 | Located in the eastern section site of site, circa 2.0m from the development boundary. | Situated adjacent to an existing footpath (in good condition). Potential rhizome could extend beneath the footpath. | Surface growth amounted to circa 0.25sqm<br><br>Size of infestation is considered very small. | Up to circa 0.25m | Sporadic, isolated, less mature and less established infestation. Due to time of year, the surface growth was dead. | Due to proximity to the development boundary, associated rhizome may extend beyond the development boundary.<br><br>Surrounding area appeared as though it had been previously disturbed.<br><br>JK2 was situated on the edge of an existing stockpile (which contains other invasive plants). |

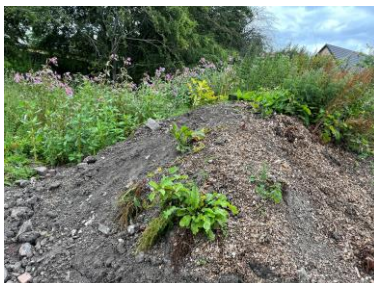
| Japanese Knotweed | |
|---|---|
| JK3, JK4, JK5 | |

| JK3 | Located in the eastern section of site, circa 5.5m from the boundary. | Situated circa 5m from an existing footpath (in good condition). | <p>Surface growth amounted to circa 0.7qm</p> <p>Size of infestation is considered very small</p> | Up to circa 0.4m | <p>Sporadic, isolated, less mature and less established infestation. Due to time of year, the surface growth was dead.</p> | <p>Surrounding area appeared as though it had been previously disturbed.</p> <p>JK3 was situated on an existing stockpile (which contains other invasive plants).</p> <p>Due to close proximities, JK3 could potentially share same rhizome as JK2 and JK4.</p> <p>As mentioned earlier in this report, JK3 was chemically treated by JKSL in August 2026. The surface growth was viable when surveyed in July 2026..</p> |

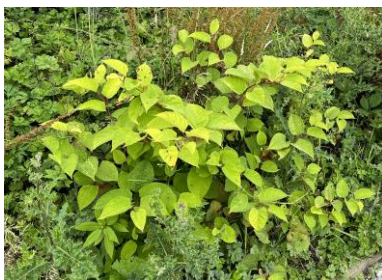
| Japanese Knotweed | |
|---|---|
| JK6 | |

| JK6 | Located in the eastern section of site, circa 3.5m from the boundary. | Situated adjacent to an existing footpath (in good condition). Potential rhizome could extend beneath the footpath. | <p>Surface growth amounted to circa 1sqm</p> <p>Size of infestation is considered small.</p> | Up to circa 0.8m | <p>Sporadic, isolated, less mature and less established infestation. Due to time of year, the surface growth was dead.</p> | <p>Surrounding area appeared as though it had been previously disturbed.</p> <p>JK6 was situated on the edge of an existing stockpile (which contains other invasive plants).</p> <p>Due to close proximities, JK6 could potentially share same rhizome as JK5, JK7 and JK8.</p> <p>As mentioned earlier in this report, JK6 was chemically treated by JKSL in August 2026. The surface growth was viable when surveyed in July 2026.</p> |

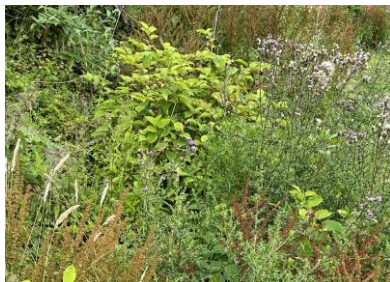
| Japanese Knotweed | |
|---|---|
| JK7+JK8 | |

| JK7 | Located in the eastern section of site, circa 3m from the boundary. | Situated adjacent circa 1.5m from existing footpath (in good condition). Potential rhizome could extend beneath the footpath. | Surface growth amounted to circa 0.2sqm<br><br>Size of infestation is considered very small. | Up to circa 0.6m | Sporadic, isolated, less mature and less established infestation. Due to time of year, the surface growth was dead. | Surrounding area appeared as though it had been previously disturbed.<br><br>JK7 was situated on the edge of an existing stockpile (which contains other invasive plants).<br><br>Due to close proximities, JK7 could potentially share same rhizome as JK6 and JK8.<br><br>As mentioned earlier in this report, JK7 was chemically treated by JKSL in August 2026. The surface growth was viable when surveyed in July 2026. |
| JK8 | Located in the eastern section of site, circa 4m from the boundary. | Situated adjacent circa 2.5m from existing footpath (in good condition). Potential rhizome could extend beneath the footpath. | Surface growth amounted to circa 1.5sq,<br><br>Size of infestation is considered large. | Up to circa 1.6m | Sporadic, isolated, less mature and less established infestation. Due to time of year, the surface growth was dead. | Surrounding area appeared as though it had been previously disturbed.<br><br>JK8 was situated on the edge of an existing stockpile (which contains other invasive plants).<br><br>Due to close proximities, JK8 could potentially share same rhizome as JK6 and JK7.<br><br>As mentioned earlier in this report, JK7 was chemically treated by JKSL in August 2026. The surface growth was viable when surveyed in July 2026. |

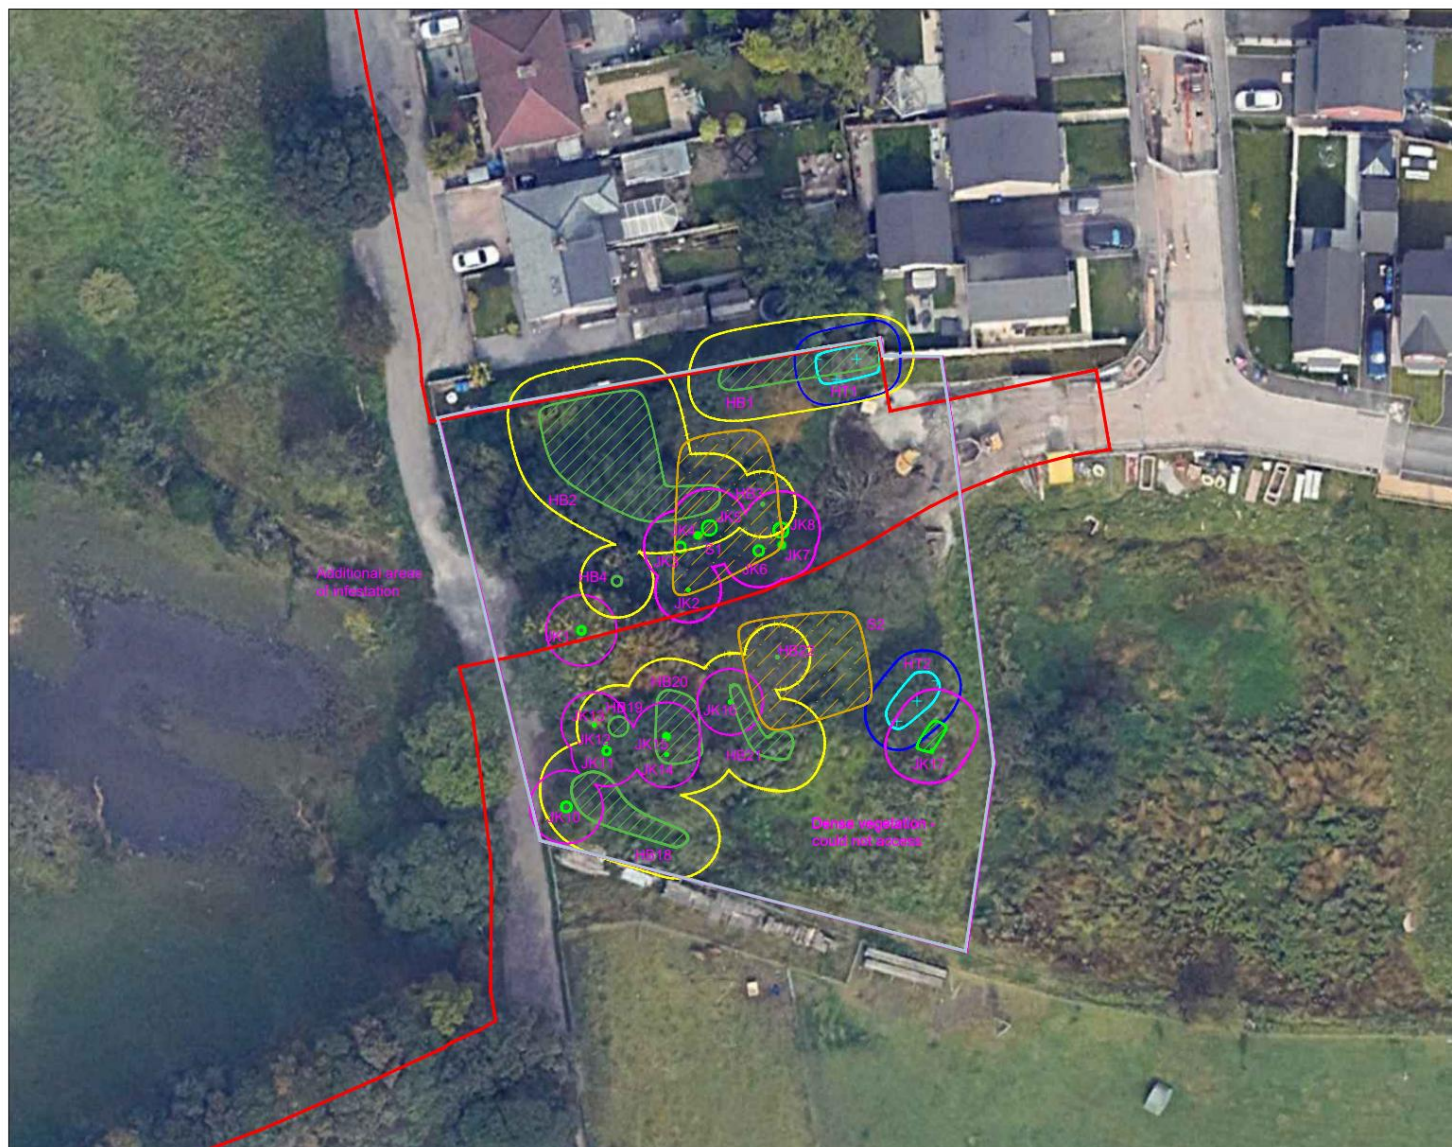
## Appendix 2. Drawing JK25-0499-01

DISCLAIMER:  
SURVEY BASED ON VISUAL INSPECTION OF SURFACE GROWTH. JKS, HBLS AND  
S1 ARE NOT IDENTIFIED IN VISUAL INSPECTION MODE. CONTINUED MONITORING OF SITE IS RECOMMENDED.
