# GEO-ENVIRONMENTAL AUDIT

## PHASE 1 PRELIMINARY RISK ASSESSMENT

### PROPOSED COMMERCIAL DEVELOPMENT

**Rochdale Sports Club**

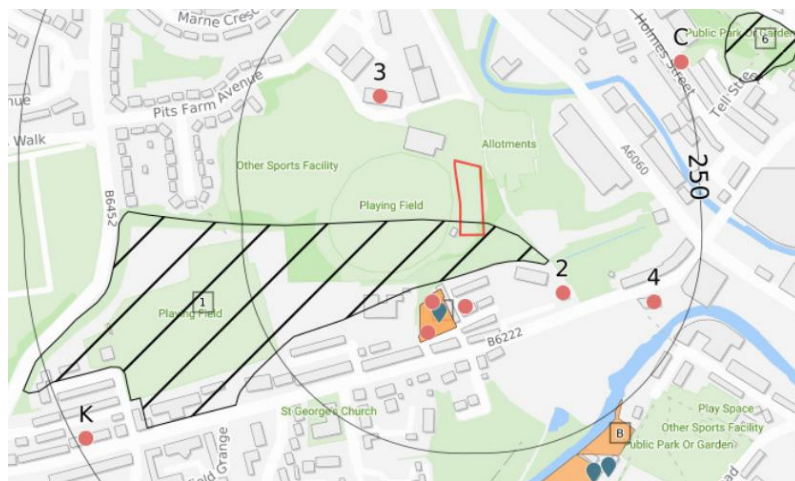
Sandy Brow Landfill Site is the name given to the local area which encroaches onto the south of the site. It was historically filled between the 1950s up to the 1970s, refer to excerpt from the Groundsure Report below:

In November 2013 the land was investigated by the LPA to ascertain if it could be designated 'Contaminated Land' under Part 2A of the 1990 Environmental Protection Act.

The investigations were undertaken by the Environmental Protection Group (EPG) and comprised twenty five probe holes, fifteen hand dug pits, soil and water samples, gas and groundwater monitoring which included Flame Ionisation Detection (FID) and the use of indoor gas canisters.

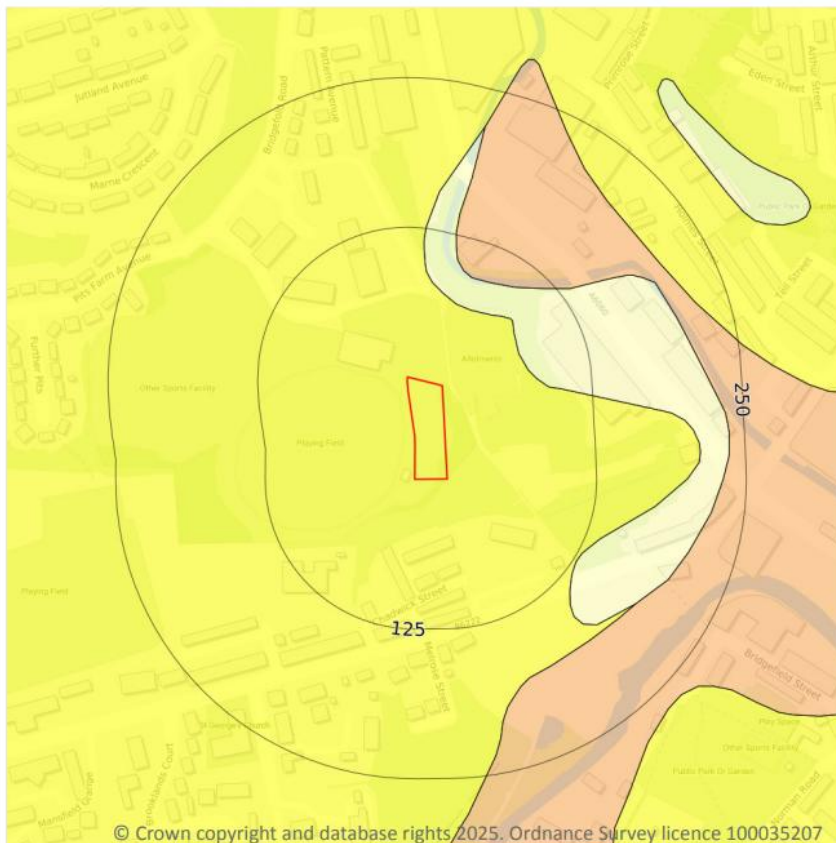
## Natural ground subsidence - Running sands

The potential hazard presented by rocks that can contain loosely-packed sandy layers that can become fluidised by water flowing through them. Such sands can 'run', removing support from overlying buildings and causing potential damage.

| Location | Hazard rating | Details |
|---|---|---|
| On site | Very low | Running sand conditions are unlikely. No identified constraints on land use due to running conditions unless water table rises rapidly. |
