# **GEO-ENVIRONMENTAL AUDIT**

## **PHASE 1 PRELIMINARY RISK ASSESSMENT**

## **PHASE 2 SITE INVESTIGATIONS**

**PROPOSED RESIDENTIAL DEVELOPMENT**  
**83 FIELDING STREET**  
**MIDDLETON**  
**ROCHDALE**  
**M24 6BG**

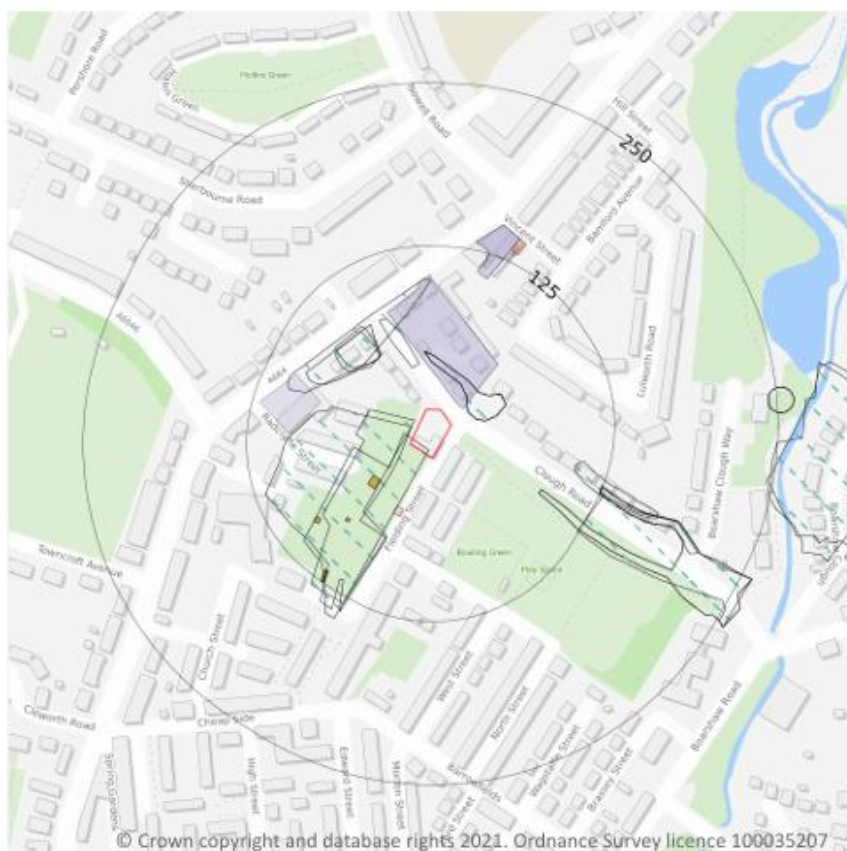
### Past land use

These historical land uses have been identified from 1:10,560 and 1:10,000 scale Ordnance Survey maps dated from the mid to late 1800s to recent times. They have the potential to have caused ground contamination. Please see the Environmental Summary to find out how these could impact the site.

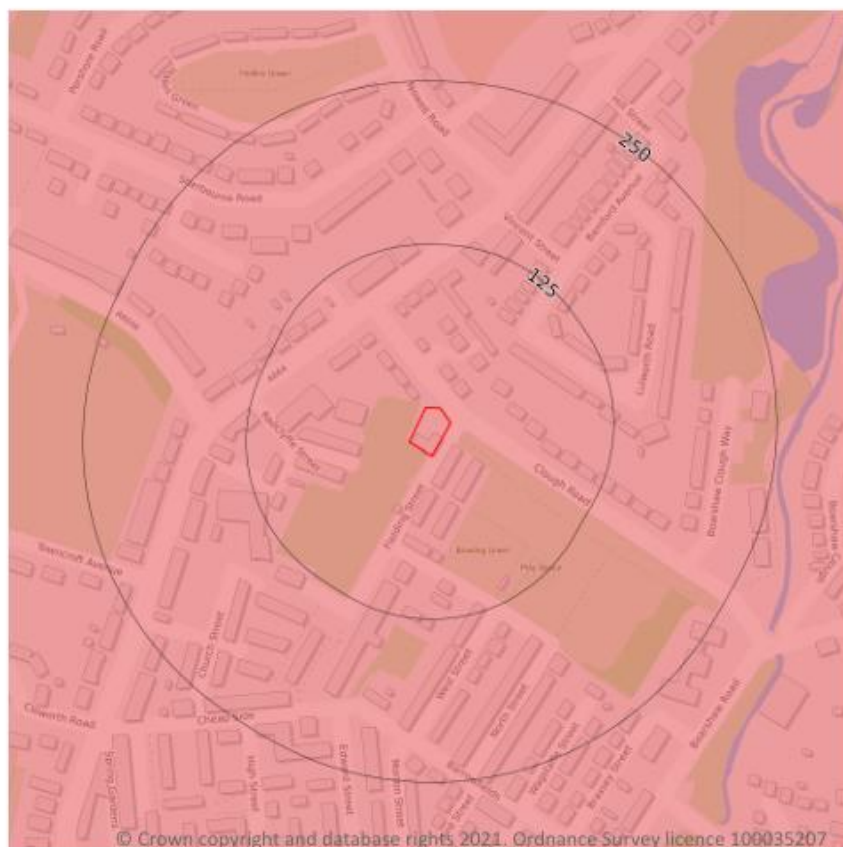
## Superficial hydrogeology

- Site Outline
- Search buffers in metres (m)
- Principal
  - Secondary A
  - Secondary B
  - Secondary Undifferentiated
  - Unproductive
  - Unknown

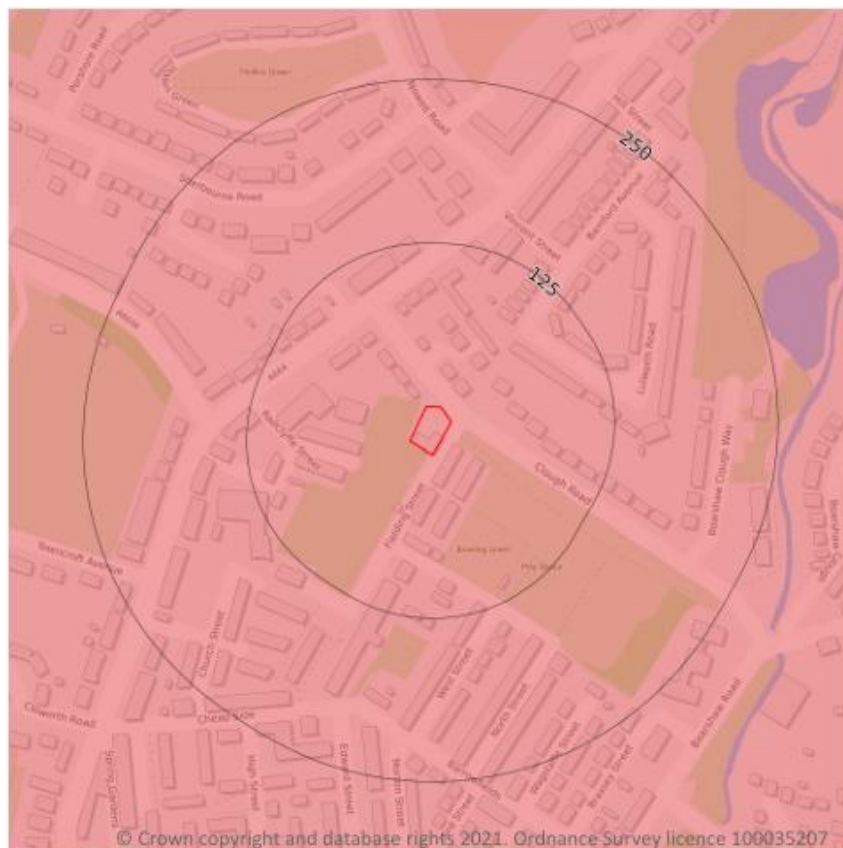
## Bedrock hydrogeology

- Site Outline
- Search buffers in metres (m)
- Principal
- Secondary A
- Secondary B
- Secondary Undifferentiated
- Unproductive
- Groundwater abstraction licence (point)
- Groundwater abstraction licence (area)
- Groundwater abstraction licence (linear)

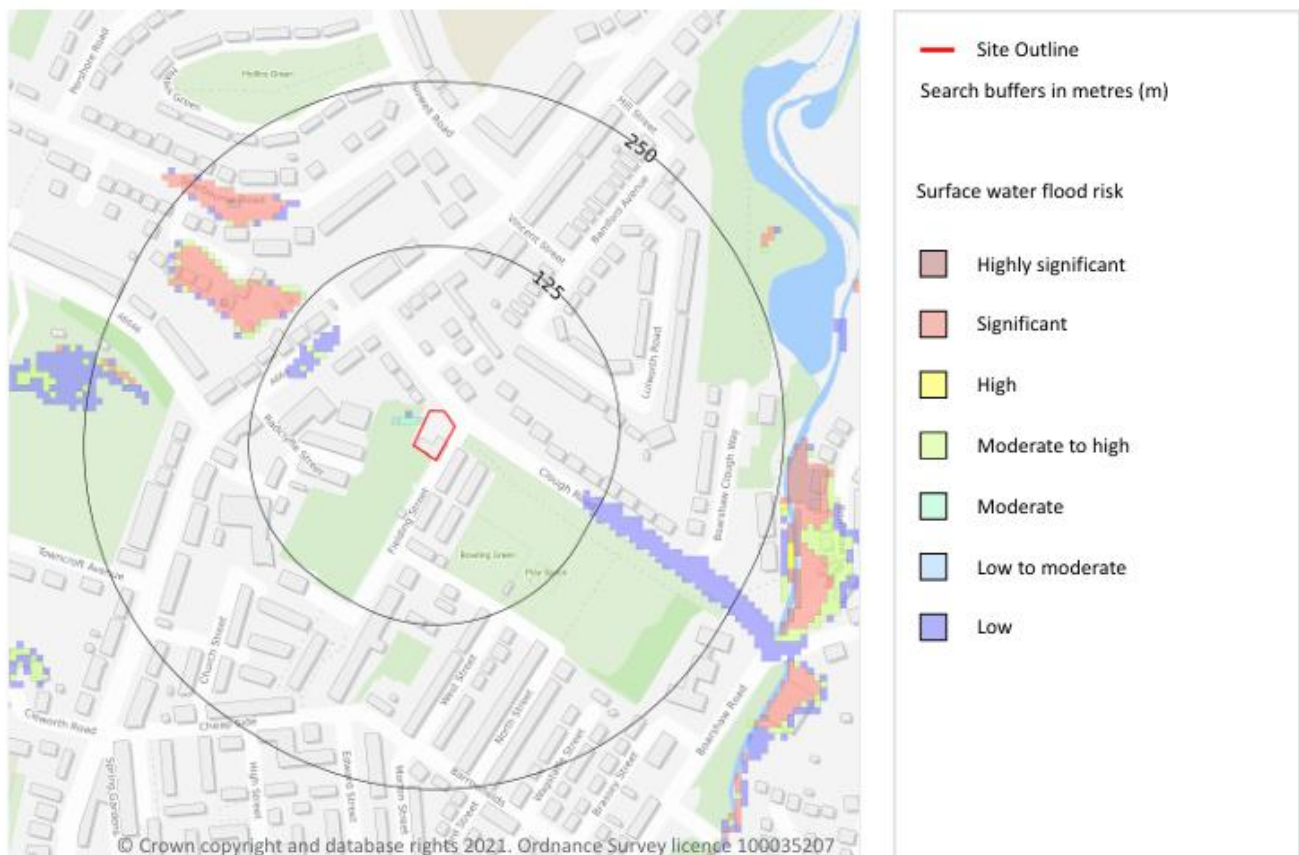
### Surface water flood risk

The property is likely to be prone to flooding following extreme rainfall, which may have an impact on insuring the property against flood risk.

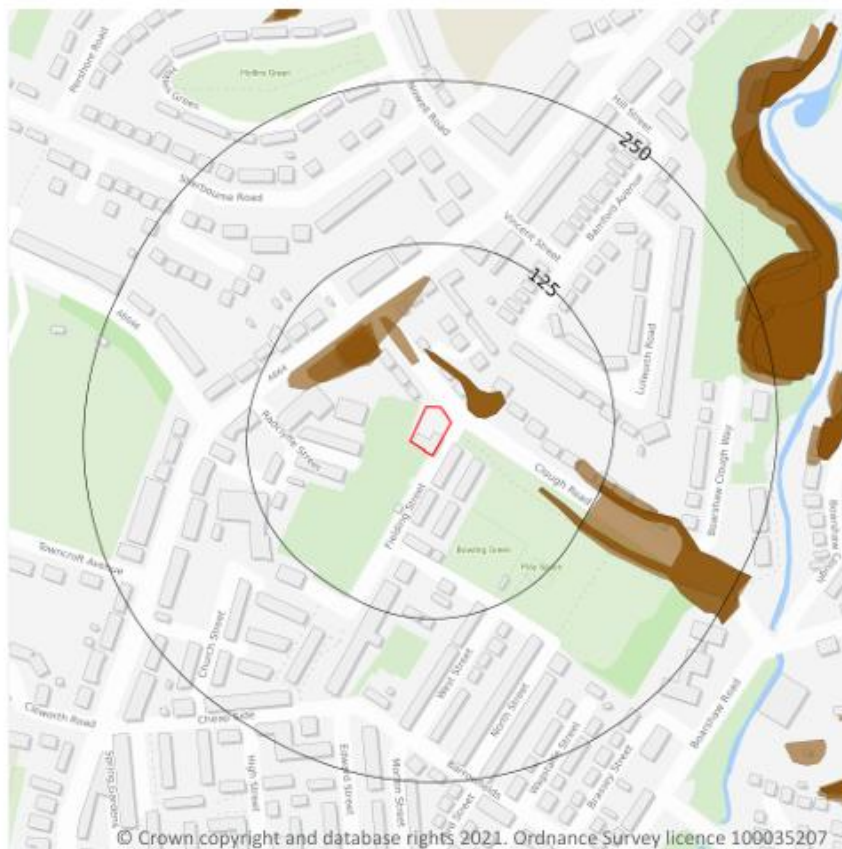
### Non-natural ground subsidence

Maps suggest the property is located near a previous pond, quarry, mine, landfill or other hole in the land. These land cavities are often filled with various materials, and this can cause structural problems. Groundsure's experts recommend that you check whether your structural surveys have taken this into account.
