# ARBORICULTURAL FEASIBILITY SURVEY

206-208 Drake Street

Tree data collection for a pre-development application

Treestyle Consultancy Ltd

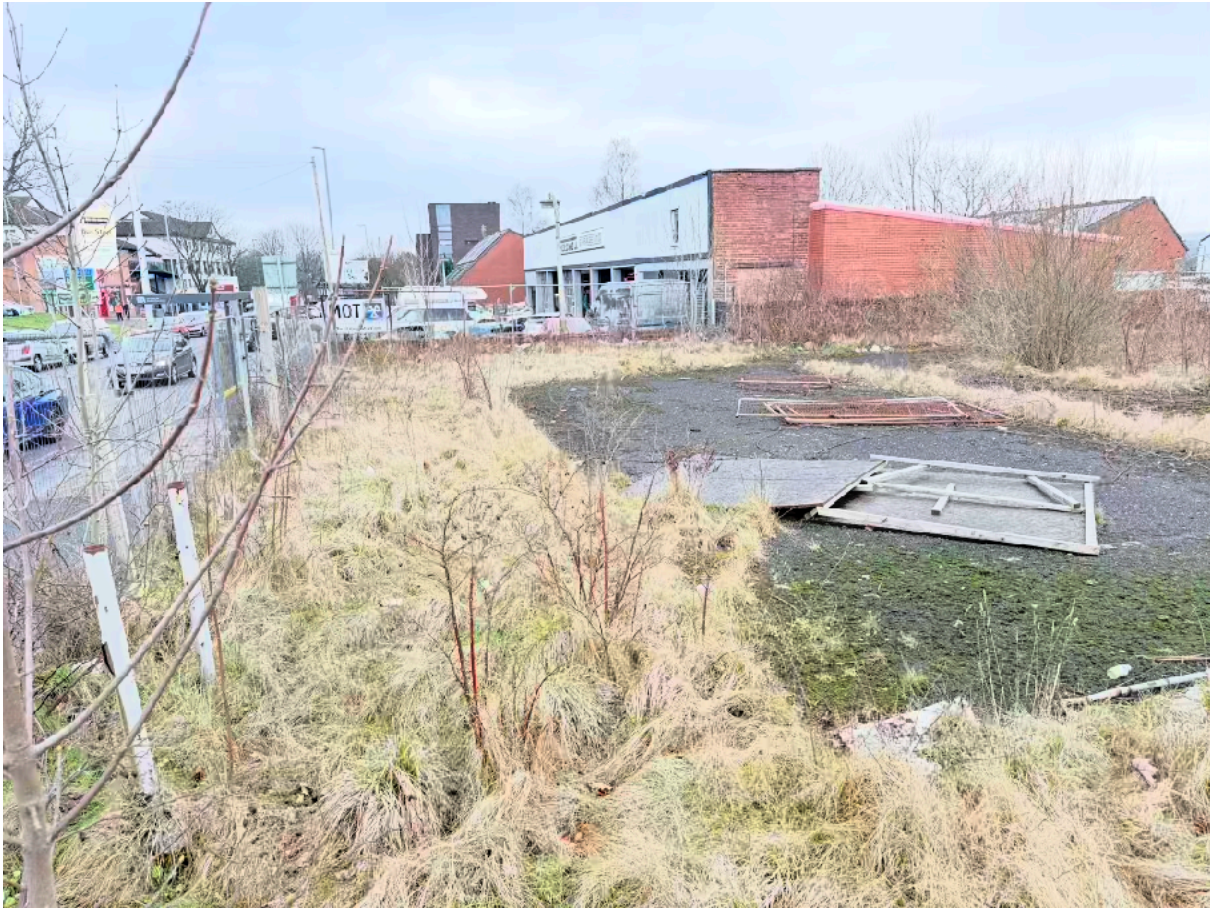
View of the ground where there are minimal trees to warrant retention

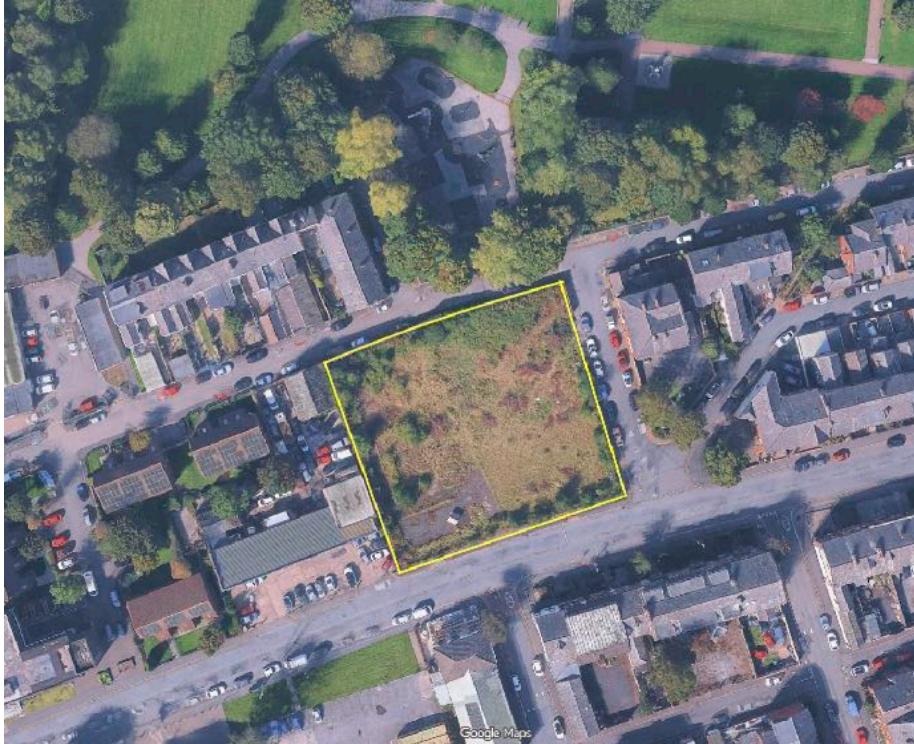
- 1.5 Located in the heart of Rochdale in what is regarded as a densely populated area, Drake Street and the surrounding community have local amenities with a public area for recreation and with local shops and businesses. Predominantly residential, the land in question is centrally located and is mostly surrounded by properties and associated infrastructure.
- 1.5.1 The grounds are made up of a few hardstanding areas within and access in three of the four sides, which is otherwise surrounded by an old stone wall. The grounds have been neglected for many years, allowing nature to take hold, with predominantly pioneer species.

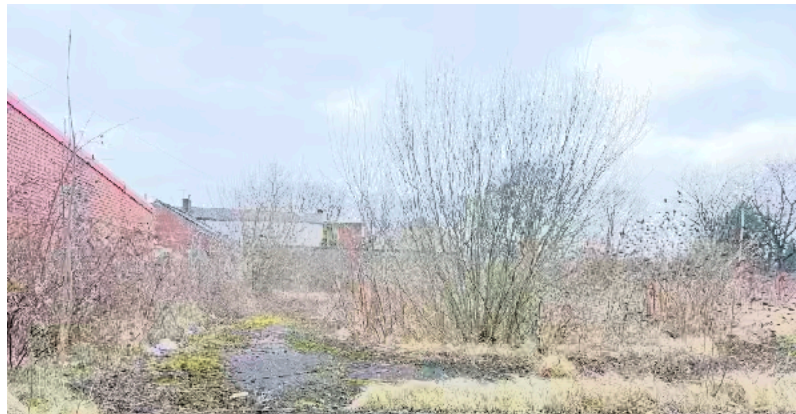
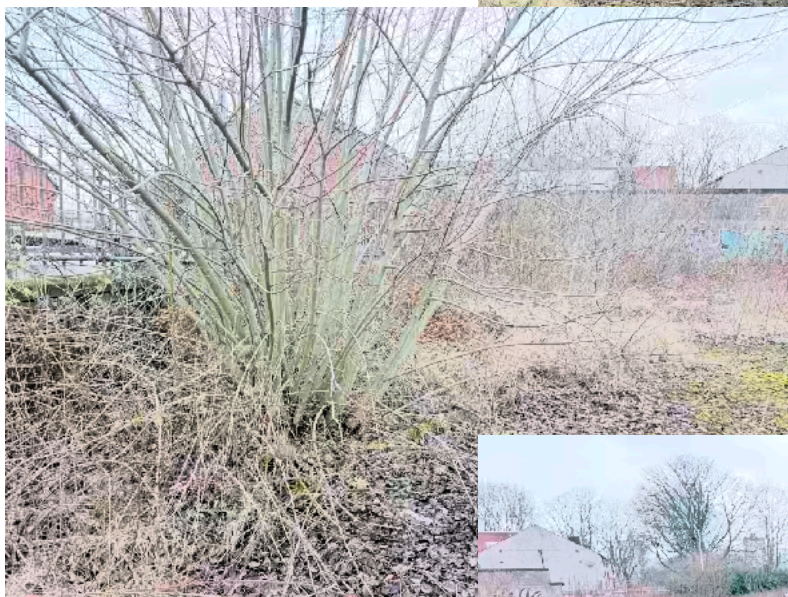
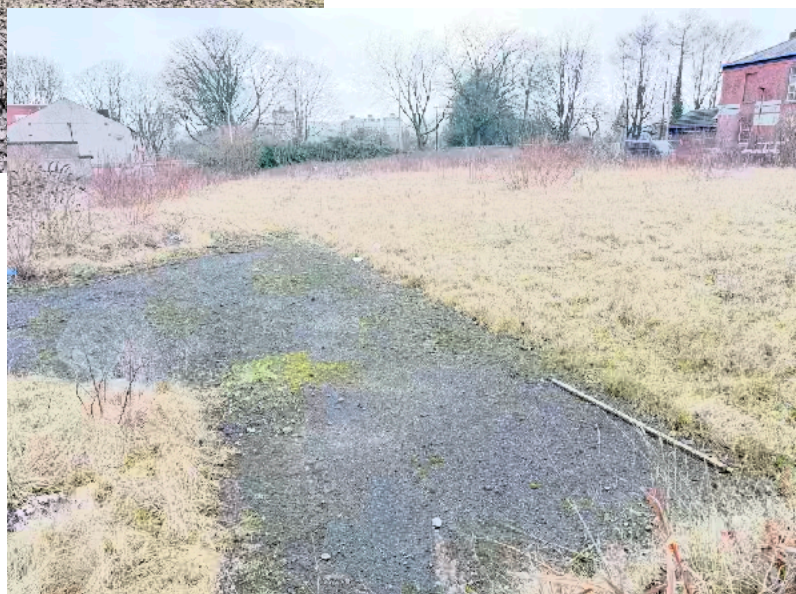
- 5.6.1 The impact of trees on the development and vice versa in allowing for future growth have all been considered. Tree size, future growth, light/shading, leaf and fruit nuisance etc have the potential to be an issue. None of the vegetation warrants retention, therefore, there are no constraints.
- 5.6.2 The images below shows the quality of the vegetation lining the boundaries, all of low quality. They have limited life potential and visual amenity value due to their species type, form and proximity to walls, buildings and public highways.

- There are above and below ground constraints with the groups lining all the boundaries and within.
