3931-04A/NR

## 206-208 DRAKE STREET, ROCHDALE – SOIL INFILTRATION TEST LETTER REPORT

IGE Consulting were instructed in March 2026 to undertake soil infiltration tests at Drake Street, Rochdale for Great Places Housing Group.

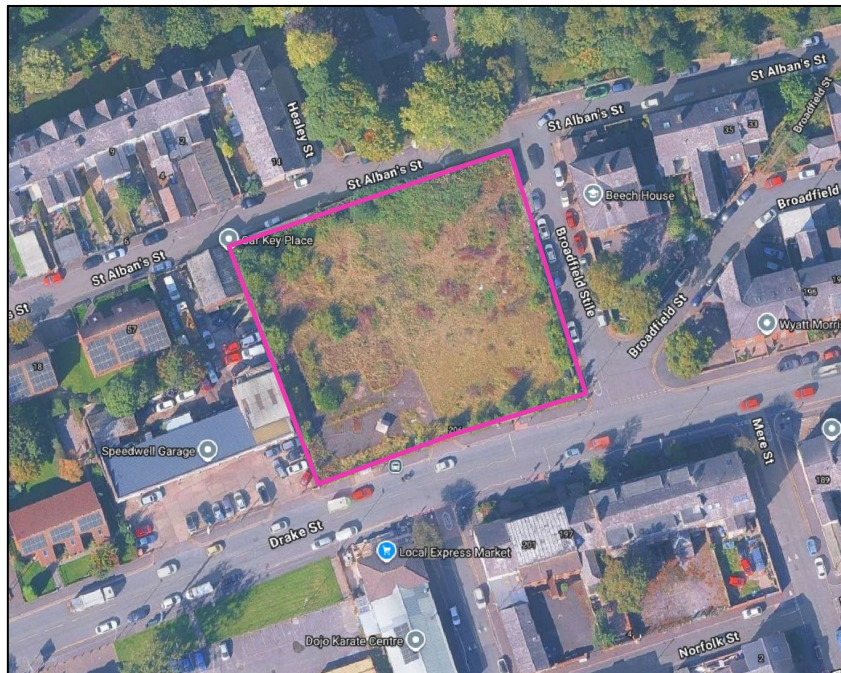
Figure 1: Aerial image of the site. The approximate site boundary is highlighted in magenta.

The site is c. 0.33 Ha, located to the north of Drake Street, Rochdale, c. 0.5km south of Rochdale Town centre, at the approximate postcode OL16 1PJ. The National Ordnance Survey Grid Reference for the centre of the site is 389439E, 412859N. The approximate site boundary is shown on the below aerial photograph, highlighted in magenta. A site location plan is contained in Appendix 2.

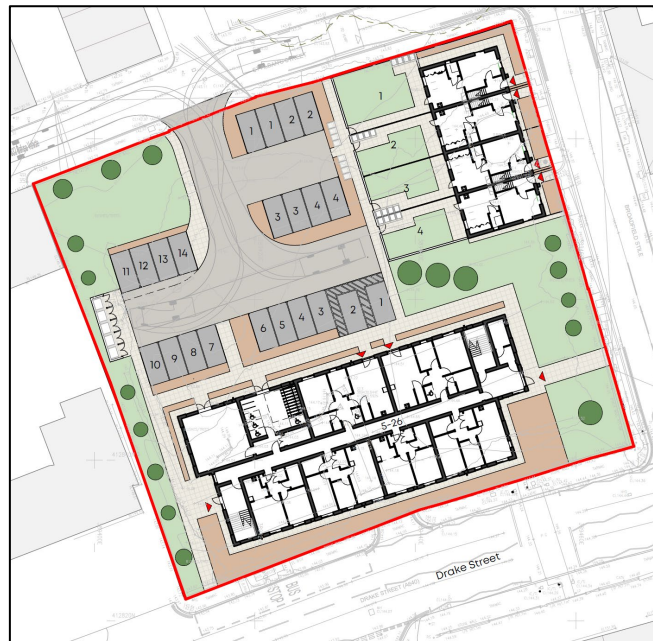
Figure 2: Extract of the Proposed Development Plan ('19146-PJA-00-ZZ-DR-A-1200-F - Proposed Site Plan'), dated December 2025.

It is the client's intention to develop the site into a low-rise residential development comprising 26 No. dwellings consisting of 4 No. semi-detached dwellings and an apartment block with associated private gardens, soft landscaping and car parking.

A proposed development plan is contained in Appendix 2 with an extract below.

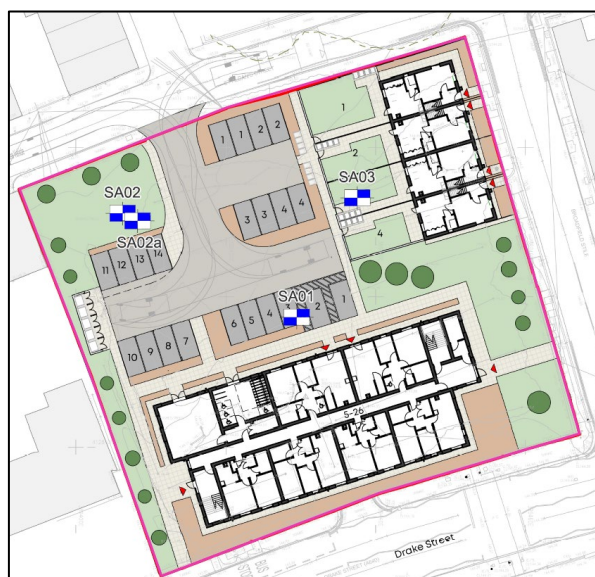
Figure 3: Extract of the exploratory hole location plan (SI-07).

An exploratory hole location plan is contained within Appendix 2 and an extract is included below.

Soil infiltration tests in accordance with BRE 365 were undertaken in SA01, SA02a and SA03, located in the central and northern site sections, respectively. A singular run was successfully undertaken in SA01 and SA03 due to slow infiltration rates and 2 No. runs were achieved in SA02a. It should be noted that the soil infiltration rates for 3 No. of the tests highlighted in red below have been calculated by extrapolation. The following infiltration rates were recorded:

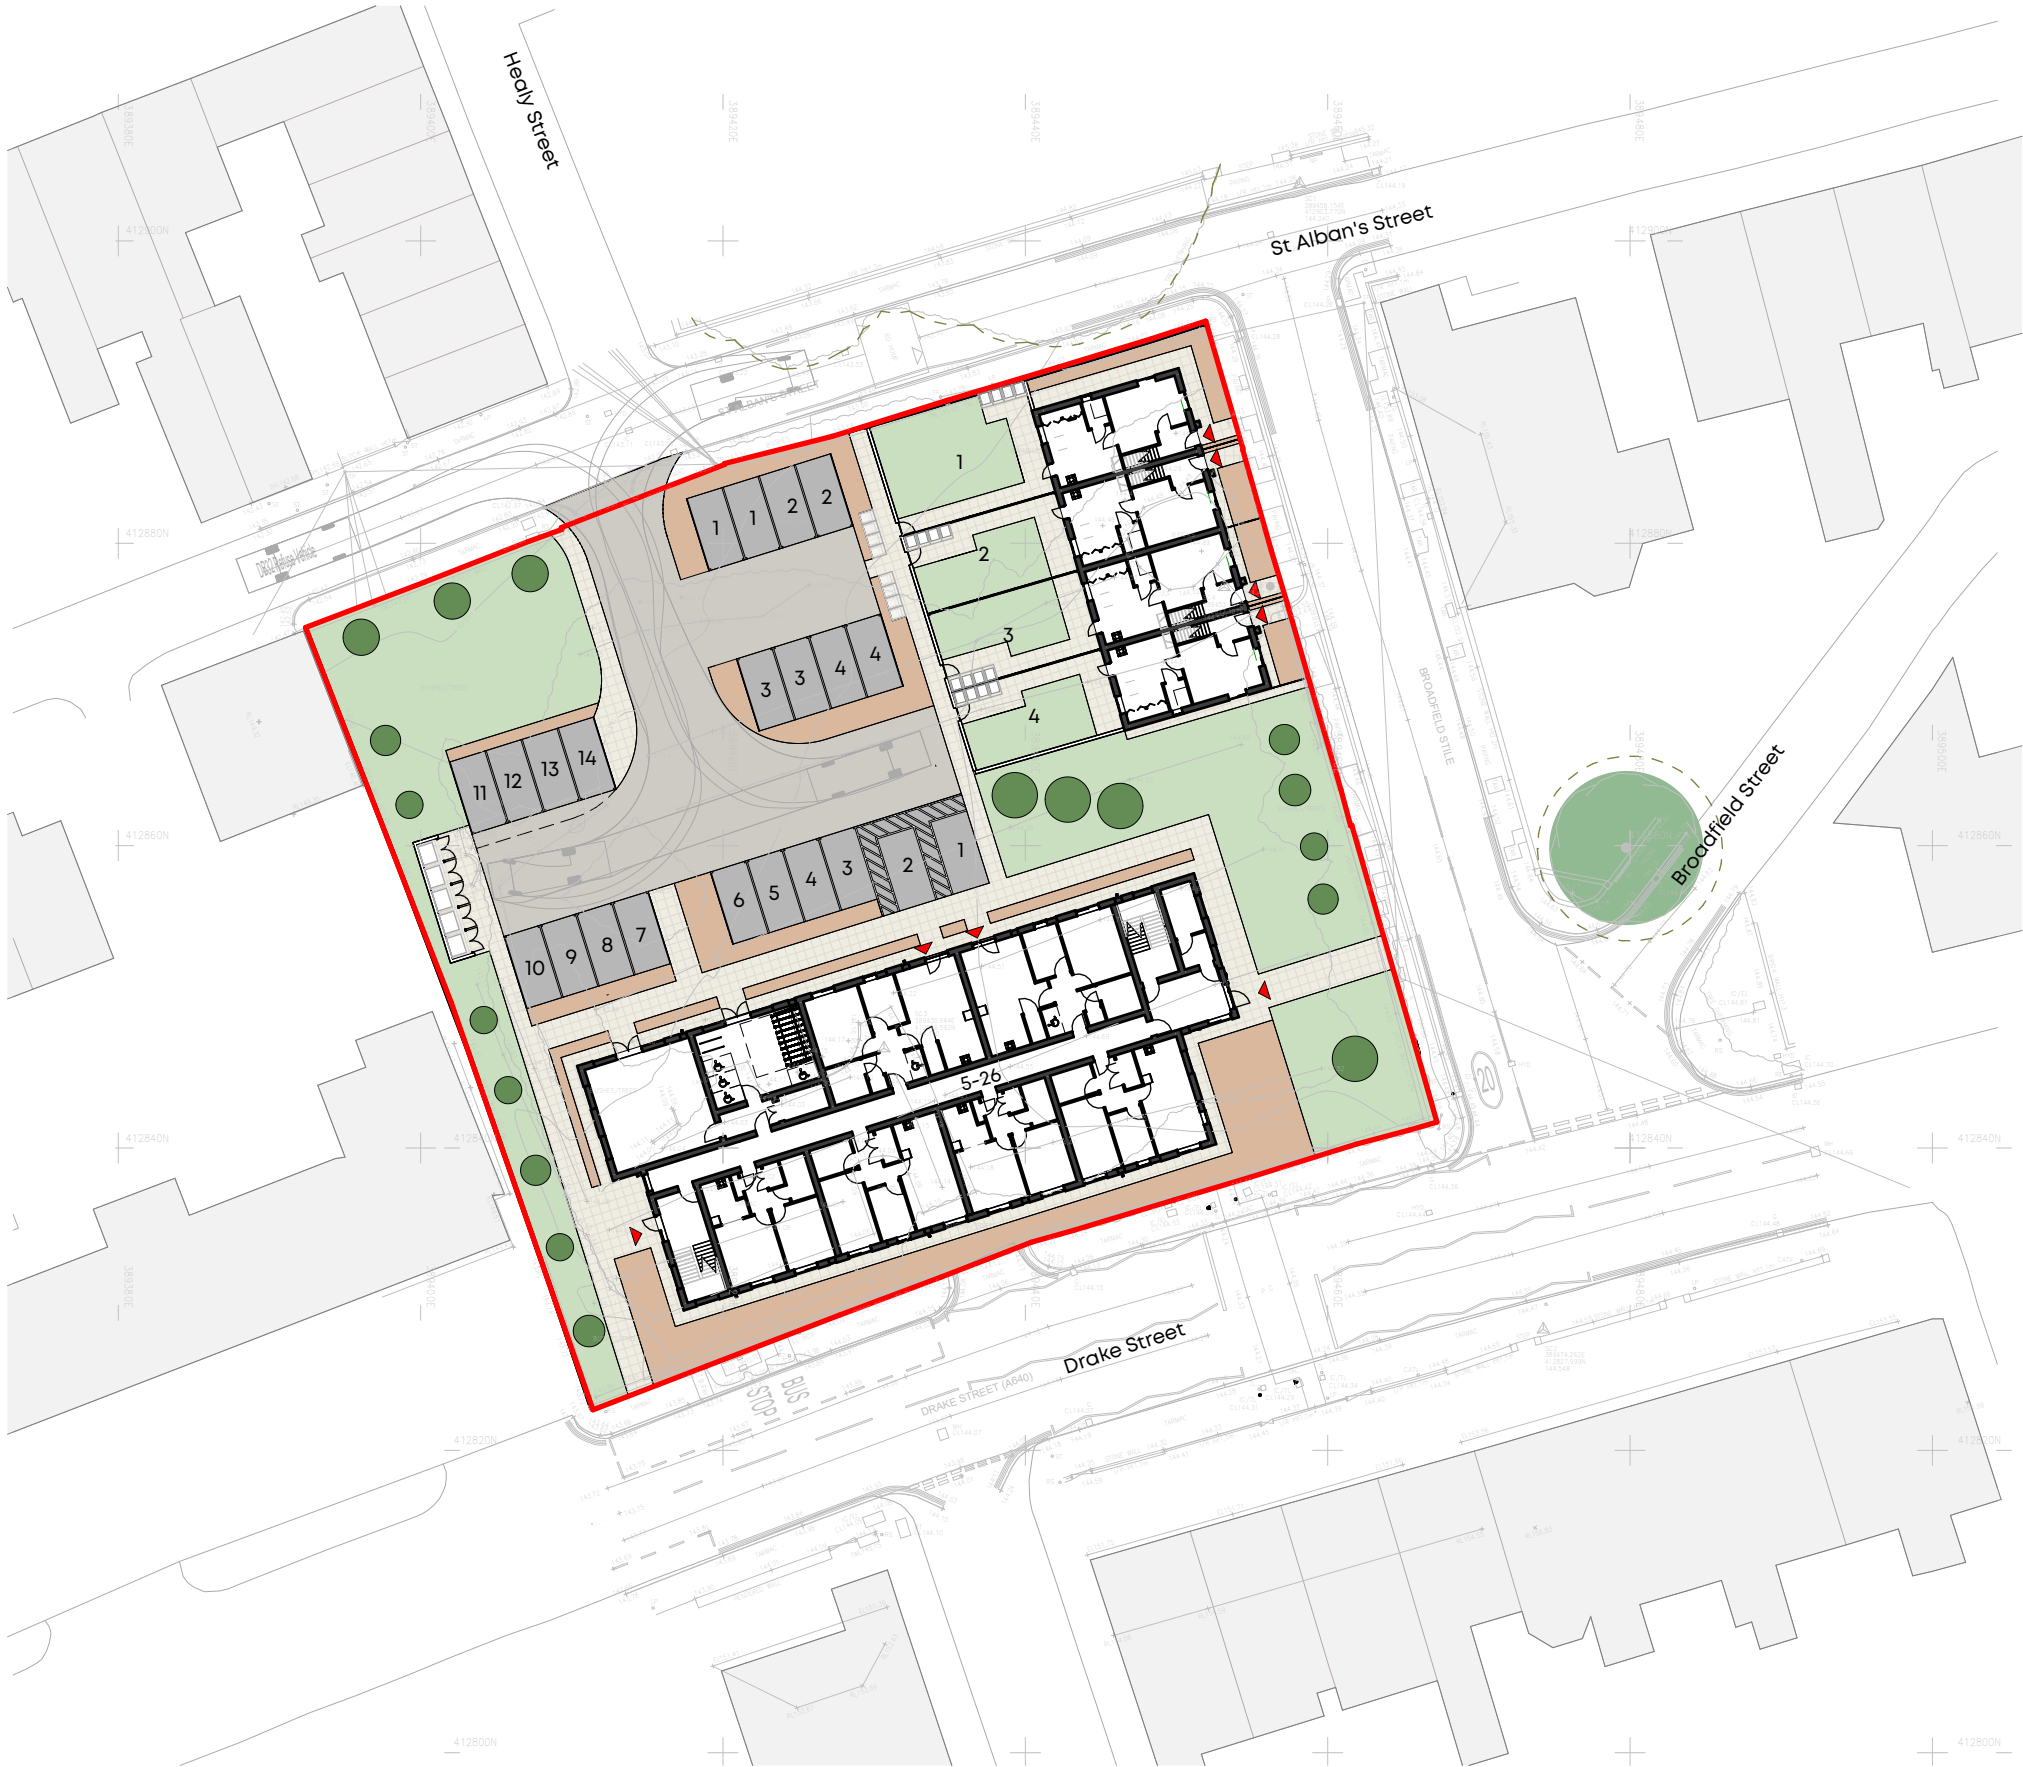
DRAWING NUMBER:  
**19146-PJA-00-ZZ-DR-A-1200-F**

1 Proposed Site Plan  
Scale: 1: 500

DRAWING TITLE:  
Proposed Site Plan

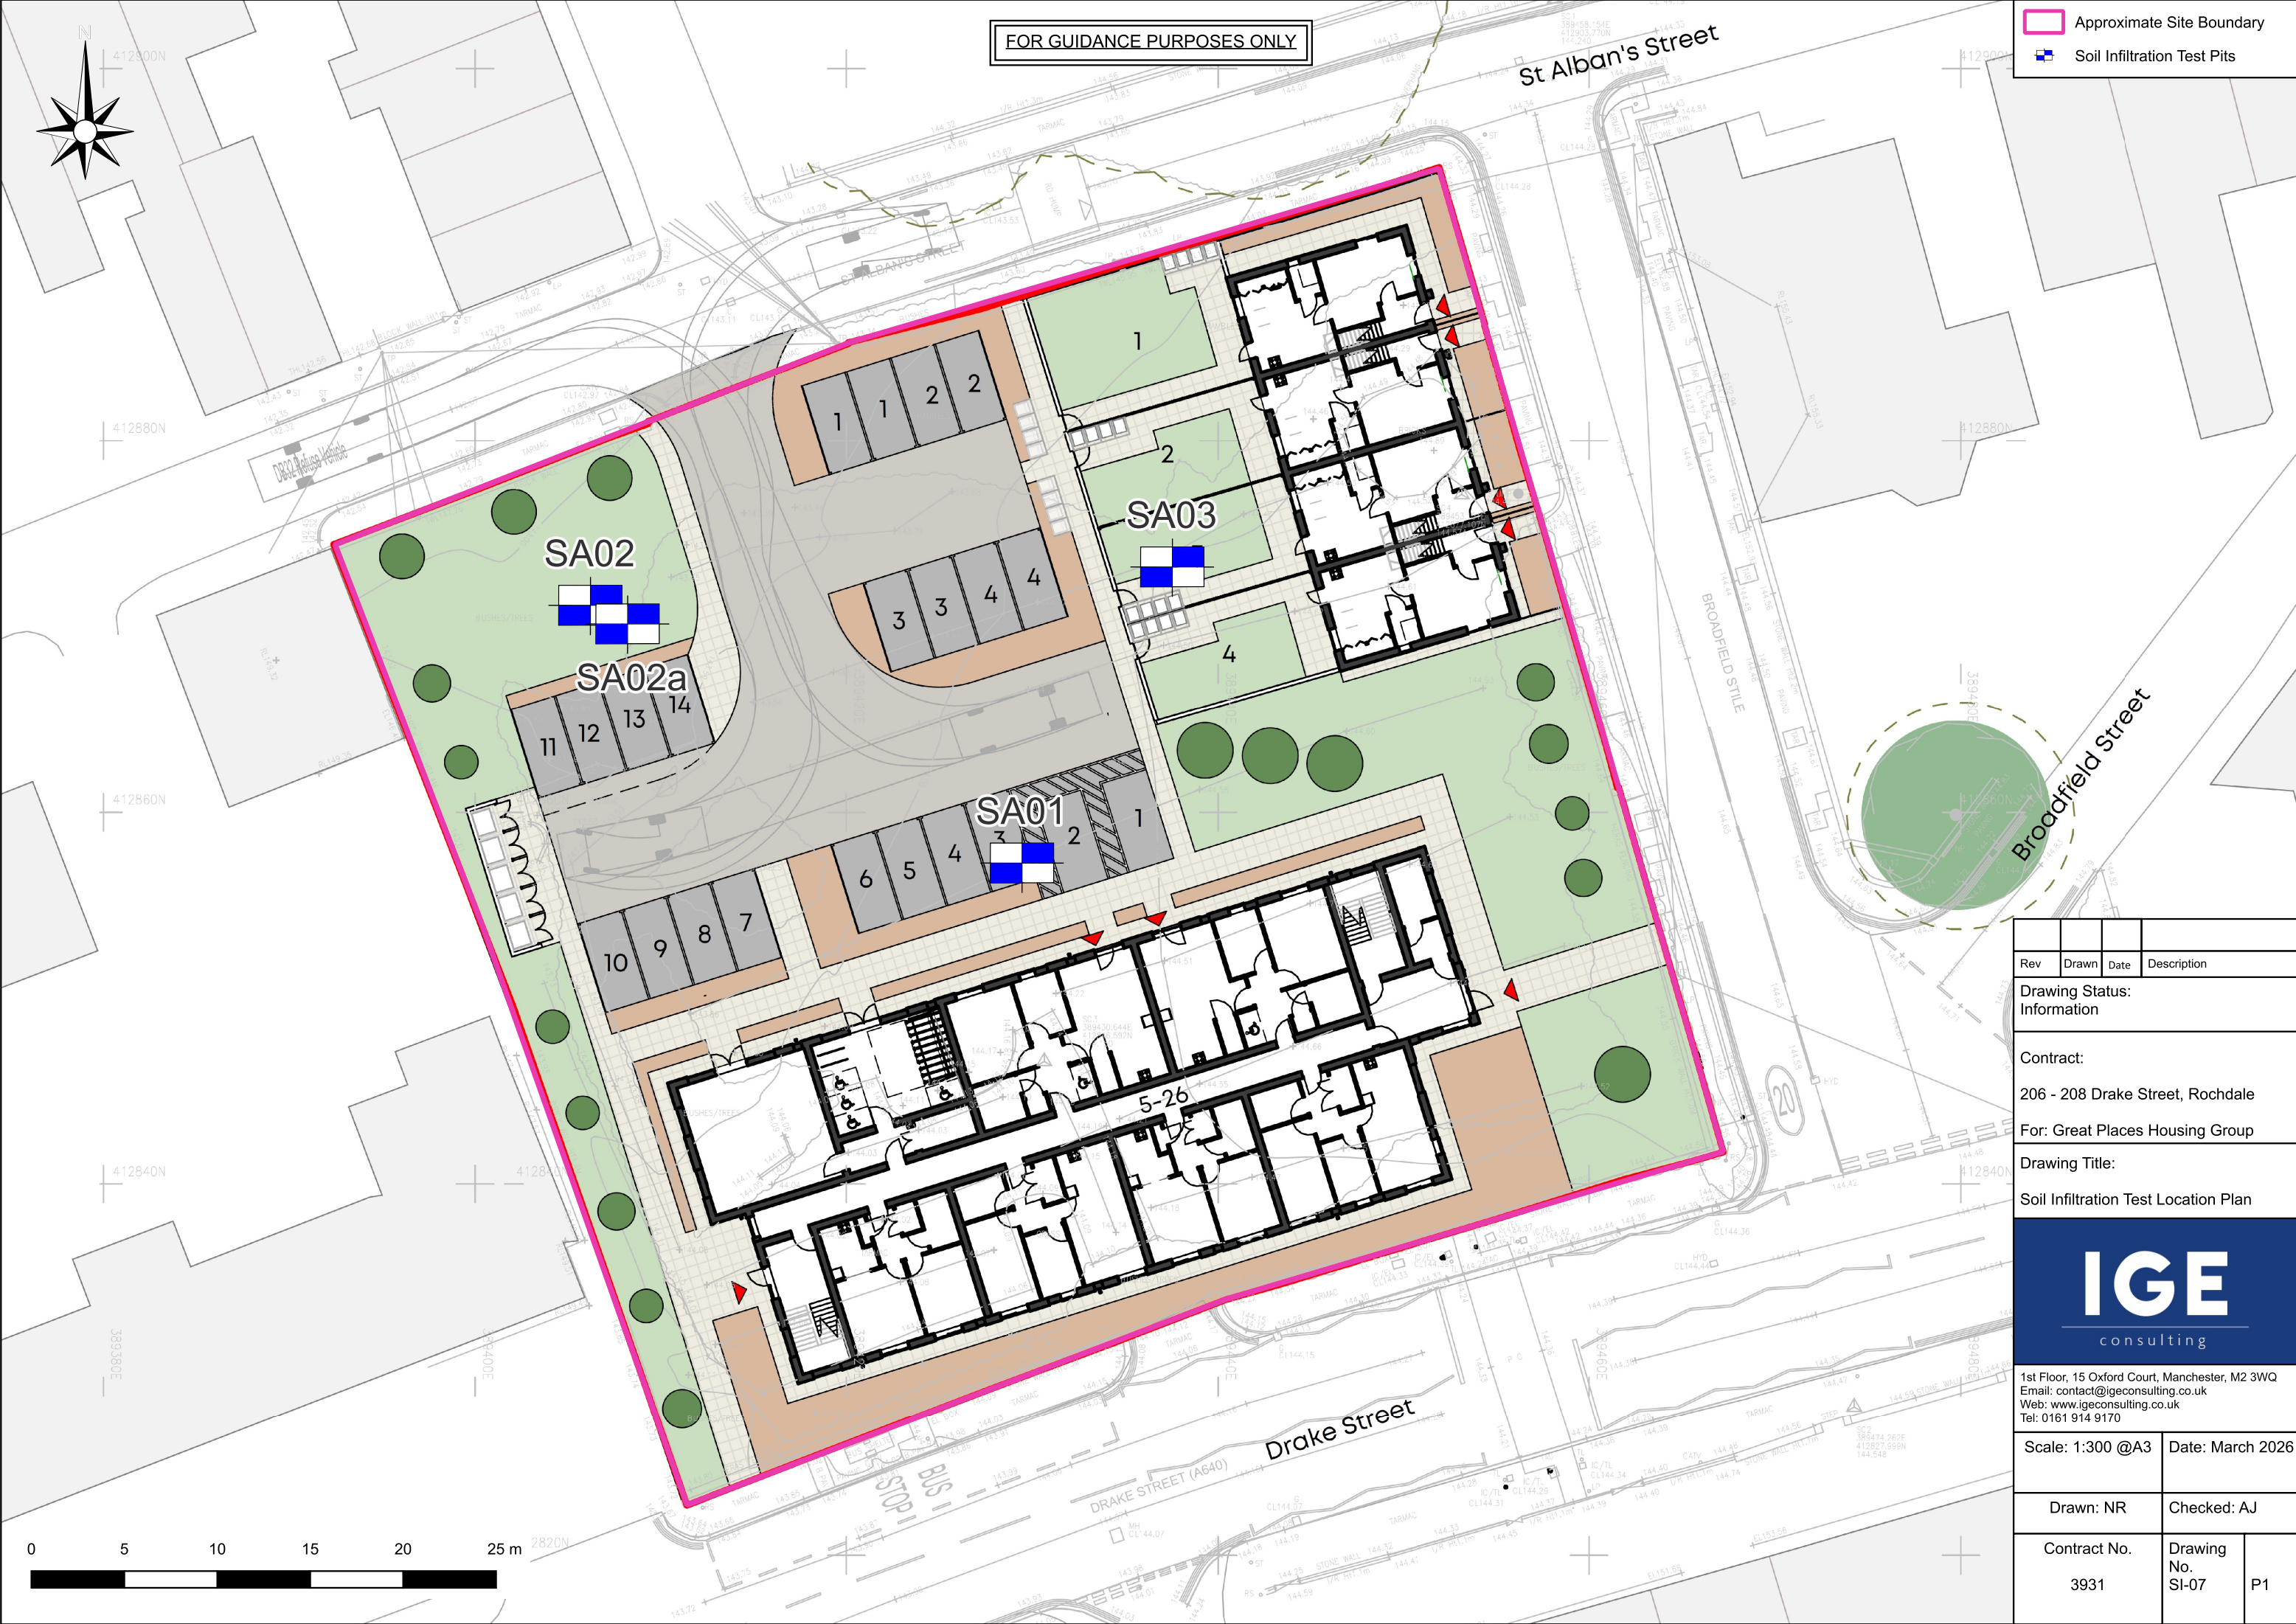
| Contract No.<br>3931 | Drawing No.<br>SI-07 | P1 | |

- Approximate Site Boundary
- Soil Infiltration Test Pits

| Drawing Title: Soil Infiltration Test Location Plan | | | |

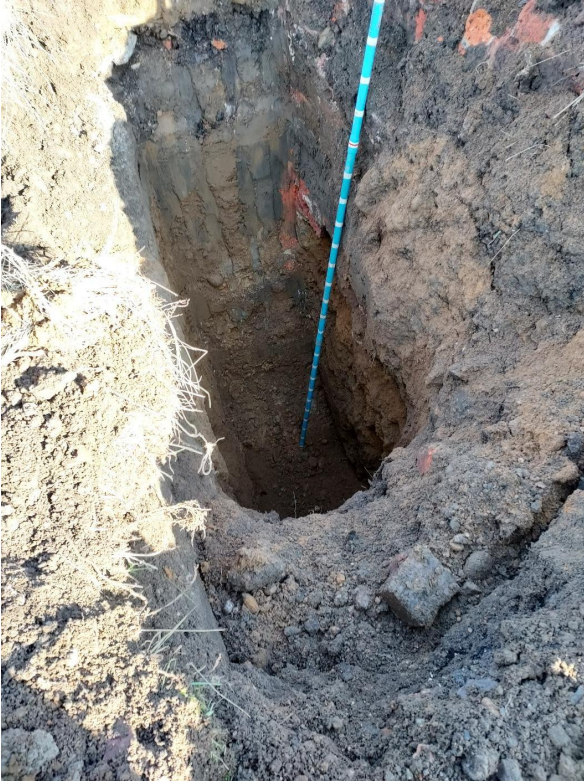
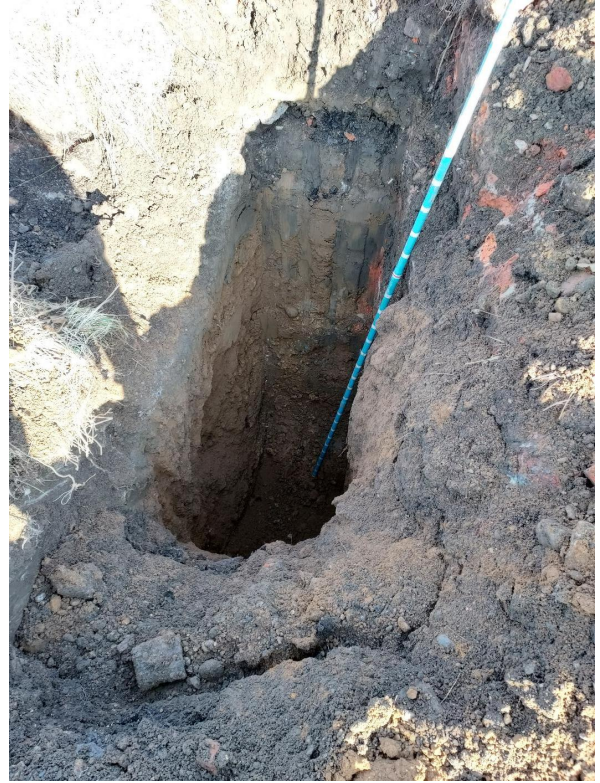
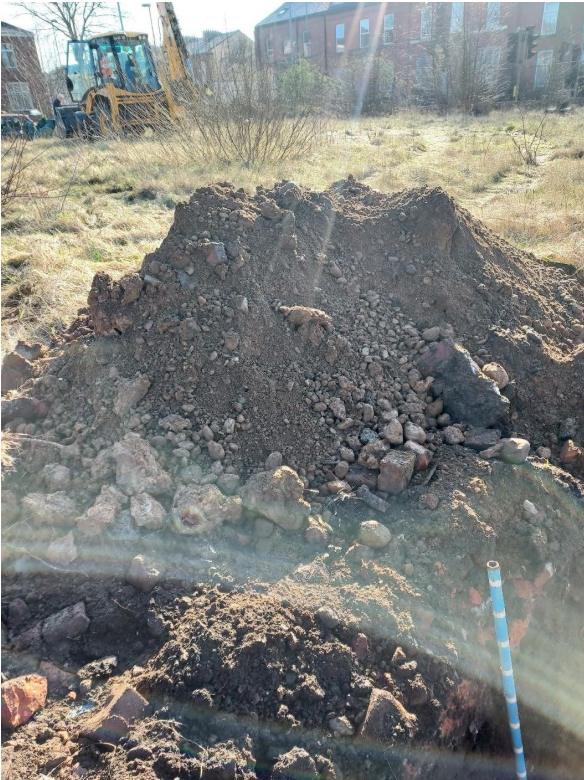
**Remarks**  
Terminated at target depth to undertake BRE 365 soil infiltration test.

0.00 - 2.70m SOAK JCB-3CX  
Stable during excavation.  
**Orientation:** 270°

Obstructions were also noted during the construction of the trial pits, namely a suspected foundation encountered between 0.20m and 1.00m bgl (144.01m to 143.21m AOD) in SA01.

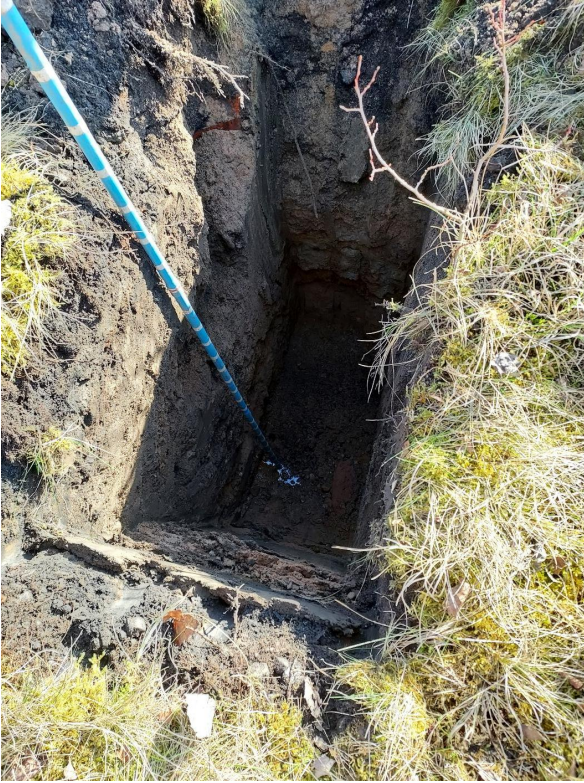
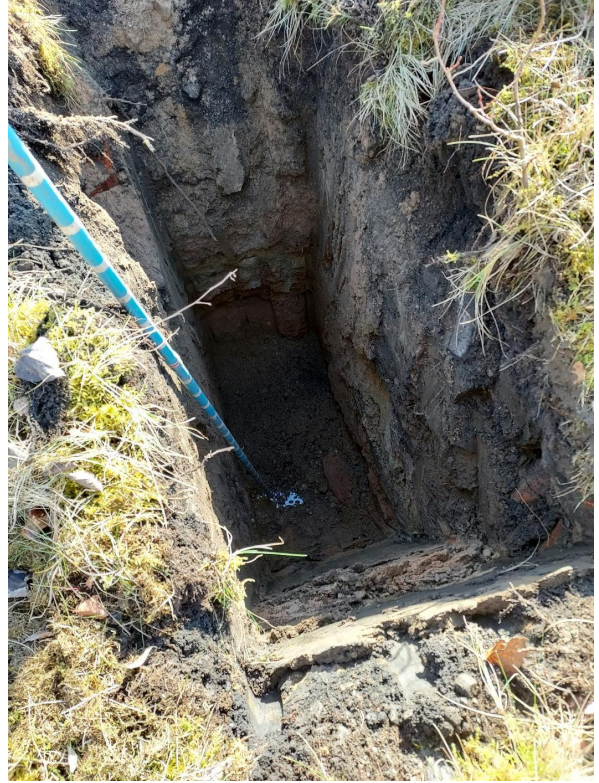
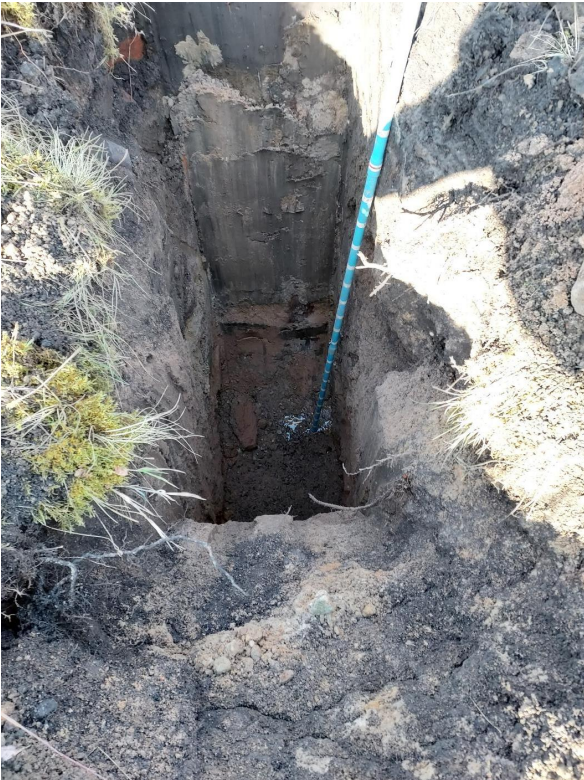
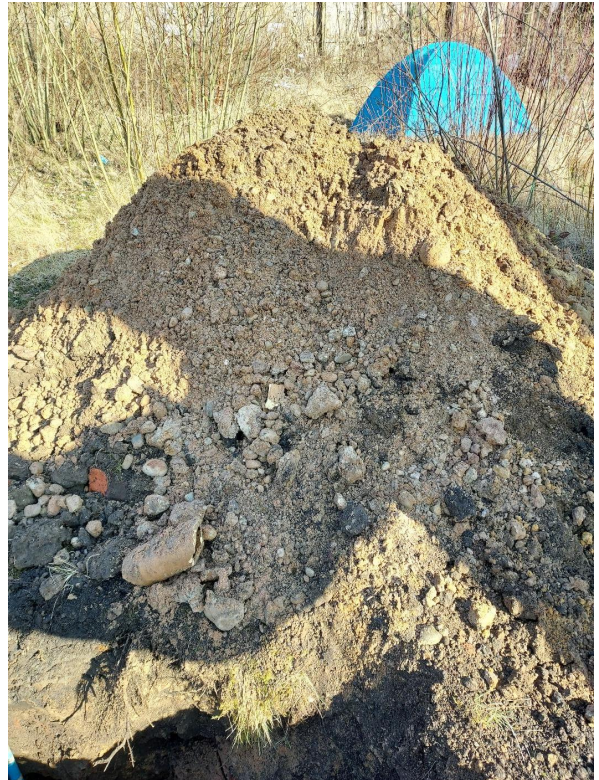
**Remarks**  
Terminated due to water strike.

0.00 - 2.80m SOAK JCB-3CX  
Stable during excavation.

No water strikes were recorded in any of the pits in which soil infiltration tests were undertaken. A slight ingress of water was recorded at the base of SA02 to a depth of 2.80m bgl, and so this pit was backfilled, relocated c. 2m to the east and re-excavated to a depth of 2.60m bgl (SA02a), where water was not encountered. Trial pit logs and photographs are contained in Appendix 3.

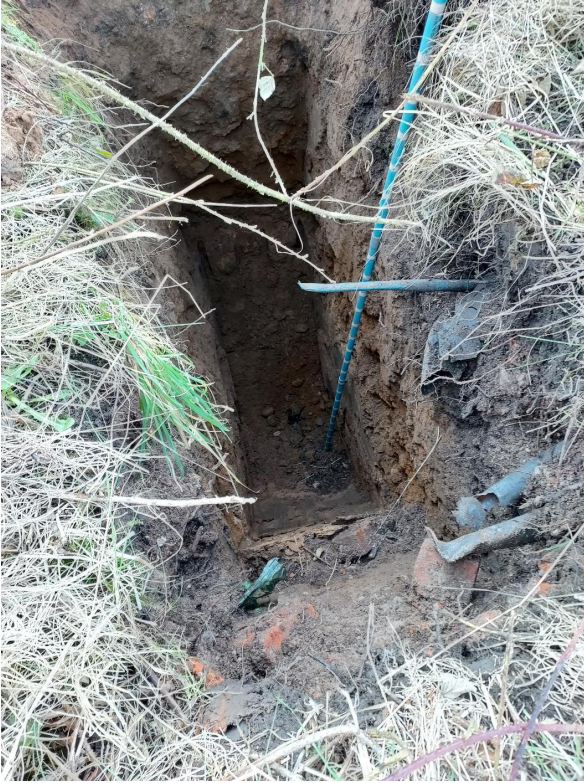
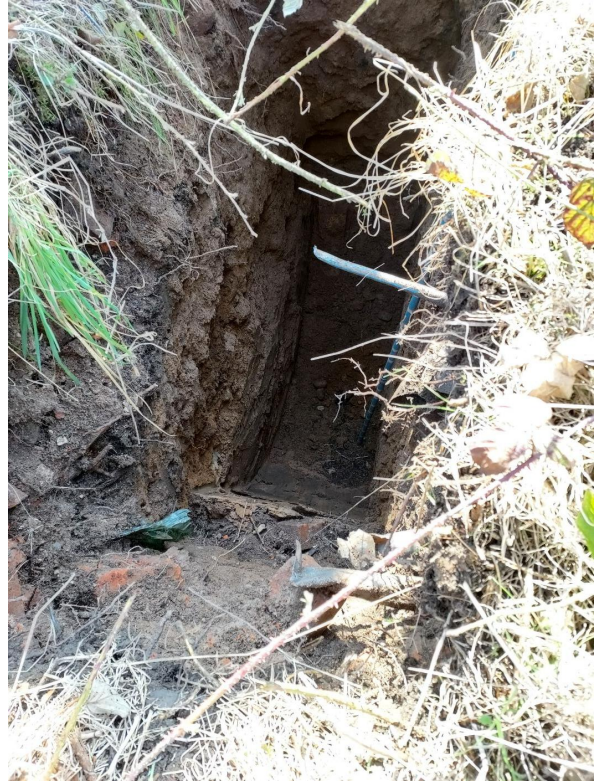
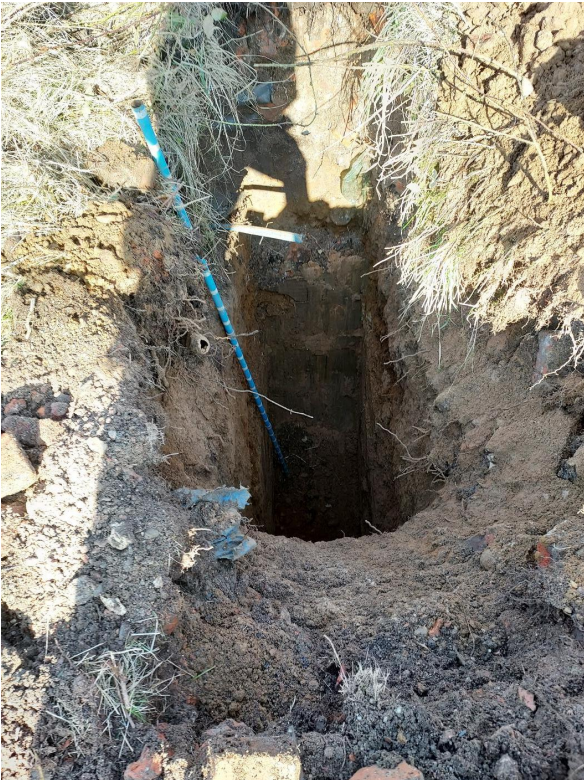
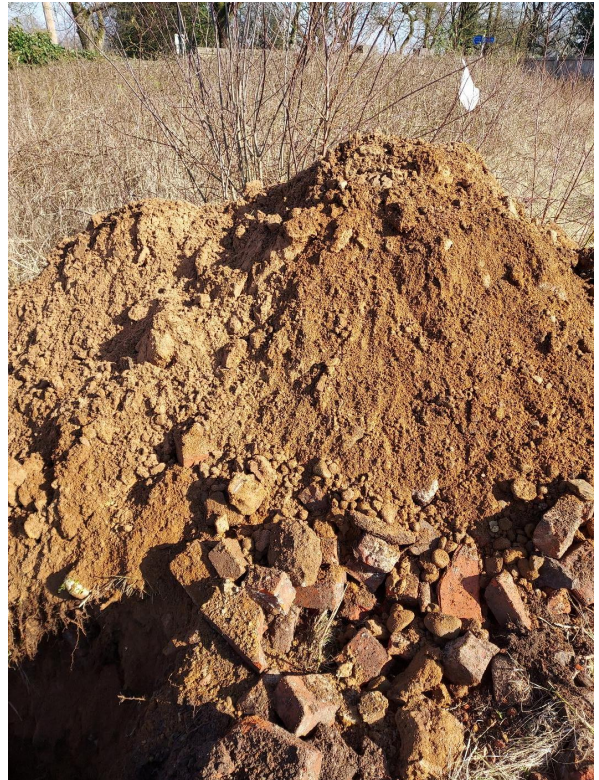
**Remarks**  
Terminated at target depth to undertake BRE 365 soil infiltration test.

0.00 - 2.80m SOAK JCB-3CX  
Stable during excavation.
