**Phase II Contaminated Land Risk Assessment ADDENDUM**

**Church Avenue, Middleton**

**June 2026**

**Site Ref: 6192/VCA-ACLRA v1.00**

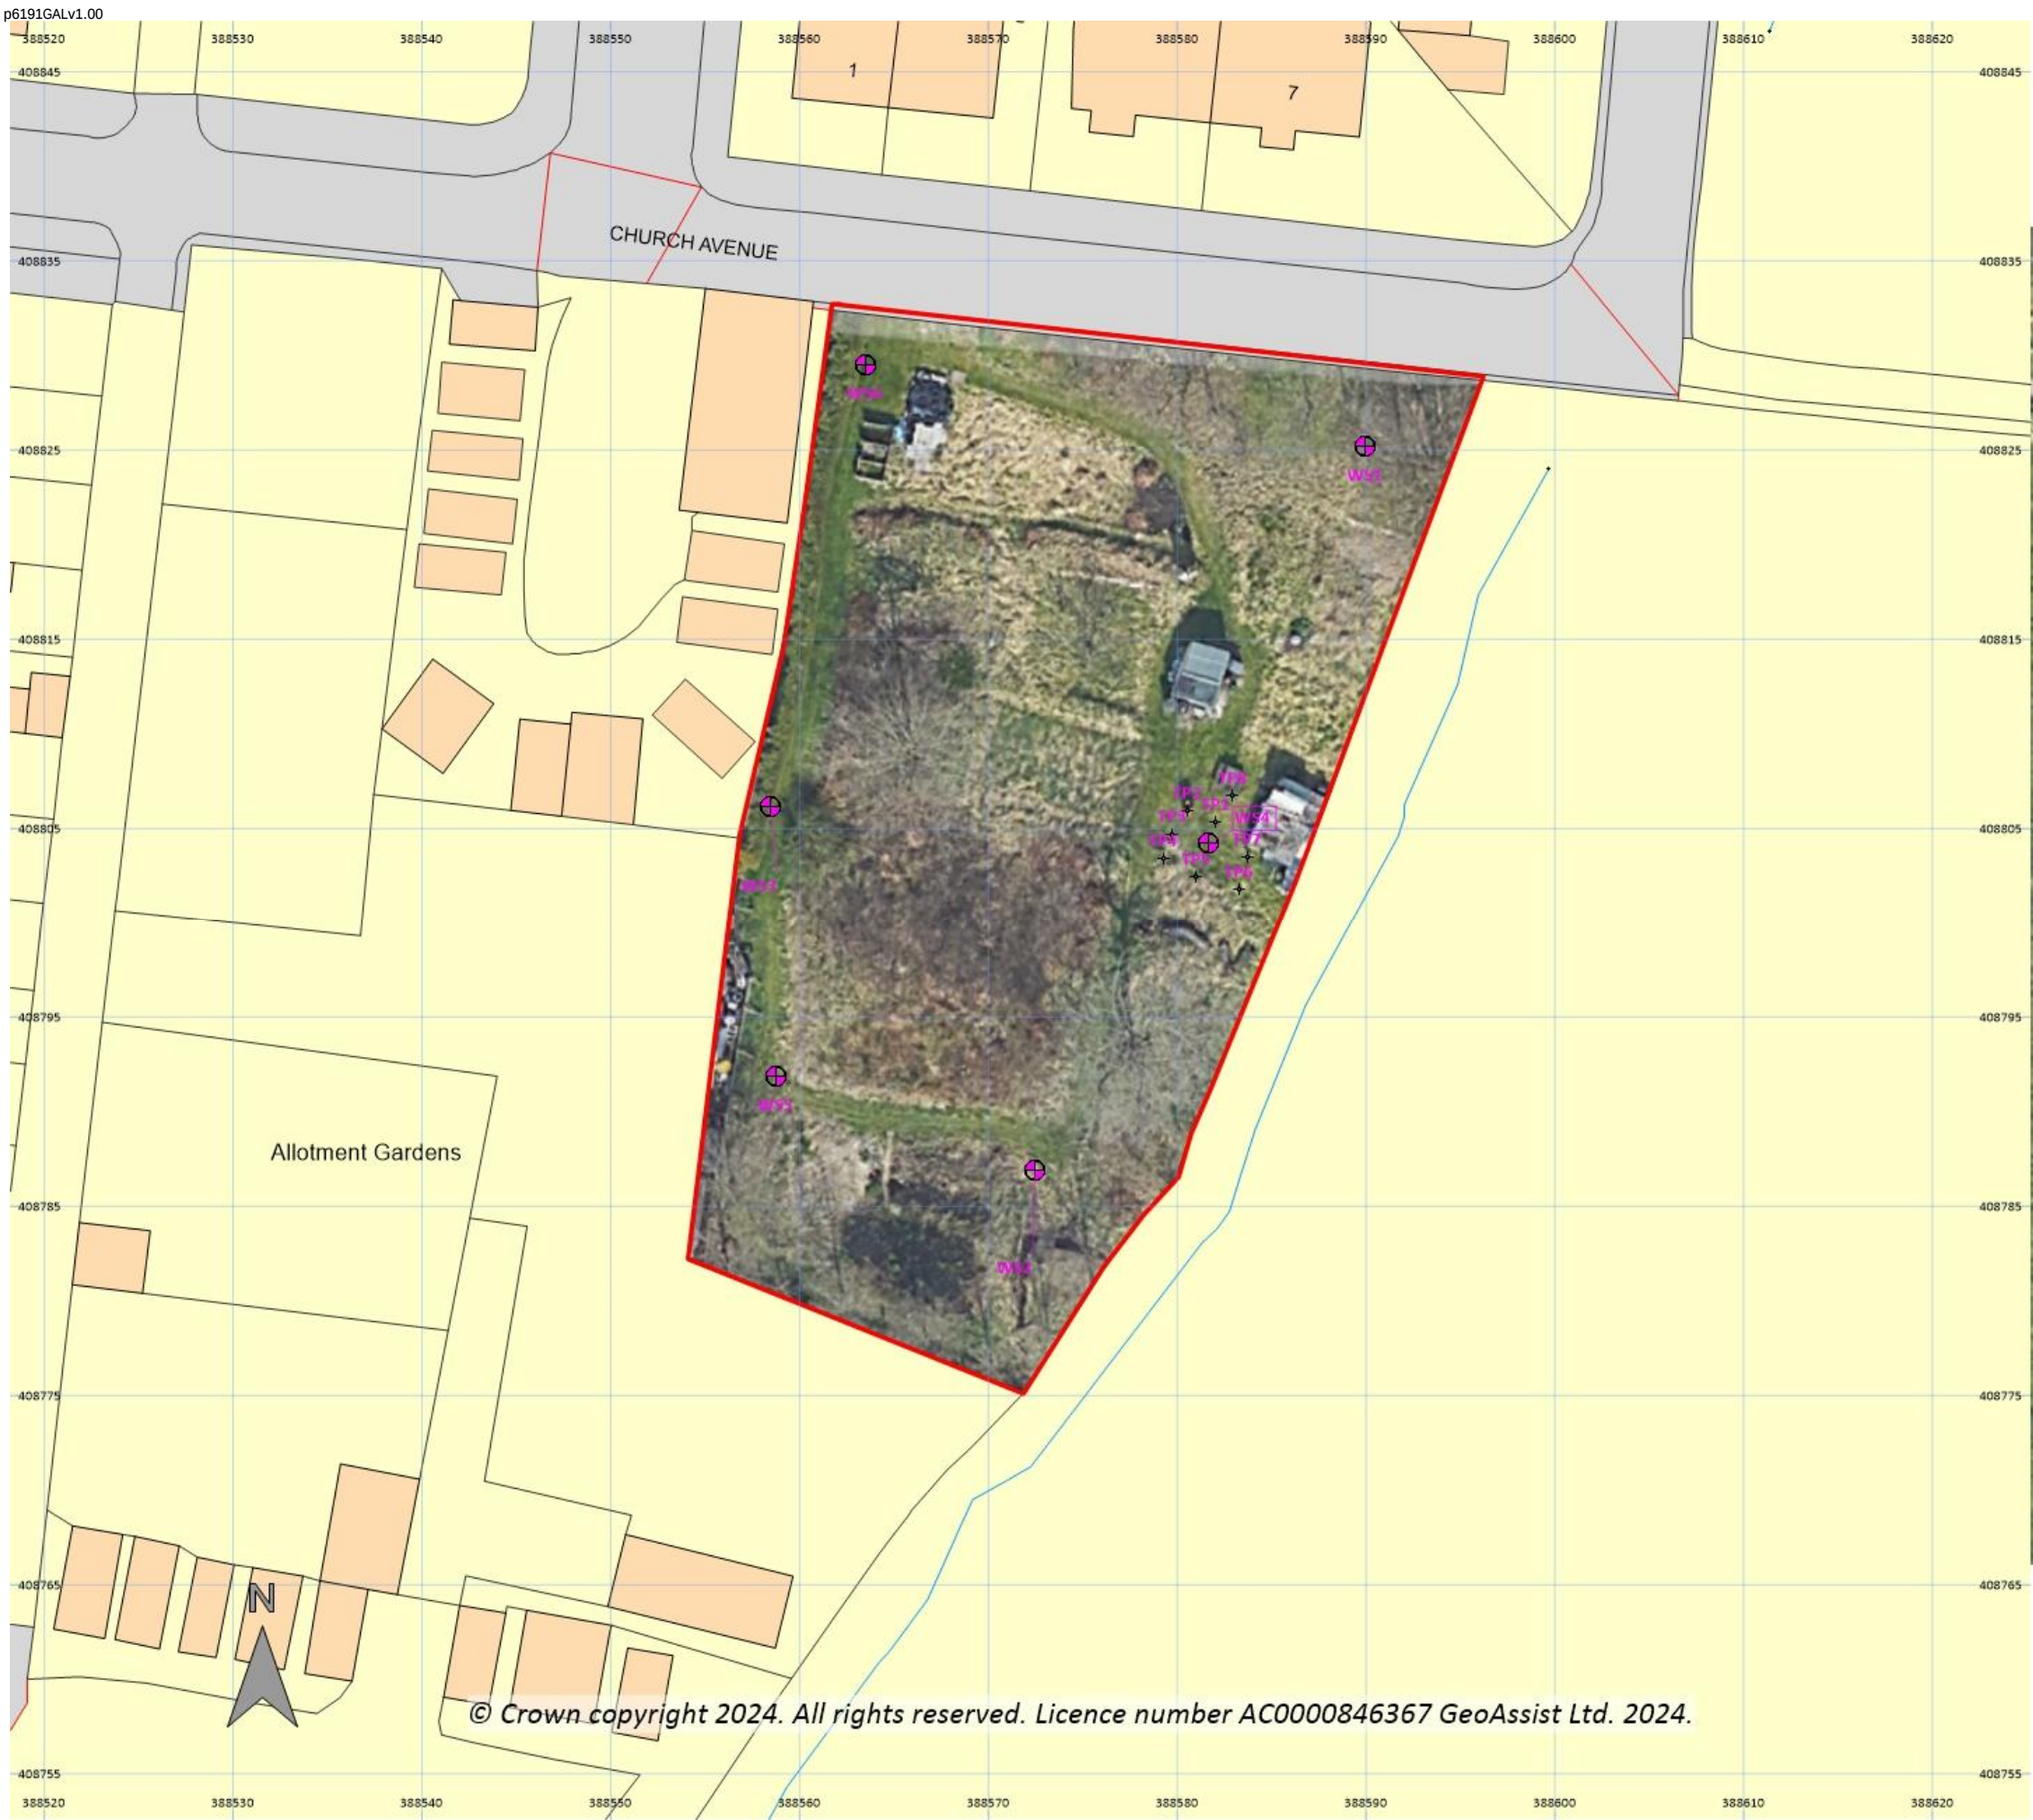
# A1 Site Plan

A plan showing the locations of the exploratory holes established as part of the investigation forms Appendix A1 to this report.

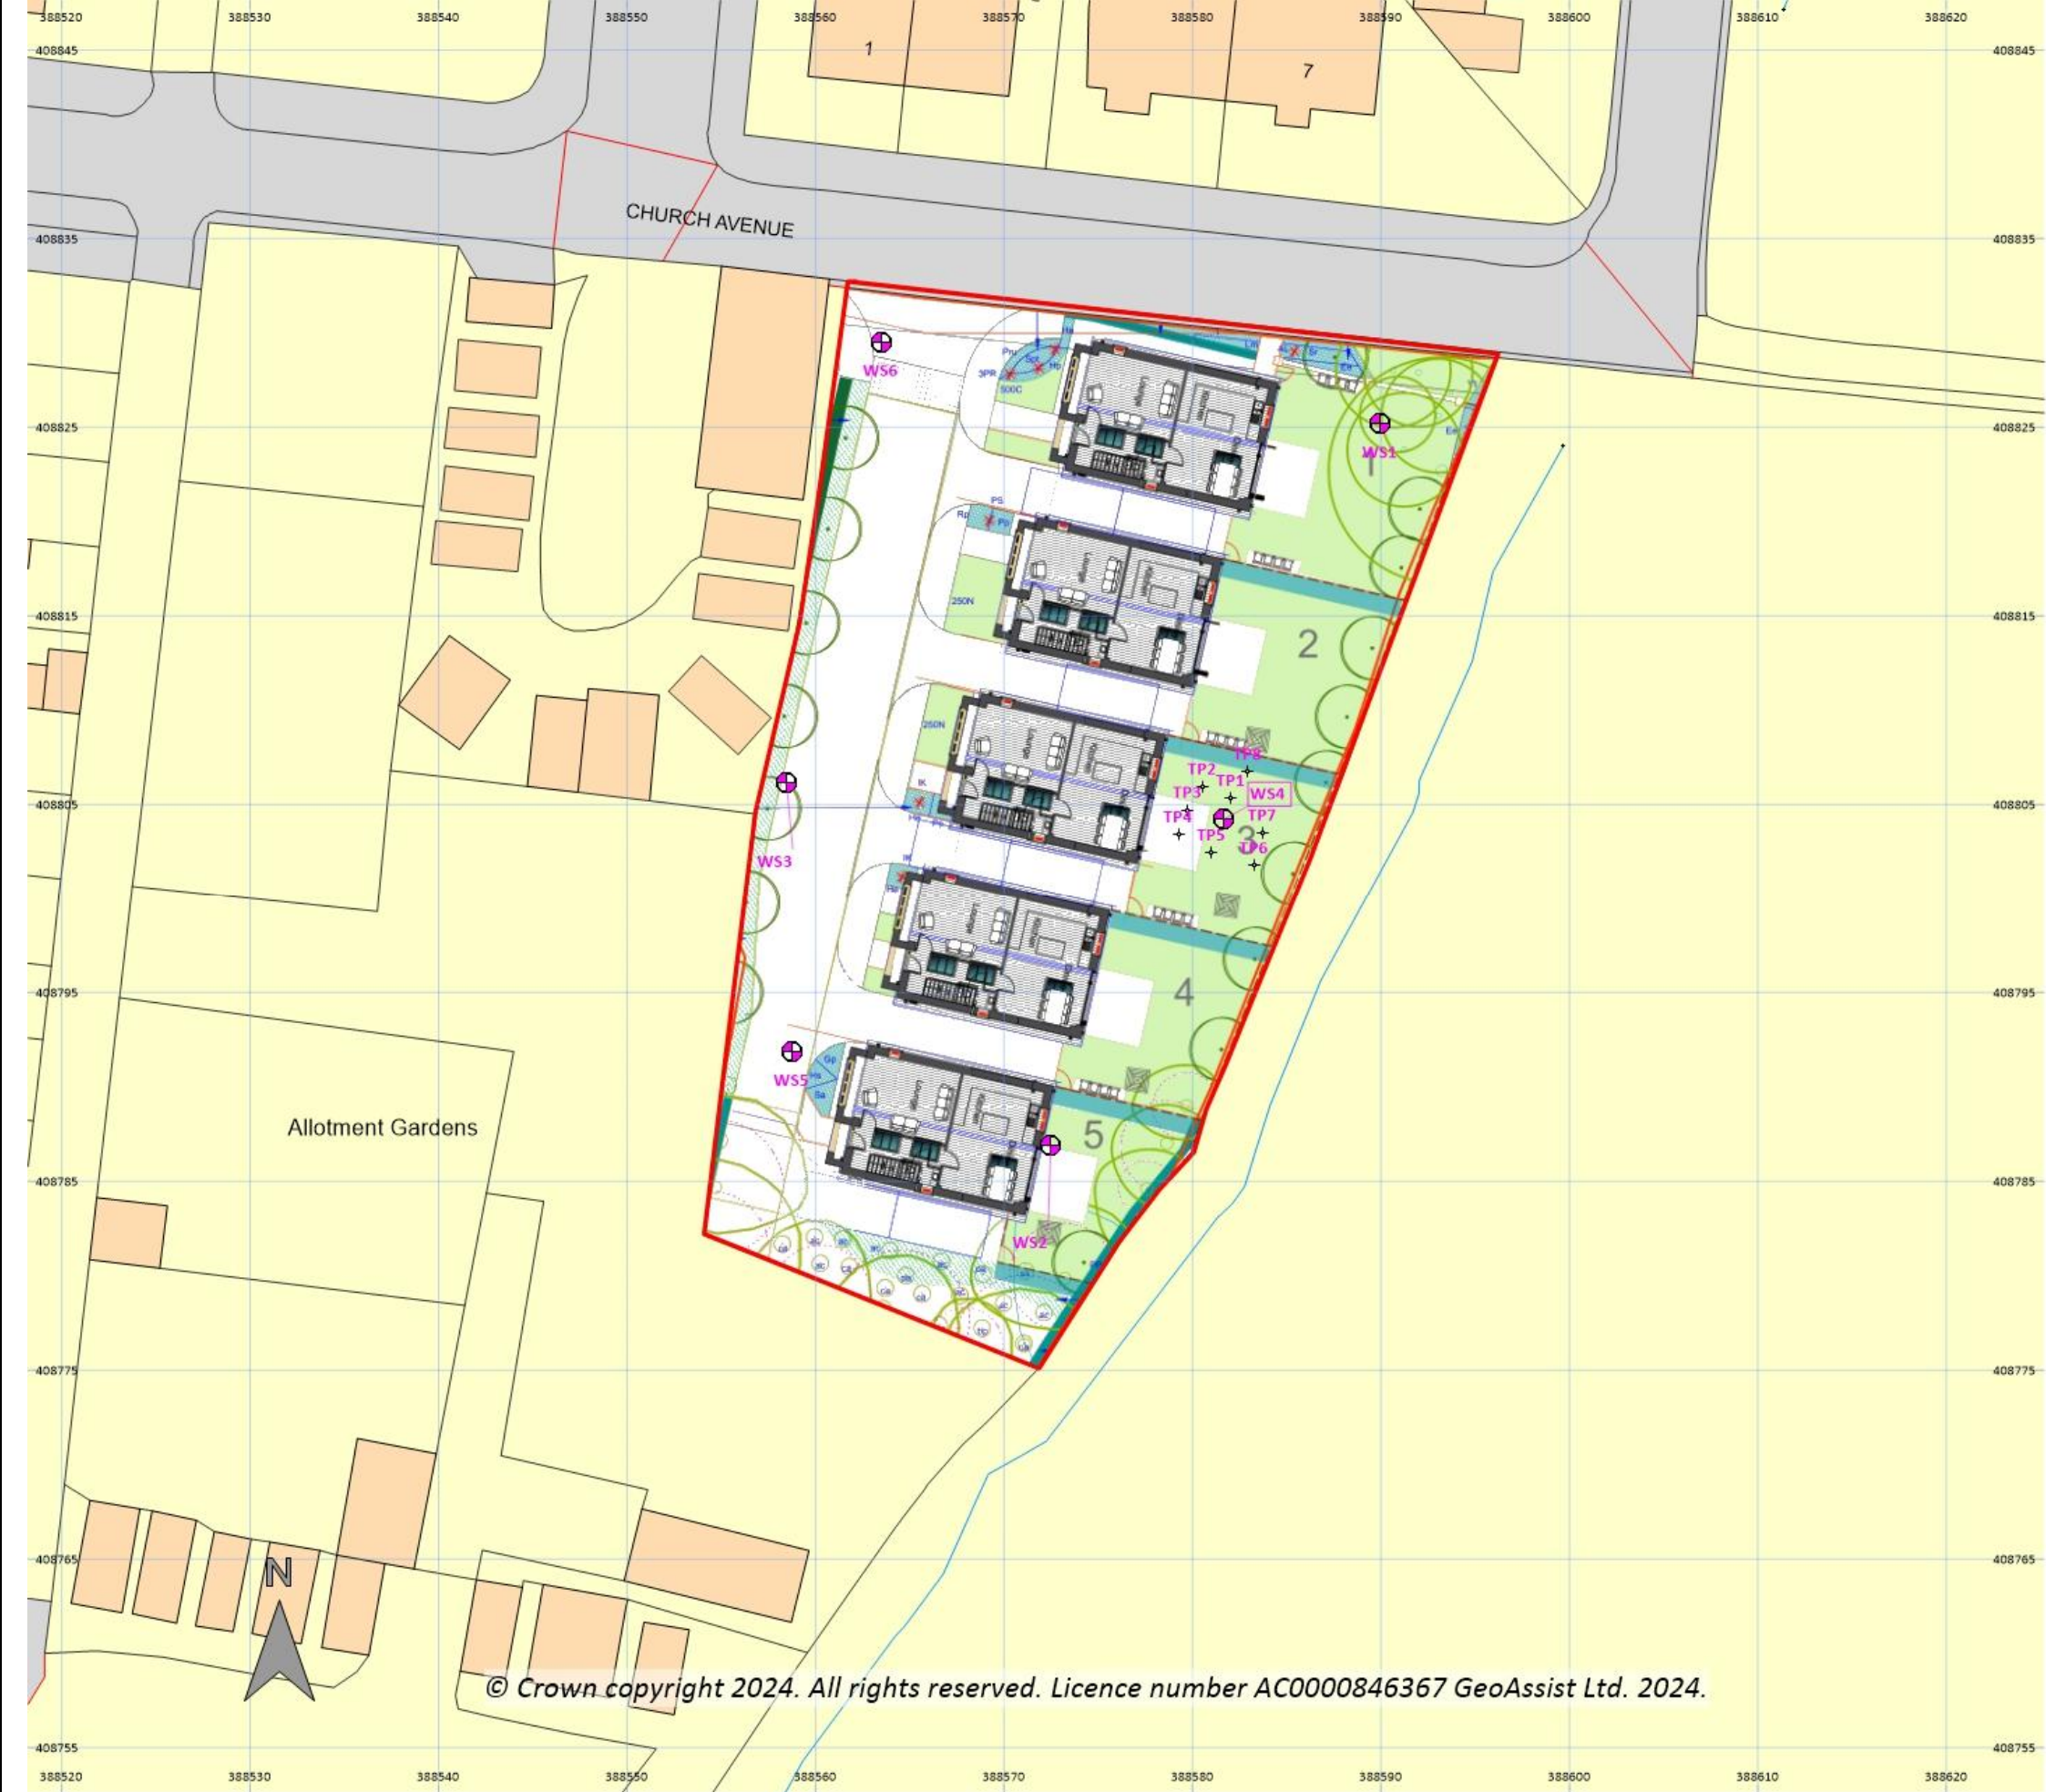
## A2 Proposed Plan

The approximate grid reference for the centre of the site is 388570, 408810 and the total area of the site is approximately 1,600m<sup>2</sup>. The area of the site scheduled for investigation is outlined with a solid blue line on the site plan in Appendix A1. The positions of both the original and additional exploratory holes are also indicated on the plan. The most recent proposed development plan is shown in appendix A2.
