## Hopwood Hall College, Rochdale

### Archaeological Evaluation and Watching Brief

## Evaluation and Watching Brief report

| Report Reference | 6182-CIV-XX-XX-R-O-3000 | | |

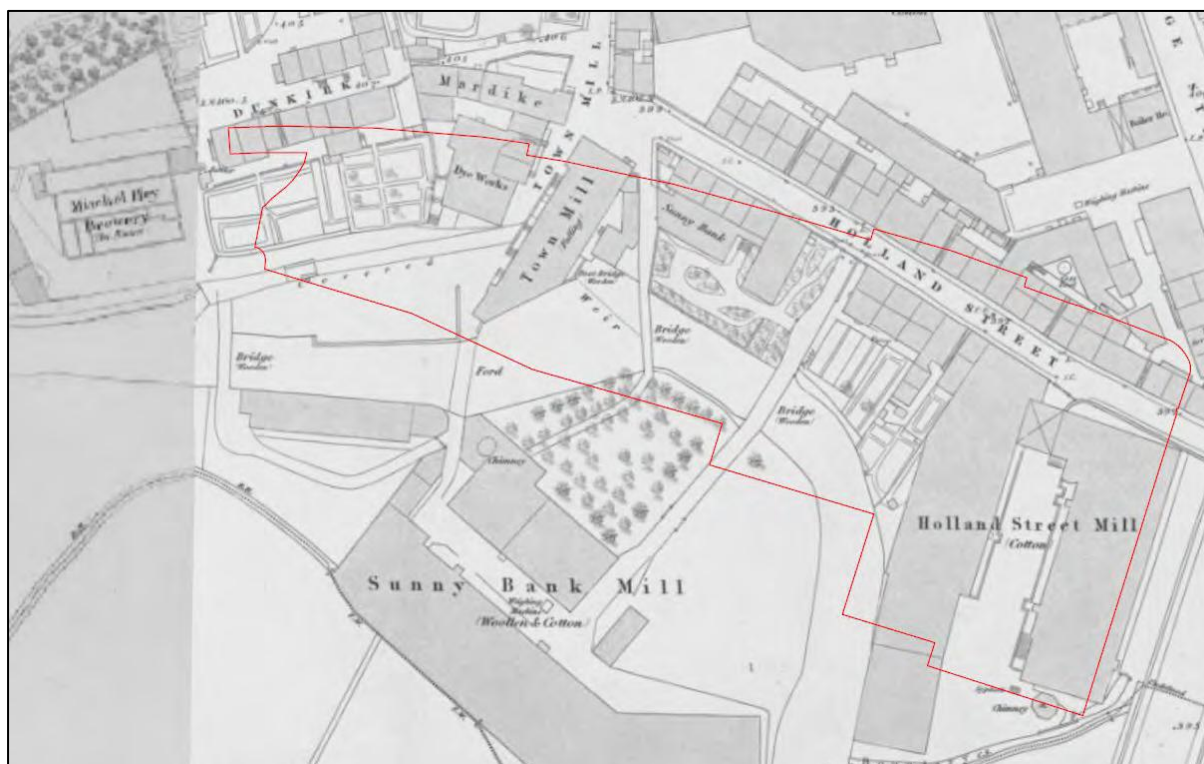
Plate 2: Extract from OS map of 1851

The Ordnance Survey map of 1851 (Plate 2; Figure 6) shows that two mills fell within the site, including Holland Street Mill in the east and Town Mill in the west. Town Mill consisted of a rectangular building that operated as a fulling mill. In addition, a dyeworks was housed in a small square building to the west of the fulling mill and may have been associated with Town Mill. The dyeworks and main mill building both had external staircases, indicating that the buildings contained cellars. The map also shows that the River Roch runs through the centre of the site with a weir built within the western half of the Site. This controlled the levels of the river, potentially built to assist with powering waterwheels at the mills and to prevent flooding. The map clearly shows a headrace and tailrace diverted from the river through Town Mill, presumably to drive the water wheel. The tailrace, heading southwest back towards the river, is labelled as *'covered'* indicating that it was carried in a below ground culvert.

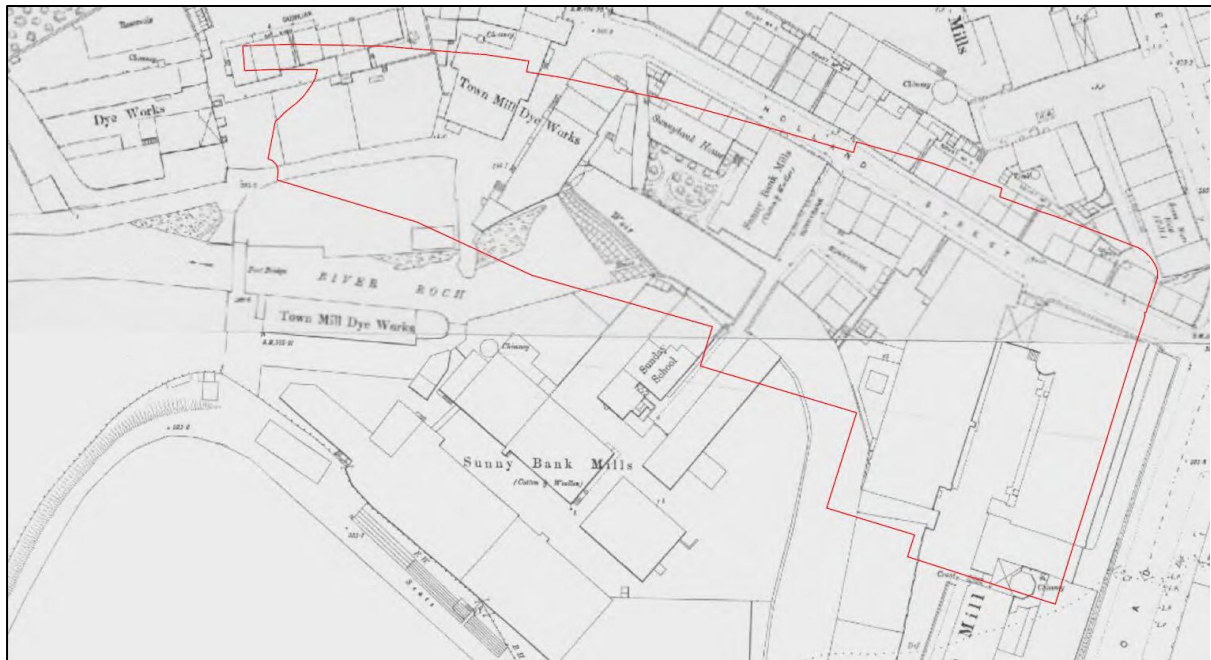
Plate 3: Extract from OS map of 1892

The Ordnance Survey Map of 1892 (Plate 3) shows that the footprint of buildings at Town Mill remained unchanged, though the dyeworks to the west had been incorporated into Town Mills. The mill no longer functioned as a fulling mill and was instead operating as a dye works. The line of the covered tailrace is still visible on the mapping and appears to have been used as an access route. The 1891 census returns revealed many of the residents were employed in the woollen or cotton industry. The Ordnance Survey map of 1910 replicates the 1892 plan, showing that no development took place within the site.

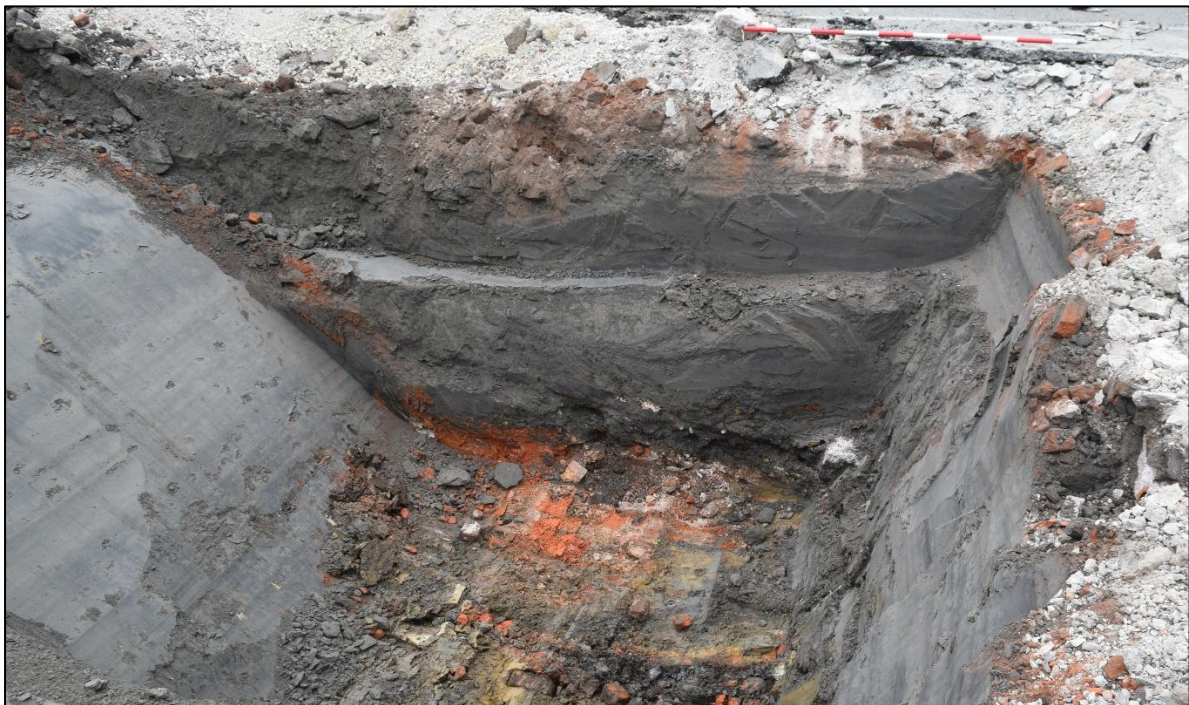
Archaeological remains in each trench were buried beneath demolition rubble overburden, described in the individual trench descriptions below. Above this overburden most of the site appeared to have been capped with a c. 2m thick deposit of very compact grey fly ash (**04**). This was not encountered in trench 2, at the furthest northern edge of the site, and was slightly thicker in trench 3 than in trench 1, so it was assumed that this was levelling out a slope down to the river to create a terrace on which to build the college (Plate 5).

*Plate 5: Fly ash levelling material 04 in trench 1, looking northwest*

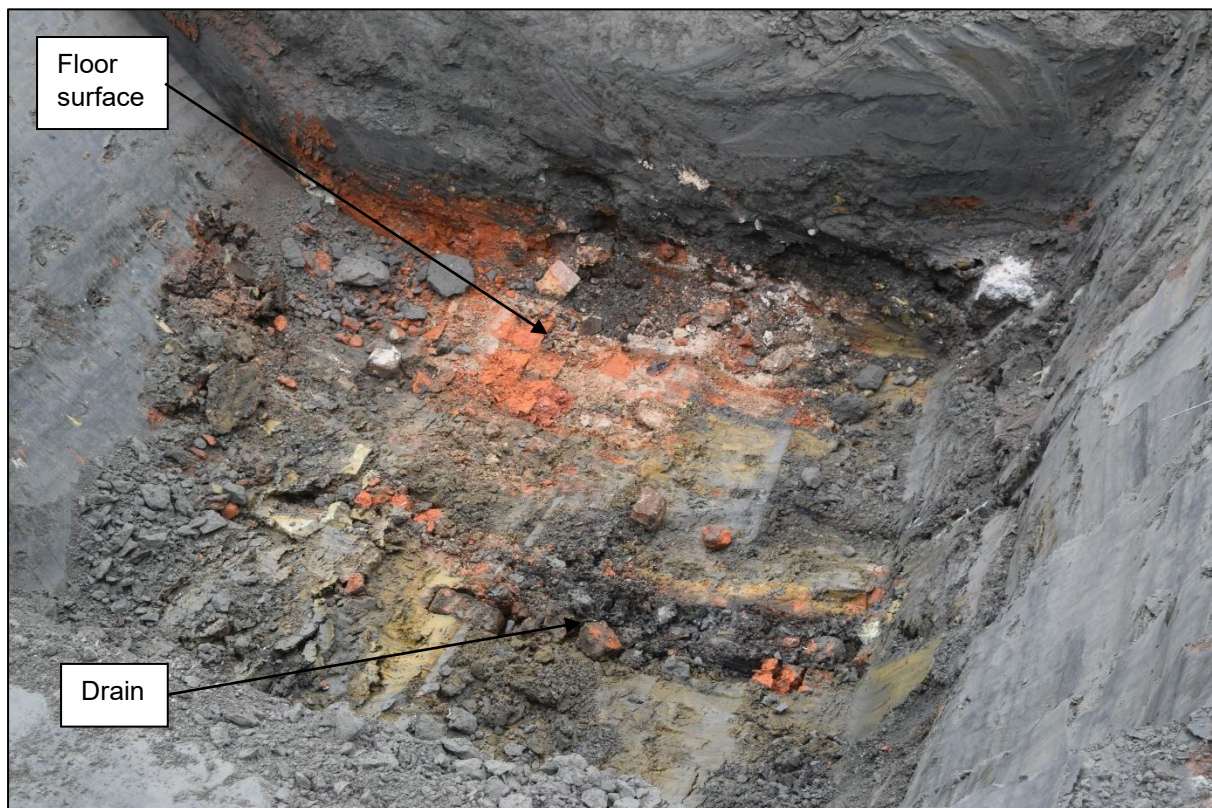
The fragmentary remains of a floor surface (**07**) and a drain (**08**) were observed at a depth of 3m. Both appeared to be constructed from hand-made bricks bonded with white lime mortar. The brick floor was built directly onto the natural clay (**09**), and the drain was cut into the clay (Plate 6).

*Plate 6: Trench 1 looking northwest*

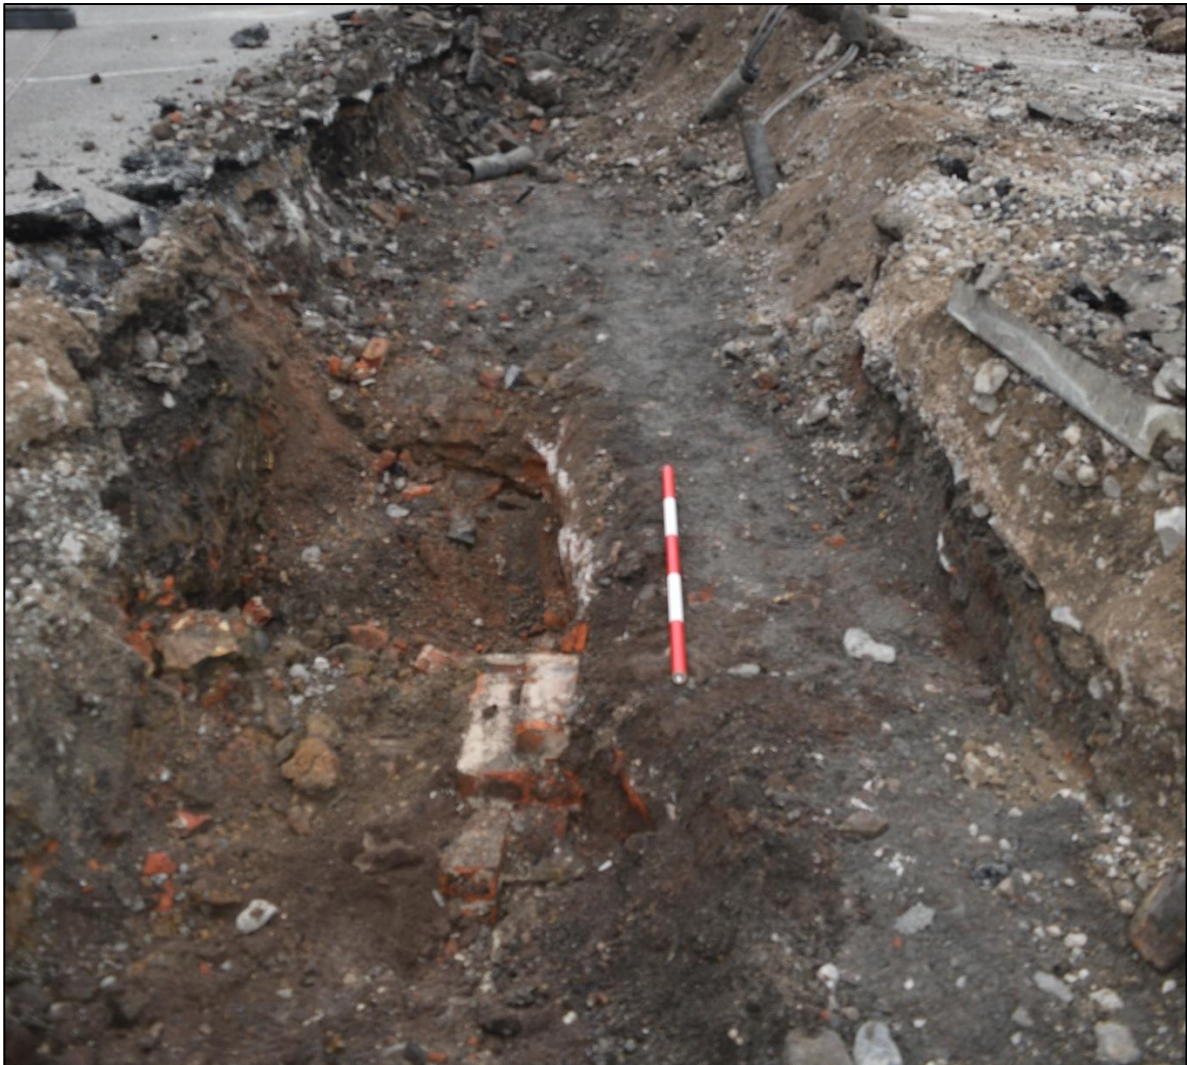
Below the hardcore layer was the same concrete ground beam encountered at the northern side of trench 1, extending across the entire length of the trench. A further ground beam was encountered to the north of this, also running along the length of the trench. A manhole lay at the east end of the trench, and a second at the west end with an electricity cable entering it from the south. Between the two beams was a 1.5m wide and 9.3m long gap which was excavated to a depth of c. 1.9m bgl (Plate 7).

*Plate 7: Ground beams in trench 2, looking east*

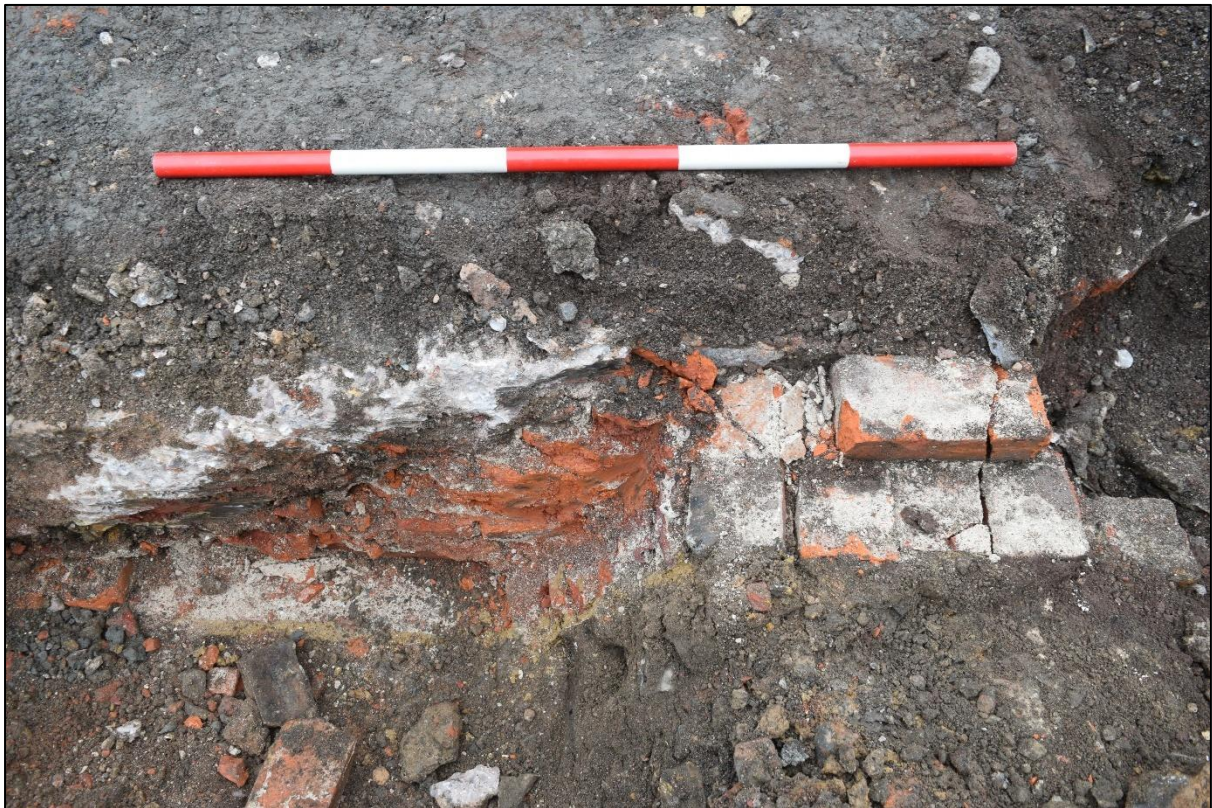
A 1.1m high section of brick wall (**11**) was encountered half way along the trench, extending northwest for 1.2m. It was two courses wide and built from hand-made bricks with white lime mortar. The wall had been truncated at both ends by the concrete ground beams (Plate 8).

*Plate 8: Wall 11, looking southwest*

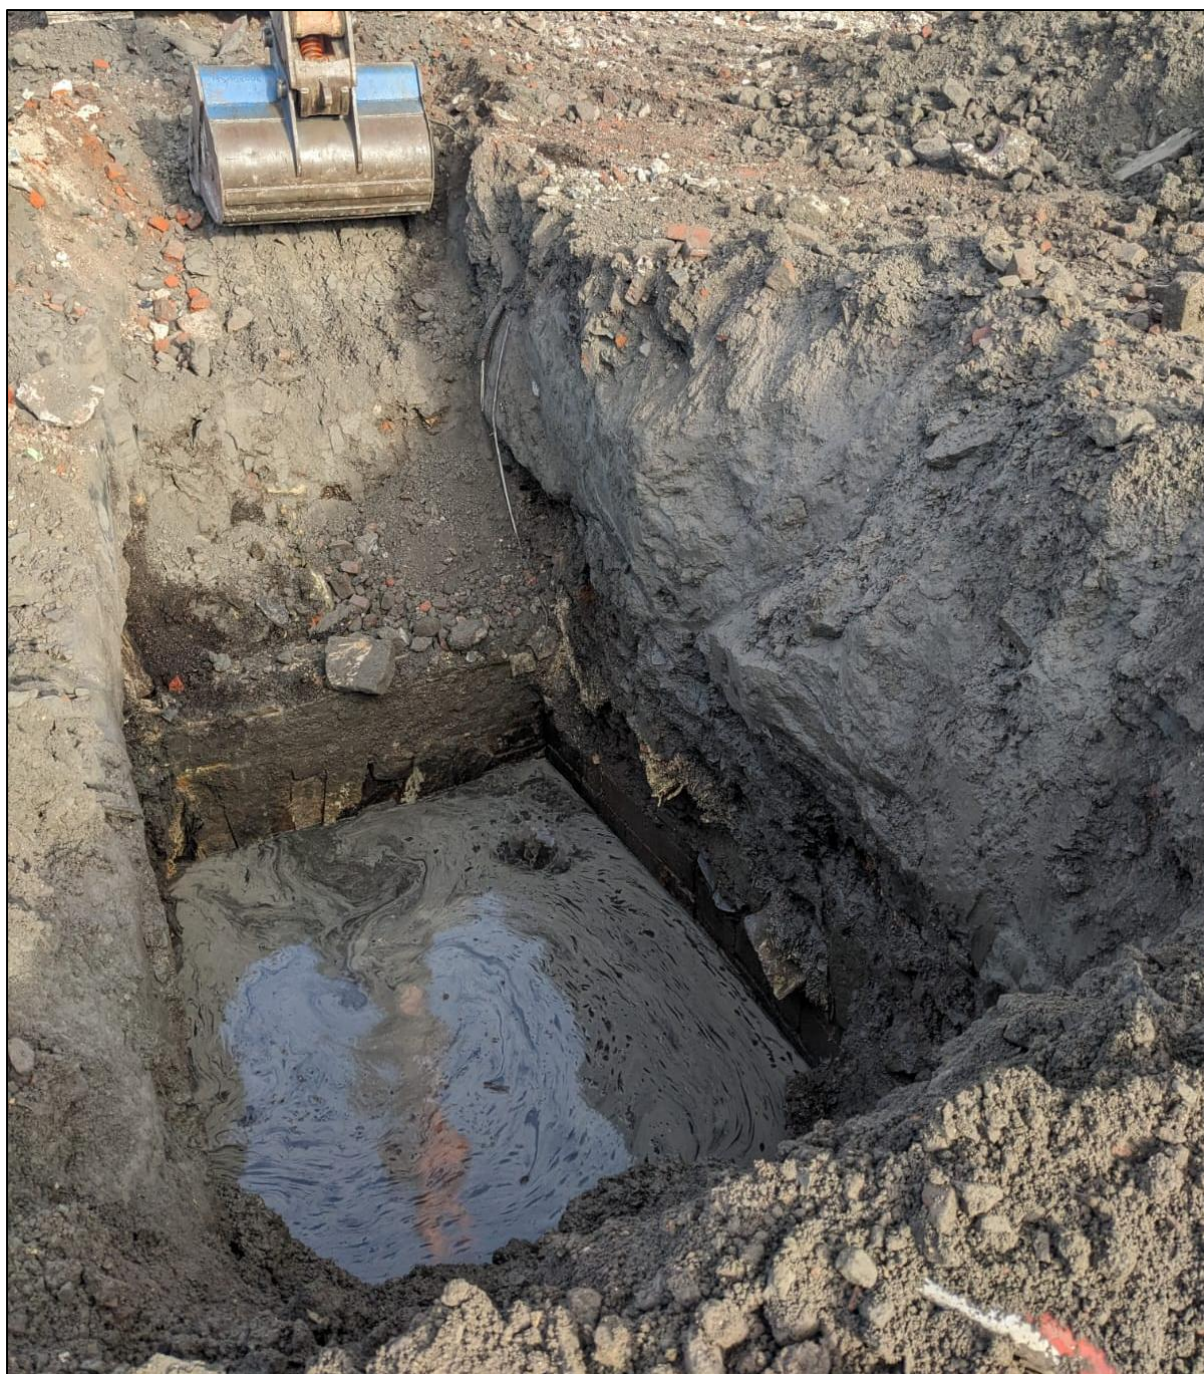
At the northwest end of the trench a substantial stone wall (**12**) was encountered at a depth of 1.8m, the position of which matched the external wall of Town Mill. Immediately to the southeast of this wall were a series of stone walls forming the waterwheel pit. The walls were built from square and rectangular stone blocks of varying dimensions. The upper surviving portions of these walls lay at a depth of 3m to 3.2m below the current ground level. The walls were able to be recorded to a depth of 4.1m bgl (the upper 1m of the walls), at which point constant flooding meant that the base of the wheel pit was not observed (Plate 9).

*Plate 9: Flooding during excavation, looking north*

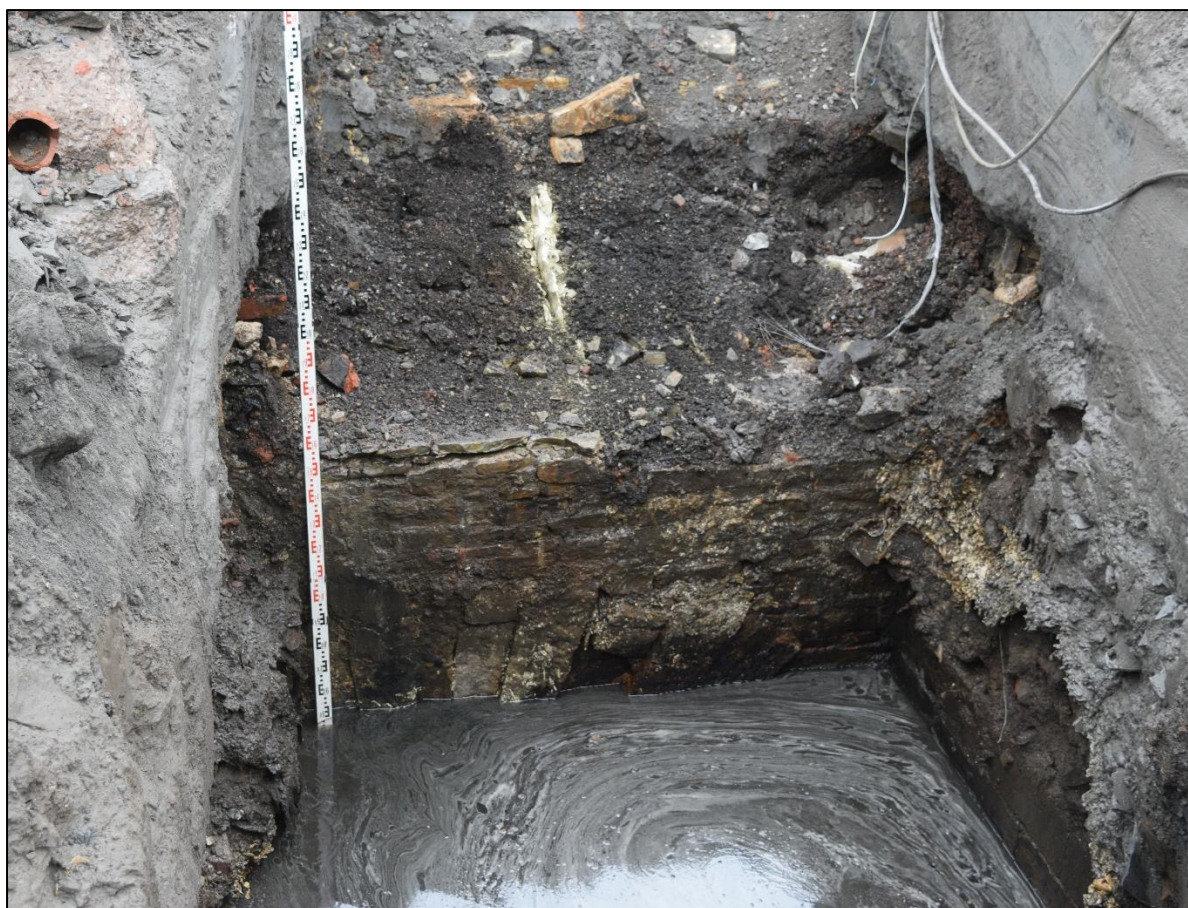
Wall **13** abutted wall **12** at its southeast side, and contained a stone arch running below wall **12** to the northwest, forming the start of the tailrace culvert. Within the trench 2.4m width of the arch was visible, with the top of the voussoirs c. 1m below the top of wall **13** (Plate 10).

*Plate 10: Walls 12, 13 and 14, looking northwest*

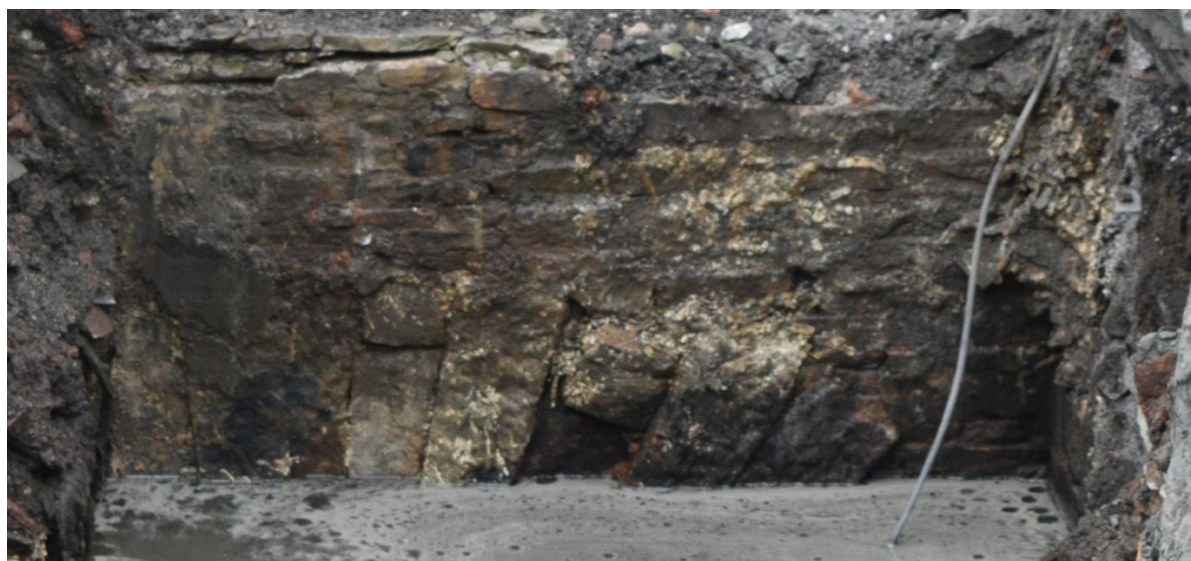
One of the visible voussoirs appeared to be the tallest, suggesting that it was the keystone. If so, this lay towards the southwest edge of the trench, some 2.1m from the northeast side of the arch, suggesting a full width of c. 4m (Plate 11).

*Plate 11: Voussoirs in wall 13, looking northwest*

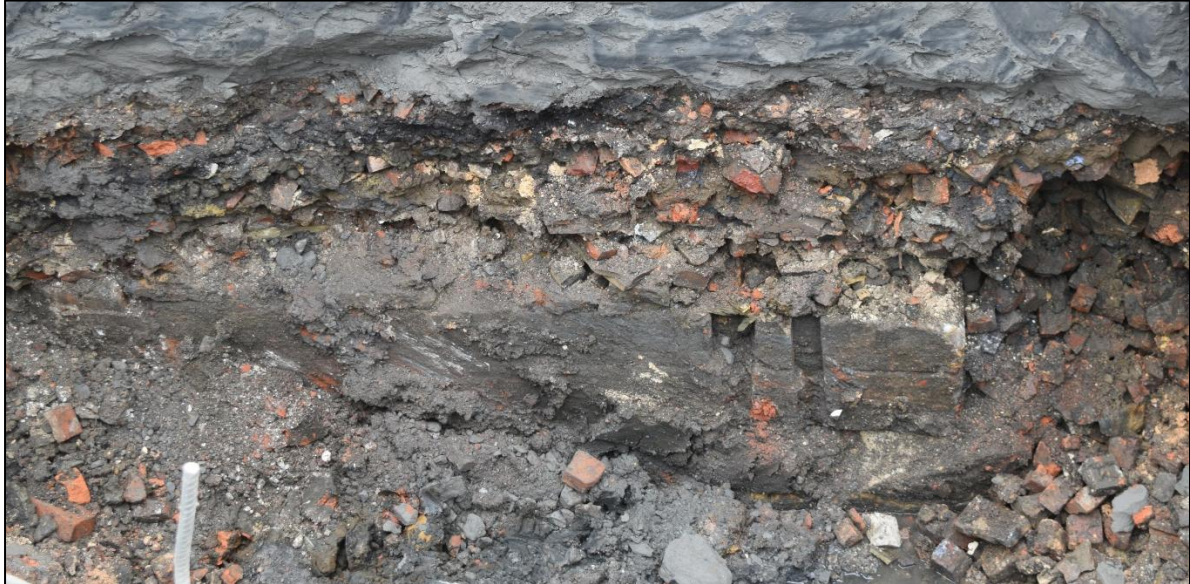
Wall **14** formed the northeast wall of the wheel pit, and wall **16** the southwest wall. Only a short section of the southwest wall was visible, running northwest from the headrace wall **17** for c. 1.5m, at which point it turned southwest into the trench edge, widening the wheel pit (Plate 12).

*Plate 12: Wall 16 turning back into the trench edge, sluice gate housing visible, looking southwest*

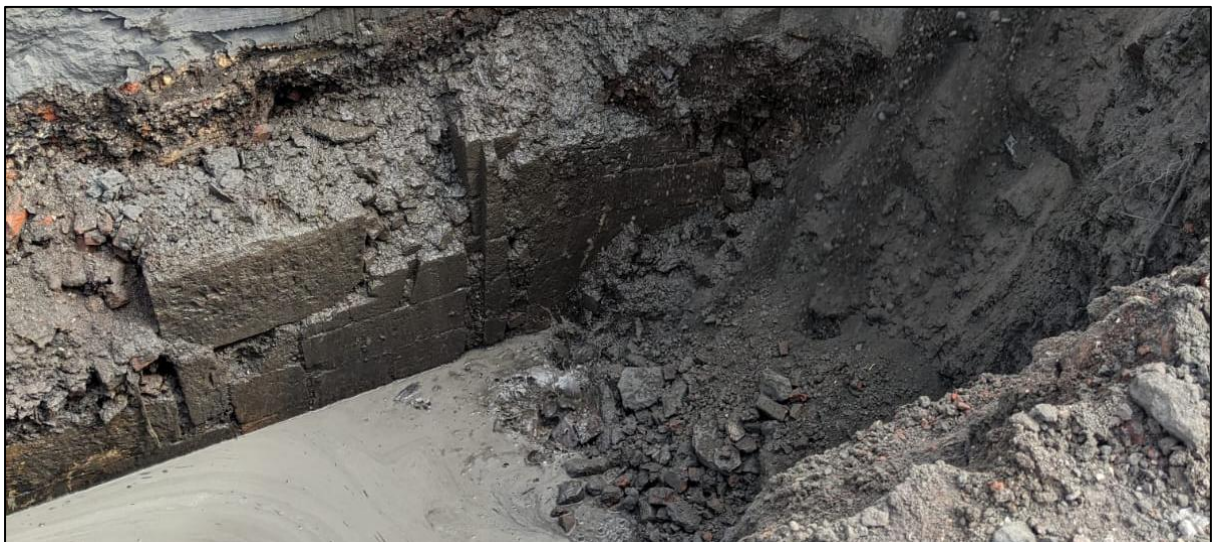
Two larger stone blocks were observed within the northeast wall **14**, to either side of the central point of the wall. Although heavily truncated it was felt that this formed the remains of the housing for the central axle (Plate 13).

*Plate 13: Larger block in wall 14, possibly part of axle housing, looking east*

The possible axle housing was suggested by the two larger blocks observed within the northeast wall, and the position of this structure in the centre of the main wheel pit. The wall at this point had been heavily damaged, but this may be due to the removal of the cast iron axle housing prior to demolition.

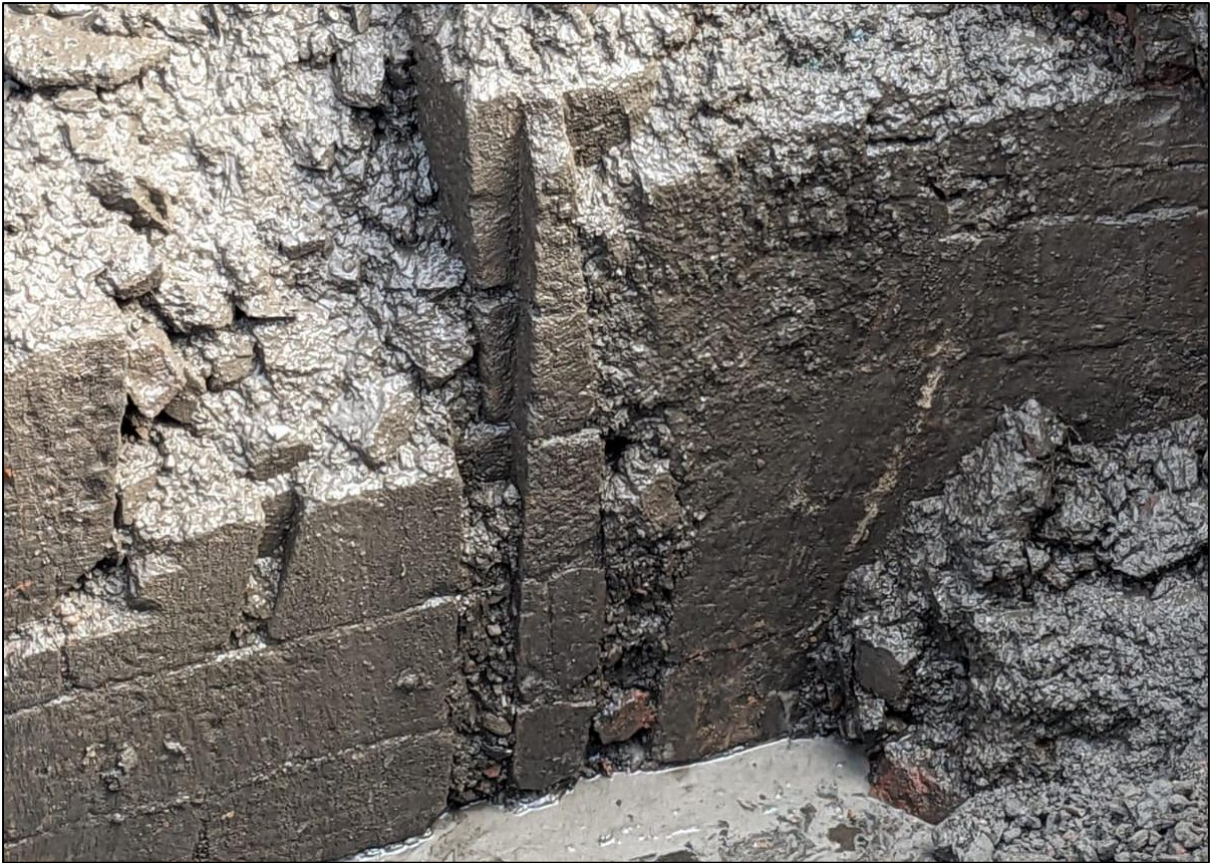
Observed at the southeast end of both walls **14** and **16**, and opposite each other, were two narrow vertical grooves carved into the stone blocks. These lay just beyond the headrace and were likely the housing for a sluice gate (Plates **12** and **14**).

*Plate 14: sluice gate housing in wall 14, looking east*

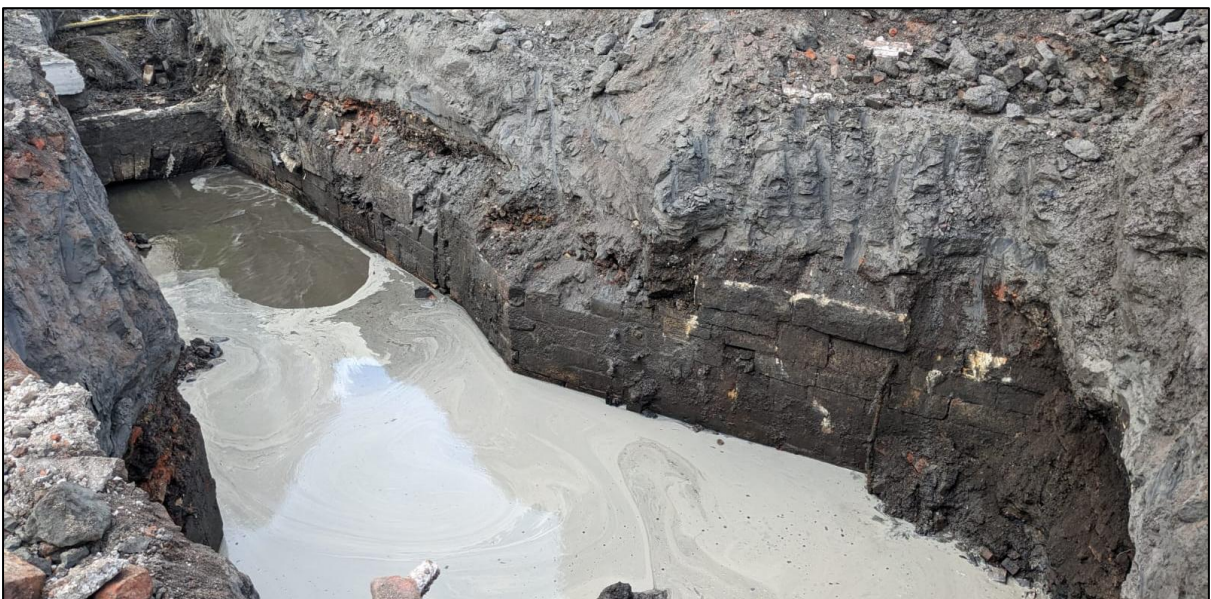
At the southeast side of the trench walls **15** and **17** formed the sides of the headrace. These angled inwards from the wheel pit walls, narrowing the entrance to the headrace from 3.5m in the wheel pit to 2.6m wide just inside the headrace, before widening again to the southeast, creating an hourglass shape in plan (Plate 15).

*Plate 15: Wheel pit and head race, looking north*

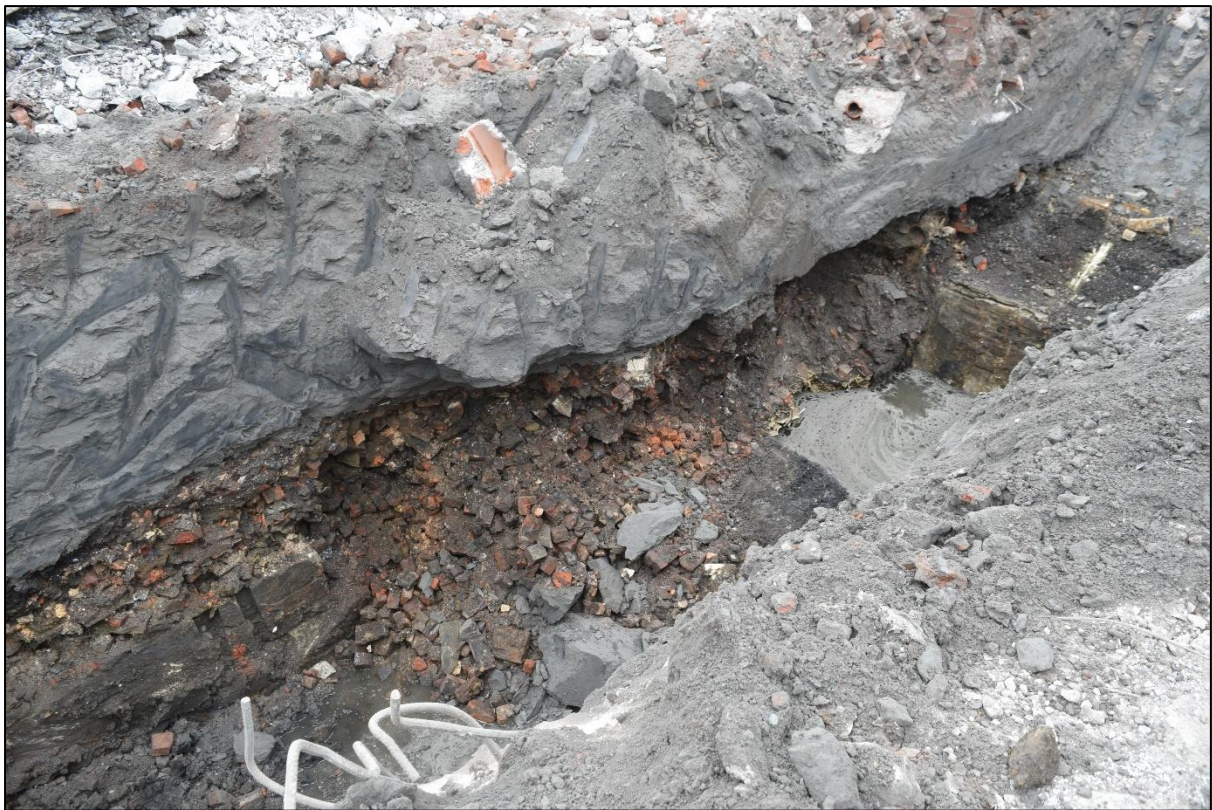
Above deposit **18** was 1.8m to 2m of the compact fly ash **04**, with hardcore, bedding and tarmac above (Plate 16).

*Plate 16: Overburden and fly ash capping, looking west*
