Outbuildings @ Primrose Hill  
Farm,  
Rochdale Road East,  
Heywood,  
OL10 1RL.

## Bat Presence/Absence Survey Report

| Report Number | MALIK/26-002 |

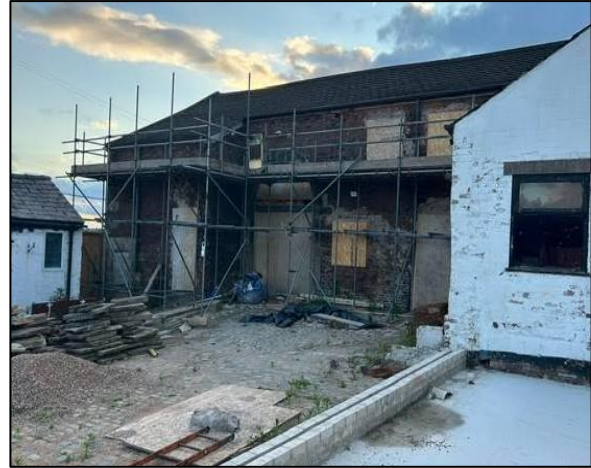
A walkover inspection was undertaken prior to the surveys. Ongoing refurbishment works were evident within parts of the Site, including the erection of scaffolding and associated building works to the principal barn structure. As the timing and extent of these works relative to the previous bat surveys are unknown,

it has not been possible to determine whether they represent a material change in the suitability of the buildings for roosting bats. However, the surveys were undertaken to determine the current presence or likely absence of roosting bats, and no bats were observed emerging from, re-entering, or otherwise utilising the surveyed buildings during either survey.

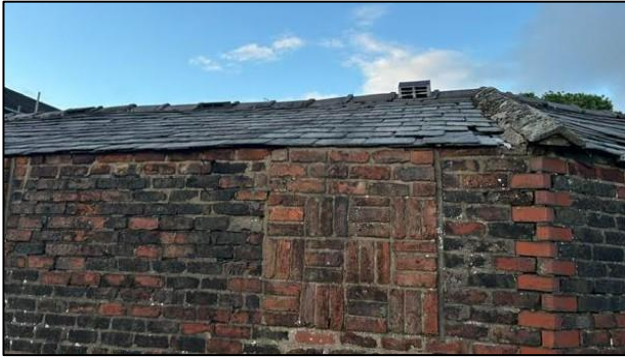
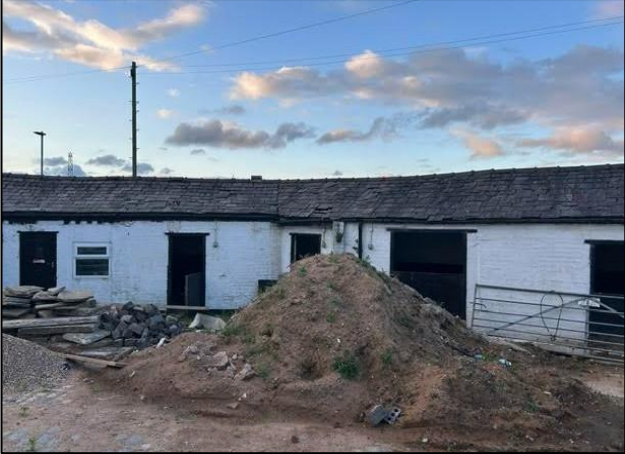
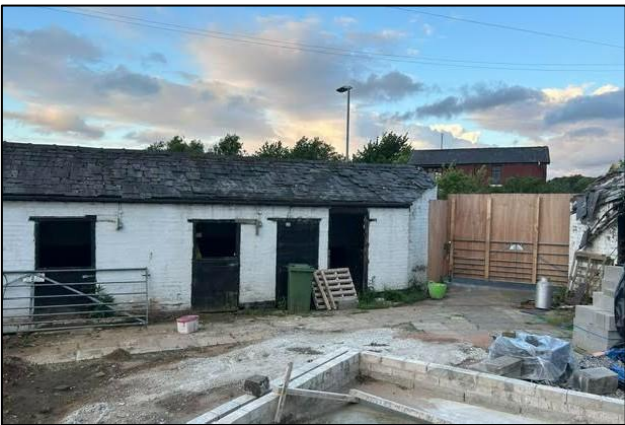
**Figure 1;** Surveyor

Surveyor locations are shown in the accompanying plan (*see Figure 1 – Surveyor Location Plan below*).

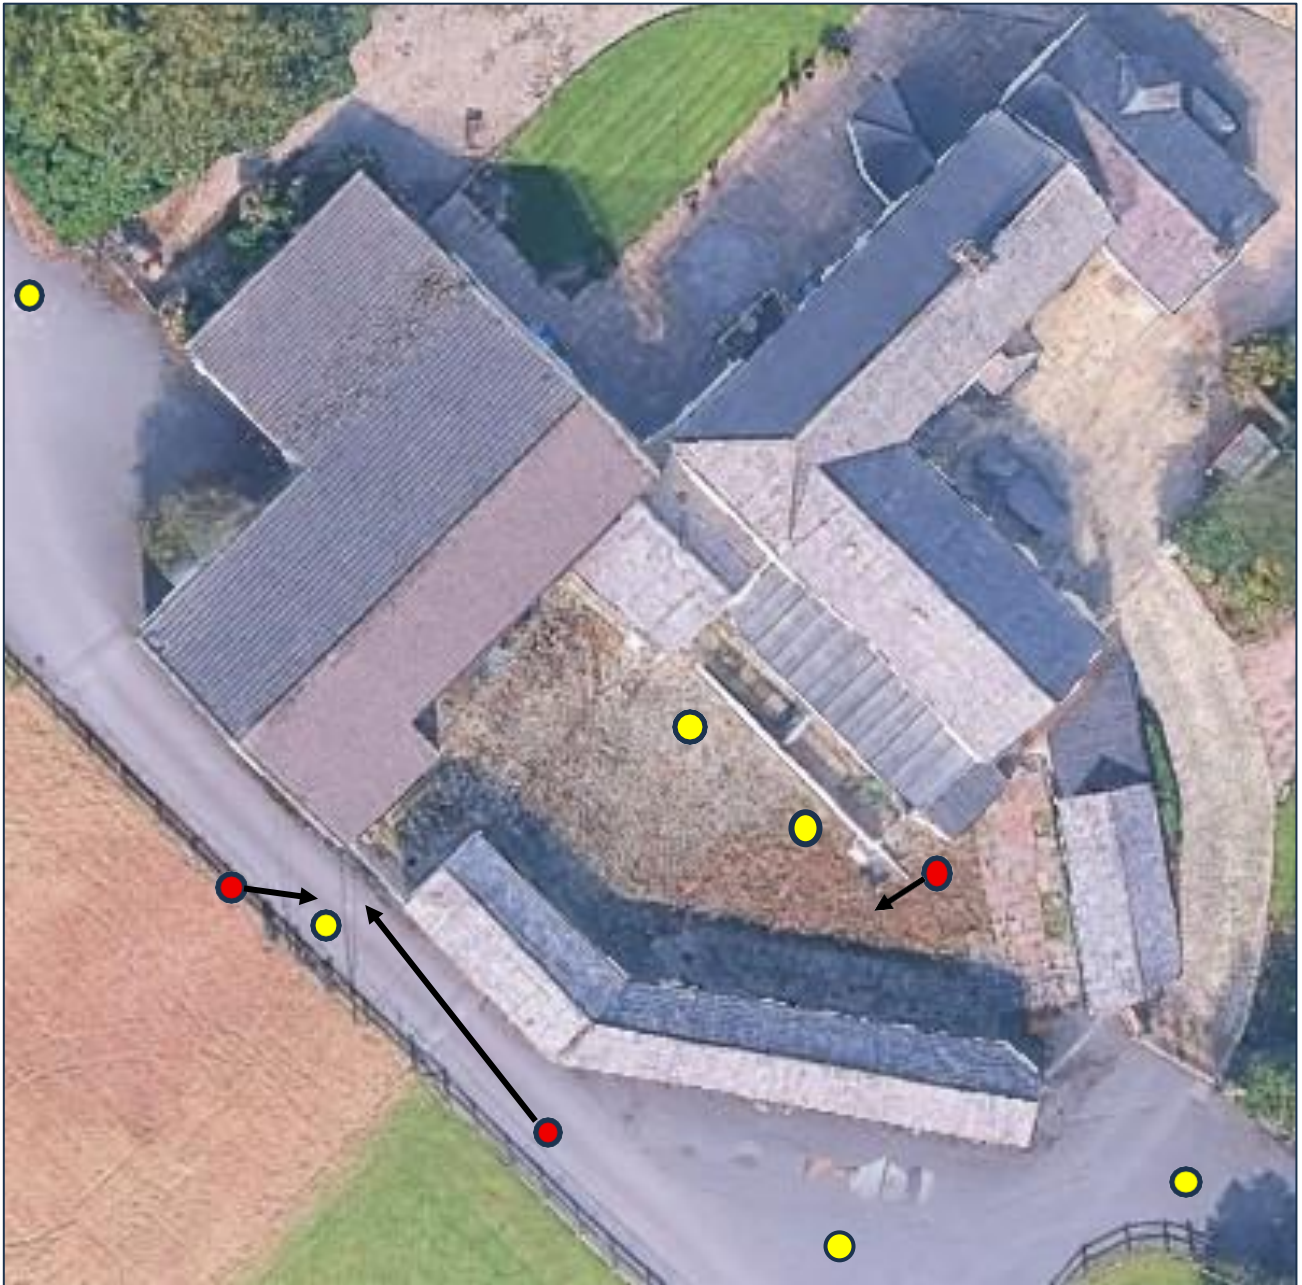
Survey positions provided clear views of all elevations and rooflines of the buildings, enabling simultaneous monitoring of all identified potential bat access and emergence points.

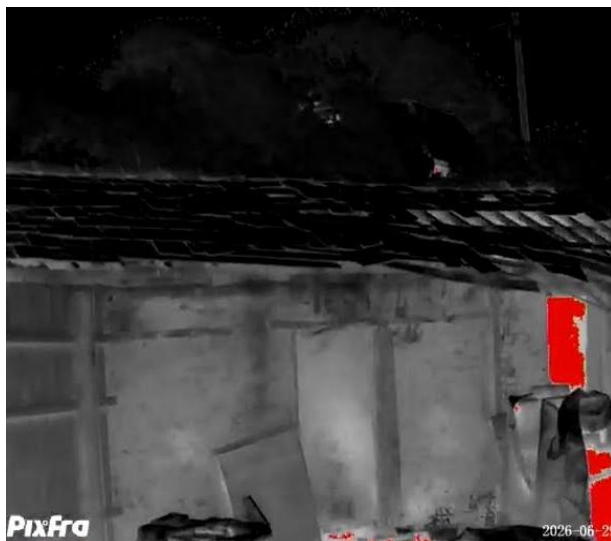
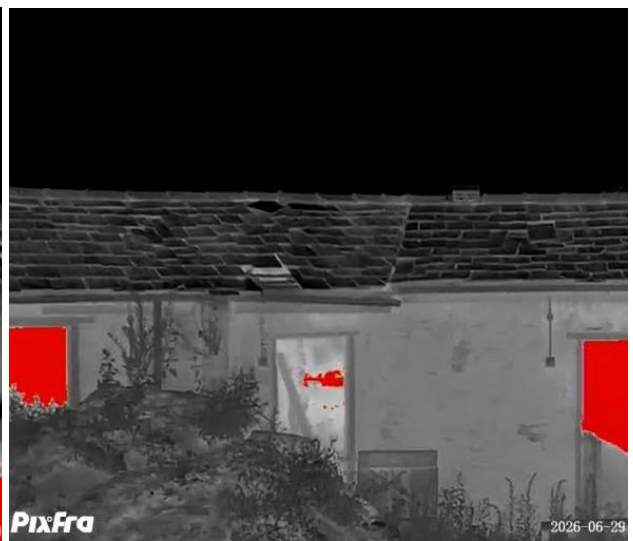
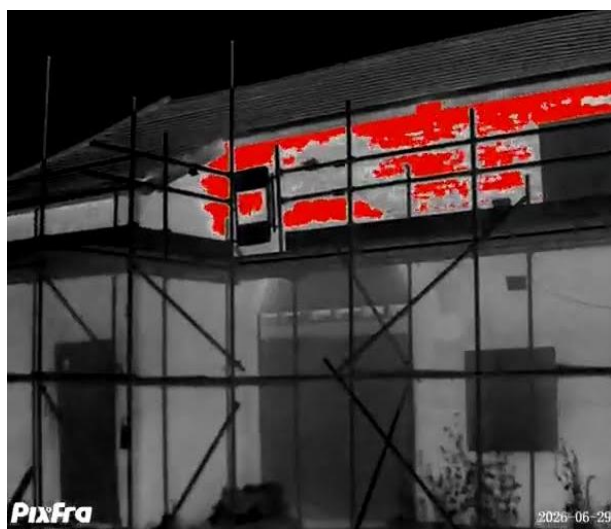
A number of thermal imaging cameras (IRPro 19mm, Pixfra ARC, and Hikmicro LH19) were employed during the survey in accordance with Bat Conservation Trust's Bat Surveys for Professional Ecologists: Good Practice Guidelines (4th edition, 2023). The use of thermal imaging enhances detection capabilities, particularly in low-light conditions or where visual observation is obstructed. It enables surveyors to detect the heat signatures of bats in flight or emerging from potential roost features, allowing for more accurate assessment of presence/absence and behavior. All thermal observations were conducted by a trained and experienced operator and were cross-referenced with acoustic data for species identification. Images captured using the device are included as supporting evidence.
