## **LAND AT HOPWOOD HALL COLLEGE, MIDDLETON**

### **ADDENDUM TO CURTILAGE ASSESSMENT REPORT**

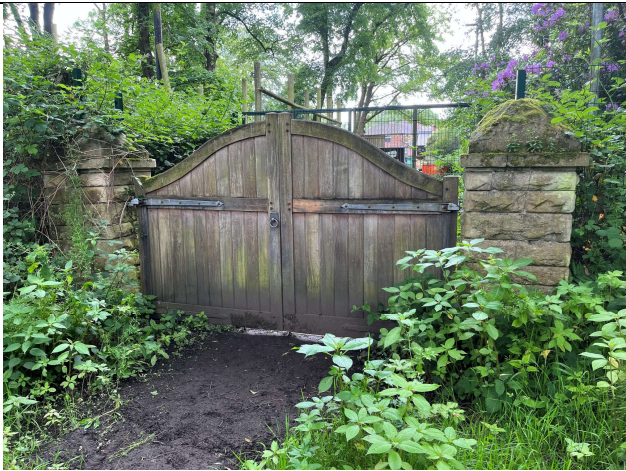
| APPENDIX 1: INVENTORY OF IDENTIFIED REMAINING FEATURES | | | | |
|---|---|---|---|---|
| 2 | Gate piers to the north driveway entrance from Oaken Bank Road enclosing the college to the north. | Two coursed, rock-faced finished stone gate piers with stone pyramidal cappings. Renewed timber gates. | | |

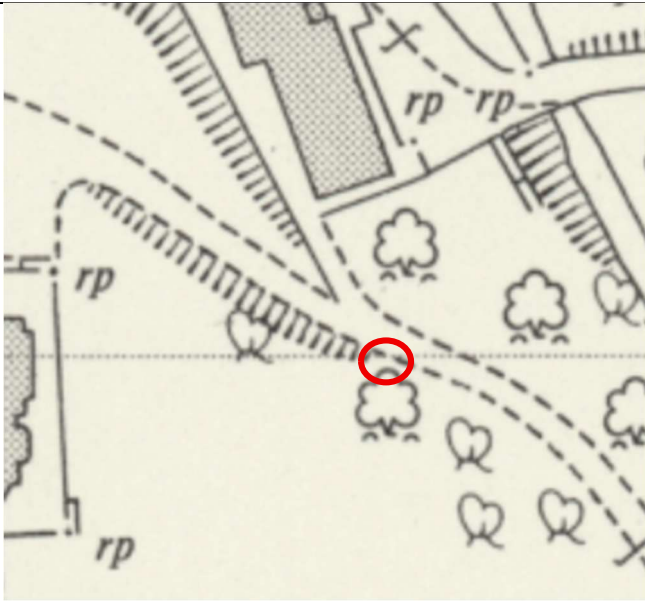
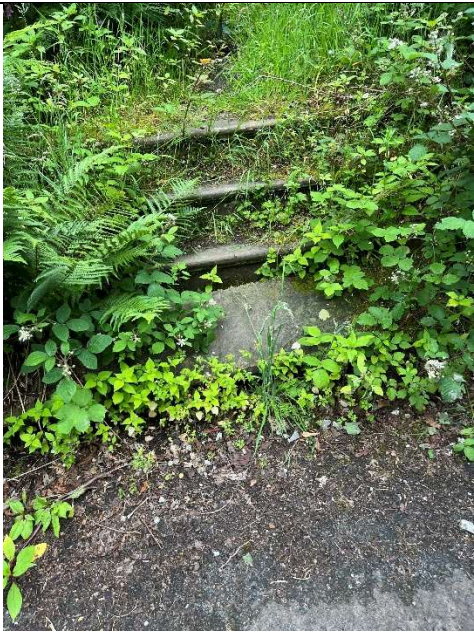
| 3 | Stone steps | Series of stone steps in vegetative bank between the existing lower trackway and upper road to the hall. The steps are partially concealed by vegetation and are not captured on historic mapping but sited adjacent to an area shown to be banked on historic mapping. | | |

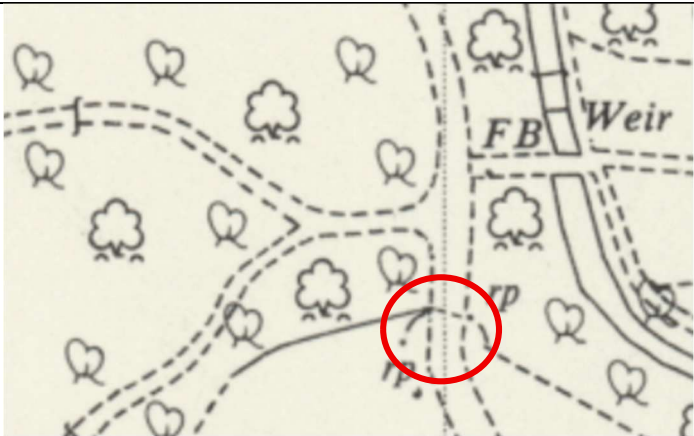
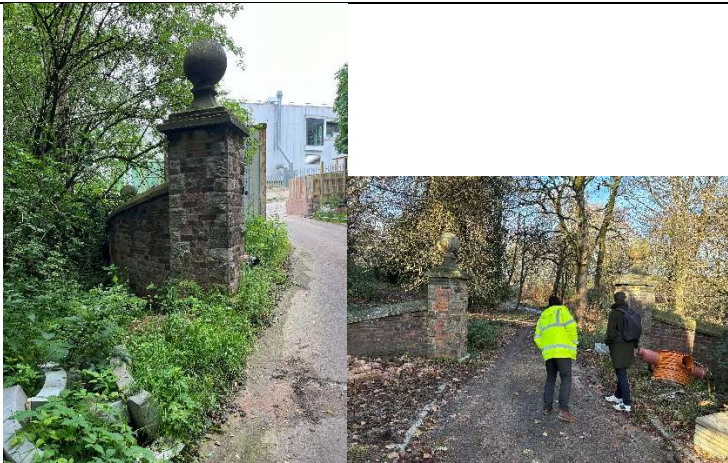
| 4 | Gate piers and flanking walls located to north of the modern college building on original south driveway towards the hall. | Red brick gate piers with rock-faced stone quoins, stone capping and stone ball finials. Red brick, curved flanking screen walls connect to two outer piers with matching stone ball finials. Flanking screen walls are capped with rounded stone copings. Some evidence of localised rebuilding to the gate piers which appears to have resulted in evidence of former gates (e.g pintles / lead pockets). | | |

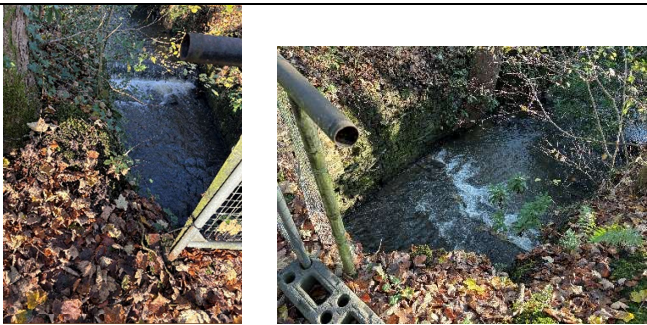
| 5 | Footbridges over Trub Brook | Two footbridges remain over the Trub Brook to the southeast of the hall. Both appear to have been subject to phases of rebuilding but retain earlier brickwork to the base. A stone weir remains between the rebuilt bridges. Sections of the Trub Brook are stone-lined in proximity to the bridges and to the north, where the Trub Brook passes under Oaken Bank Road and out of the college grounds. | | |

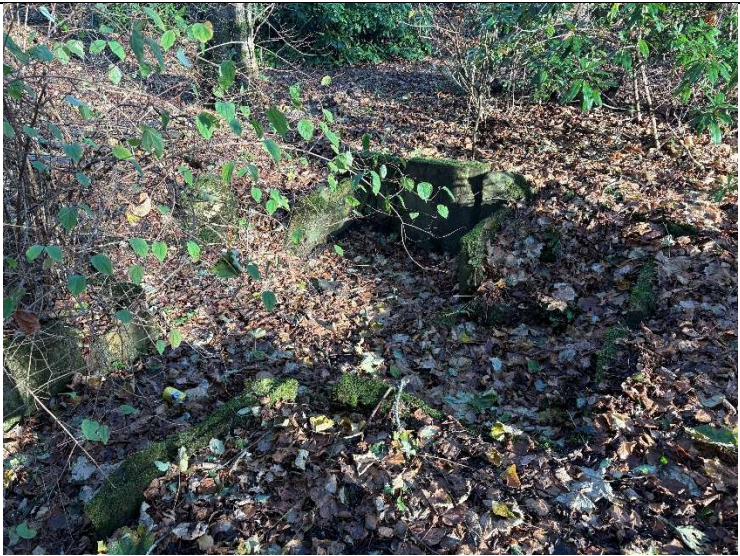
| 6 | Former garden to southeast | <p>There remains evidence of a former, planned garden shown on historic mapping. This garden lies to the southeast of the hall. A central area of brick remains enclosing a tree which corresponds to the circular feature shown on historic mapping. Other remnants of the pathways and a possible glass house (shown on earlier mapping) are visible as small kerb stones.</p> | | |

- 3.1 The primary area of focus is the land to the east and southeast of the hall. Here historic mapping indicates that the landscape had been formally laid out as gardens by the mid-20<sup>th</sup> century, with organised paths radiating from a central circular feature. Earlier OS mapping also records a network of paths and trackways crossing this area, including footbridges over Trub Brook from the mid-19<sup>th</sup> century onwards. Surviving stone and brick edging associated with these former pathways provides tangible evidence of the earlier formal garden layout and demonstrates that this landscape formed part of the designed setting of the hall.

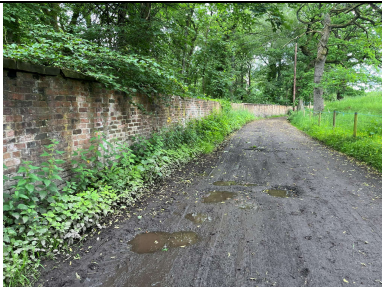
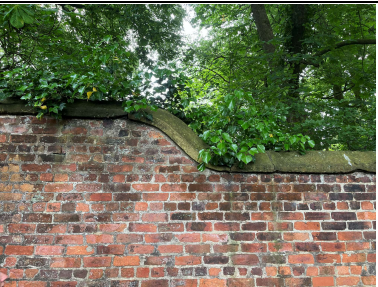
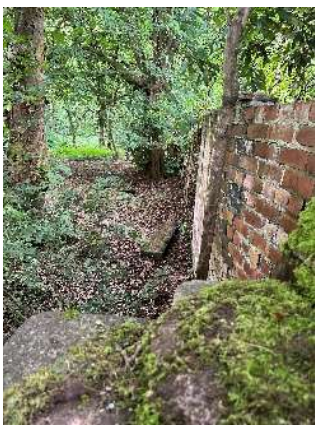
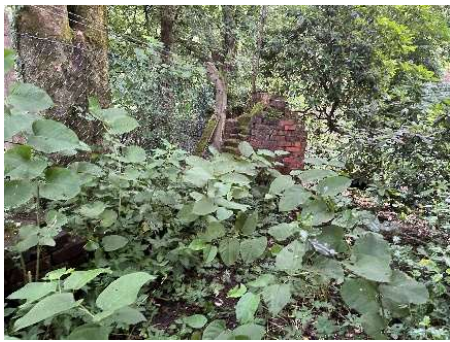
| 7 | Red brick boundary wall to Oaken Bank Road and within grounds to east of former mill. | <p>Significant sections of a red brick wall remain to the northeast, east and southeast of the hall. The wall encloses the college grounds from Oaken Bank Road and forms a defined boundary to the college and areas of the historic parkland associated with Hopwood Hall. The wall survives in varying condition, with evidence of repair and rebuilding noted to the section close to the former stables as well as other sections further south. The wall continues to the southeast and east of Hopwood Mill, terminating adjacent to the northeast bank of Trub Brook. At this point, a former building appears to have been built into, or immediately adjacent to, the wall.</p> | | |

- 3.2 The surviving boundary treatment also provides important evidence for defining the extent of the historic curtilage. Along the eastern and northeastern edge of the present college campus, substantial lengths of historic red brick boundary wall survive. This wall enclosed the historic estate from Oaken Bank Road and forms a clear and deliberate physical boundary separating the designed parkland from adjoining land. Evidence of a former gateway, now infilled, survives to the northwest of Hopwood Mill and indicates a controlled access point into the parkland, probably serving the mill.

- 3.3 The boundary wall continues eastwards along Oaken Bank Road, enclosing Hopwood Mill Pond and Hopwood Mill to the north, before turning southwards through the woodland to the east of the mill. Although sections of this boundary wall have been lost, sufficient remains survive to establish its historic alignment with confidence. The surviving sections demonstrate

a deliberate enclosure of the parkland and associated estate buildings and establish a clear distinction between land forming part of the designed estate and land beyond.

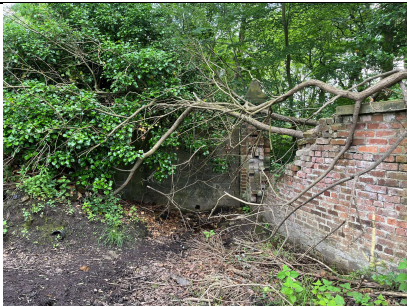
| 8 | Former Entrance | Evidence within the red brick boundary wall enclosing the estate to the east of a former entrance into the parkland survives to the northwest of the former mill pond. The opening is visible on historic mapping and was accessed from Oaken Bank Road. The opening has been infilled with modern material and is now partially concealed behind vegetation. | | |

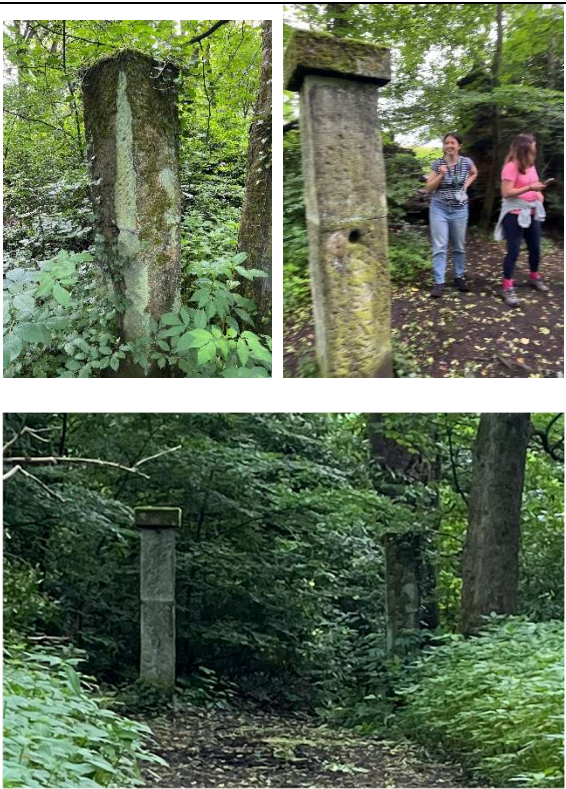
| 9 | Gate piers to trackway | Close to the infilled former opening are two tall, slim stone gate piers, which are set either side of a former trackway shown on historic mapping. Evidence of gates remains in the form of pintles and lead pockets. The northeast pier retains a square stone capping, while that to the southwest has been removed. | | |

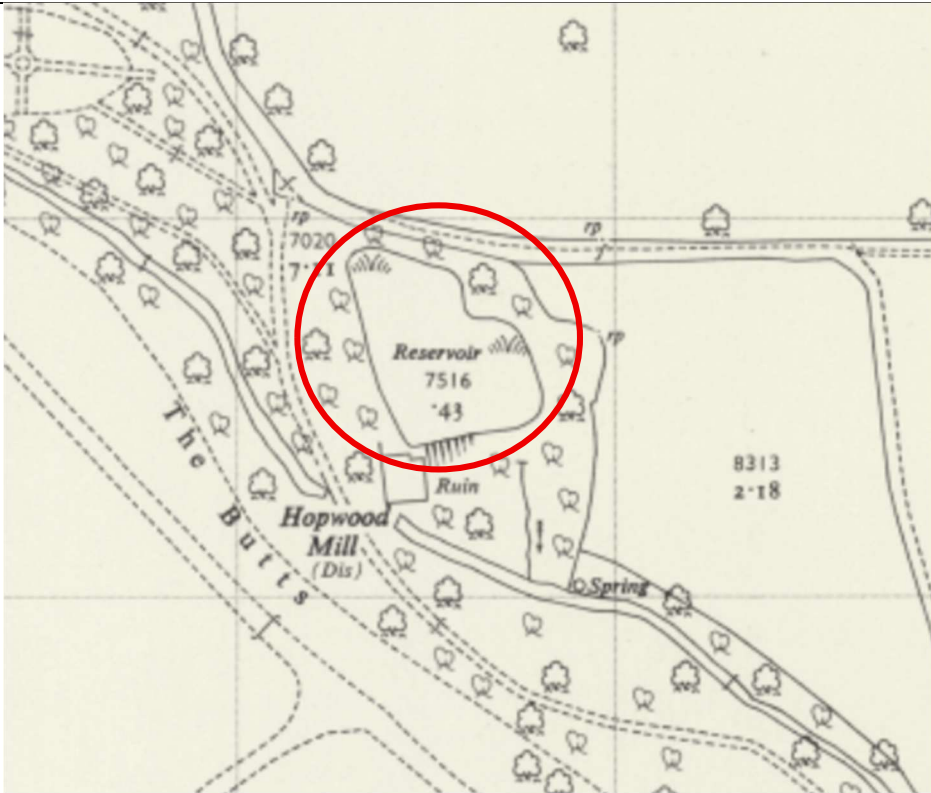
| 10 | Mill Pond | <p>The former mill pond to the immediate north of the site of Hopwood Mill remains. The pond is shown on historic mapping (recorded as reservoir) and is located within the area of parkland which is enclosed by the extant red brick boundary wall to Oaken Bank Road.</p> | <p>A historical map of a parkland area. A red circle highlights a 'Reservoir' labeled '7516' and '43'. Below the reservoir is a 'Ruin' and further down is 'Hopwood Mill (Dis)'. The map also shows 'The Butts' and 'Oaken Bank Road'.</p> | - |

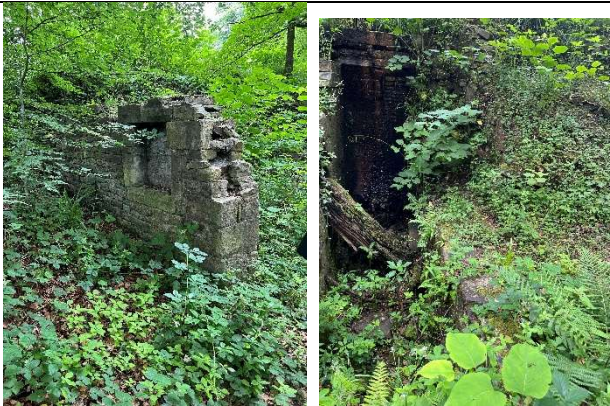
| 11 | Ruins of Hopwood Mill | <p>Upstanding remains of Hopwood Mill are visible within the wooded grounds around the Trub Brook. The remains reveal that the mill was built of random-coursed stone with rubble infill. The wheel housing remains visible to the east of the ruins.</p> | <p>A historical map of the same parkland area. A red circle highlights the 'Ruin' of 'Hopwood Mill (Dis)'. The map also shows the 'Reservoir' (7516) and 'Oaken Bank Road'.</p> | <p>Two photographs showing the upstanding remains of Hopwood Mill. The left photo shows a stone structure partially obscured by green foliage. The right photo shows a stone structure with a large opening, also surrounded by green foliage.</p> |

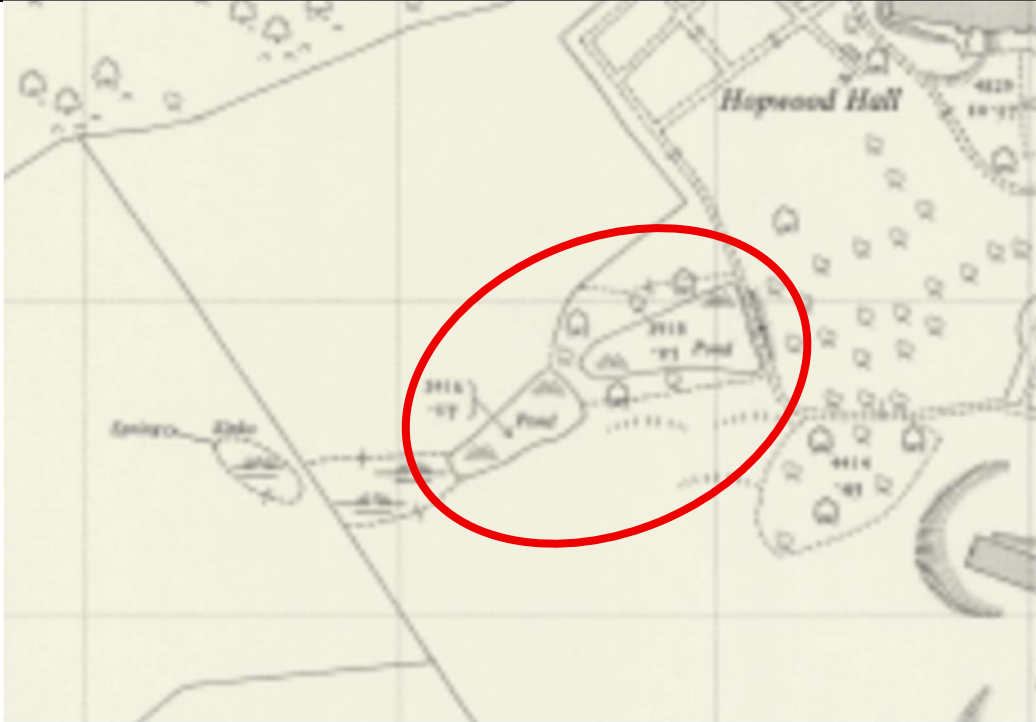
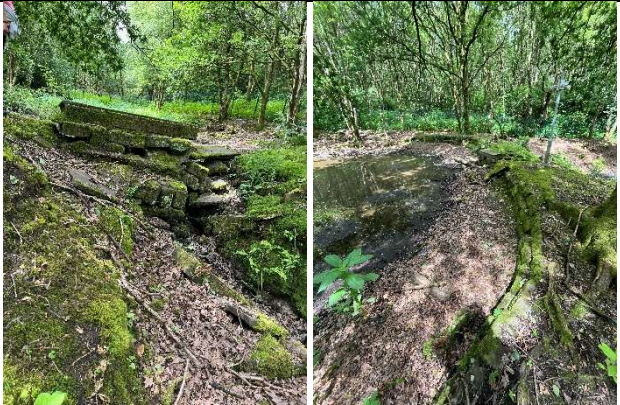
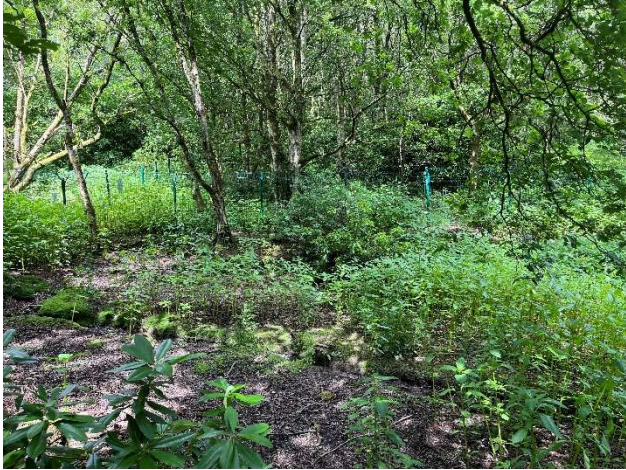
| 12 | Lake and associated cascade and stone-lined feed channel | <p>To the southeast of the hall, within current woodland, are the remains of a lake/pond feature which is shown on historic mapping from 1839 (Tithe Survey). The lake is divided into upper and lower sections, with water fed into the lower section from the upper section by a stone cascade. Feeding the upper lake is a stone-lined channel which leads from a 'Spring' recorded on later OS mapping. The lake is characteristic of planned 'picturesque' parks of the 18<sup>th</sup> and early 19<sup>th</sup> centuries. The feature is clearly engineered through the stone-lined channel, cascade and stone-lined banks which remain to the upper lake.</p> | | |

- 3.7 Whilst the focus of this assessment is on the land to the southeast of the hall in proximity to the site of the proposed new college building, it is apparent that, to the southwest of the hall, there are remains of a former designed lake system within an extant area of woodland. The lake is recorded on the 1839 Tithe Map and Apportionment, where it formed part of land owned and occupied by Robert Gregge Hopwood, and is subsequently shown within the area identified as "parkland" on the 1889–1890 Ordnance Survey (OS) mapping. Despite naturalisation of the surrounding landscape, the lake retains substantial evidence of its original engineered form, including stone-lined banks, a stone cascade and a stone-lined feeder channel. Such features are characteristic components of 18th- and early 19th-century picturesque parkland design and clearly demonstrate an intentional designed relationship with Hopwood Hall. As such, the curtilage associated with Hopwood Hall has been extended to include the lake and the surrounding land, as shown to be in the same ownership as Hopwood Hall in 1942.

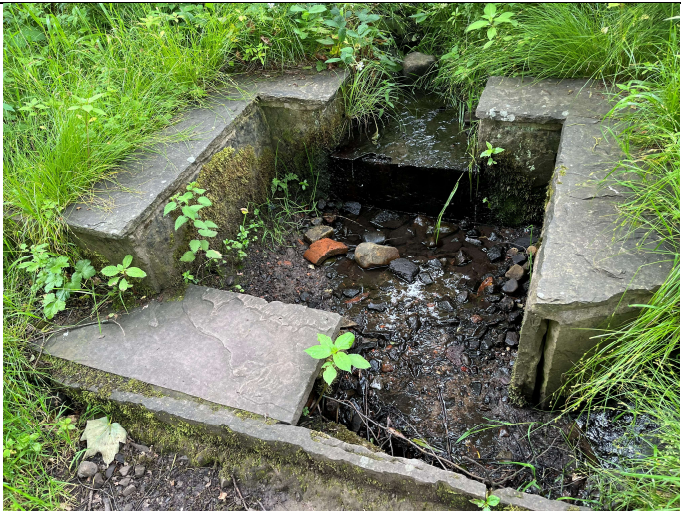
| 13 | Stone drainage feature | <p>A stone-lined drainage channel remains to the west of the northern gate piers. The feature appears to fall just outside of the college ownership boundary but may be related to the wider historic drainage arrangement which served the estate.</p> | | |

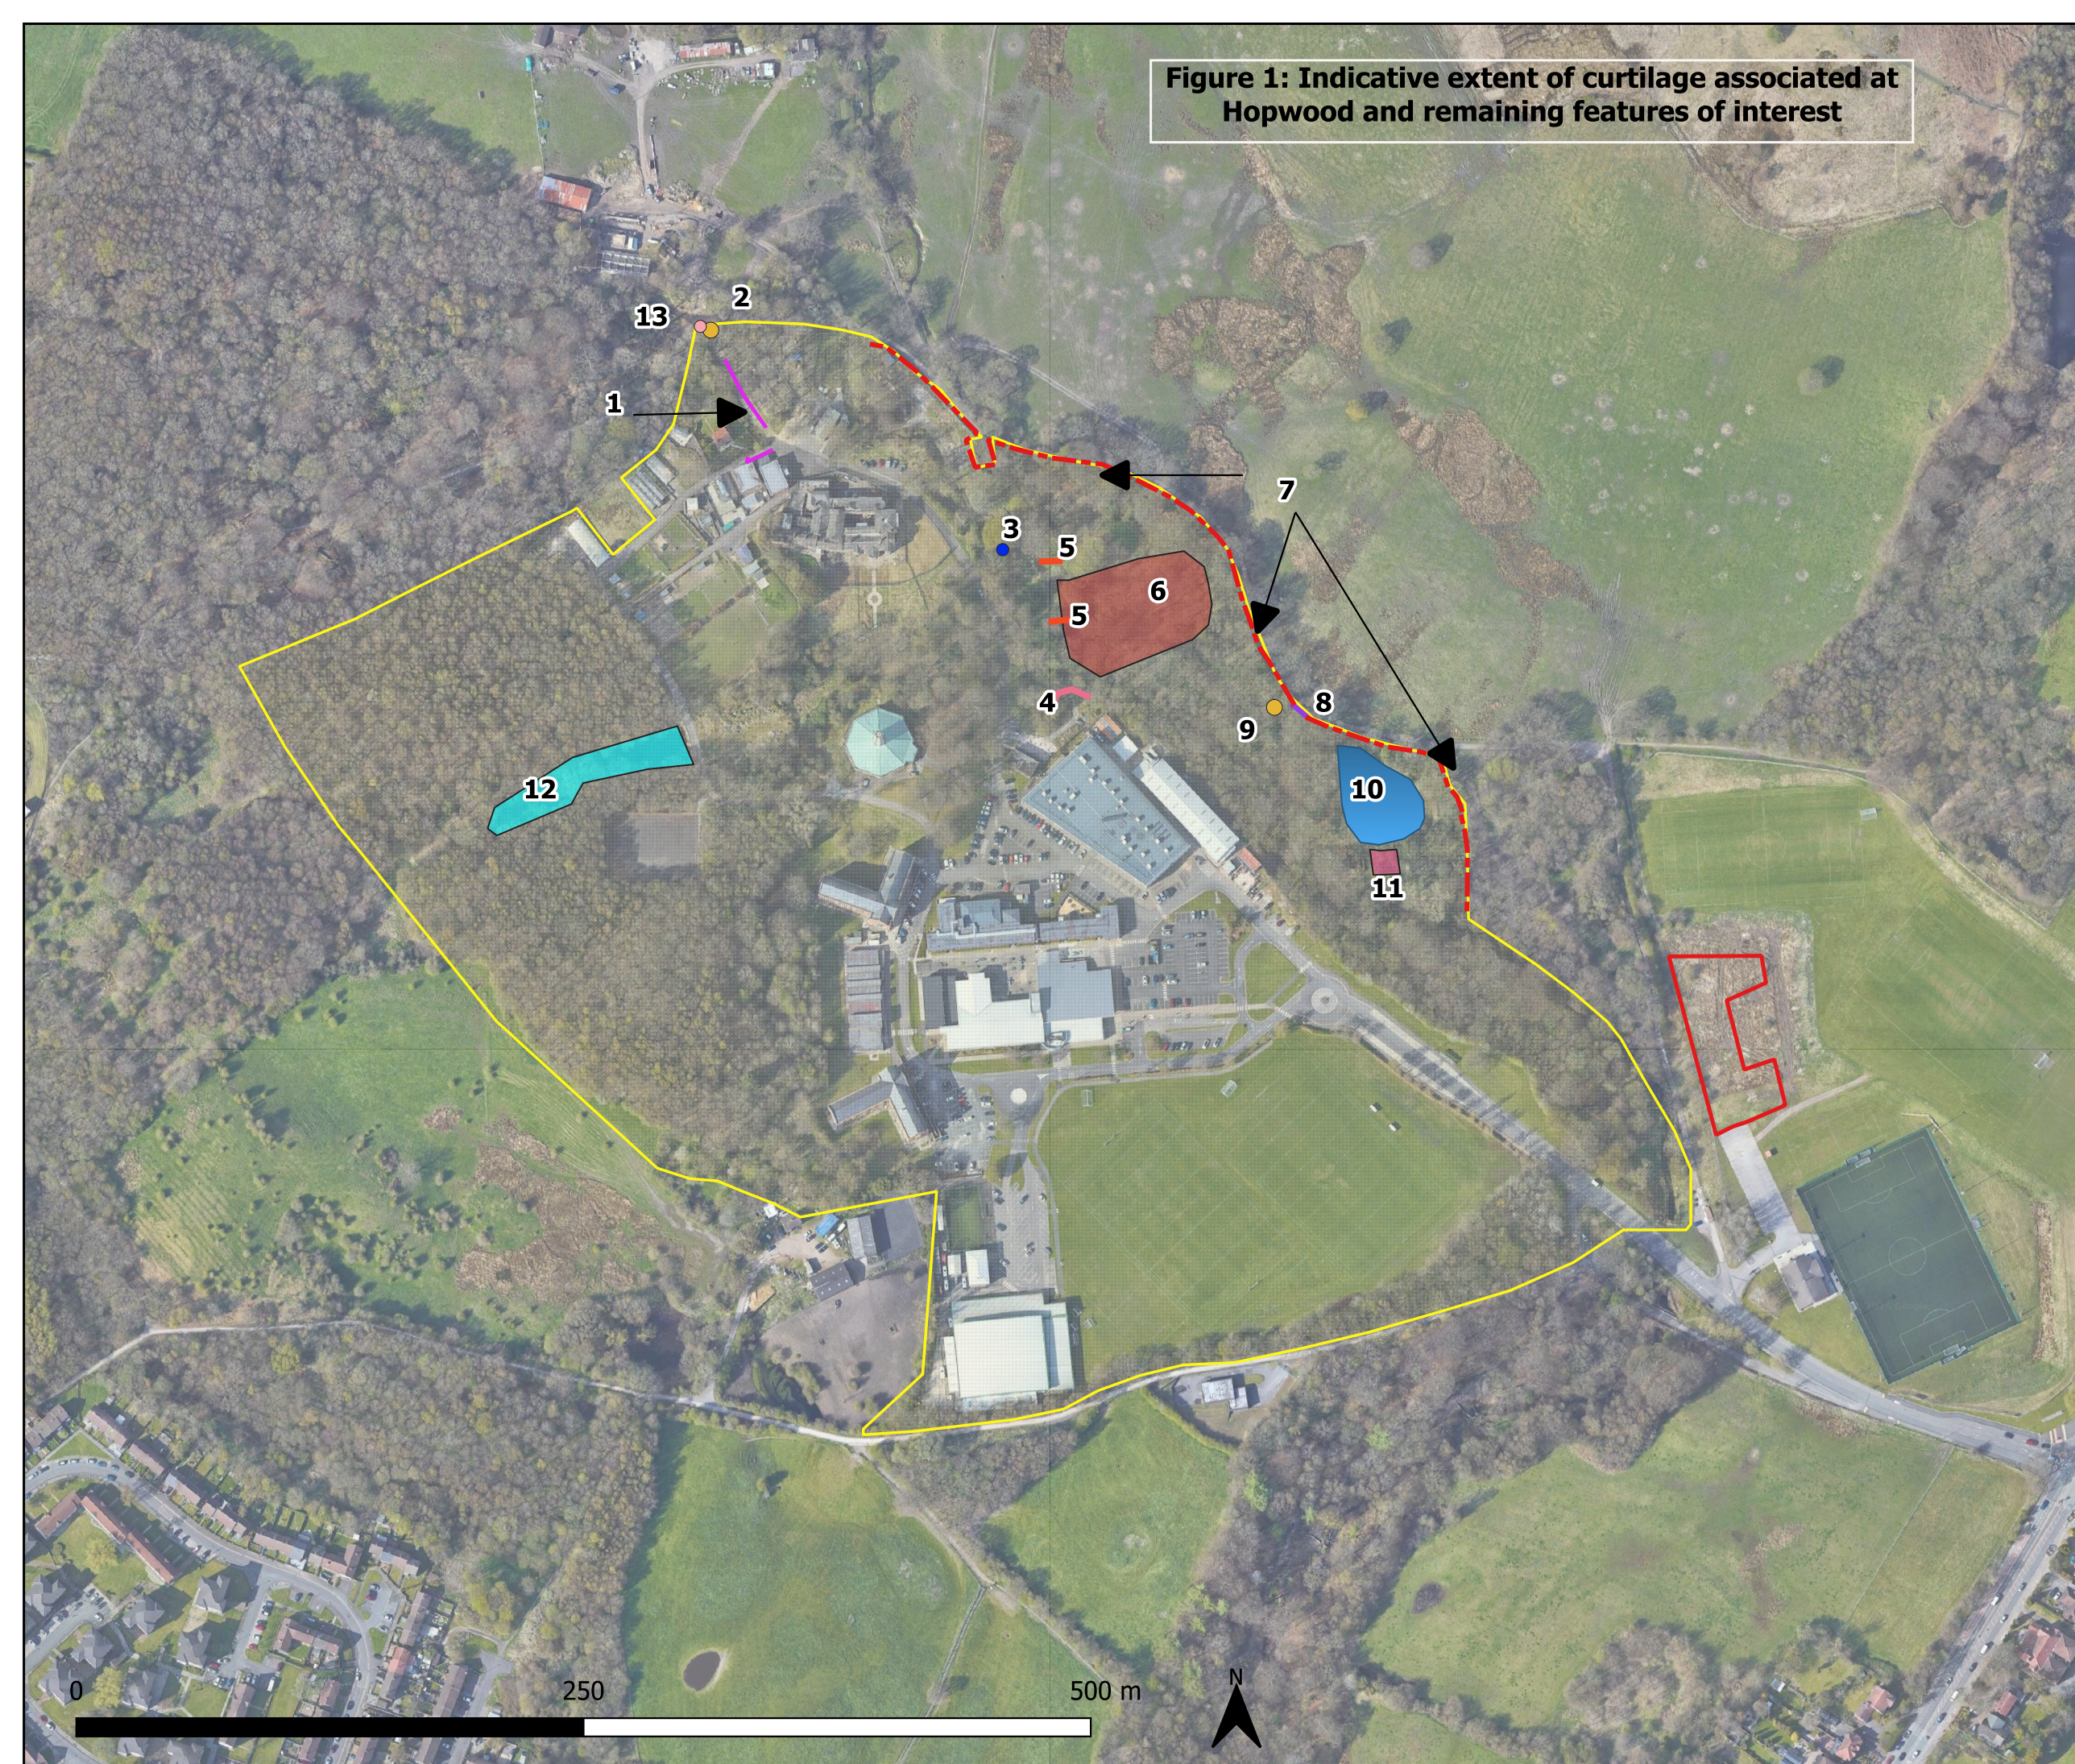
**Figure 1: Indicative extent of curtilage associated at Hopwood and remaining features of interest**

- 3.8 Accordingly, it is considered that the indicative curtilage shown on Figure 001 Rev B represents the most likely extent of the land which demonstrates a physical layout and ancillary association with Hopwood Hall. The boundary drawn takes in the walled gardens to the northwest of the hall, the gardens and woodland to the northeast, east and southeast which are enclosed from Oaken Bank Road and the adjacent by red brick boundary wall, the area of the former stables to the east of the hall, the lake and former parkland which lie to the south and southwest of the of the hall. At the southeast extent, the boundary follows the alignment of the remaining section of red brick wall to the east of the former mill and then follows the alignment of the Trub Brook.

- Indicative Site Boundary
- Anticipated extent of Curtilage of Hopwood
- 1 Standing stones
- 2 & 9 Stone gatepiers
- 3 Stone steps
- 4 Brick and Stone gatepiers
- 5 Footbridge
- 6 Planned garden
- 7 Red brick boundary
- 8 Former entrance in brick boundary wall to Oakden Bank Road
- 10 Mill pond
- 11 Ruins of Hopwood Mill
- 12 Former lakes and associated features
- 13 Stone drainage feature

- 2.3 The site walkover identified a number of surviving historic landscape features which, when considered alongside historic mapping, provide clear evidence of the relationship between Hopwood Hall and its surrounding grounds. An inventory of the identified features is included within Appendix I of this addendum and they are also shown on Figure 001 Rev B.
