## **Appendix 14.9: Peatland Condition Assessment**

This Peatland Condition Assessment (PCA) has been prepared by Fluid Environmental Consulting (Fluid) on behalf of the Applicant to support the Environmental Statement (ES) for Scout Moor Wind Farm (the 'Project for Assessment'). The assessment has been informed by detailed peat survey data collected by Fluid in April, July, August, October and December 2024, February 2025, March and April 2026, as well as habitat surveys undertaken by Atmos Consulting (Atmos) in 2024.

The Project for Assessment will comprise 12 wind turbines, with a blade tip height typically of 180 m, associated infrastructure and ancillary development.

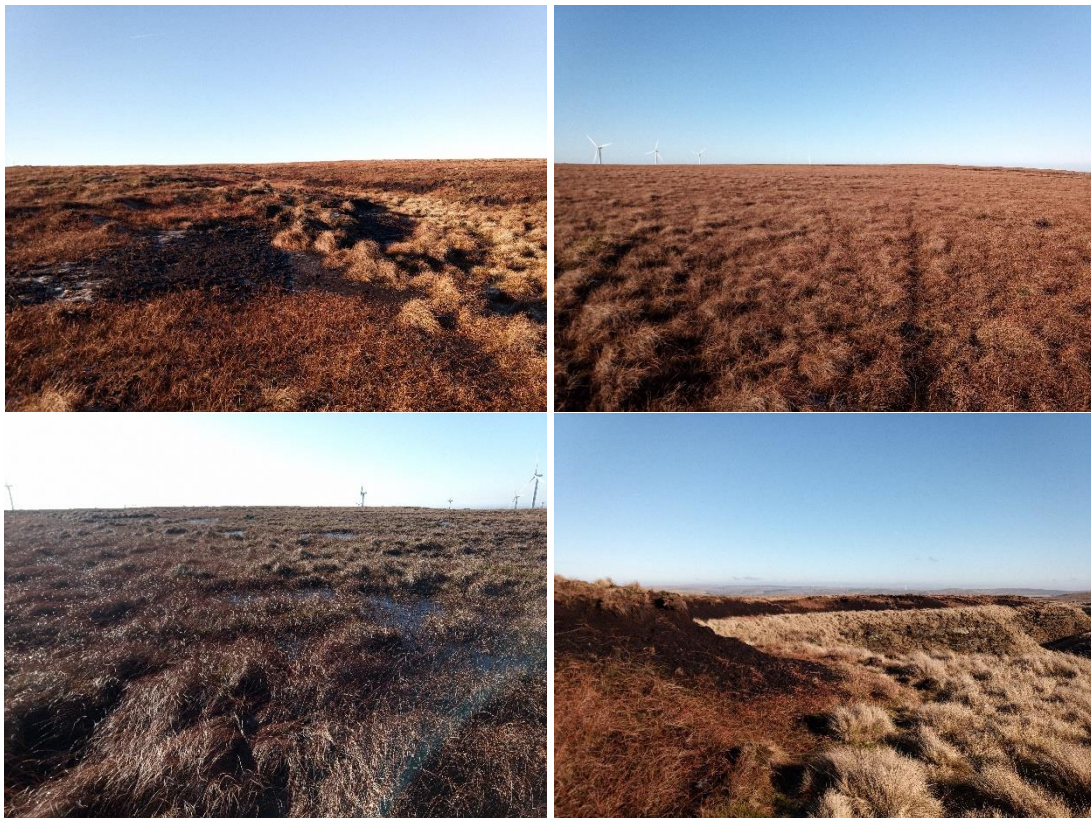
The northwest portion of the Assessment Boundary featured an area of relatively intact M20 blanket bog in mosaic with M3 bog pool communities, covering the plateau which encompasses Hail Storm Hill. In the dry conditions encountered on the day of the survey, much of what may have been historic M3 pools were visible as bare peat patches and ongoing micro erosion. *Sphagnum* species were generally rare, and the habitat dominated by tussock-forming *Eriophorum vaginatum*. In flatter and drier areas of the plateau this formed a species poor carpet with little structural variation. Clear modifying influences were present in these areas.

Several areas of the plateau were observed where Near-Natural features were retained as M3 pools with hummock-hollow formations and *Sphagnum* species including *S. capillifolium*, *S. rubellum*, *S. subnitens* and *S. papillosum*. These were mostly limited to a flat area north of the summit of Hail Storm Hill and other areas on the plateau where local topography has

Active peat erosion was ongoing at the peripheries of the plateau where bare peat and deep erosional gullies were frequent. This community generally transitioned to grassland communities U5 and U6 below the actively eroding peat layer. The areas of Actively-Eroding peatland here featured wide gully systems and expansive bare peat areas.

(Clockwise from top left): Plate 1 – Bare peat surfaces common across M3/M20 mosaic; Plate 2 – Tussocky *Eriophorum vaginatum* growth in drier area of the M3/M20 mosaic; Plate 3 – Actively eroding peat hags at peripheries of blanket bog habitat in north of Site; Plate 4 – Actively peat-forming M3 bog pool with *Sphagnum* hummocks observed.

contributed to the retention of water in these systems. In one location a Near-Natural bog pool feature was located immediately beside an actively eroding peat hag that was likely a similar quality feature in the past; therefore these areas of intact peatland are likely highly vulnerable to impacts from construction activities and should be avoided.

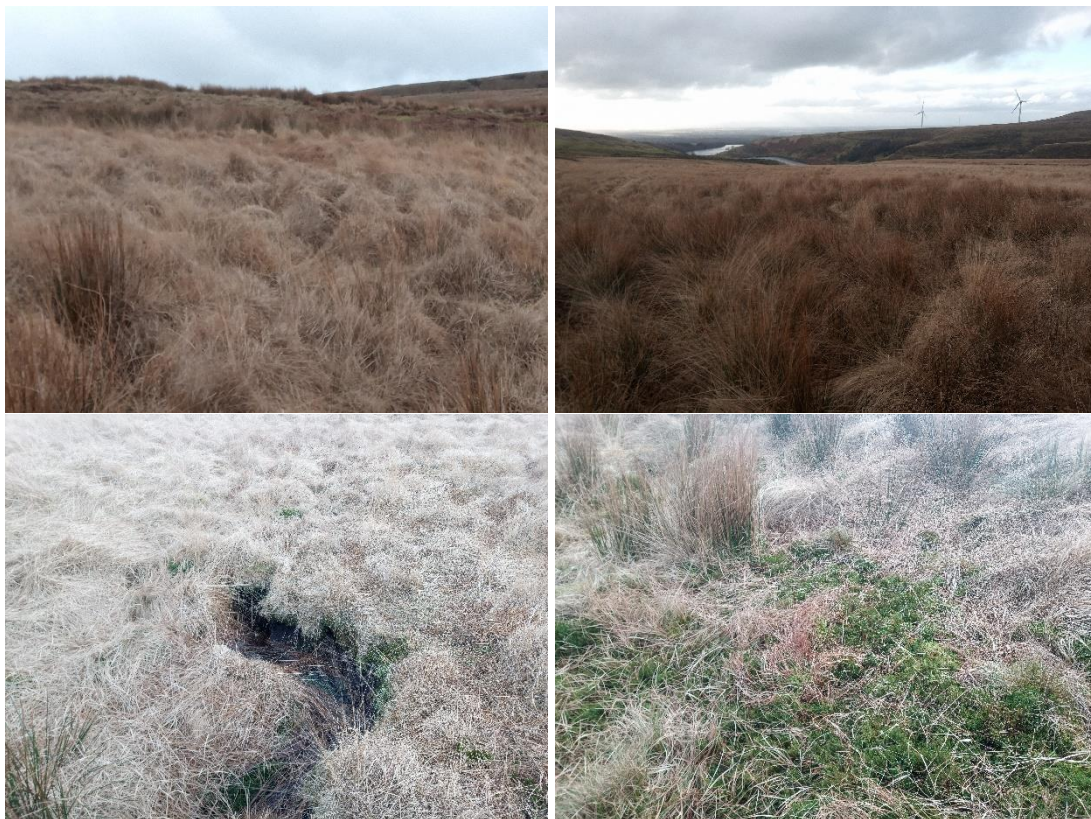
The majority of the Assessment Boundary centred on a north to south ridgeline encompassing several gentle summits to the east of the M3/M20 plateau. This area was much drier, with mostly M25, U5 and U6 habitats. The M25 habitats present were dominated by *Molinia caerulea*, with little *Sphagnum* presence and lacking microtopographical features typically associated with active or near-natural peatland systems. It has therefore all been classified as being in a Modified condition. Some erosional features were noted where areas of bare peat and peat hags were visible however these were generally of a size too small to be mapped as Actively Eroding polygons.

(Clockwise from top left): Plate 5 – dry M25 habitat within base of stabilised historic erosional gully; Plate 6 – patch of *Juncus effusus* within wetter drainage line within wider M25 habitat; Plate 7 – small area of quaking bog (ca. 3 m x 3 m) within M25 habitat with some *Sphagnum* growth; Plate 8 – Small peat pipe within M25 habitat.

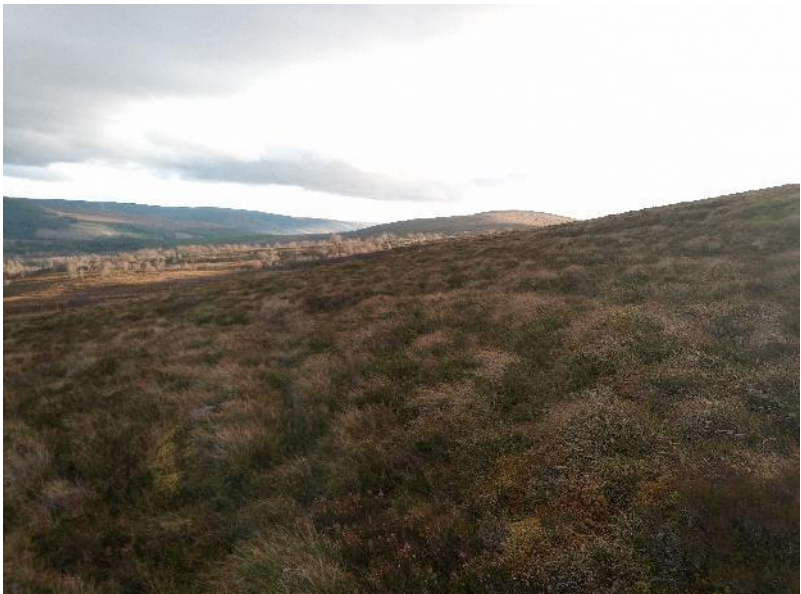
| Target note ID | Location | Target Note | Photo |
|---|---|---|---|
| 1 | SD 84640 19784 | Some Sphagnum species. Heavily modified, tussocky grass, not actively peat forming. Rushes are within natural diffuse flow path. | |

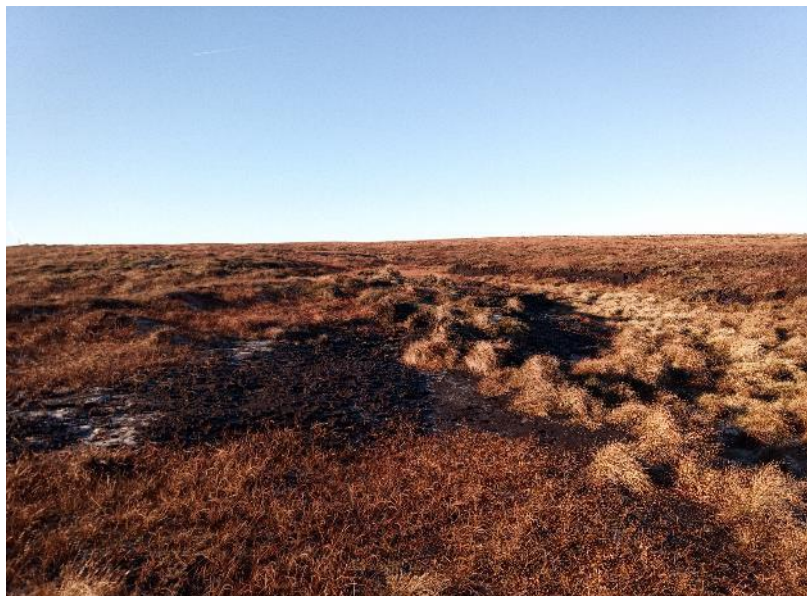
| Target note ID | Location | Target Note | Photo |
|---|---|---|---|
| 2 | SD 84341 19313 | Bare peat common across area | |

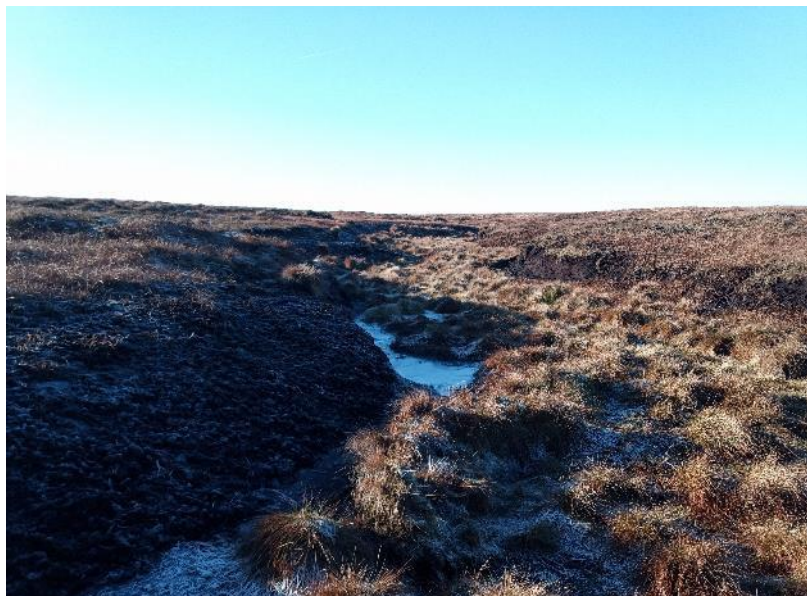
| Target note ID | Location | Target Note | Photo |
|---|---|---|---|
| 3 | SD 84306 19293 | Actively Eroding in lower reaches of gully, bare peat and haggling. | |

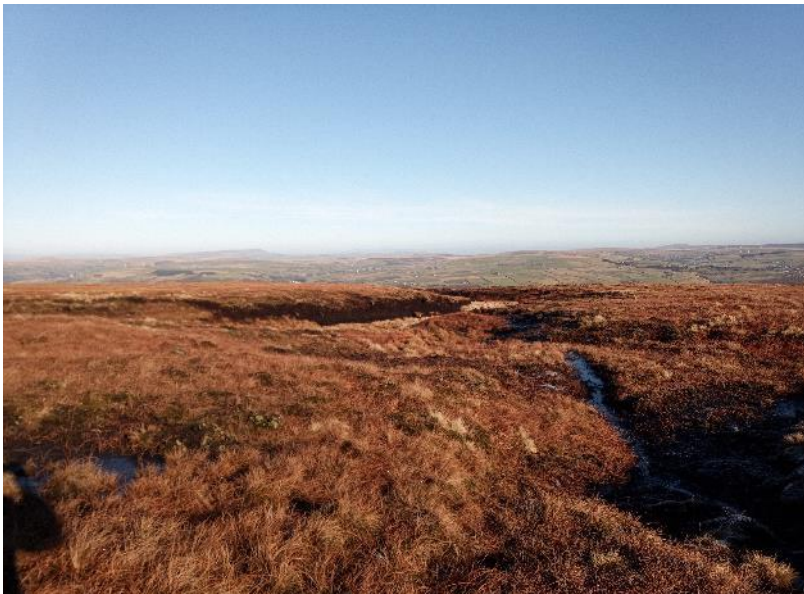
| Target note ID | Location | Target Note | Photo |
|---|---|---|---|
| 4 | SD 84127 19182 | Actively Eroding with bare peat. | |

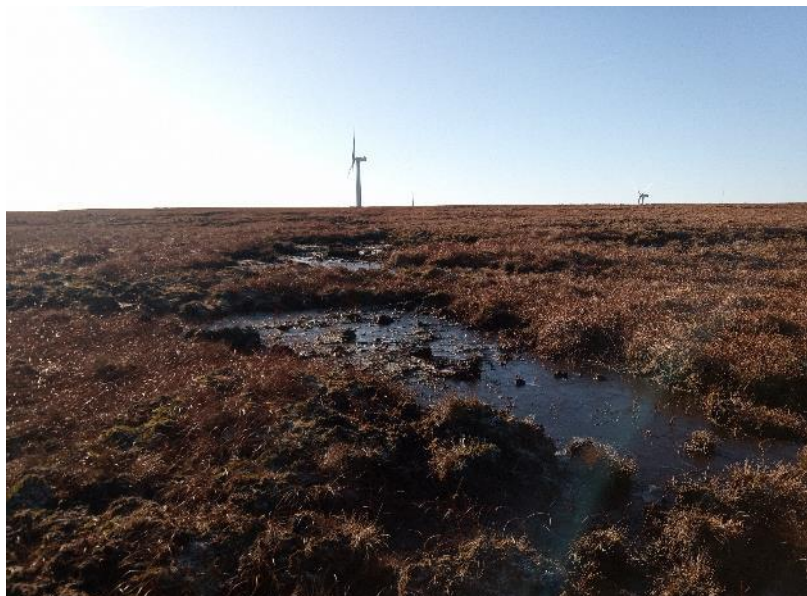
| Target note ID | Location | Target Note | Photo |
|---|---|---|---|
| 5 | SD 84095 19175 | More actively eroding patches – dark patches of historic M3 visible on aerial photography. | |

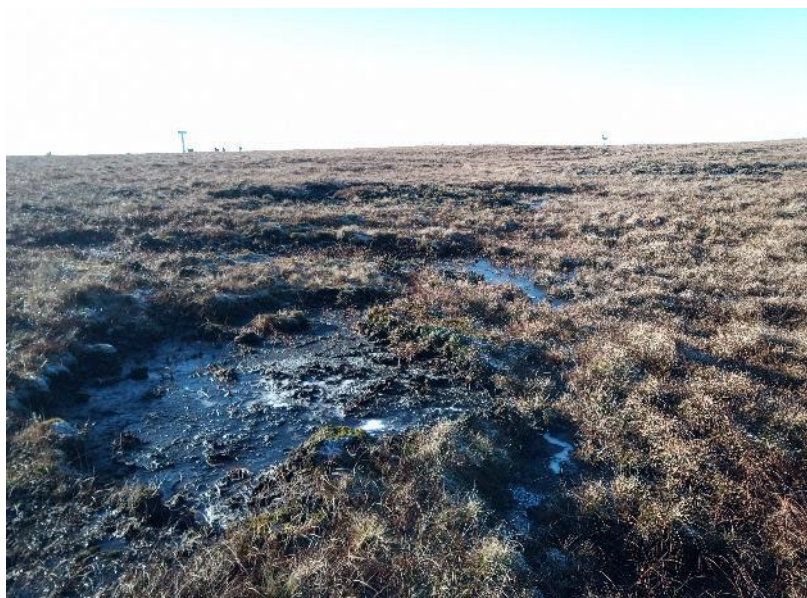
| Target note ID | Location | Target Note | Photo |
|---|---|---|---|
| 6 | SD 84021 19246 | Gully is actively eroding, bare peat patches present south of gully. | |

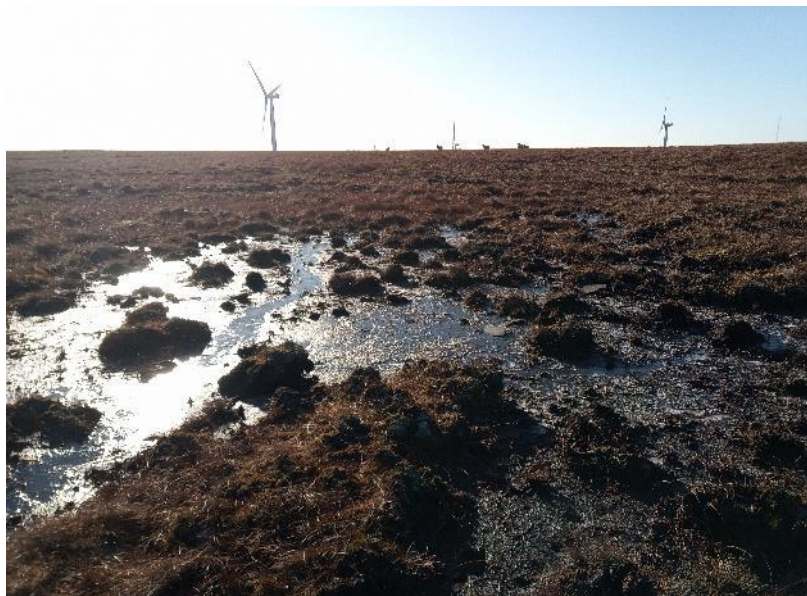
| Target note ID | Location | Target Note | Photo |
|---|---|---|---|
| 7 | SD 84002 19215 | Early stages of erosion, bare peat in M3 bog pools | |

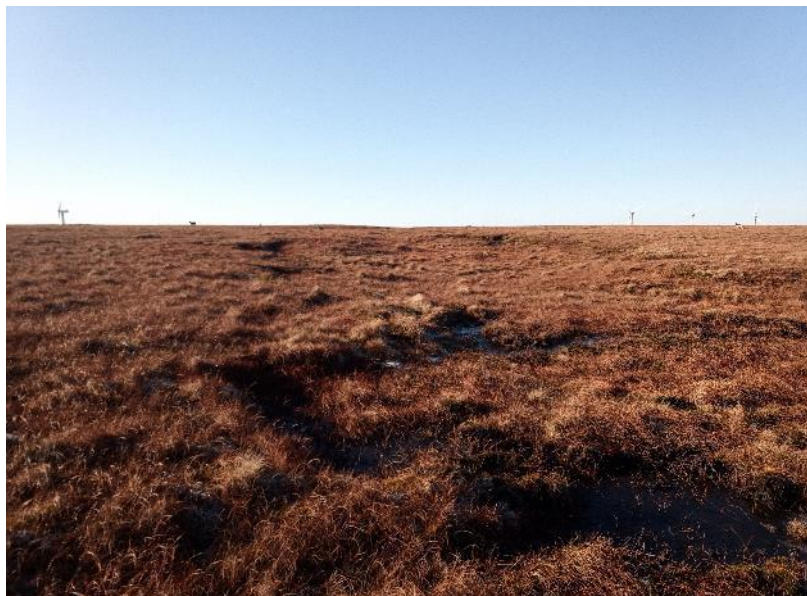
| Target note ID | Location | Target Note | Photo |
|---|---|---|---|
| 8 | SD 83970 19213 | Patches of bare peat frequent across plateau. | |

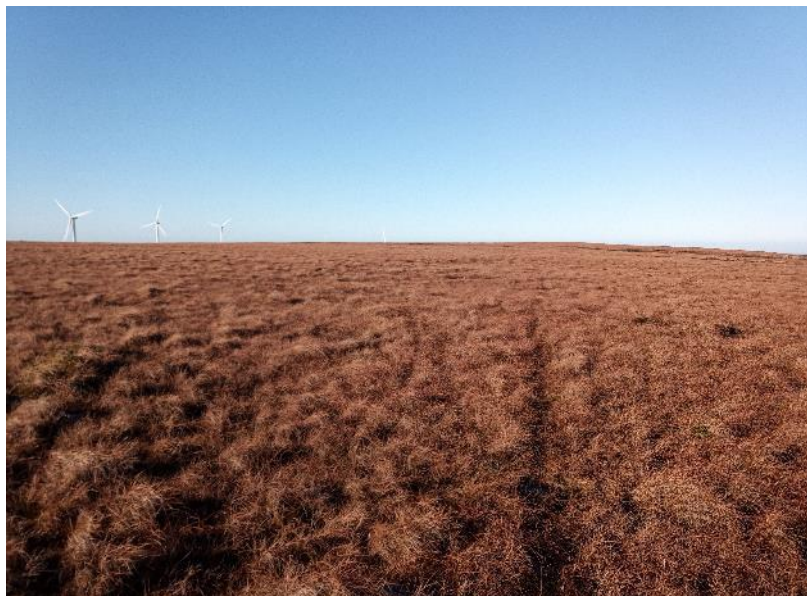
| Target note ID | Location | Target Note | Photo |
|---|---|---|---|
| 9 | SD 83846 19260 | Modified, graminoid dominated tussocky M20 habitat. | |

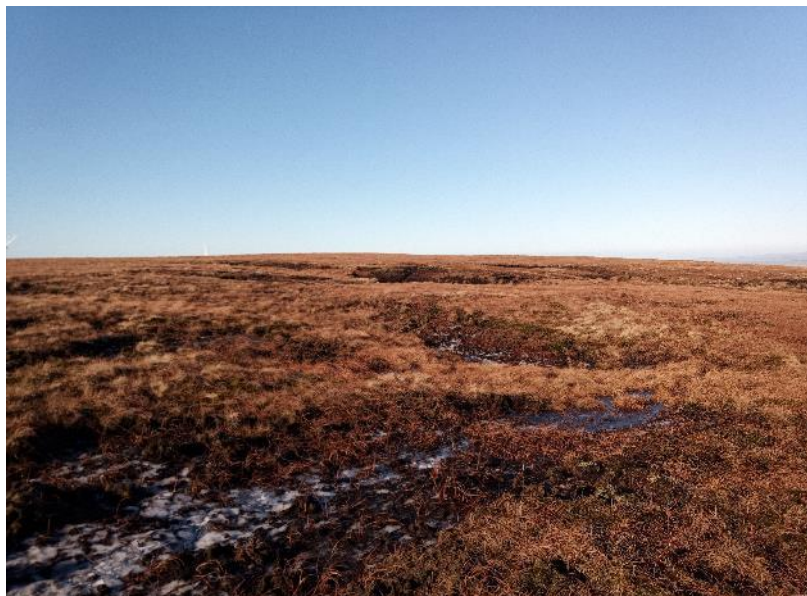
| Target note ID | Location | Target Note | Photo |
|---|---|---|---|
| 10 | SD 83804 19314 | Actively eroding around gully peripheries. | |

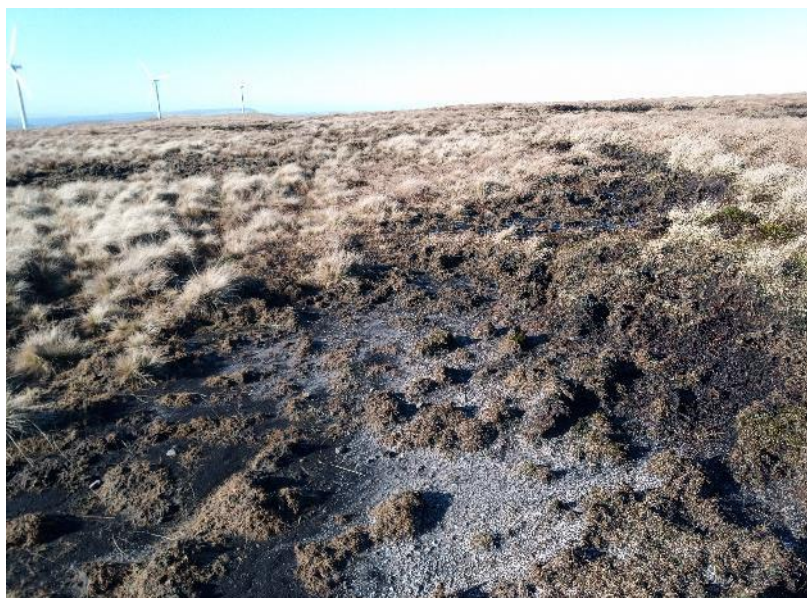
| Target note ID | Location | Target Note | Photo |
|---|---|---|---|
| 11 | SD 83588 19192 | Peat eroded to mineral soil driving transition to U5 habitat. Actively eroding condition. | |

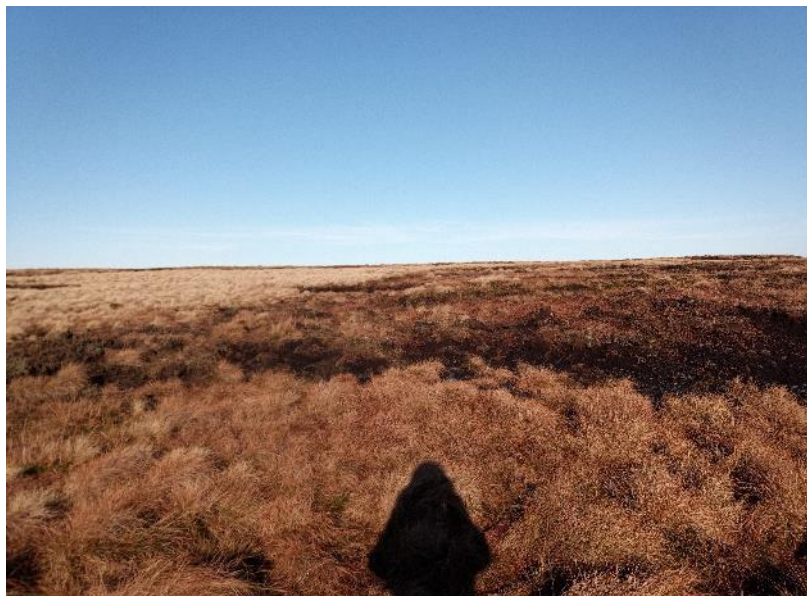
| Target note ID | Location | Target Note | Photo |
|---|---|---|---|
| 12 | SD 83534 19179 | Photo shows peat eroded to mineral soil with U5 colonising. | |

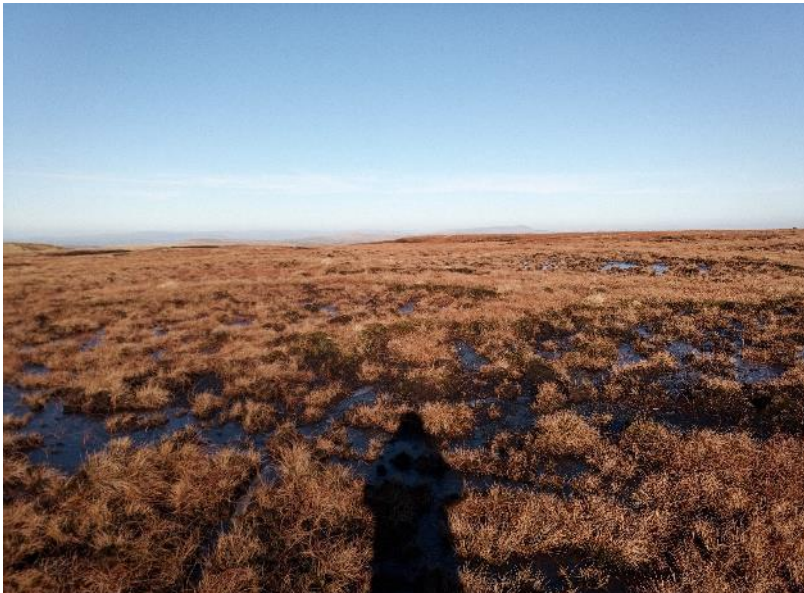
| Target note ID | Location | Target Note | Photo |
|---|---|---|---|
| 13 | SD 83482 19284 | Frequent bare peat patches. | |

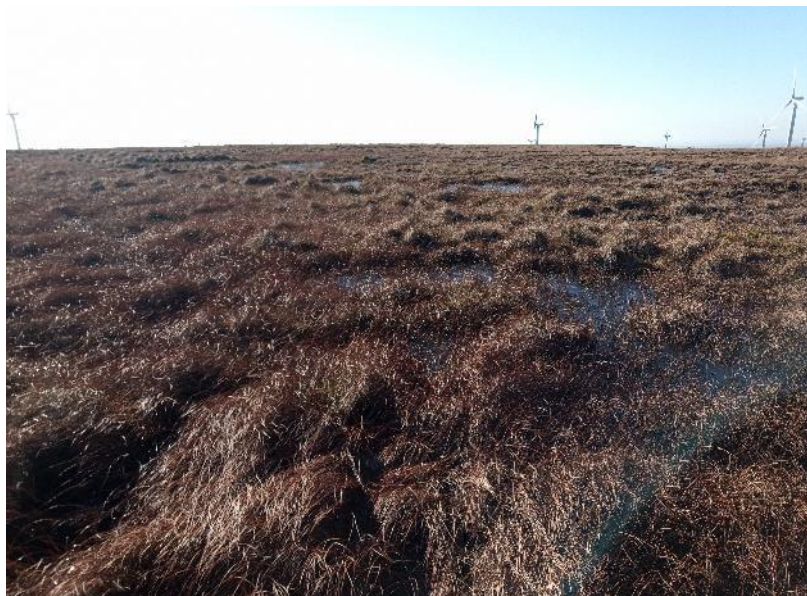
| Target note ID | Location | Target Note | Photo |
|---|---|---|---|
| 14 | SD 83518 19331 | Pool with <i>Sphagnum</i> and <i>Eriophorum vaginatum</i> | |

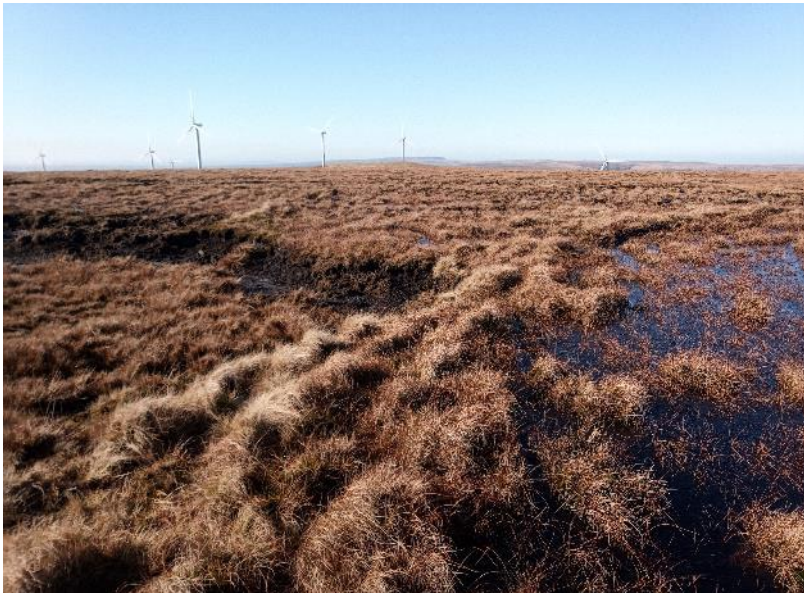
| Target note ID | Location | Target Note | Photo |
|---|---|---|---|
| 15 | SD 83533 19260 | Hagging immediately adjacent to bog pool with Near-Natural features retained. | |

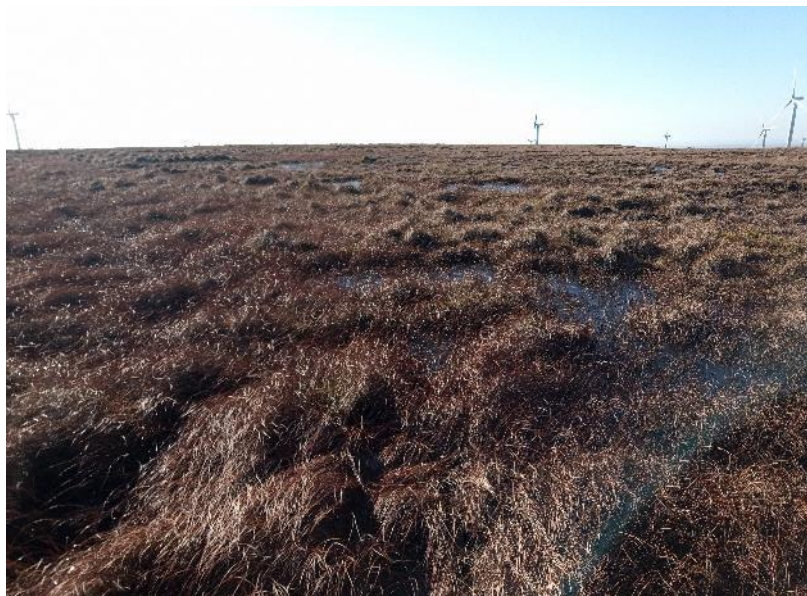
| Target note ID | Location | Target Note | Photo |
|---|---|---|---|
| 16 | SD 83546 19300 | Tussocky <i>Eriophorum vaginatum</i> growth adjacent to Near-Natural bog pool features. | |

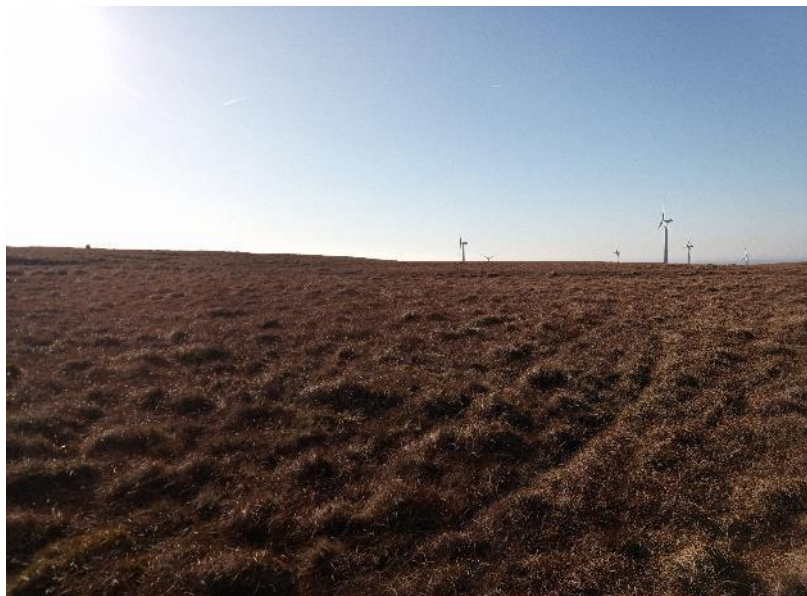
| Target note ID | Location | Target Note | Photo |
|---|---|---|---|
| 17 | SD 83586 19368 | Modified M20. | |

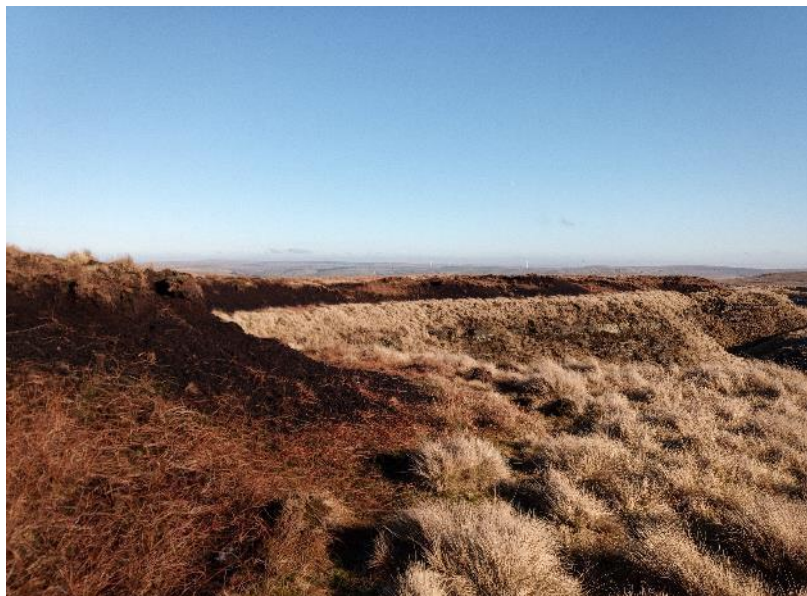
| Target note ID | Location | Target Note | Photo |
|---|---|---|---|
| 18 | SD 83516 19394 | Actively Eroding peatland at peripheries of plateau. | |

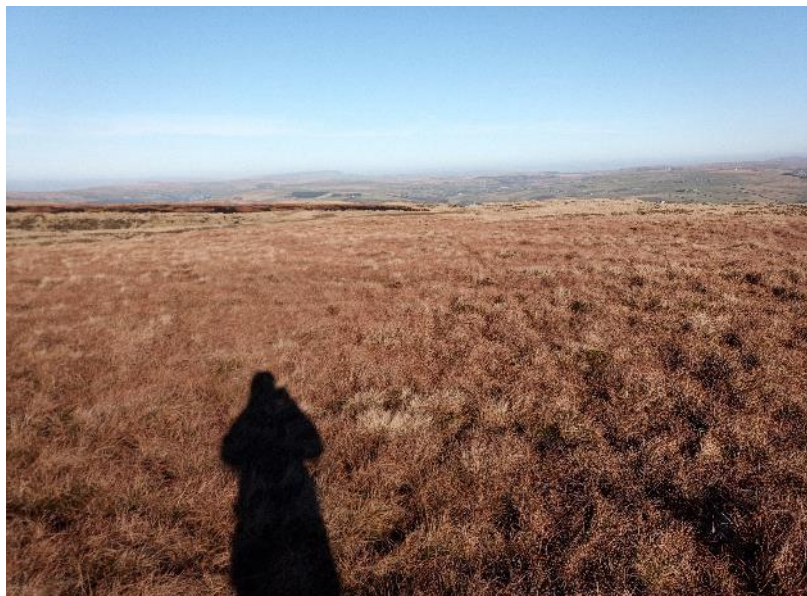
| Target note ID | Location | Target Note | Photo |
|---|---|---|---|
| 19 | SD 83424 19420 | Modified condition M20. | |

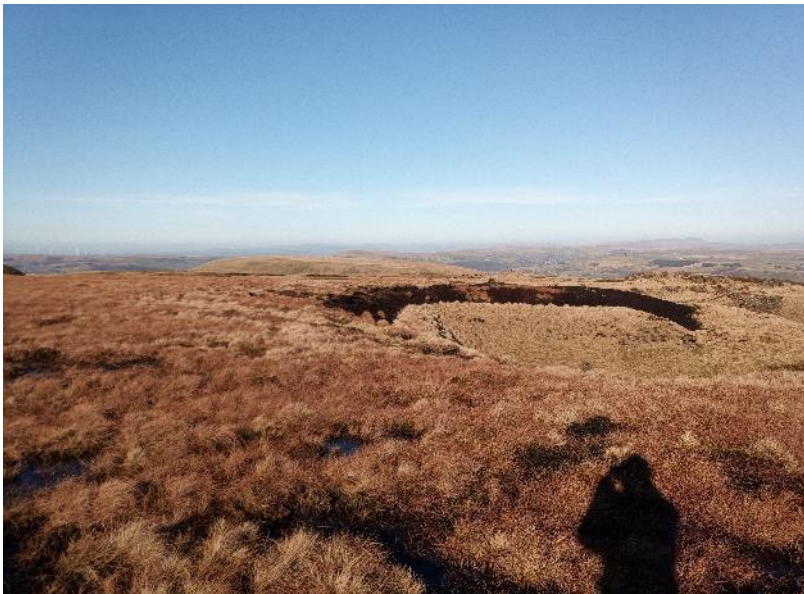
| Target note ID | Location | Target Note | Photo |
|---|---|---|---|
| 20 | SD 83337 19616 | M20 habitat on summit of small rise. Actively eroding at peripheries modified condition in centre. Elevated with rock outcrops and peat hags at edges. | |

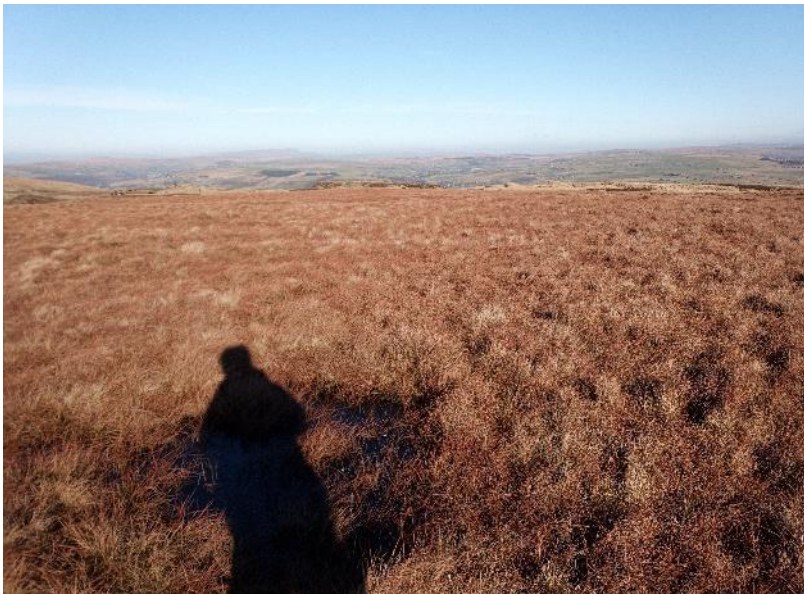
| Target note ID | Location | Target Note | Photo |
|---|---|---|---|
| 21 | SD 83260 19611 | Better condition to west of rise, still eroding at edges. | |

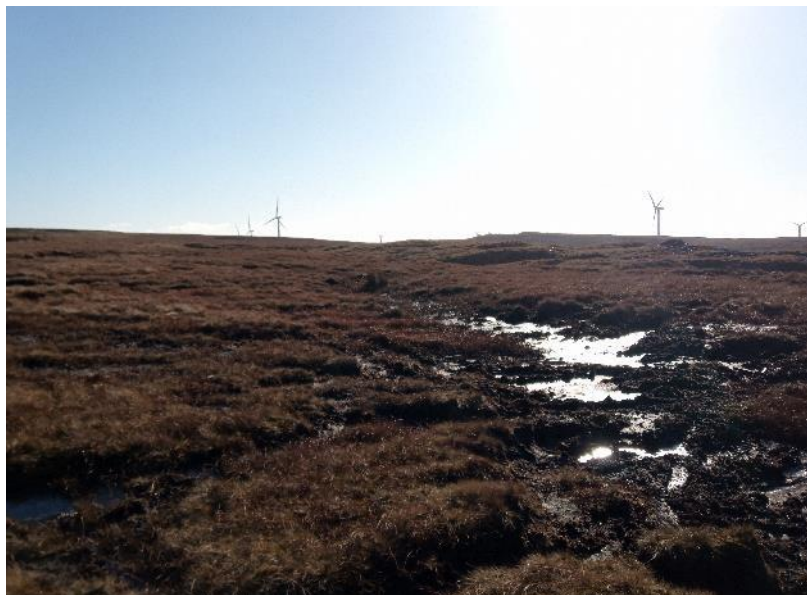
| Target note ID | Location | Target Note | Photo |
|---|---|---|---|
| 22 | SD 83119 19467 | Area actively eroding with poaching from livestock. | |

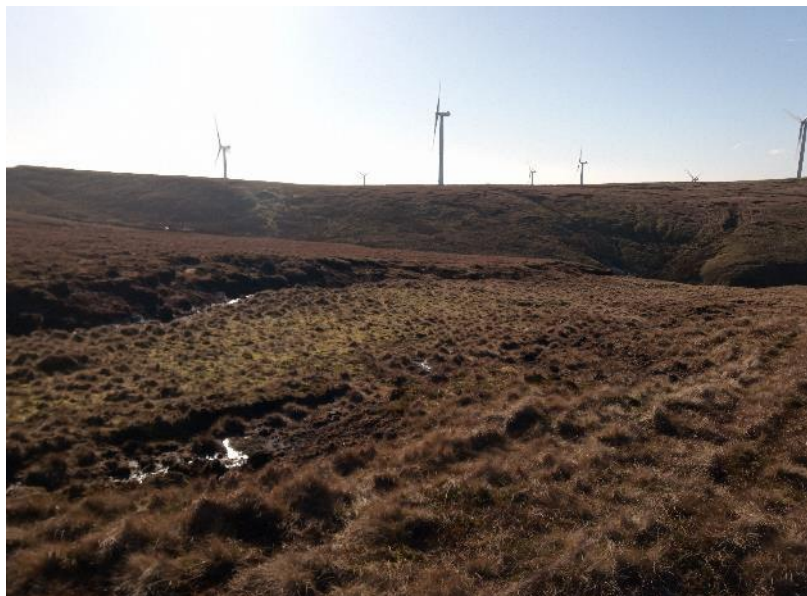
| Target note ID | Location | Target Note | Photo |
|---|---|---|---|
| 23 | SD 83061 19349 | Modified, some bare peat, heavily grazed. Eroding into gullies at periphery. | |

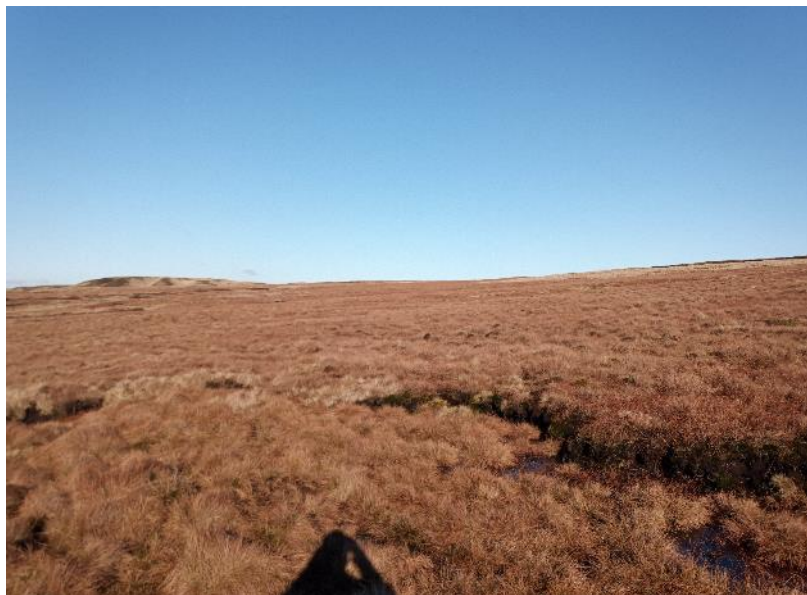
| Target note ID | Location | Target Note | Photo |
|---|---|---|---|
| 24 | SD 83158 19044 | Small area of M20, eroding at edges, heavily modified condition. | |

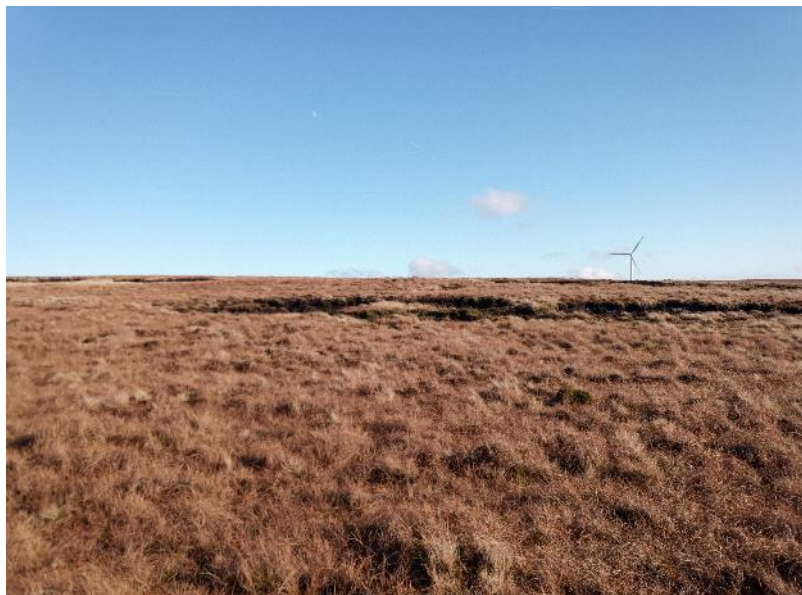
| Target note ID | Location | Target Note | Photo |
|---|---|---|---|
| 25 | SD 83334 19093 | Modified west, Actively Eroding in areas to east and beneath turbine. | |

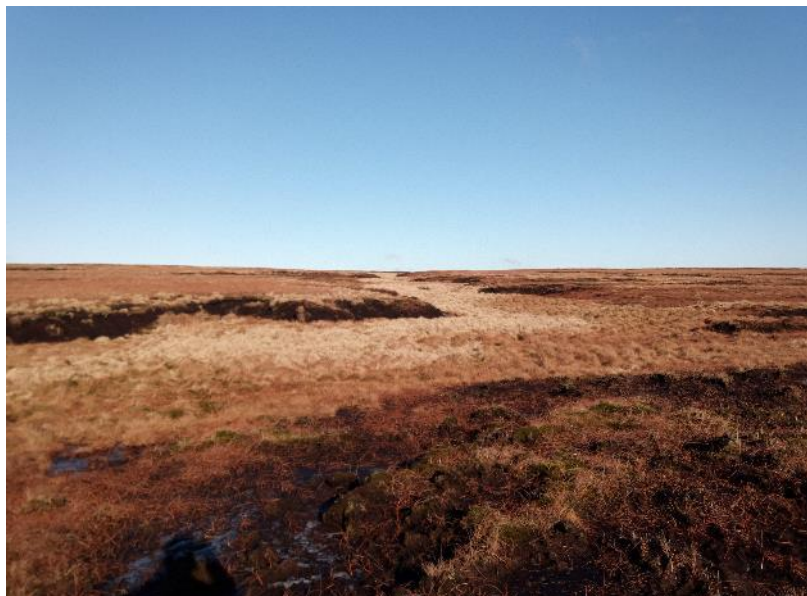
| Target note ID | Location | Target Note | Photo |
|---|---|---|---|
| 26 | SD 83406 19095 | Widespread peat haggging. | |

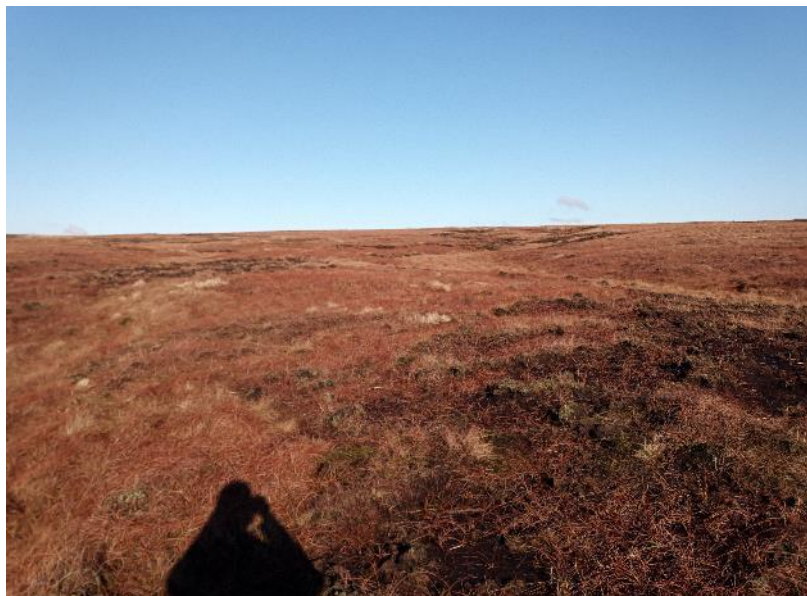
| Target note ID | Location | Target Note | Photo |
|---|---|---|---|
| 27 | SD 83597 18956 | Extensive bare peat. | |

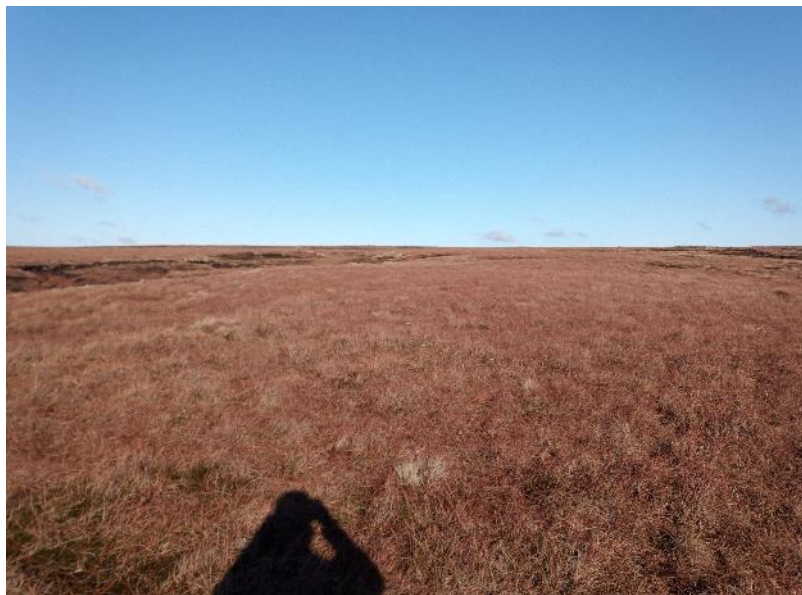
| Target note ID | Location | Target Note | Photo |
|---|---|---|---|
| 28 | SD 83636 19017 | Small area of modified condition between gullies. | |

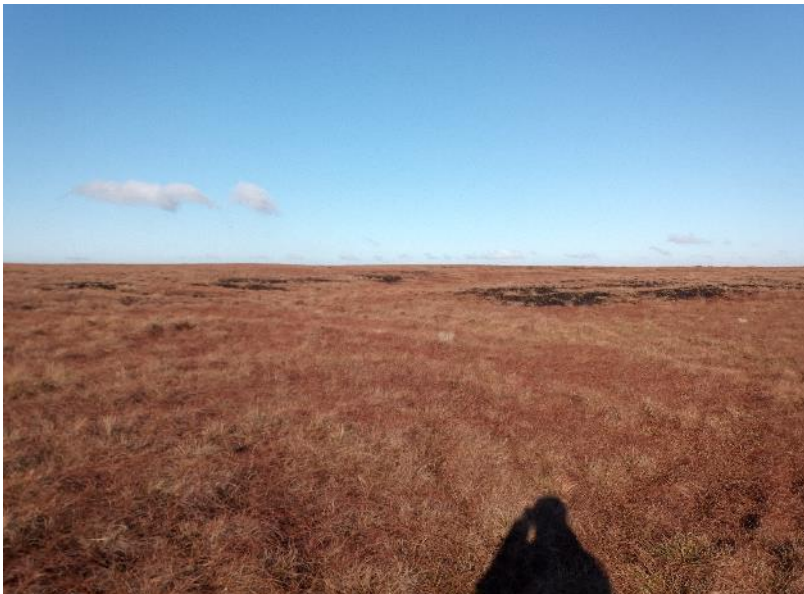
| Target note ID | Location | Target Note | Photo |
|---|---|---|---|
| 29 | SD 83792 19029 | Small patch modified condition with bare peat surrounding shallow gully features. | |

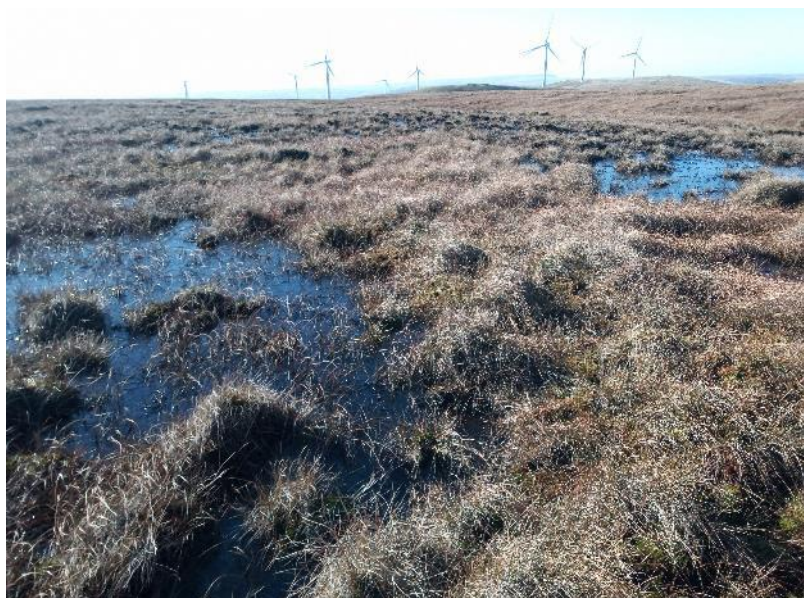
| Target note ID | Location | Target Note | Photo |
|---|---|---|---|
| 30 | SD 83818 19022 | Peat-forming M3 pool adjacent to bare peat erosional features. | A photograph showing a peat-forming M3 pool, which is a small, shallow body of water surrounded by peat vegetation. The pool is situated in a landscape with wind turbines visible in the background, indicating a rural or agricultural setting. The peat vegetation is brown and appears to be in a state of erosion or degradation. |

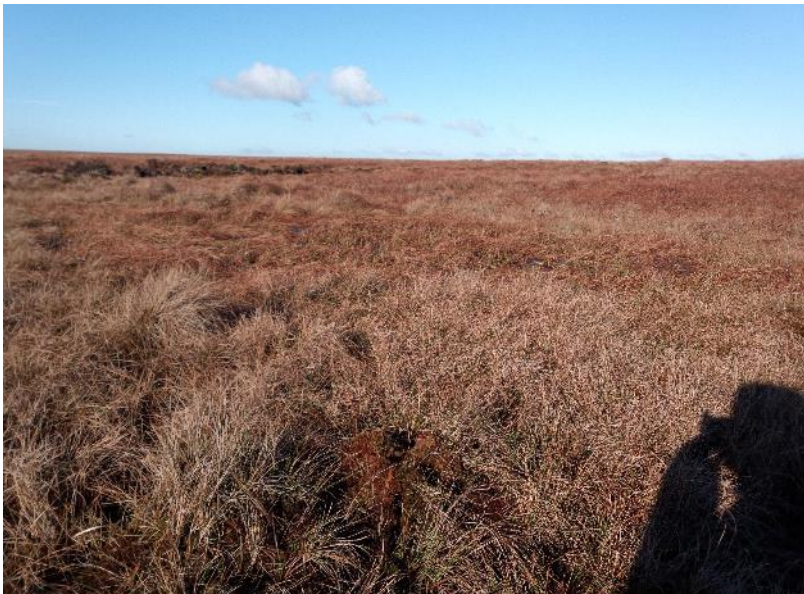
| Target note ID | Location | Target Note | Photo |
|---|---|---|---|
| 31 | SD 83922 19032 | Modified condition. | |

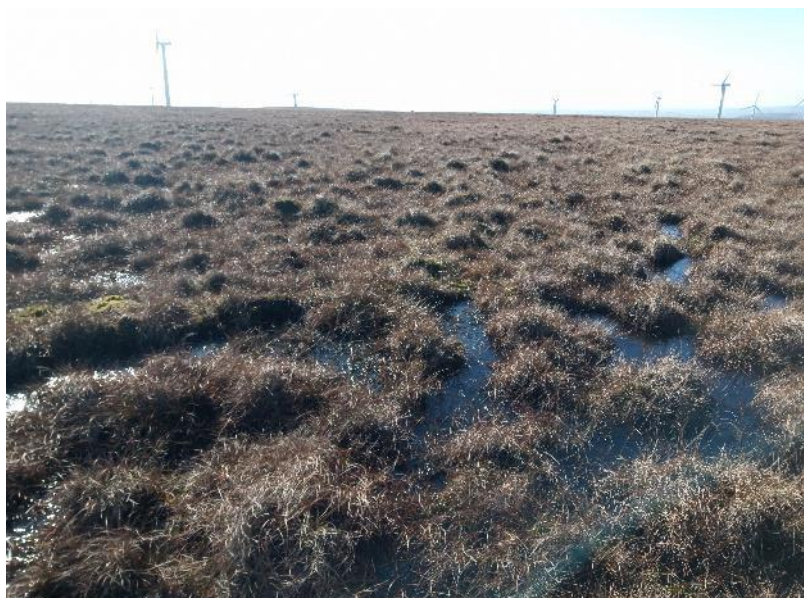
| Target note ID | Location | Target Note | Photo |
|---|---|---|---|
| 32 | SD 83913 18993 | M3 pools with Sphagnum species present. | |

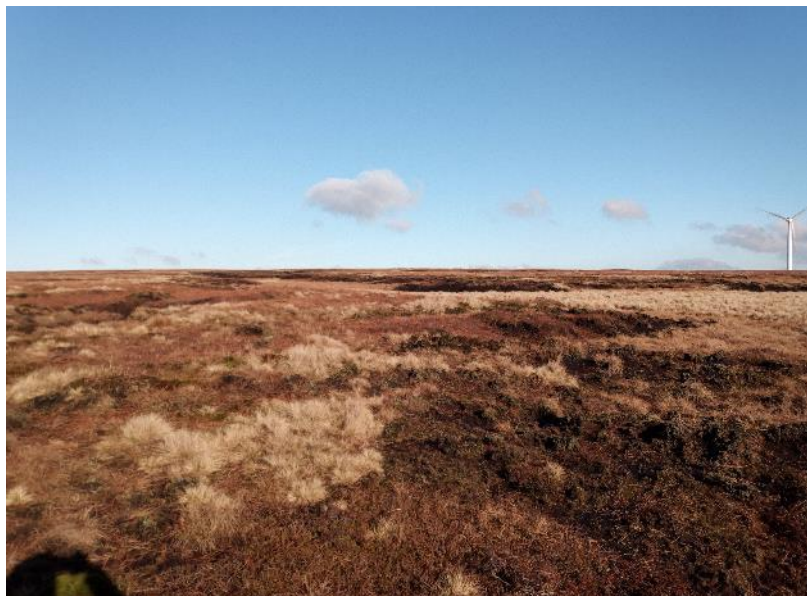
| Target note ID | Location | Target Note | Photo |
|---|---|---|---|
| 33 | SD 83686 18771 | Turbine base is Actively eroding in places, areas of modified peatland between gullies. | |

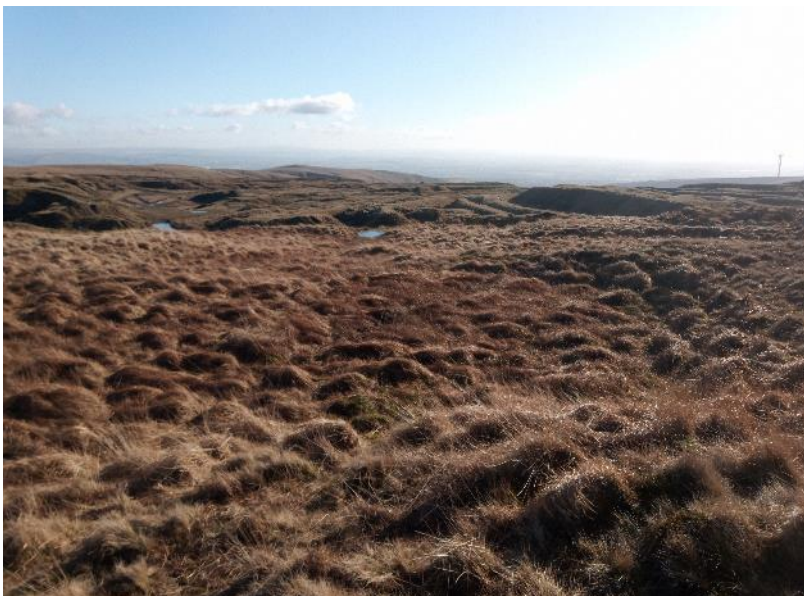
| Target note ID | Location | Target Note | Photo |
|---|---|---|---|
| 34 | SD 84821 18835 | Modified | |

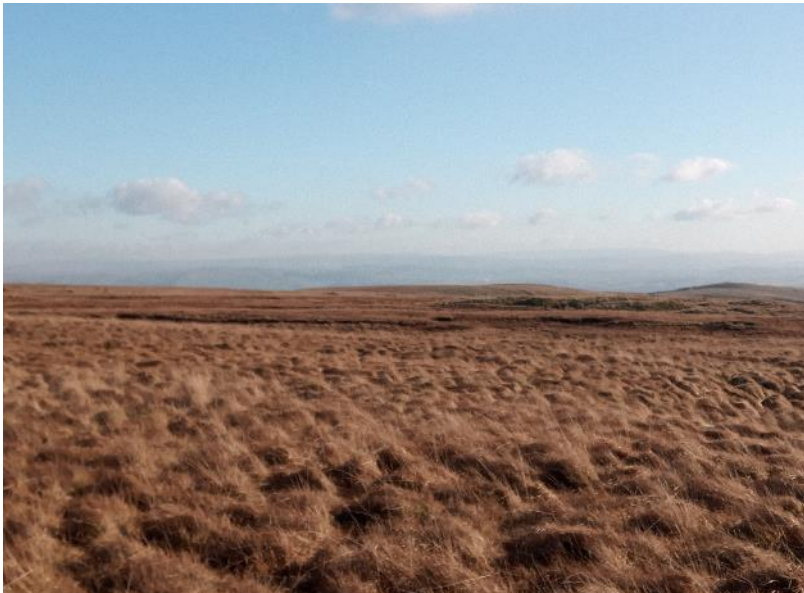
| Target note ID | Location | Target Note | Photo |
|---|---|---|---|
| 35 | SD 85021 18913 | M17 in hollow. Modified. | |

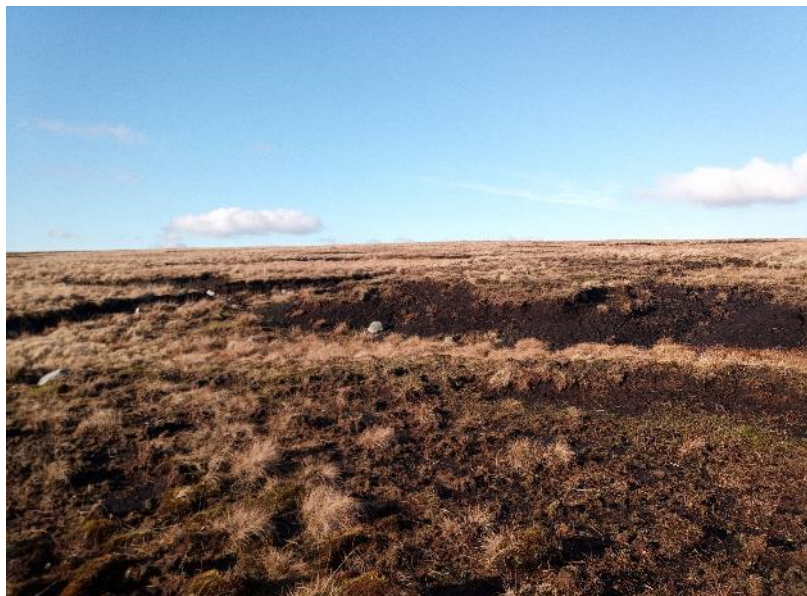
| Target note ID | Location | Target Note | Photo |
|---|---|---|---|
| 36 | SD 85151 18859 | Actively eroding here, photo taken from NW. | |

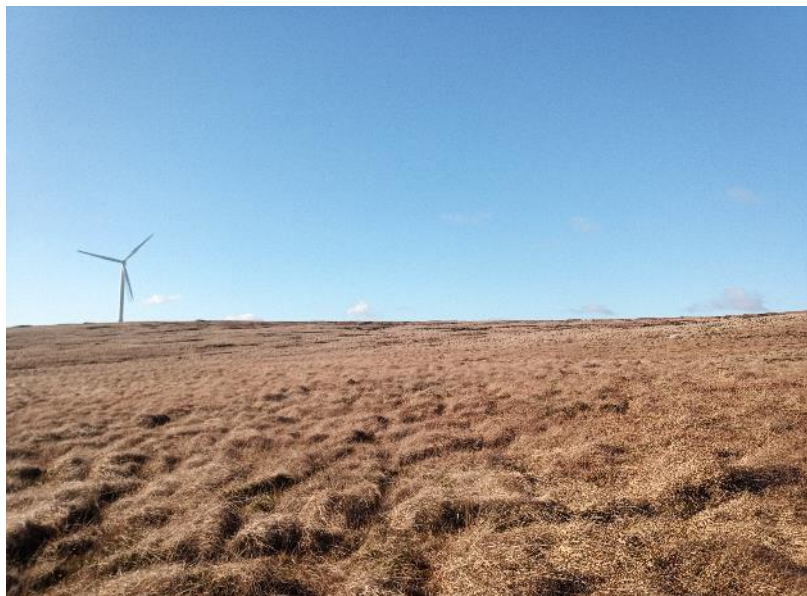
| Target note ID | Location | Target Note | Photo |
|---|---|---|---|
| 37 | SD 85228 18971 | M25 heavily modified graminoid dominated with dense tussock formation. | |

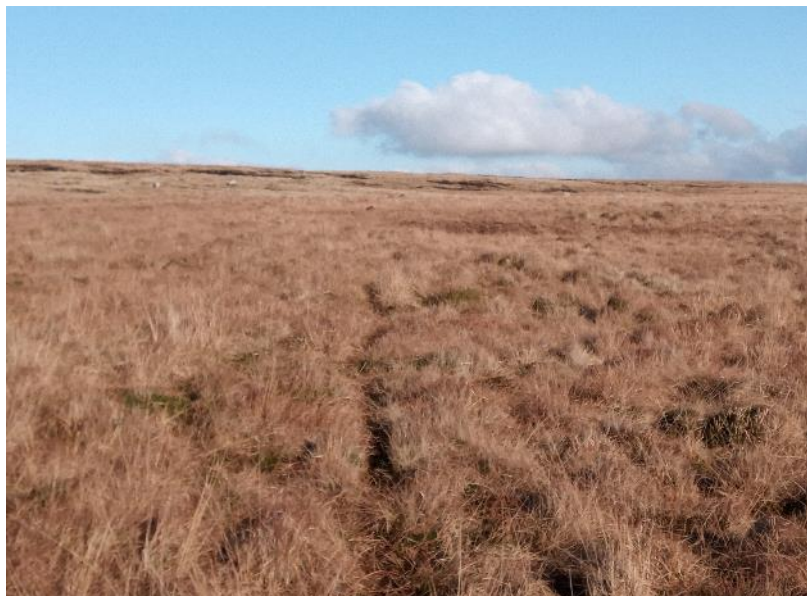
| Target note ID | Location | Target Note | Photo |
|---|---|---|---|
| 38 | SD 85121 19093 | AE photo from south. | |
