## **Appendix 14.9: Peatland Condition Assessment**

This Peatland Condition Assessment (PCA) has been prepared by Fluid Environmental Consulting (Fluid) on behalf of the Applicant to support the Environmental Statement (ES) for Scout Moor Wind Farm (the 'Project for Assessment'). The assessment has been informed by detailed peat survey data collected by Fluid in April, July, August, October and December 2024, February 2025, March and April 2026, as well as habitat surveys undertaken by Atmos Consulting (Atmos) in 2024.

The Project for Assessment will comprise 12 wind turbines, with a blade tip height typically of 180 m, associated infrastructure and ancillary development.

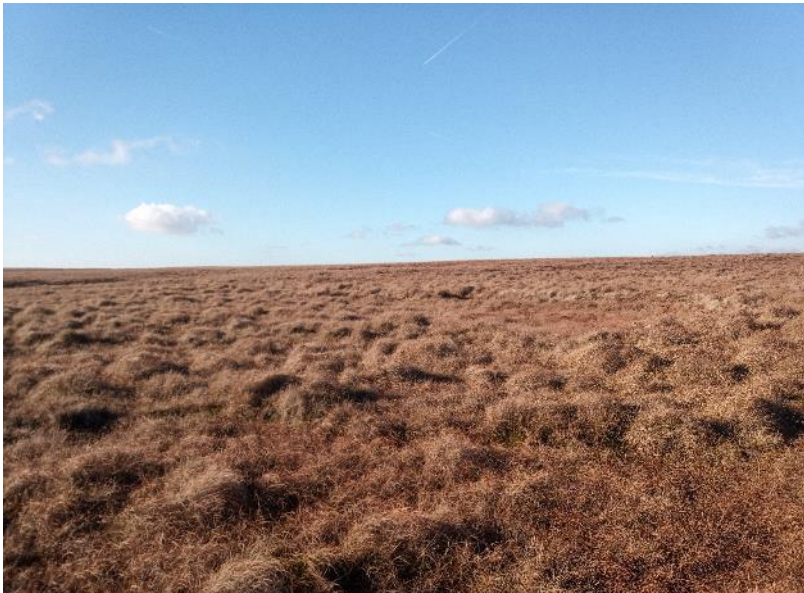
| Target note ID | Location | Target Note | Photo |
|---|---|---|---|
| 39 | SD 85463 18984 | Habitat modified and heavily grazed, graminoid dominated. | |

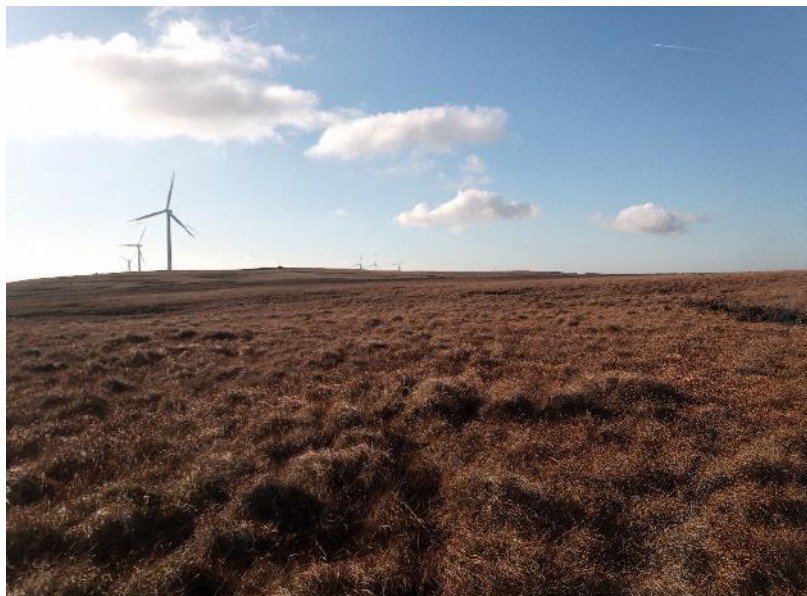
Two small areas of quaking bog within M25 communities were observed during the site walkover. These indicate intact hydrological conditions however are both species-poor and

| Target note ID | Location | Target Note | Photo |
|---|---|---|---|
| 40 | SD 85419 19002 | Small area of quaking bog. | |

located within areas of modified and graminoid dominated M25. They are noted as target notes 40 and 69 and should be avoided by the development.

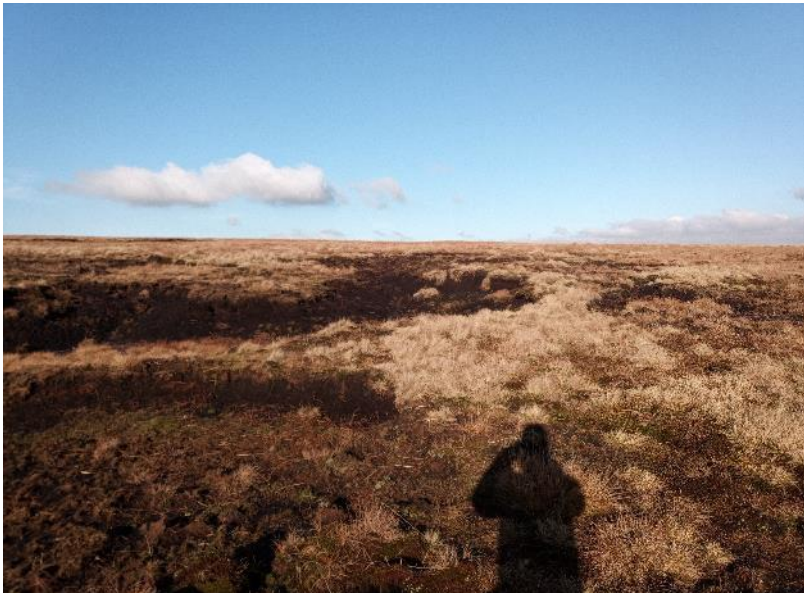
| Target note ID | Location | Target Note | Photo |
|---|---|---|---|
| 41 | SD 85279 19152 | Erosional features within wider modified habitat. | |

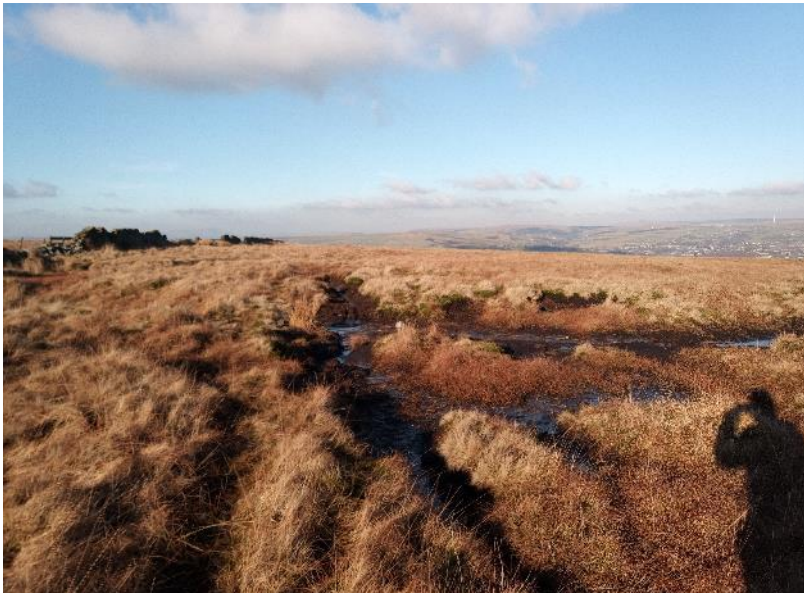
| Target note ID | Location | Target Note | Photo |
|---|---|---|---|
| 42 | SD 85333 19716 | Two small erosional features within wider modified habitat. | |

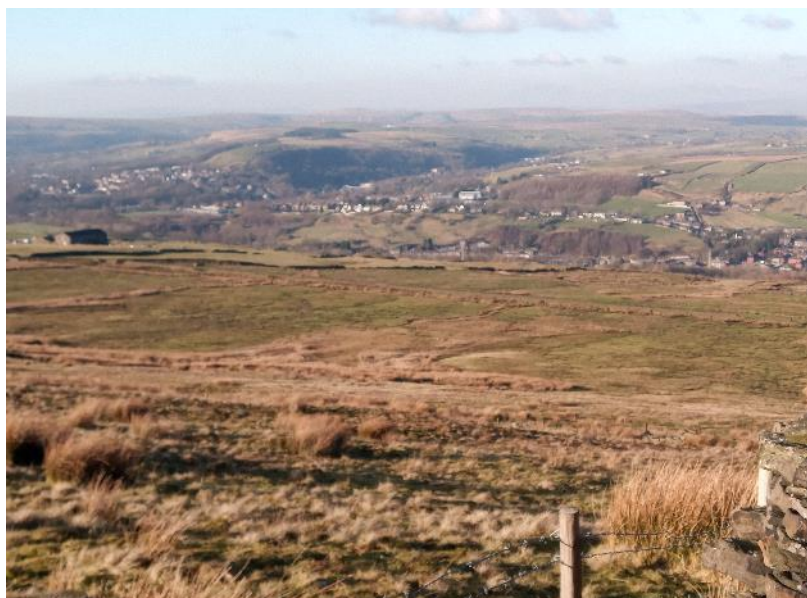
| Target note ID | Location | Target Note | Photo |
|---|---|---|---|
| 43 | SD 85100 20393 | Modified | |

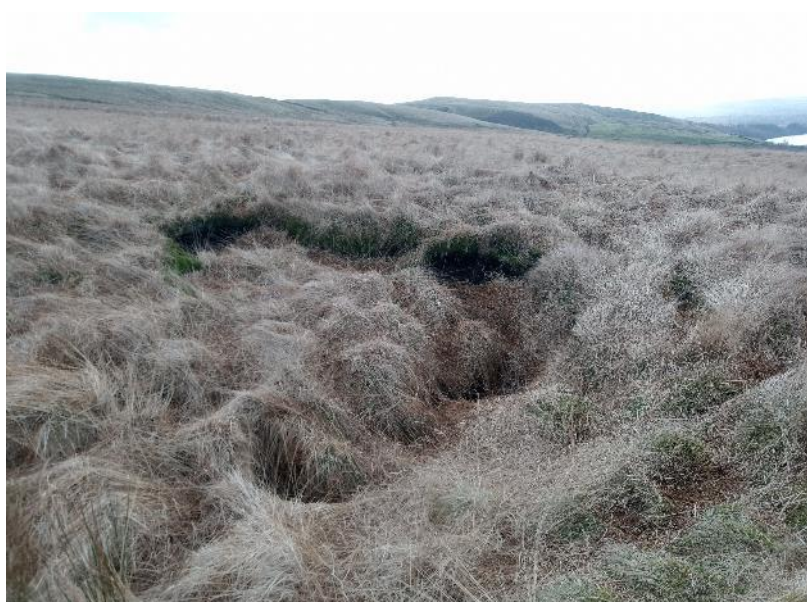
| Target note ID | Location | Target Note | Photo |
|---|---|---|---|
| 44 | SD 85550 18379 | Dense and tussocky M25 habitat with erosional feature. | |

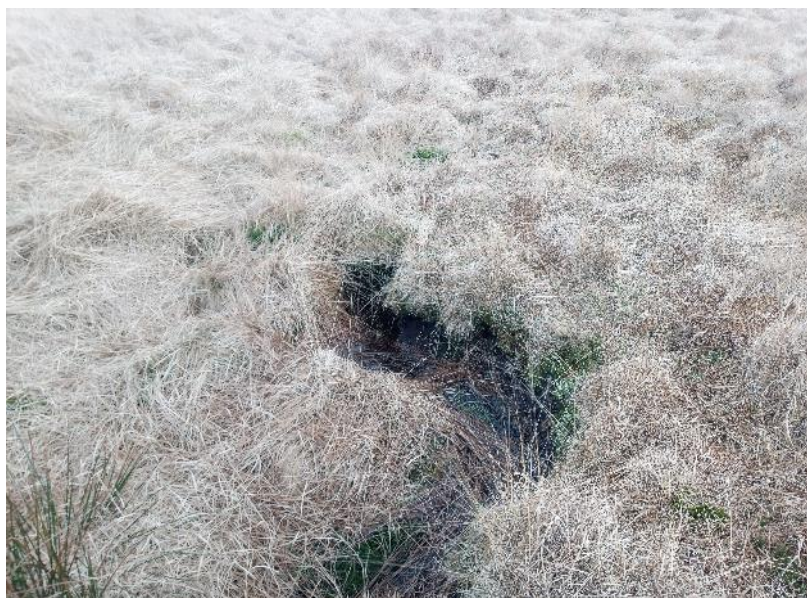
| Target note ID | Location | Target Note | Photo |
|---|---|---|---|
| 45 | SD 85423 18271 | Peat pipe/sink in M25 habitat. | |

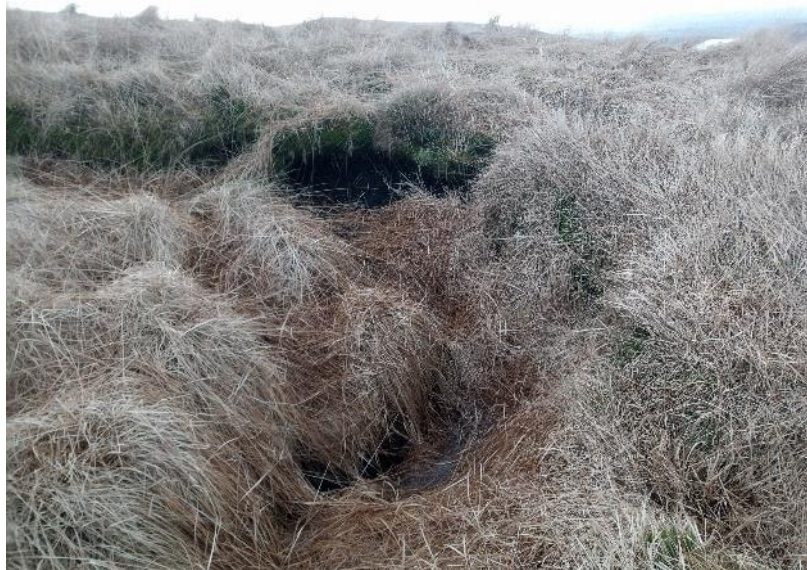
| Target note ID | Location | Target Note | Photo |
|---|---|---|---|
| 46 | SD 85418 18253 | Outflow and additional pipe. | |

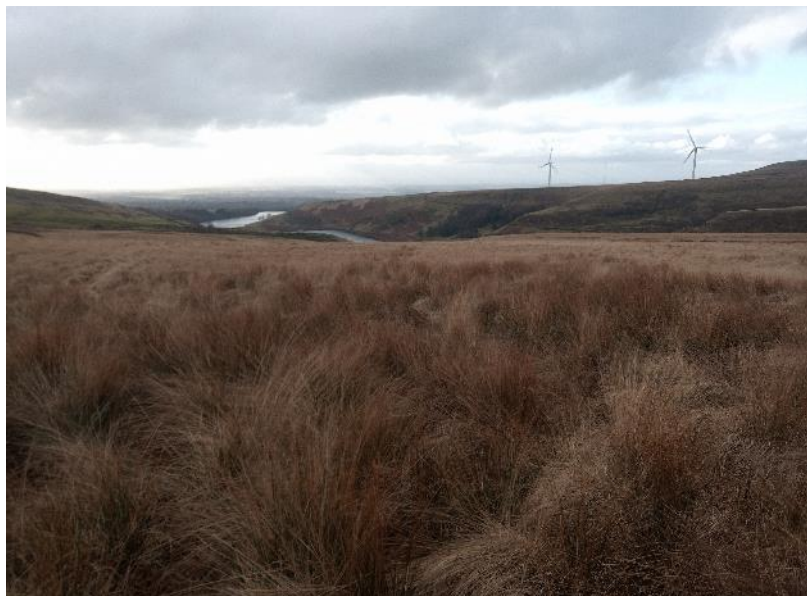
| Target note ID | Location | Target Note | Photo |
|---|---|---|---|
| 47 | SD 85402 18202 | <i>Juncus effusus</i> within underground flow path near peat pipe. | |

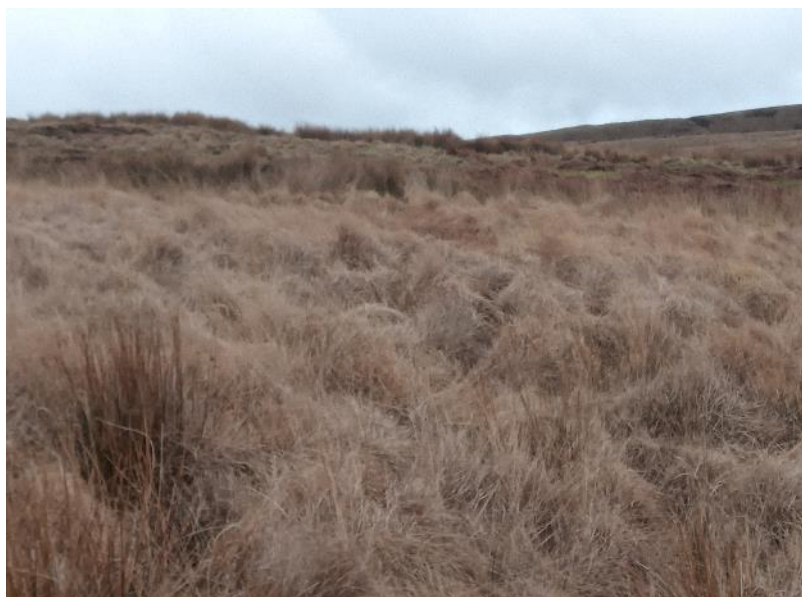
| Target note ID | Location | Target Note | Photo |
|---|---|---|---|
| 49 | SD 85257 18209 | Gully somewhat stabilised from here under well-established M25 that is a response to heavy grazing. Some bare peat upgradient but looks to be stabilising. Upgradient erosion due to vehicle tracks | |

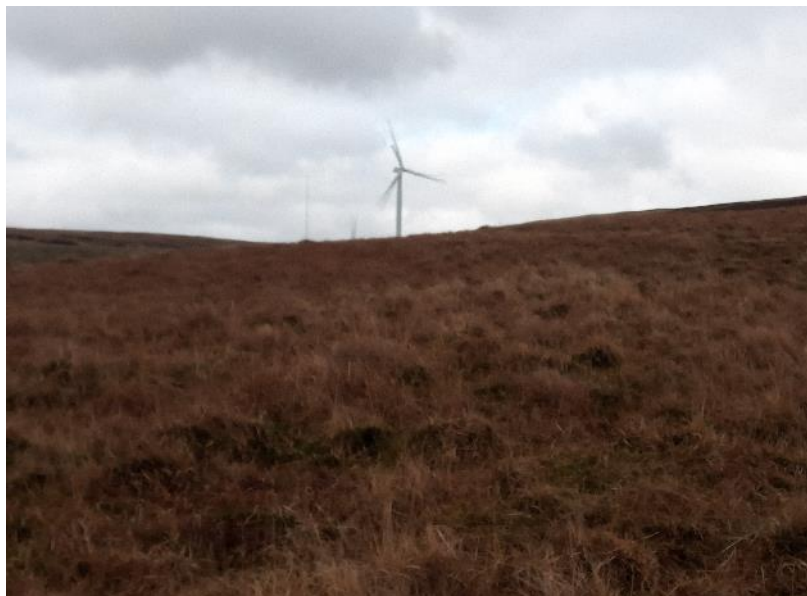
| Target note ID | Location | Target Note | Photo |
|---|---|---|---|
| 50 | SD 84973 18050 | Modified, graminoid dominated, some heather, tussocky | |

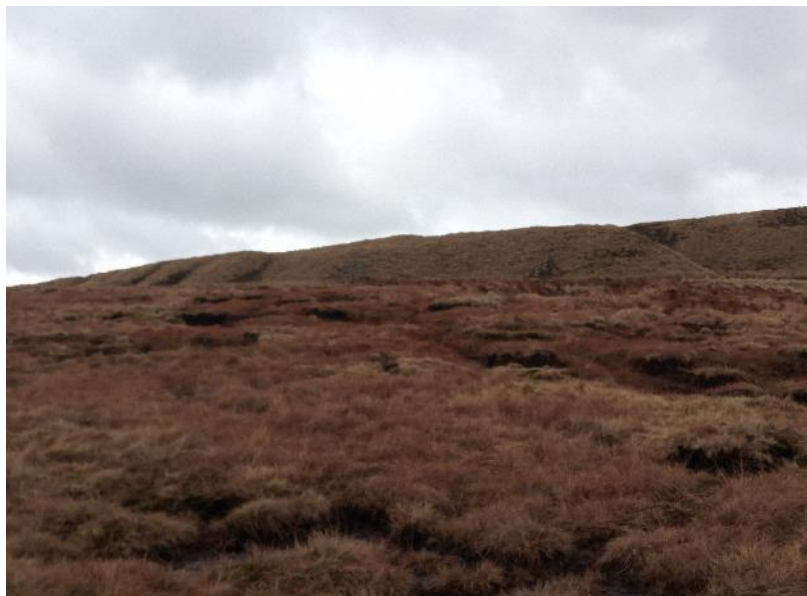
| Target note ID | Location | Target Note | Photo |
|---|---|---|---|
| 52 | SD 84860 18399 | AE extensive bare peat eroded to mineral soil in places | |

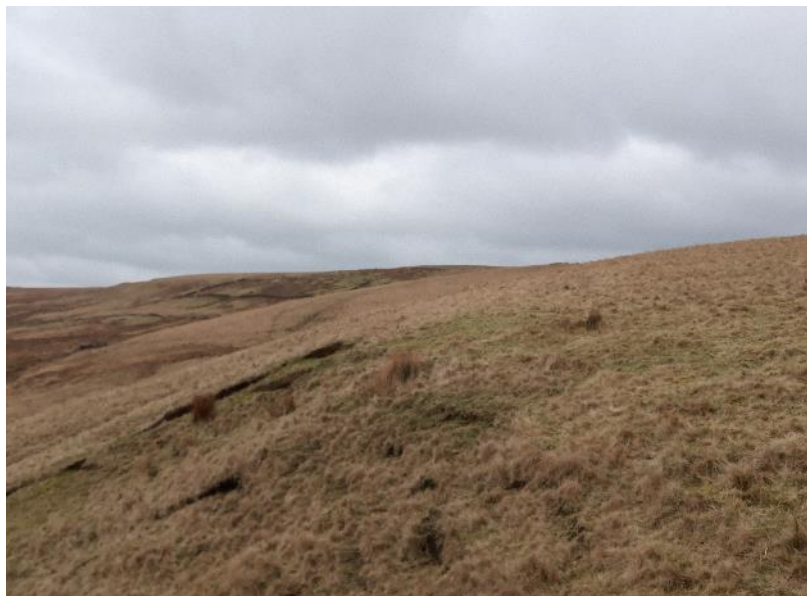
| Target note ID | Location | Target Note | Photo |
|---|---|---|---|
| 53 | SD 85128 17997 | Small hag in dry modified habitat. | |

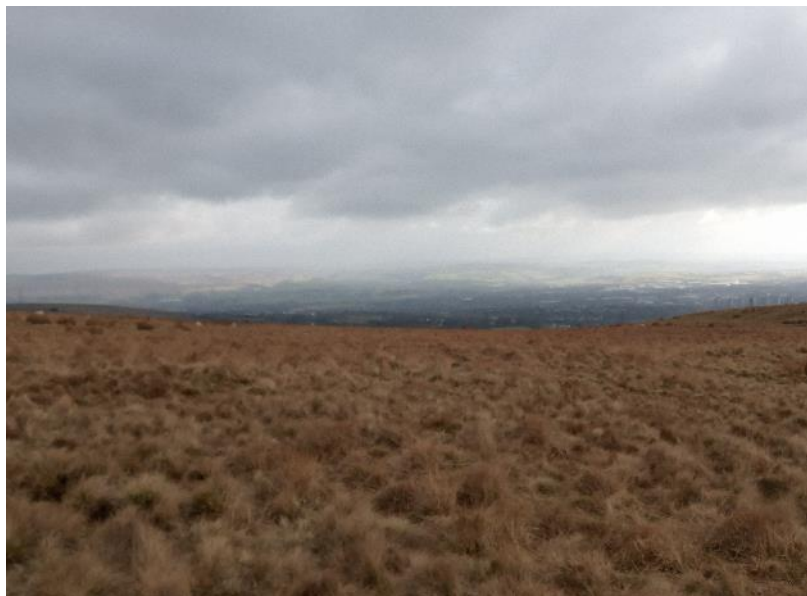
| Target note ID | Location | Target Note | Photo |
|---|---|---|---|
| 56 | SD 85754 17922 | Modified condition, Sphagna absent. | |

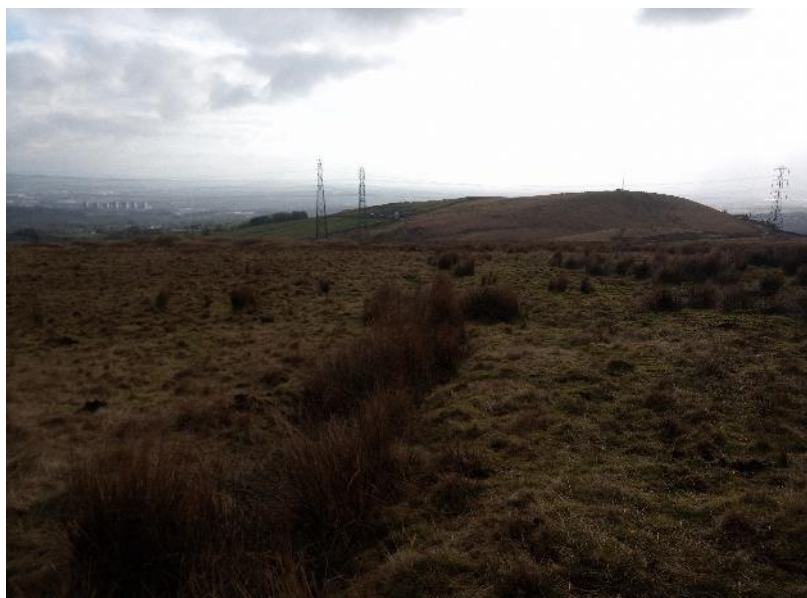
| Target note ID | Location | Target Note | Photo |
|---|---|---|---|
| 57 | SD 85821 17619 | Drain | |

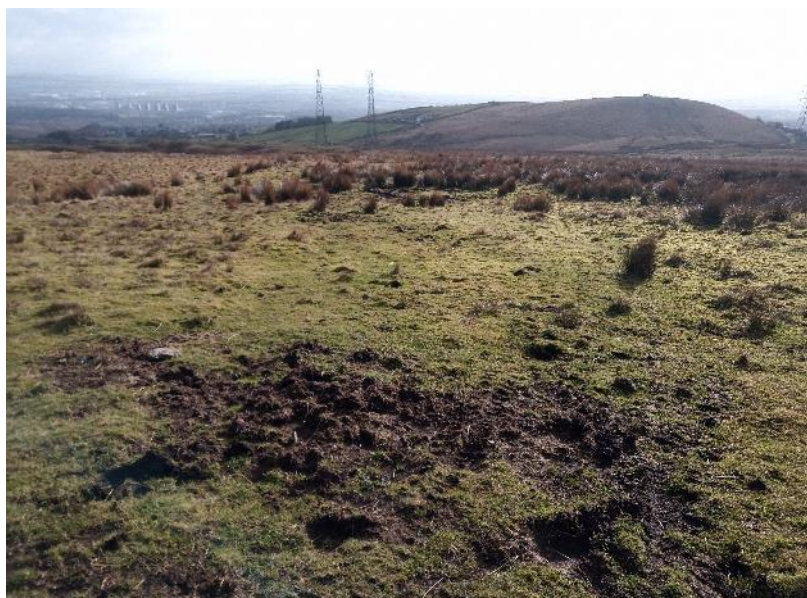
| Target note ID | Location | Target Note | Photo |
|---|---|---|---|
| 59 | SD 86465 16517 | Livestock poaching | |

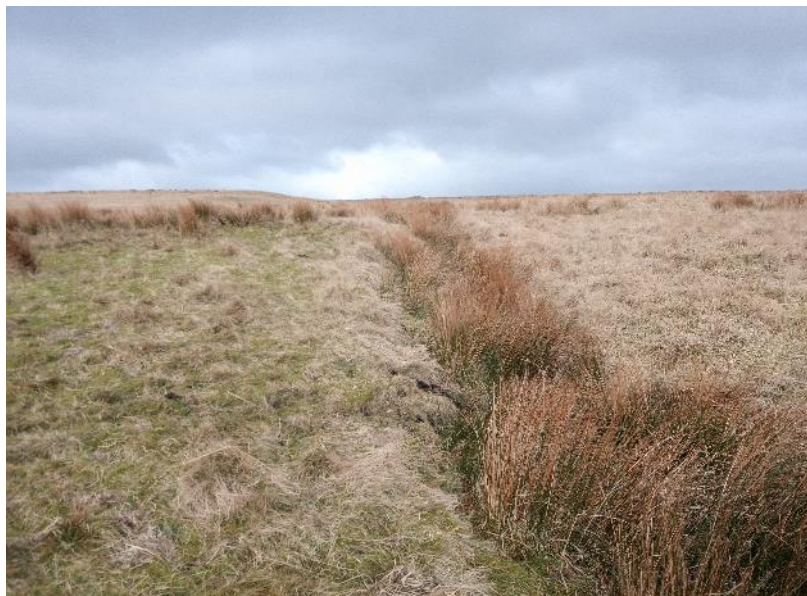
| Target note ID | Location | Target Note | Photo |
|---|---|---|---|
| 60 | SD 86491 16514 | Drain within heavily modified habitat. | |

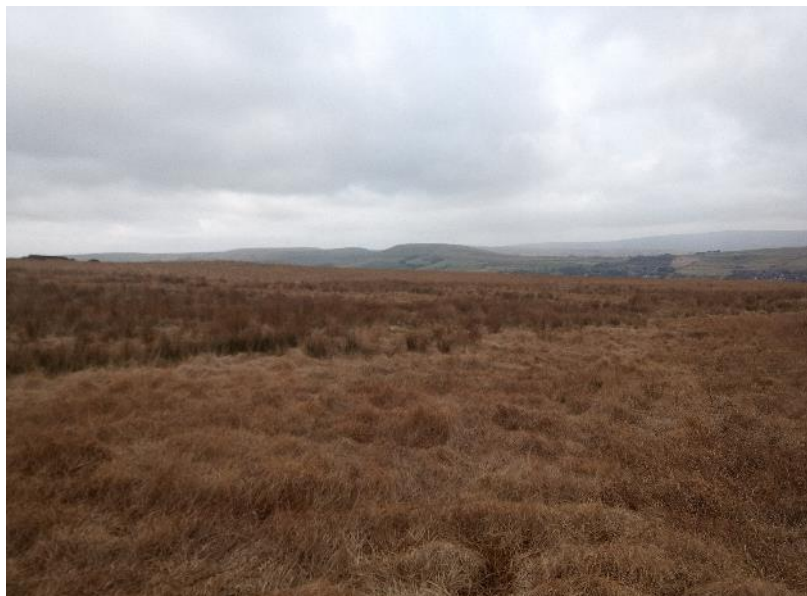
| Target note ID | Location | Target Note | Photo |
|---|---|---|---|
| 61 | SD 86717 16555 | Modified, dry condition. | |

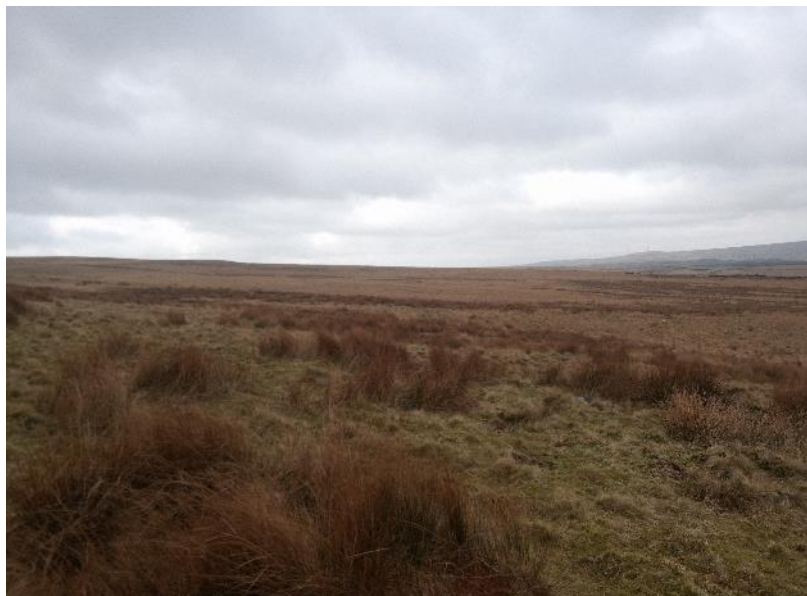
| Target note ID | Location | Target Note | Photo |
|---|---|---|---|
| 62 | SD 86606 16633 | Modified, dry condition. | |

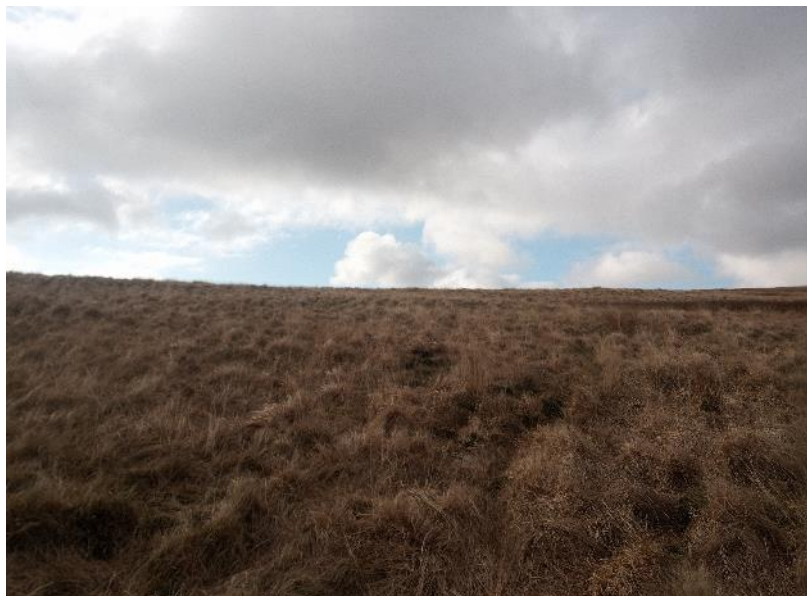
| Target note ID | Location | Target Note | Photo |
|---|---|---|---|
| 63 | SD 86510 17393 | Modified | |

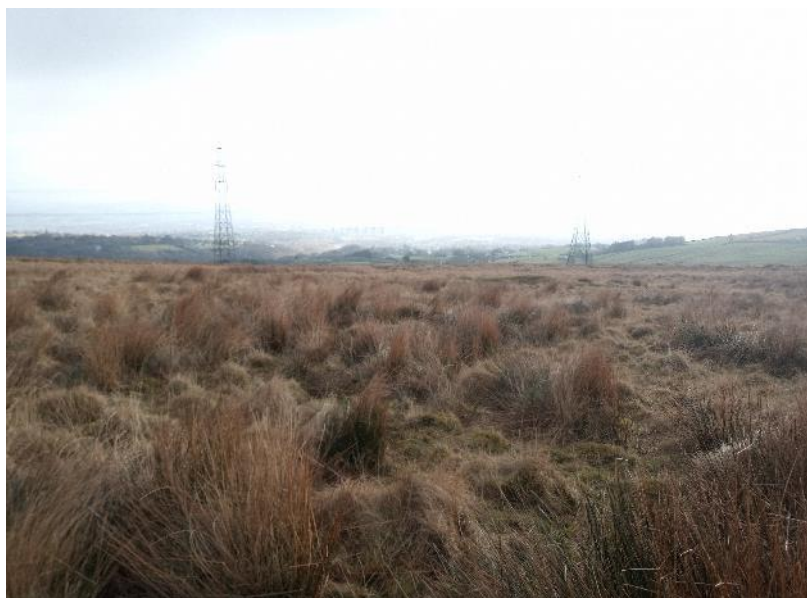
| Target note ID | Location | Target Note | Photo |
|---|---|---|---|
| 64 | SD 86672 17545 | Modified vegetation. | |

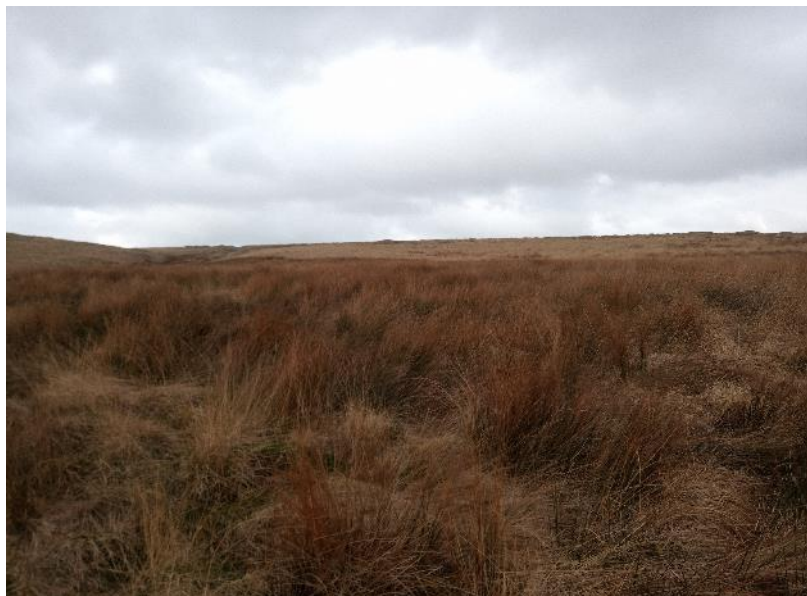
| Target note ID | Location | Target Note | Photo |
|---|---|---|---|
| 65 | SD 86658 17556 | Patch of <i>Juncus effusus</i> ,<br><i>Sphagnum</i> absent | |

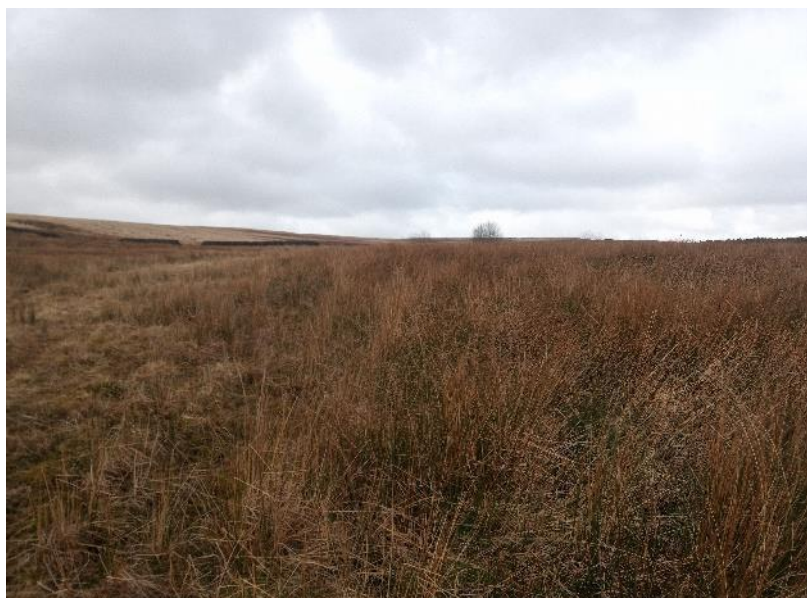
| Target note ID | Location | Target Note | Photo |
|---|---|---|---|
| 66 | SD 86674 17636 | M6c habitat in natural drainage line. | |

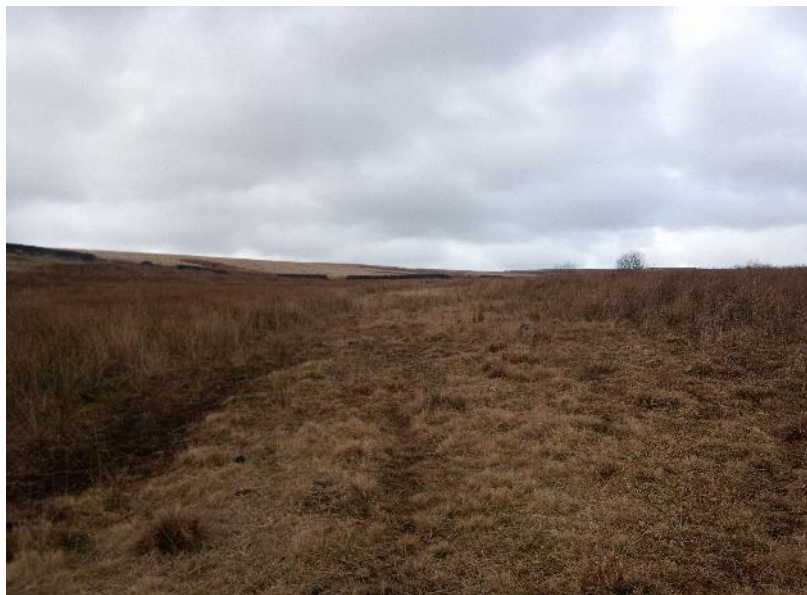
| Target note ID | Location | Target Note | Photo |
|---|---|---|---|
| 67 | SD 86694 17665 | Dry strip adjacent to M6c | |

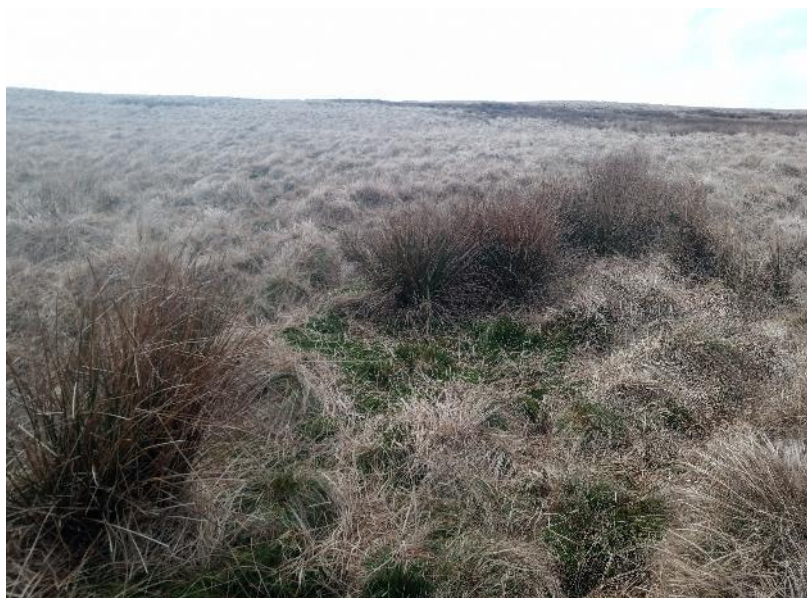
| Target note ID | Location | Target Note | Photo |
|---|---|---|---|
| 68 | SD 86419 17858 | Modified condition tussocky grass growth. | |

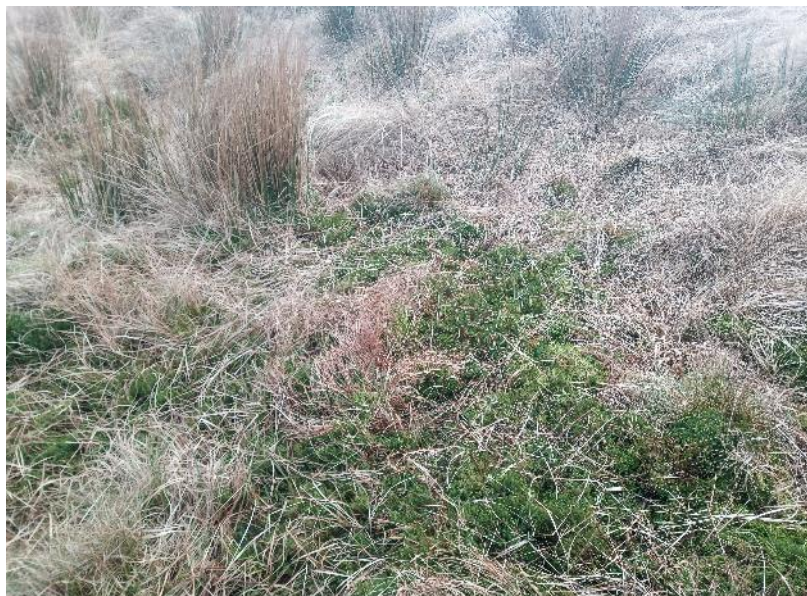
| Target note ID | Location | Target Note | Photo |
|---|---|---|---|
| 69 | SD 86378 17946 | Spring with small patch of quaking bog ca 3x3m | |

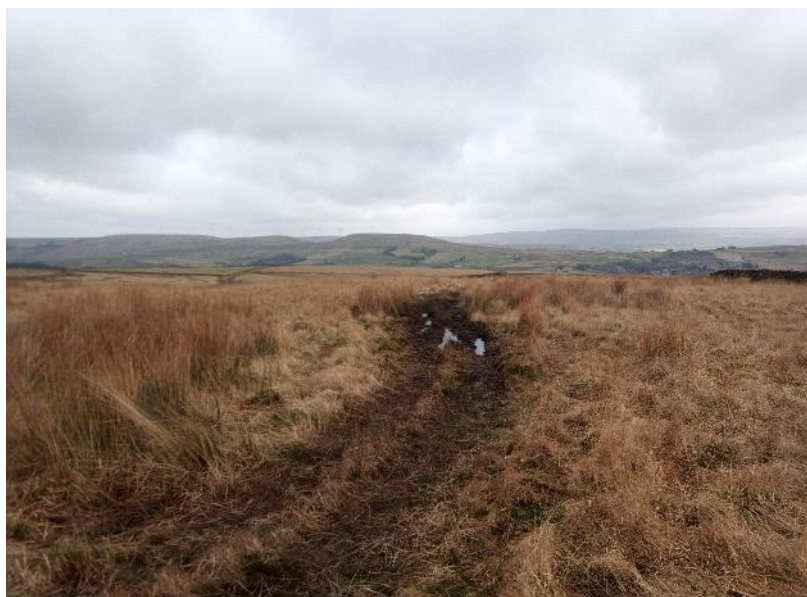
| Target note ID | Location | Target Note | Photo |
|---|---|---|---|
| 70 | SD 86655 18236 | Vehicle disturbance - bare peat exposed on track | |
