## **Appendix 14.5: Watercourse Crossing Inventory**

**Table 1 Watercourse Crossing Inventory**

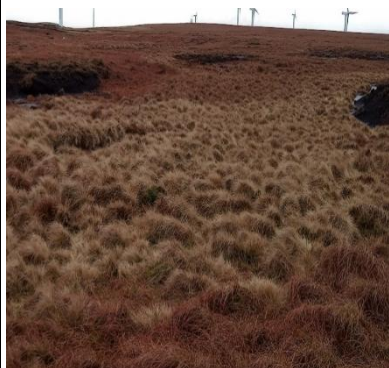
**Upstream from crossing location  
WC1**

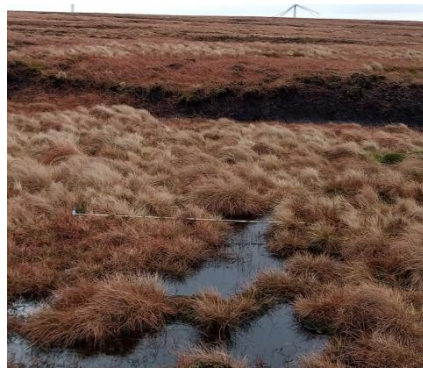
| ID | Grid Reference | | Watercourse Name | Infrastructure Location | Type of Crossing | Description |
|---|---|---|---|---|---|---|
| WC1 | 383530 | 419078 | Tributary to Scout Moor High Level Reservoir<br><br>1:10,000 scale OS-mapped watercourse | Adjacent to T14 in the west of Assessment Boundary. | The topography at the chosen location is appropriate for a single span bottomless arch. | <p><b>Channel dimensions:</b> Flow is highly diffuse, with water spread across shallow puddles rather than confined to a distinct, continuous channel. At the time of the visit, the most defined portion of the channel measured approximately 0.5 m wide and 0.25 m deep.</p> <p><b>Valley dimensions:</b> The feature is an erosional gully formed within peat, with banks reaching approximately 1 m in height. The gully spans around 15 m from bank to bank, with a gently sloping transition into the surrounding peatland.</p> <p><b>Substrate:</b> The bed is primarily composed of bare peat, with localised deposits of silt and sand in lower-lying areas.</p> <p><b>Channel form:</b> A broad, shallow erosional peat gully with an ill-defined channel, where flow is dispersed across multiple shallow depressions rather than a single, continuous path.</p> <p><b>Flow conditions:</b> Gentle flow was observed at the time of the visit, occurring as diffuse surface water movement across the gully floor rather than within a well-defined channel.</p> <p><b>Anticipated level of authorisation:</b> Standard Permit.</p> |

**Watercourse crossing location  
WC1**

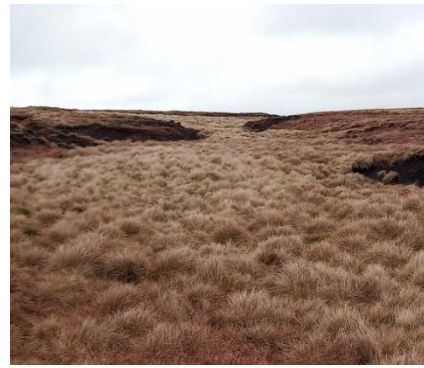
**Downstream from crossing location  
WC1**

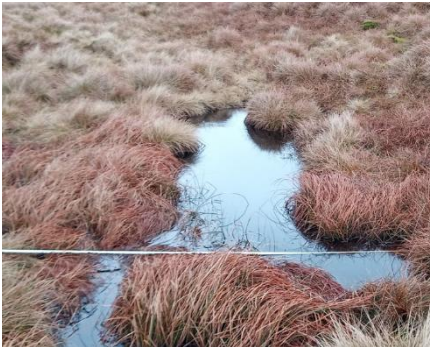
| ID | Grid Reference | | Watercourse Name | Infrastructure Location | Type of Crossing | Description |
|---|---|---|---|---|---|---|
| WC2 | 383709 | 418906 | <p>Unnamed channel that dissipates to the south</p> <p>1:10,000 scale OS-mapped watercourse</p> | <p>Access track in west of Assessment Boundary. Located ~220m south-east of WC1.</p> | <p>The topography at the chosen location is appropriate for a single span bottomless arch.</p> | <p><b>Channel dimensions:</b> At the time of the visit, the water depth was approximately 0.3 m, with flow contained within a shallow, gently sloping channel.</p> <p><b>Valley dimensions:</b> The feature is a U-shaped erosional gully incised into peat, with banks standing around 1.8 m high. The gully spans approximately 9 m from bank to bank, with a gradual transition into surrounding peatland.</p> <p><b>Substrate:</b> The channel bed is predominantly composed of sand, with minimal organic material or exposed peat. Some areas may include finer sediments transported during higher flows.</p> <p><b>Channel form:</b> A broad, shallow erosional gully formed within the peat, shaped by gradual water movement. The channel lacks well-defined banks at the base, with flow spread across a gently meandering path.</p> <p><b>Flow conditions:</b> Flow was observed to be slow and steady, with no significant turbulence or abrupt changes in water level. Water movement appeared consistent with baseflow-dominated conditions, though higher flows may occur during wetter periods.</p> <p><b>Anticipated level of authorisation:</b> Standard Permit.</p> |

| ID | Grid Reference | | Watercourse Name | Infrastructure Location | Type of Crossing | Description |
|---|---|---|---|---|---|---|
| | Upstream from crossing location WC2 | | Watercourse crossing location WC2 | Downstream from crossing location WC2 | | WC2 location from Figure 14.5 |

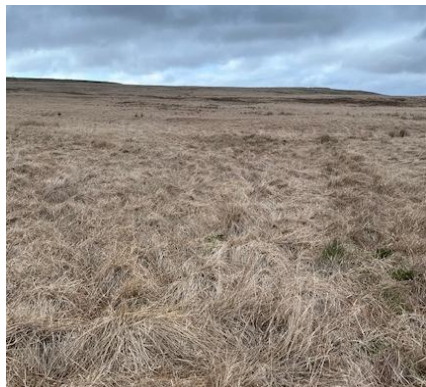
**Upstream from crossing location  
WC3**

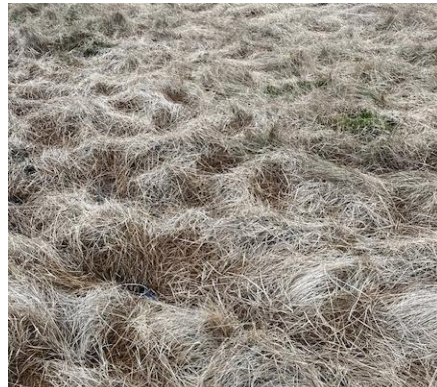
| ID | Grid Reference | | Watercourse Name | Infrastructure Location | Type of Crossing | Description |
|---|---|---|---|---|---|---|
| WC3 | 386012 | 419871 | 1:10,000 scale OS-mapped drain tributary of Greens Clough | Access track in north-east area of Assessment Boundary. Located ~2.5km north-east of WC2. | The topography at the chosen location is appropriate for a single span bottomless arch. | <p><b>Channel dimensions:</b> Flow is highly diffuse, with water present as shallow, squelchy saturation across vegetated ground rather than a defined channel. There is no distinct flow path, with water instead accumulating in minor depressions before gradually coalescing further downstream. At the time of the visit, the saturated area was approximately 1–2 m wide, with no measurable depth beyond surface wetness.</p> <p><b>Valley dimensions:</b> The feature is an ill-defined shallow depression within the peat, lacking distinct banks. Any slope present is subtle, with no clear erosional features marking the edges of the watercourse. Further downstream, the feature transitions into a more developed flow path.</p> <p><b>Substrate:</b> No distinct substrate—entirely vegetated with peatland species. The ground is saturated but intact, with no significant exposure of underlying materials such as peat, sands, or gravels.</p> <p><b>Channel form:</b> No defined channel at this location—water movement occurs as overland flow through saturated vegetation. Further downstream, this transitions into a more recognisable watercourse.</p> <p><b>Flow conditions:</b> Extremely limited flow observed, occurring as shallow seepage through vegetation rather than any visible movement of water. The water is fully integrated with the surrounding saturated ground, with no concentrated flow paths present.</p> <p><b>Anticipated level of authorisation:</b> Exemption/Standard Permit.</p> |

**Watercourse crossing location  
WC3**

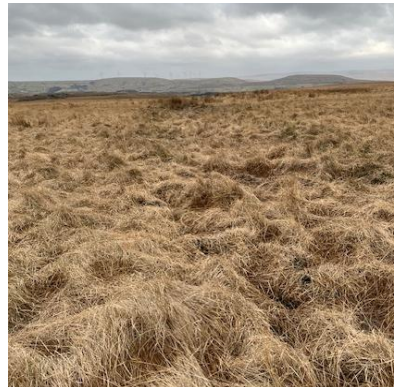
**Downstream from crossing location  
WC3**

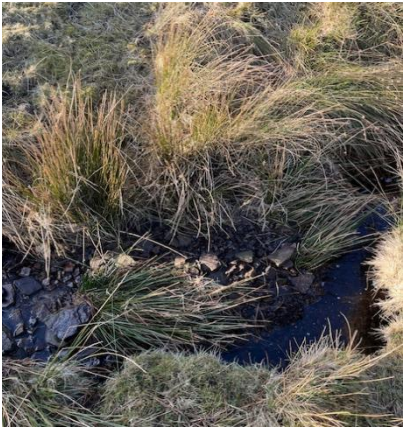
| ID | Grid Reference | | Watercourse Name | Infrastructure Location | Type of Crossing | Description |
|---|---|---|---|---|---|---|
| WC4 | 385971 | 419046 | Walstead Clough<br>1:50,000 scale OS-mapped watercourse | Access track in central area of Assessment Boundary, west of T16. | The topography at the chosen location is appropriate for a single span bottomless arch. | <p><b>Channel dimensions:</b> The watercourse is a meandering feature with a gently to moderately sloping gradient. At the point of crossing, the valley is approximately 4 m wide, with a steeper section transitioning into a broader, gentler-sloped area where the track crosses. The main channel is well-defined in this location, measuring approximately 1 m wide and 0.5 m deep, while an additional, less distinct flow path extends to around 0.5 m wide.</p> <p><b>Valley dimensions:</b> The valley is incised into weathered bedrock, with an overall gradient of approximately 8 m. The track crosses at a broader section where the valley widens and the slopes become more gradual.</p> <p><b>Substrate:</b> The channel bed consists of weathered bedrock, with sands and gravels deposited in lower-energy areas. Peat and organic material are present along the banks and in less active flow zones.</p> <p><b>Channel form:</b> A meandering watercourse transitioning through different sections of slope and confinement. At the crossing point, the channel is more incised, forming a distinct, narrow flow path, whereas upstream and downstream, it exhibits a more dispersed and dynamic morphology.</p> <p><b>Flow conditions:</b> Moderate flow observed at the time of the visit, with water moving through both the defined channel and adjacent low-lying areas. Flow is influenced by variations in gradient and substrate composition.</p> <p><b>Anticipated level of authorisation:</b> Standard Permit</p> |

| ID | Grid Reference | | Watercourse Name | Infrastructure Location | Type of Crossing | Description |
|---|---|---|---|---|---|---|
| | Upstream from crossing location WC4 | | Watercourse crossing location WC4 | Downstream from crossing location WC4 | | WC4 location from Figure 14.5 |

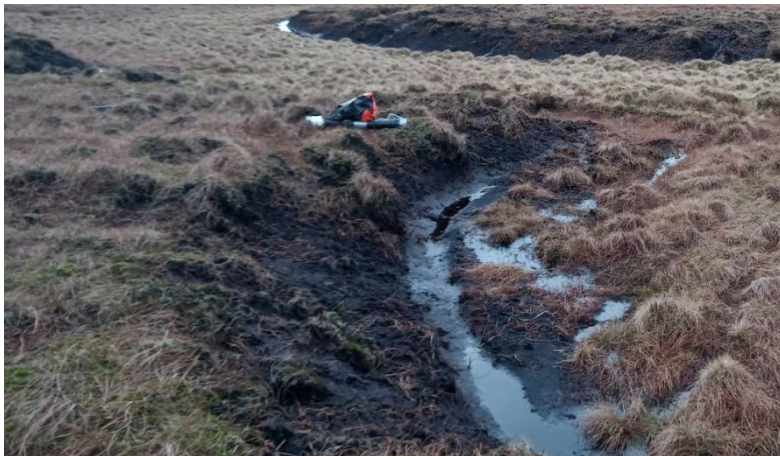
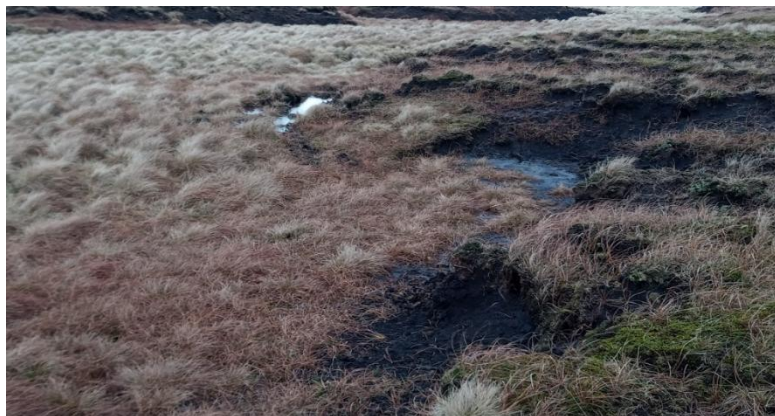
#### Erosional Peat Gulleys

It is anticipated that several additional crossings will be required over eroded peat gullies that are not all marked as watercourses. These features are found throughout the Assessment Boundary and vary in width, depth, and the quantity of water present. Flow within these gullies is typically ephemeral and diffuse, with water spread across small ponds or channels rather than in a confined channel. The proposed crossings will address the fragmented nature of the

| ID | Grid Reference | | Watercourse Name | Infrastructure Location | Type of Crossing | Description |
|---|---|---|---|---|---|---|
| Examples of erosional peat gulley that are not mapped. | Various | Various | N/A | Various across the Assessment Boundary. | The topography at the chosen location is appropriate for a single span bottomless arch. | Various dimensions. Substrate: mostly peat or vegetation. |
