# ARBORICULTURAL METHOD STATEMENT

*Land South of **Wallis Avenue,**  
**Rochdale**  
**OL16 4PS***

AWA Reference: *AWA7343AMS*

This Arboricultural Method Statement has been prepared in accordance with BS 5837:2012 – Trees in Relation to Design, Demolition and Construction – Recommendations to outline how retained trees will be protected throughout the proposed development.

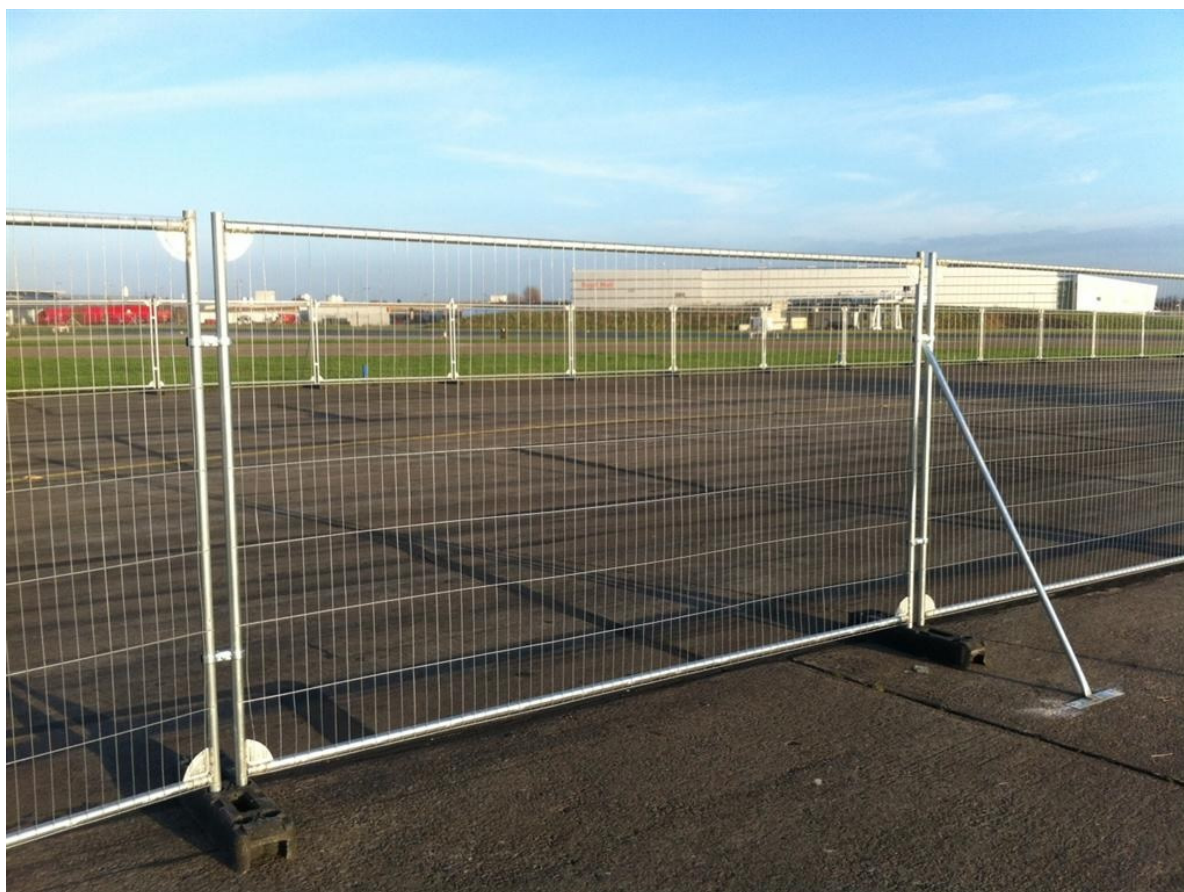
Figure 2: Secured 'Heras' type fencing with stabilizing system and anti-tamper couplers

- 4.1.5 The fencing should be joined together using a minimum of two anti-tamper couplers, installed so that they can only be removed from inside the fence (see Appendix 1 for an example). The fencing panels should be supported on the inner side by stabilizer struts, which should normally be attached to a base plate secured with ground pins or mounted on a block tray (see Appendix 1 for an example).

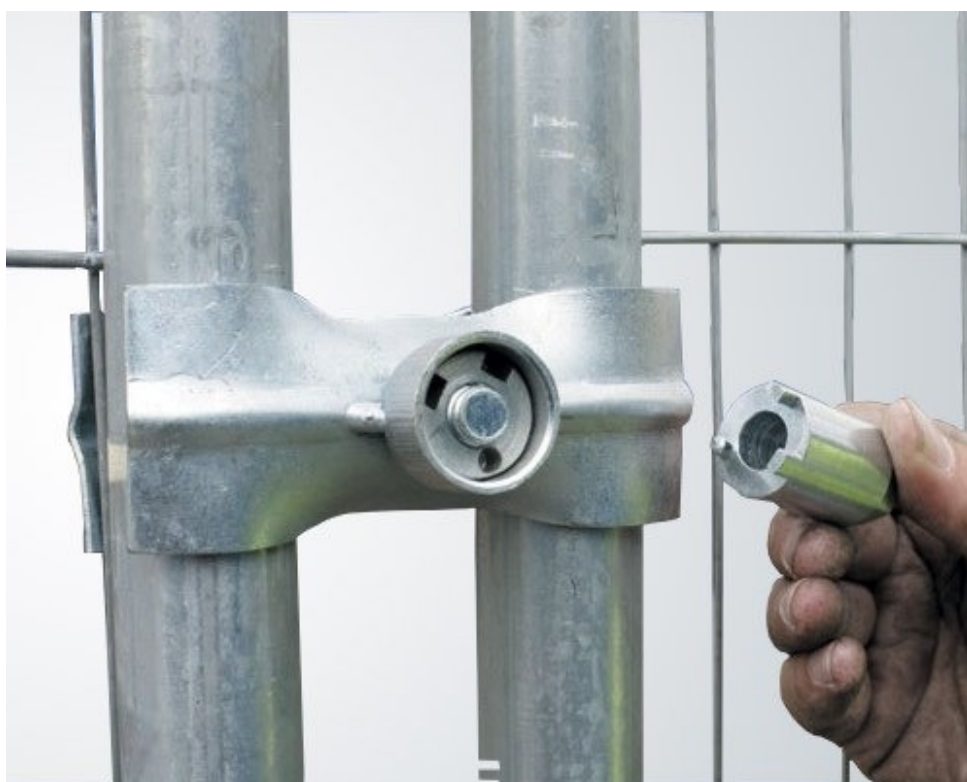
Figure 3: Anti-tamper couplers to secure fencing and avoid unauthorised access

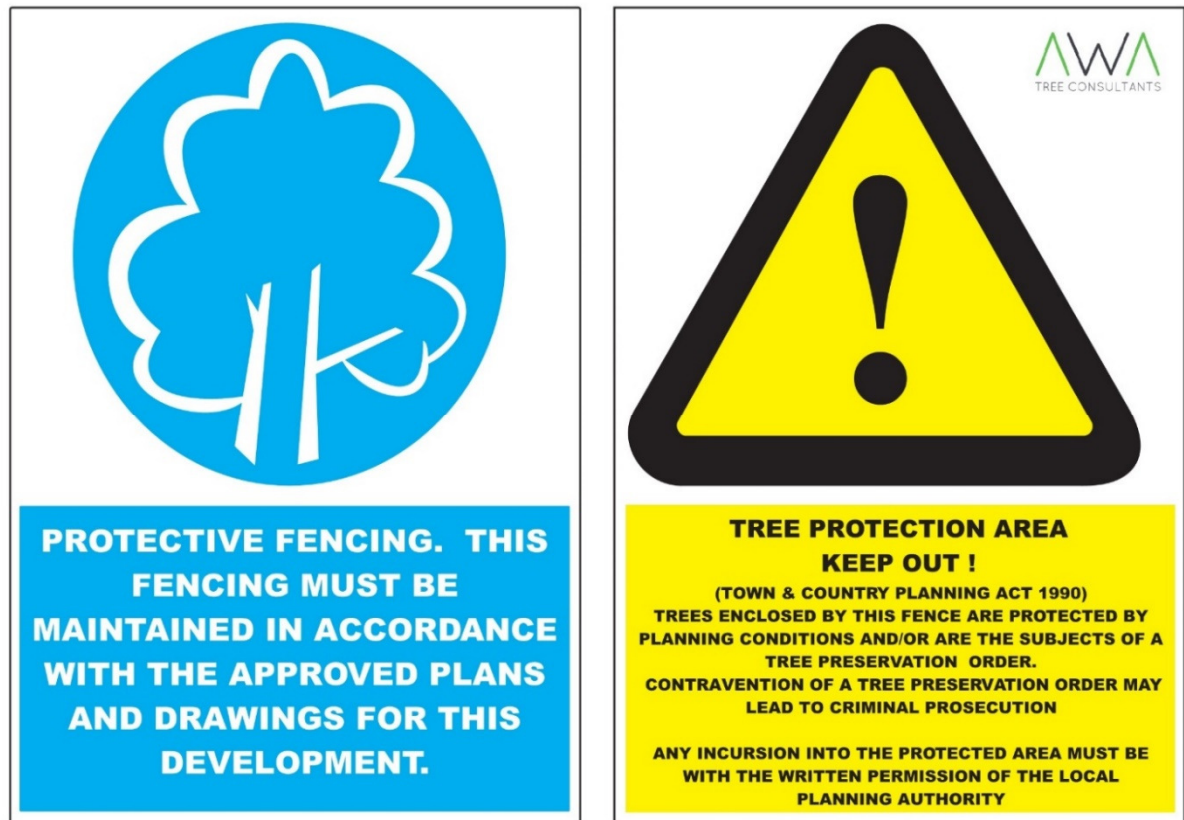
Figure 4: Warning sign for fencing

- 4.1.7 Once the fencing is erected, waterproof warning signs labelled 'Tree Protection Area' should be placed at 3m intervals to ensure that all personnel are aware of the restrictions that apply to the fenced-off area (see at Appendix 1 for example signs).

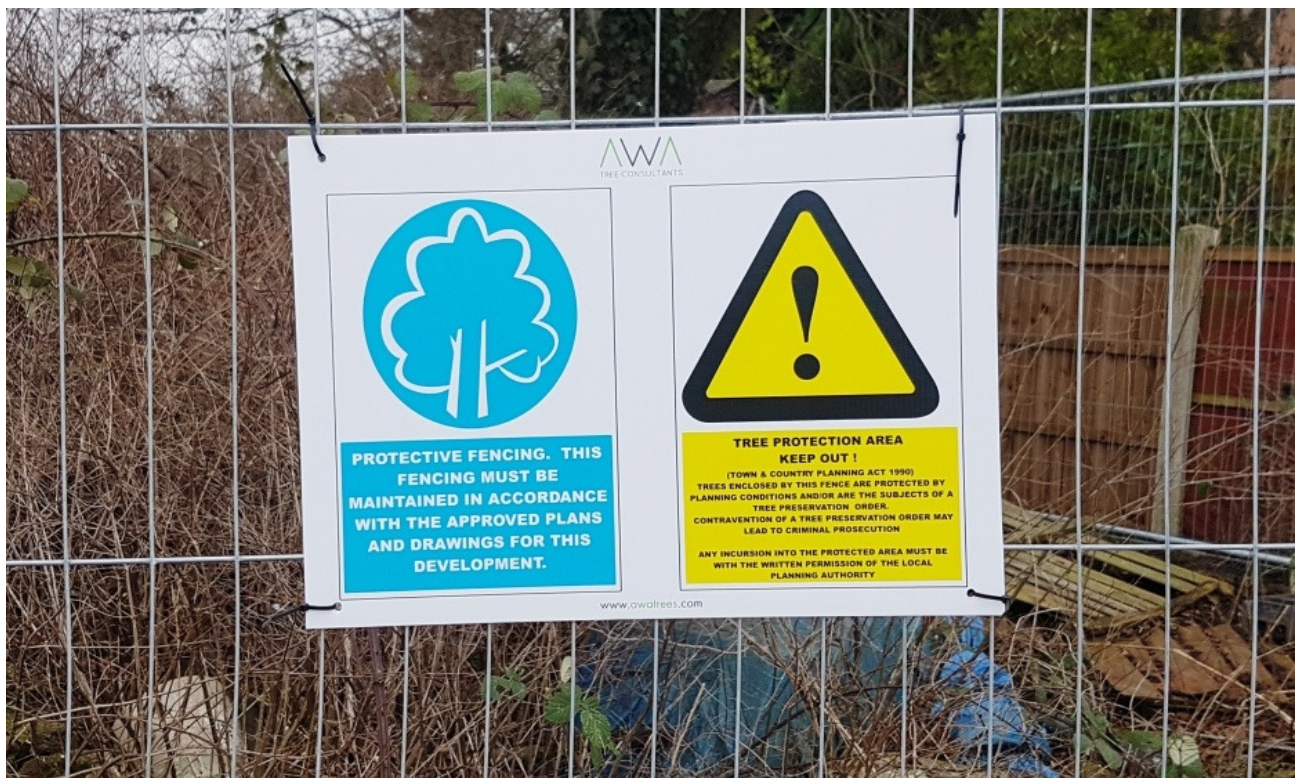
Figure 5: Example of A3 correx tree protection warning sign fixed to fencing panel
