**Supplementary  
Ground Investigation**

**Client: Lidl Great Britain Ltd**

**Lidl Rochdale Kingsway**

**Report No: 1477.03.01**

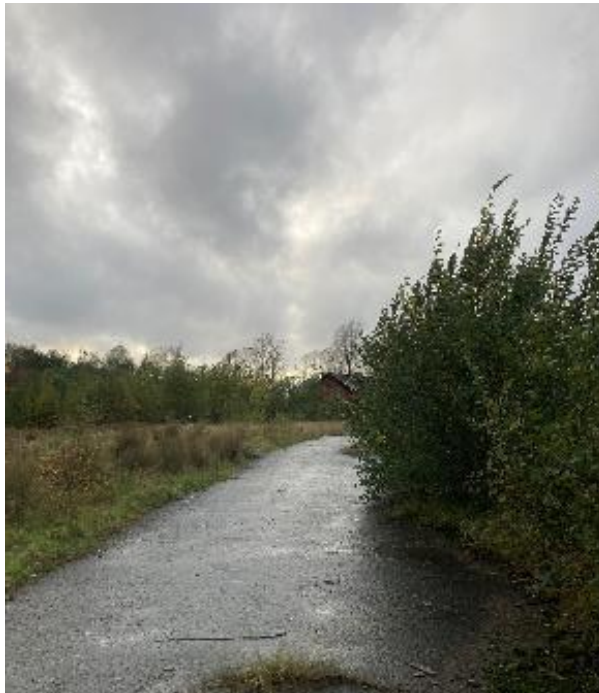
**Photo 5:** A view of the single track in the central area of the site facing towards the western boundary.

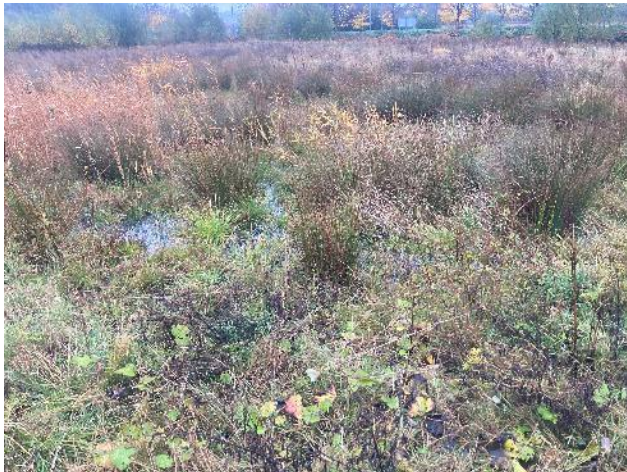
**Photo 7:** A view of the waterlogged central area of the site.

The weather conditions at the site during the fieldwork period were generally cloudy with intermittent showers and damp, standing water was noted in the central area of site and towards the eastern boundary as noted in photo 7 above.

It should be noted that an area of flooded ground was observed within the central area of the site.

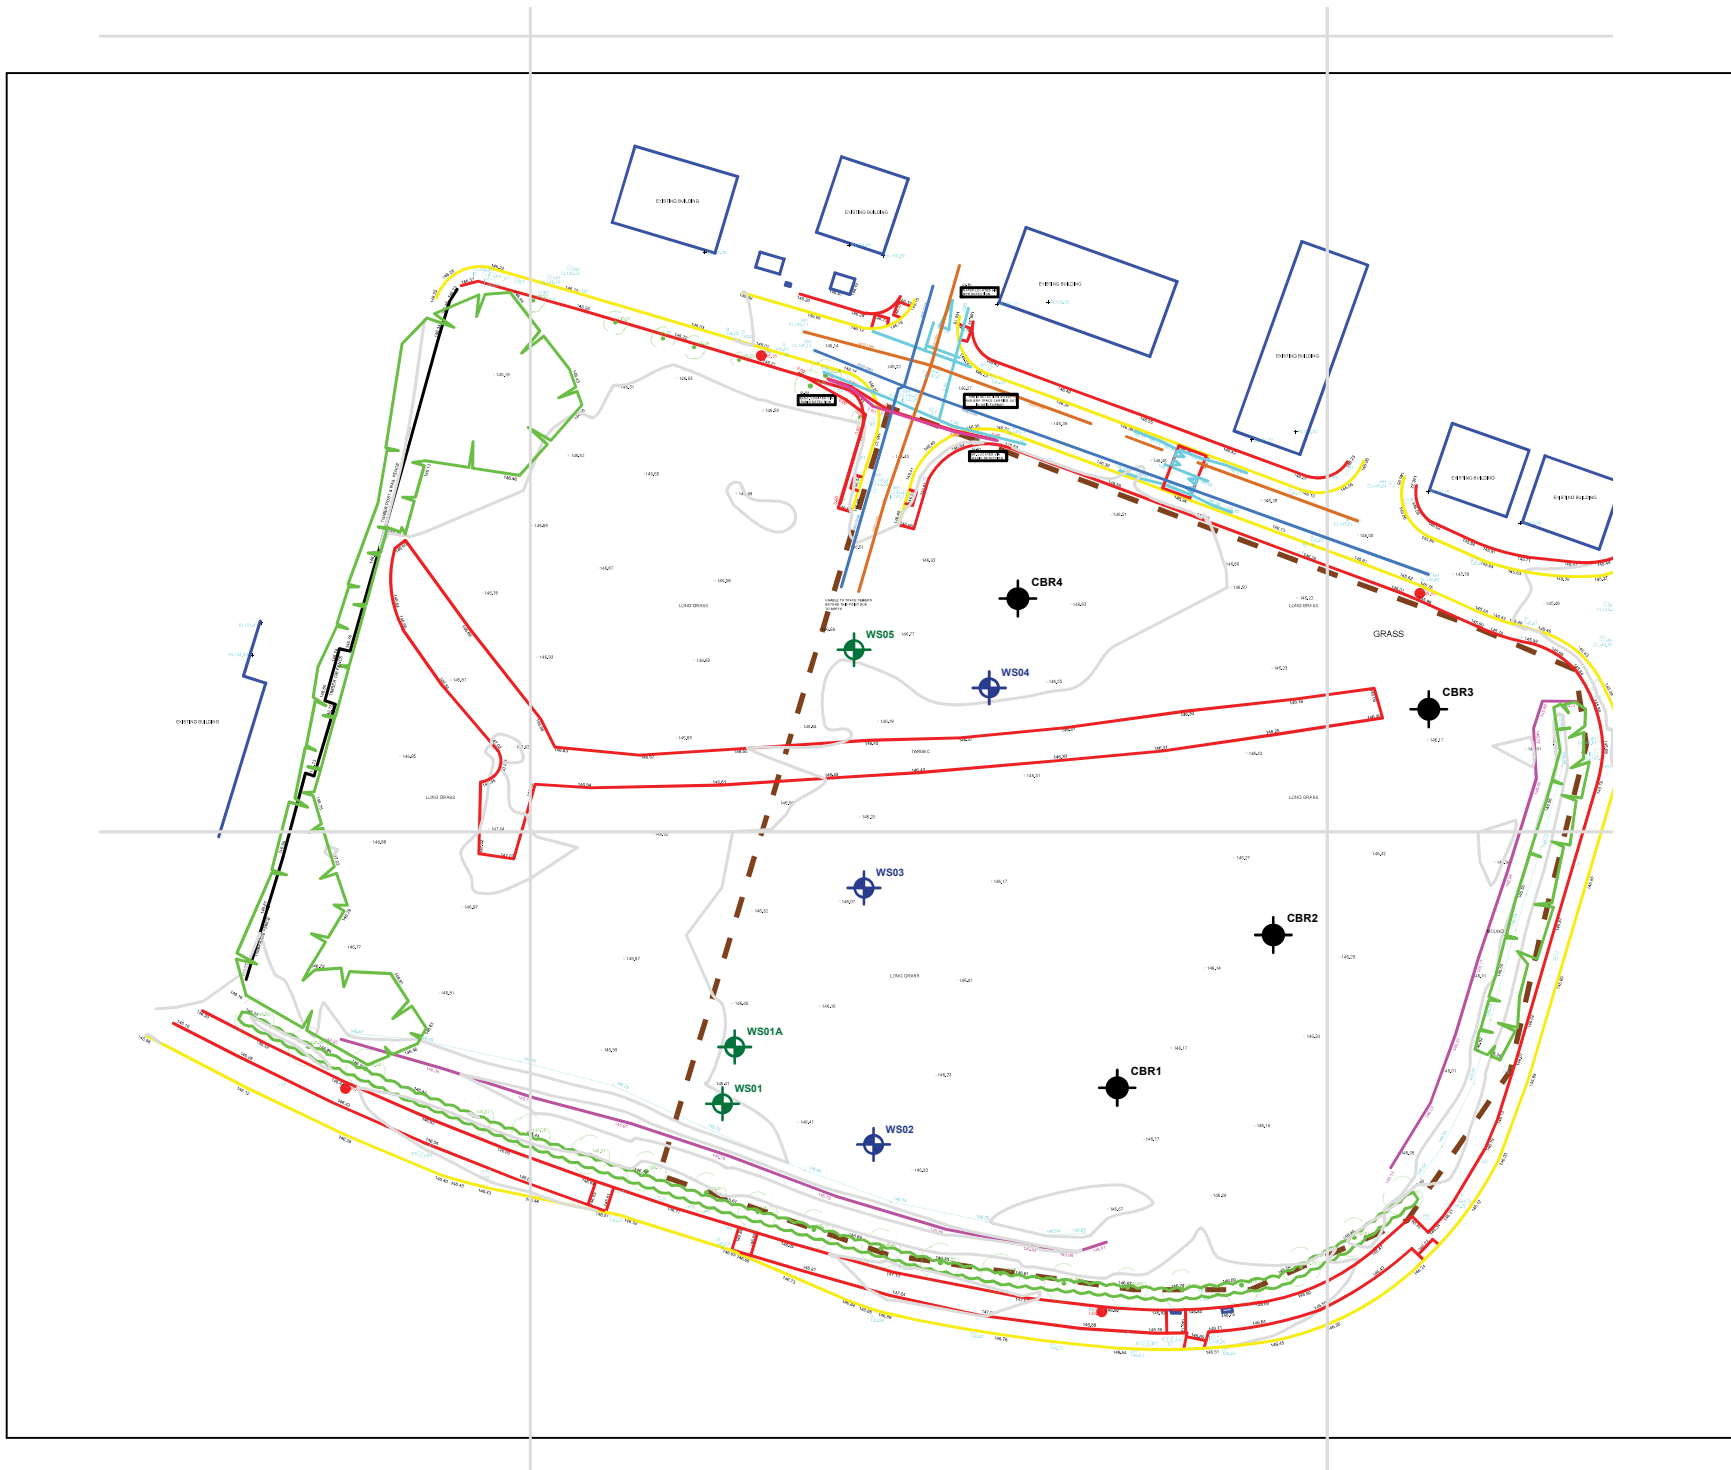
- Legend
- Approximate extent of site boundary
  - WS01 Window Sample & Installation
  - WS02 Window Sample
  - CBR1 CBR Test
