# Biodiversity Metric Report

Redwood SEN/ Land off Heywood Old Road, Middleton

Reference: 82-893-R2-1

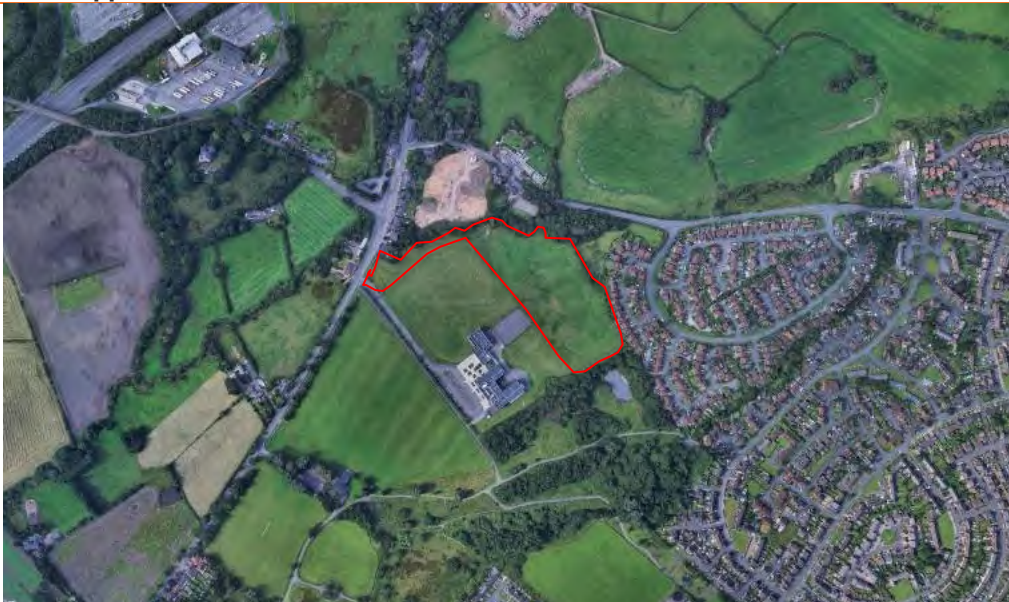
**Figure 1**      **Approximate Site Location**

The site is located at the northwestern edge of Middleton in the village of Birch. Whittle Brook forms the northern site boundary, with the southwestern boundary being demarked by the Edgar Wood Academy. Land use to the east and south is primarily given over to residential properties, the exception to this is the Bowlee Community Park, which is situated along the southeastern boundary of the site. Agricultural land expands to the north and west of the site until it meets the M62, which is located approximately 480 m northwest of the site at its closest point. Please refer to Figure 1 for the approximate site location

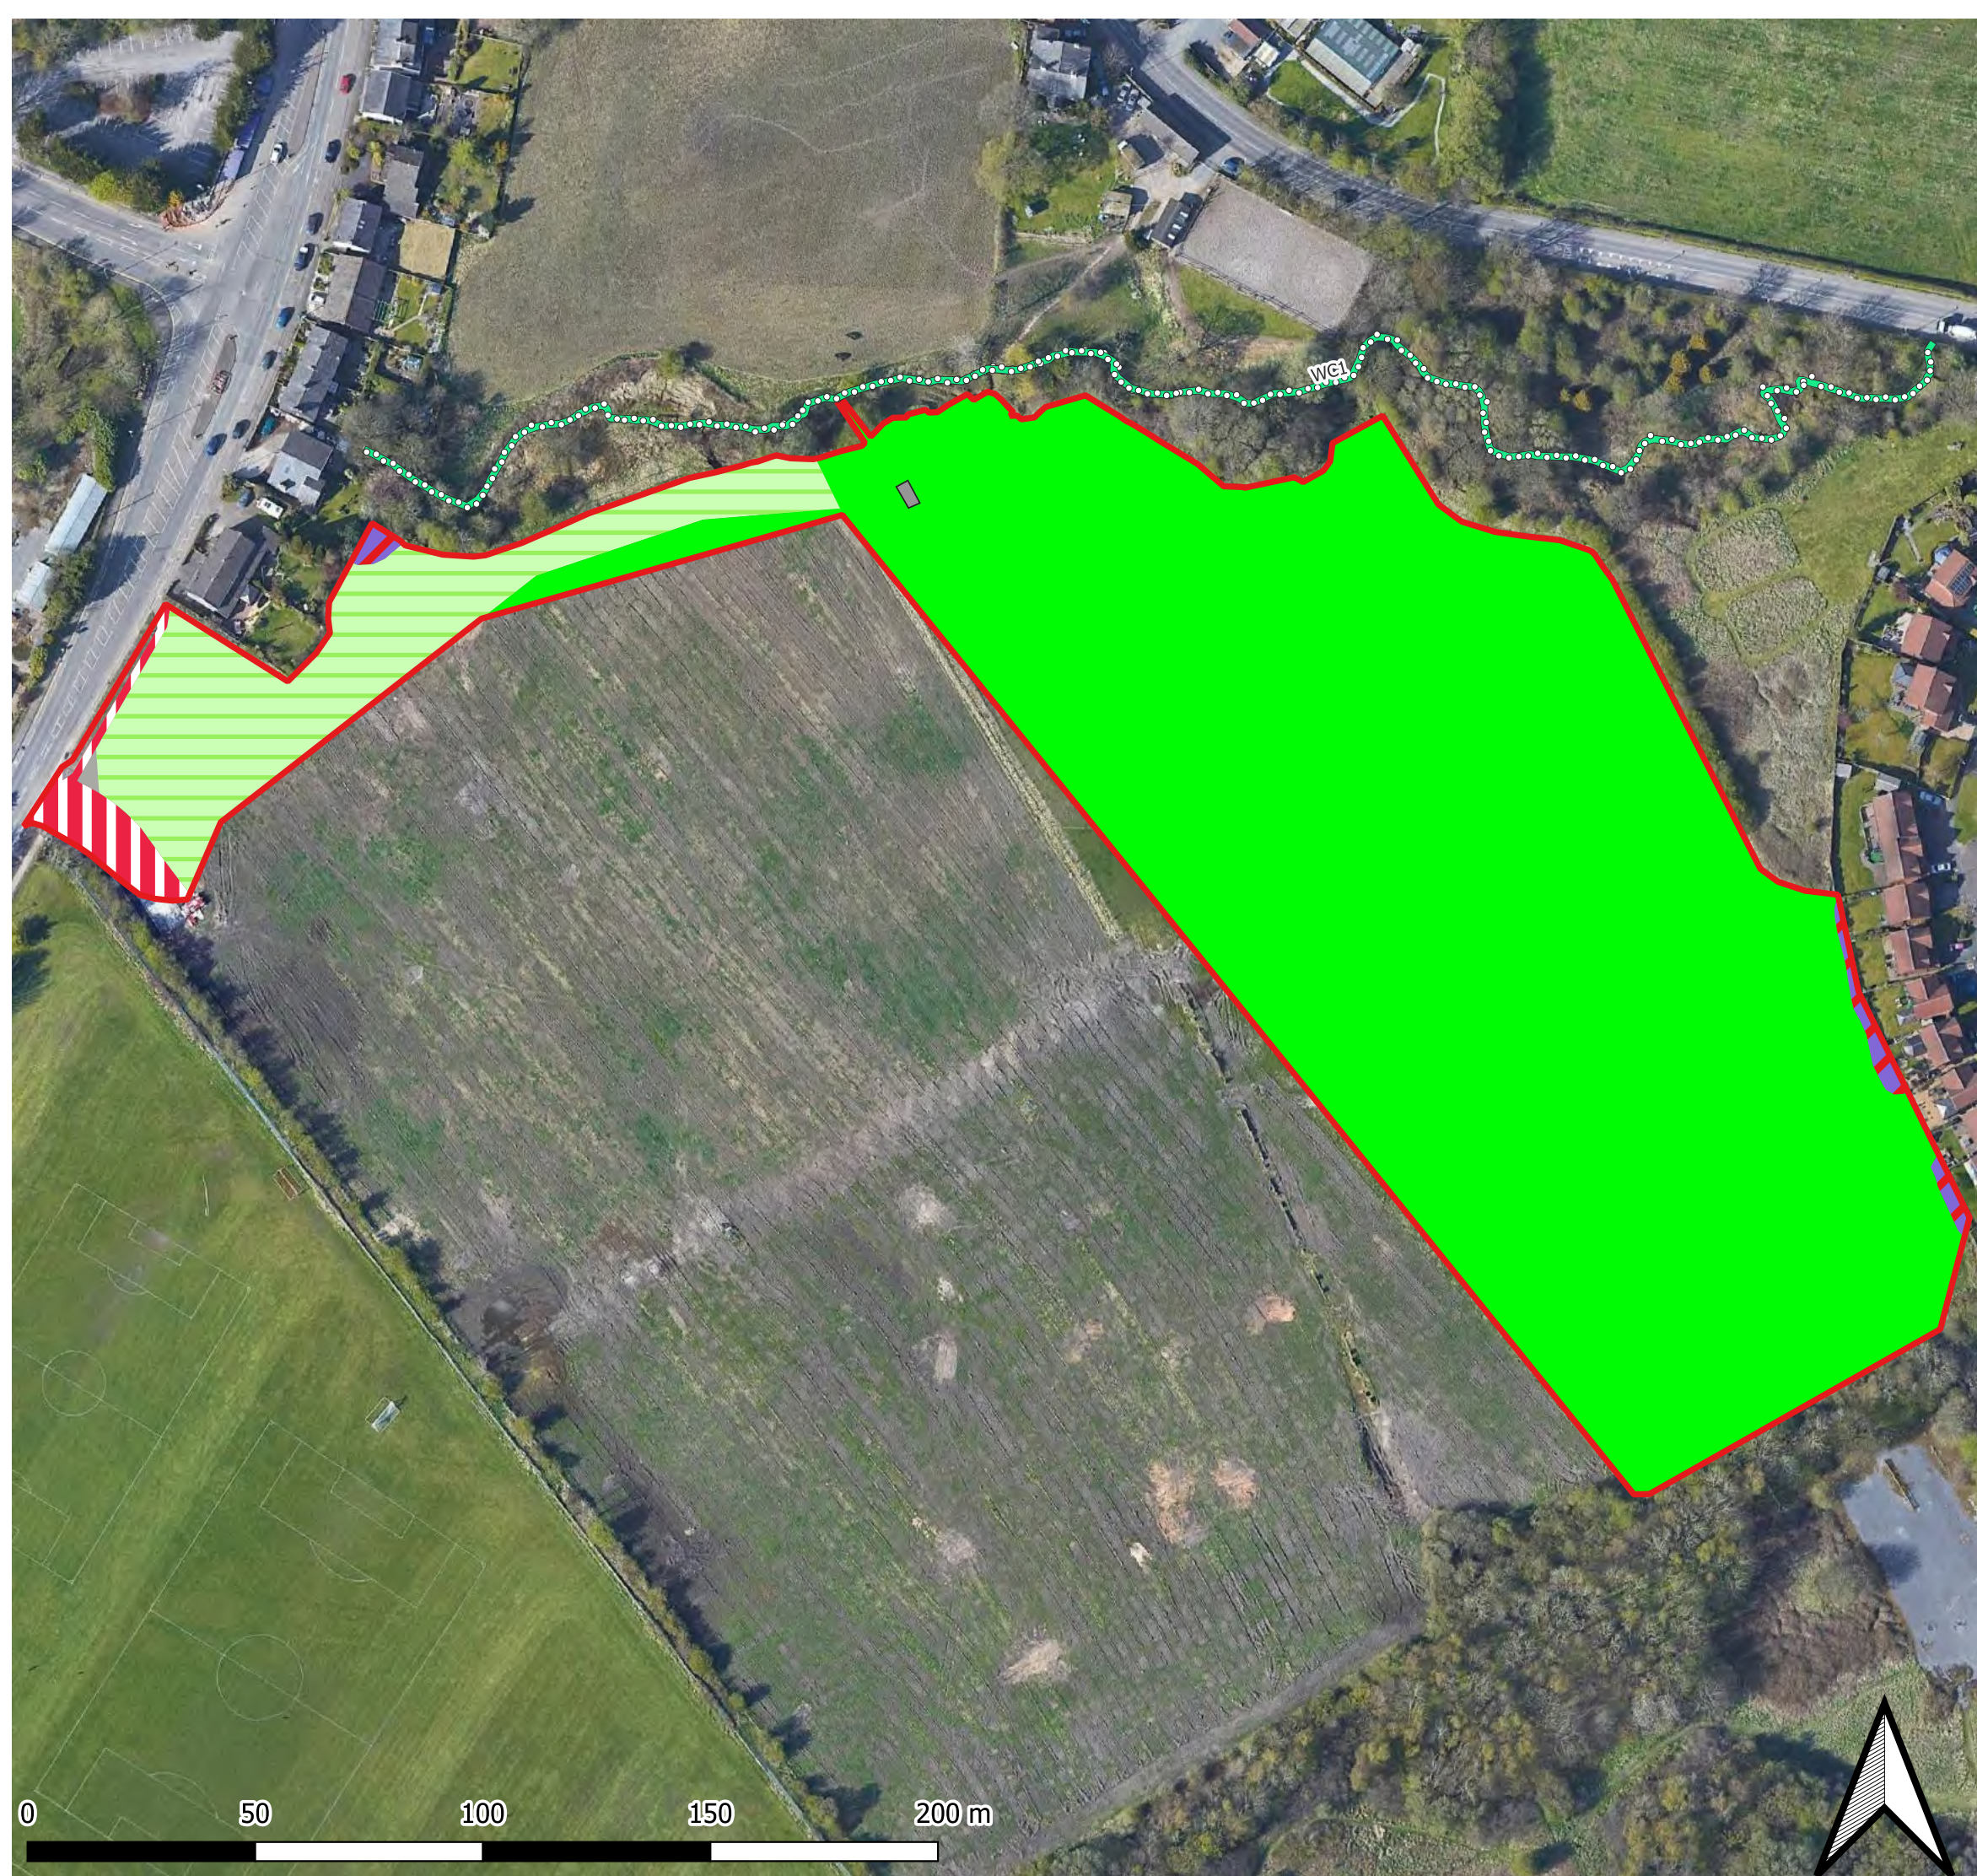
### **BASELINE PLAN**

- Red Line Boundary
- Other rivers and streams
- Bramble scrub
- Buildings
- Developed land; sealed surface
- Modified grassland
- Other neutral grassland
- Tall forbs

On-site baseline habitats were measured off the UKHab Habitat Plan using QGIS and input into the metric. Please see Appendix I for the UKHab Habitat Baseline Plan.

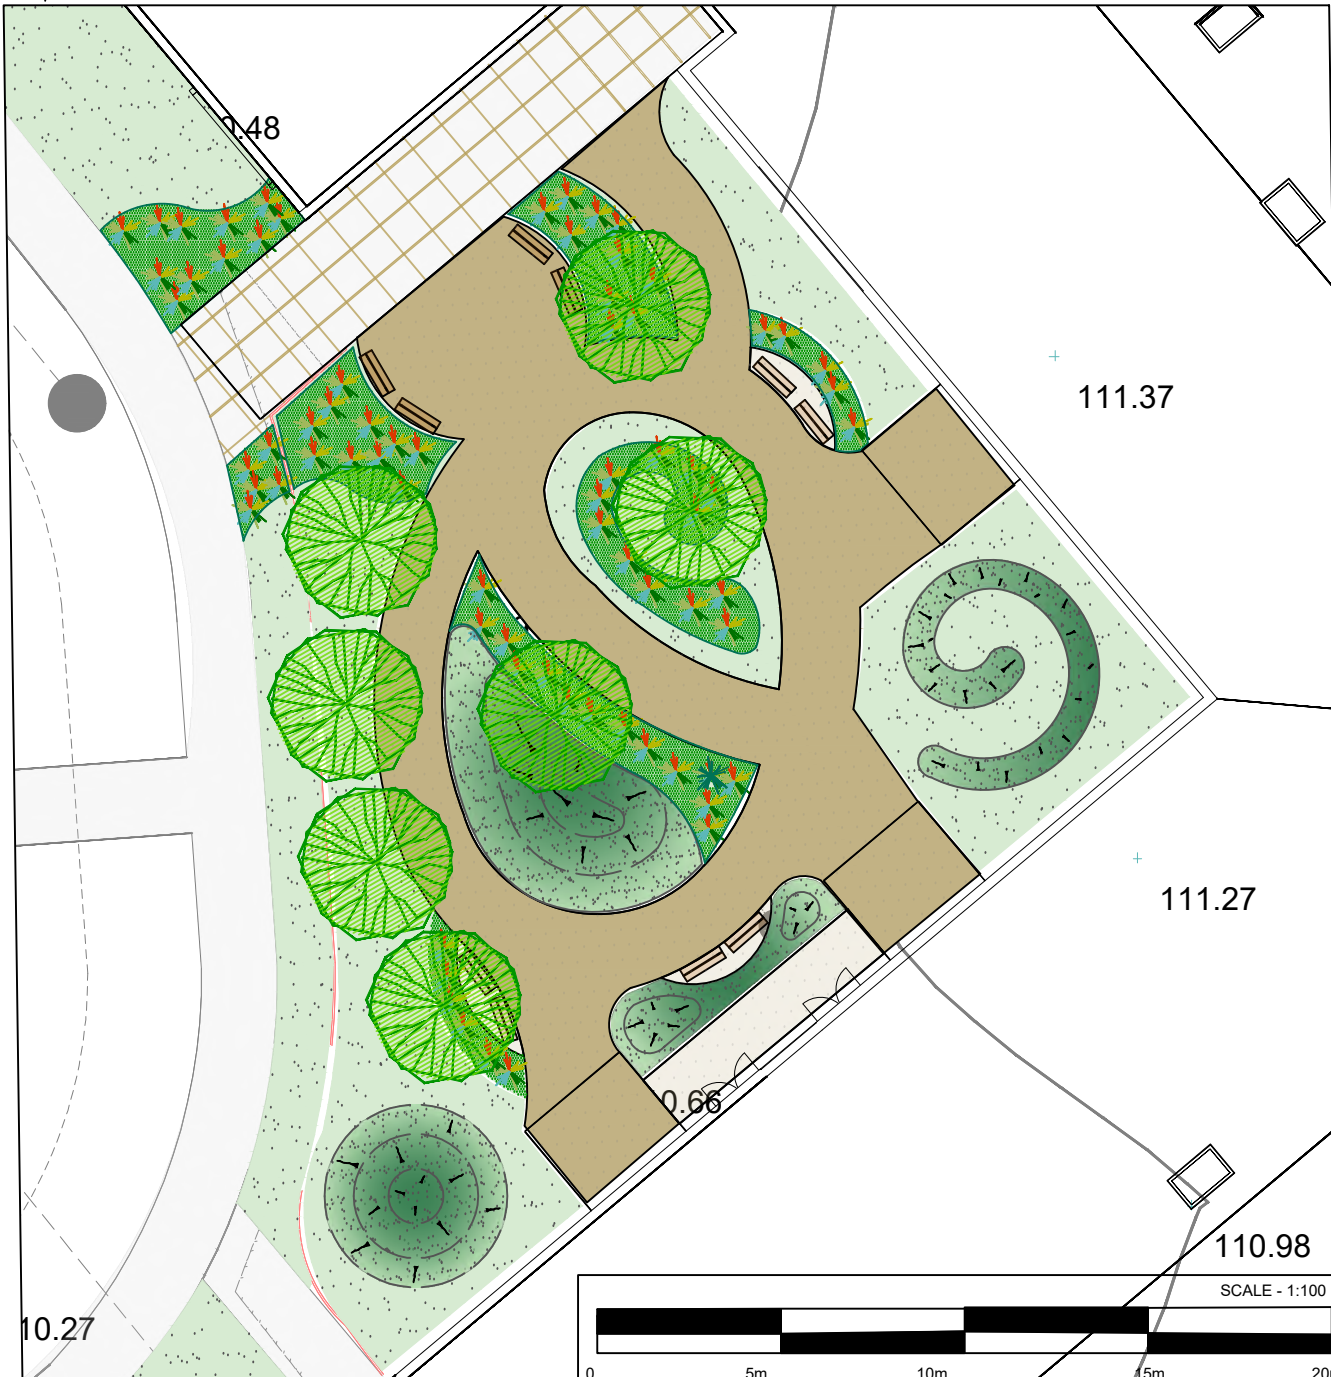
## SENSORY COURTYARD

- COMPRISING:
- ORNAMENTAL SHRUBS
- GRASSES
- TREE PLANTING
- CLOSE MOWN GRASS AREAS
- LOW GRASS MOUNDS
- SEATING AREAS

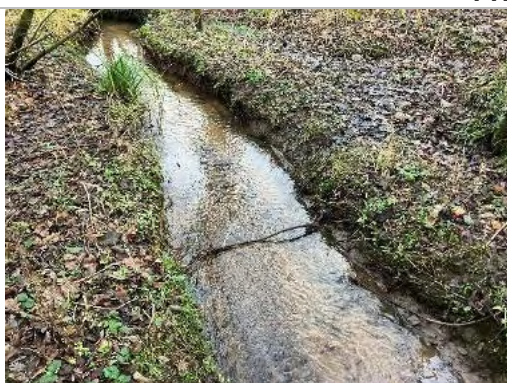
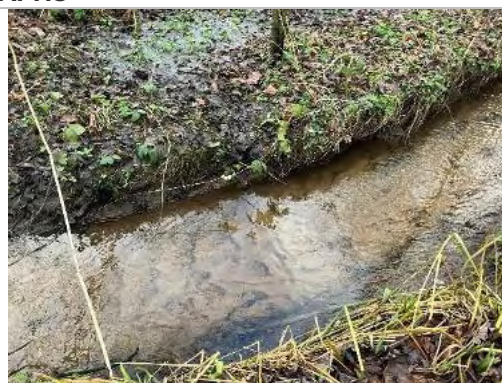
### PHOTOGRAPHS

### WHITTLE BROOK

| <b>UPSTREAM GRID REFERENCE</b> | SD 85490 07609 | <b>DOWNSTREAM GRID REFERENCE</b> | SD 85137 07594 |

Whittle Brook (WC1) is located off-site to the north. A section of WC1 lies within 10 m of the site boundary; within this section, an outfall is proposed. As such, 100 m of the watercourse length has been input into the metric. This is to consider the impacts to 10 m either side of the proposed outfall. Please see Table for a summary of the watercourse and Appendix VI for the full River Condition Assessment.
