# BIODIVERSITY METRIC REPORT

| Site: | Greenfield Lane, Rochdale |
| References: | 83-024-R2 |

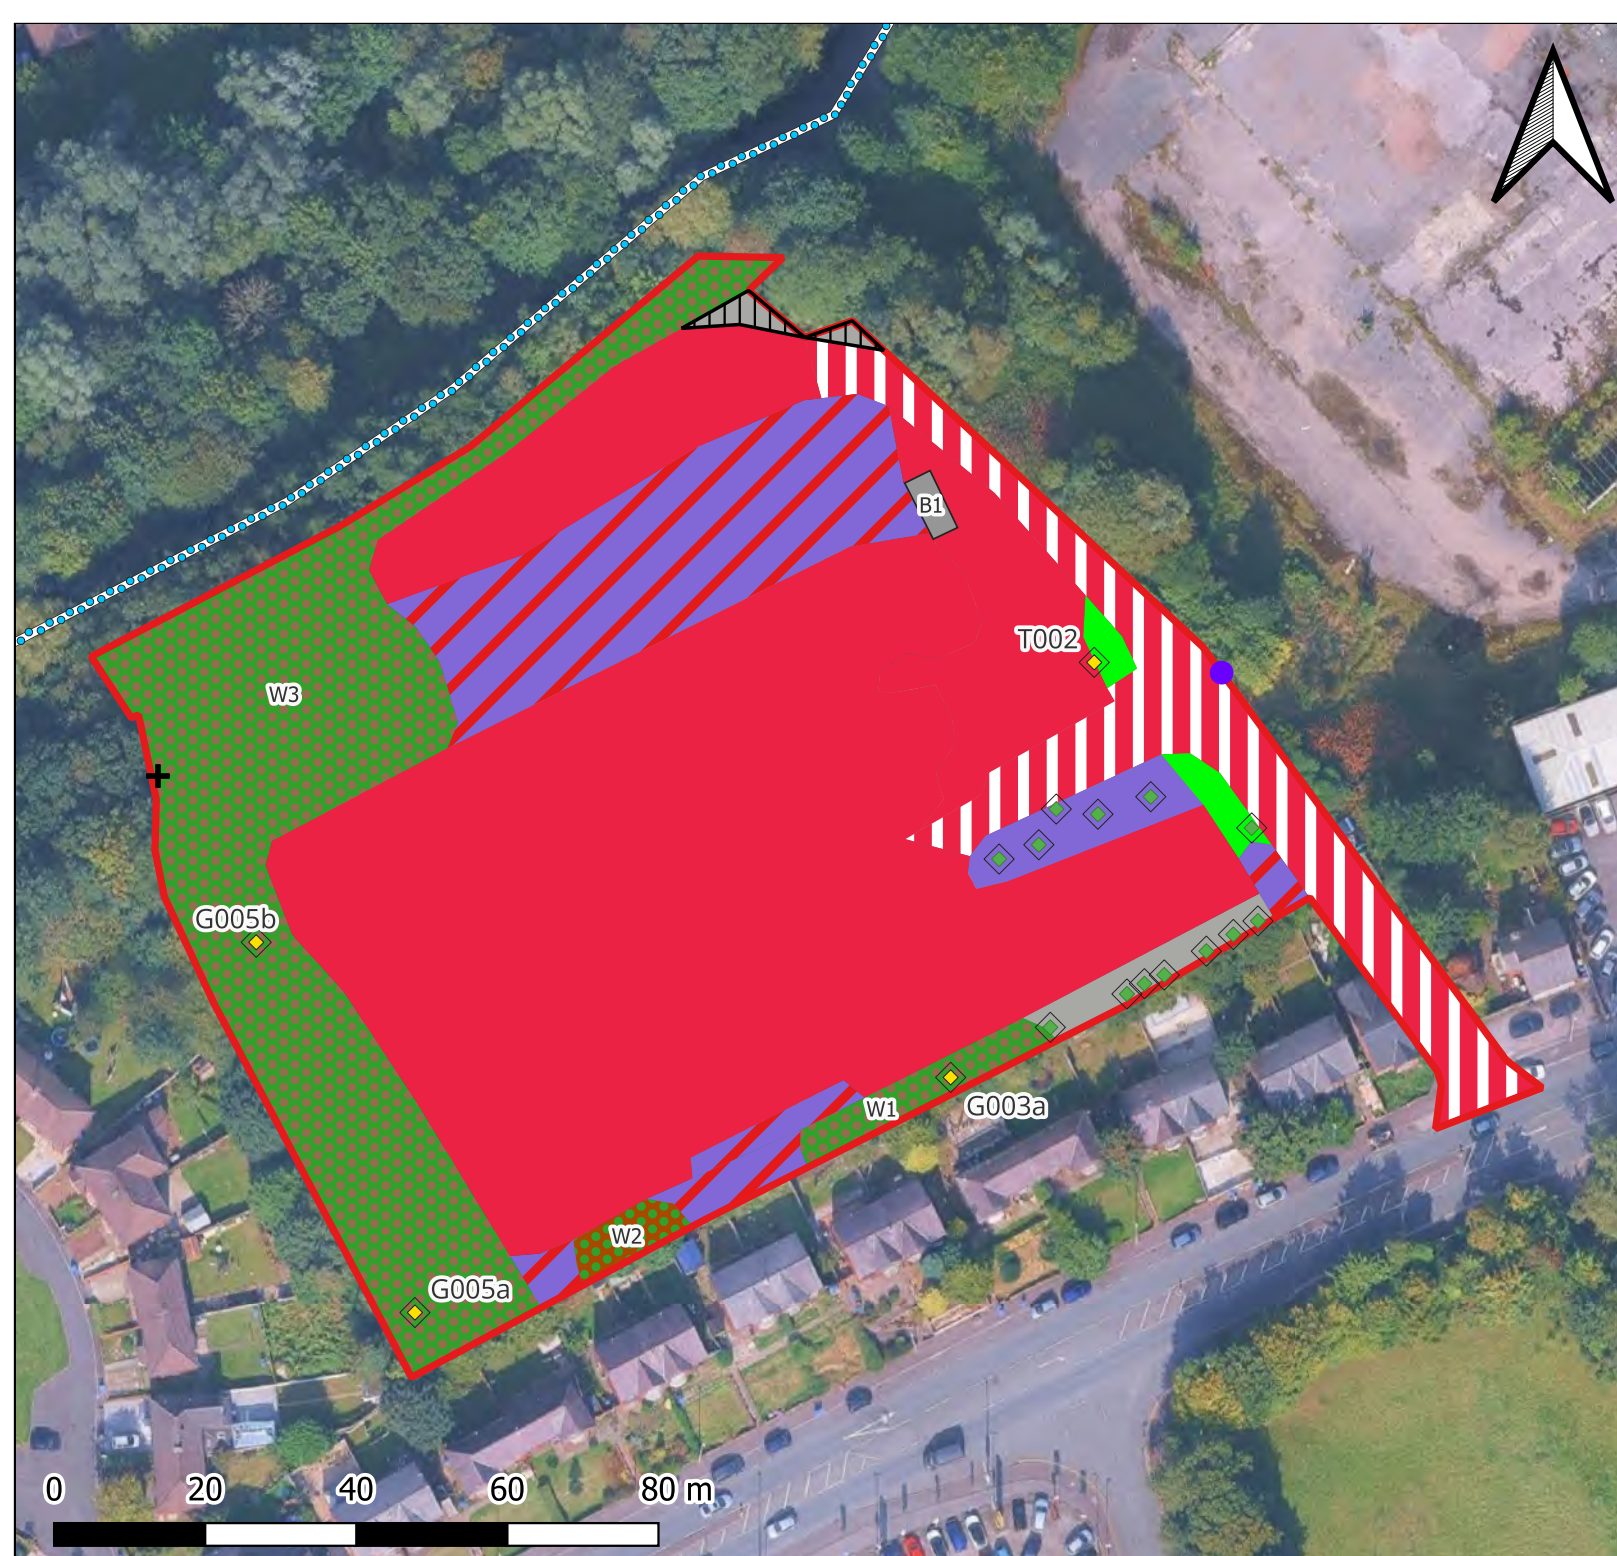
| Job title:<br>Greenfield Lane, Rochdale | | | Drawing title:<br>UKHab Habitat Plan | |

- Red line boundary
- Individual tree
- PRF-I tree
- Rochdale Canal
- Himalayan balsam area
- Himalayan balsam
- Japanese knotweed
- Developed land; sealed surface
- Buildings
- Vacant or derelict land
- Introduced shrub
- Ruderal/ephemeral
- Modified grassland
- Bramble scrub
- Mixed scrub
- Other woodland; broadleaved
- Other woodland; mixed

On-site baseline habitats were measured off the UKHab Habitat Baseline Plan using QGIS and input into the metric. The diameter at breast height (DBH) of individual trees was taken from the Arboricultural Impact Assessment (AIA) produced by E3P in June 2026 (Job Reference: 70-078), which was used to calculate the Root Protection Areas (RPAs) using the metric's tree helper.

Please see Appendix II for the UKHab Habitat Baseline Plan.

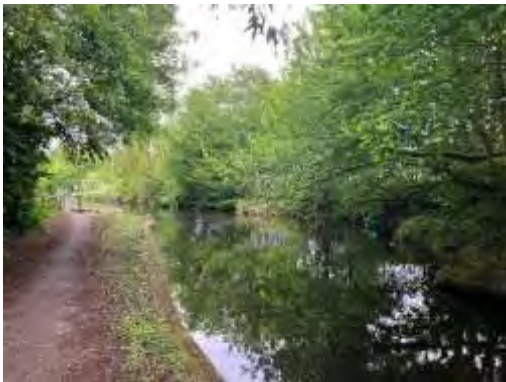
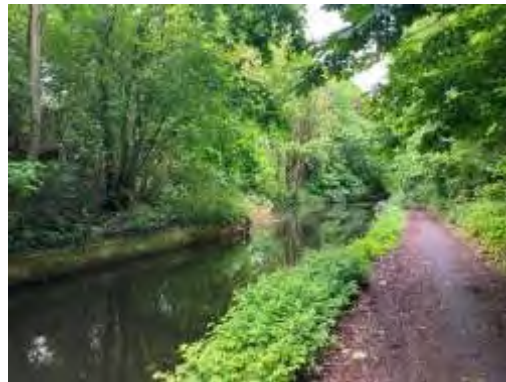
| Upstream | Downstream |

## ROCHDALE CANAL

| CONDITION ASSESSMENT CRITERIA | | RCA INDEX VALUE | NOTES/JUSTIFICATION |
|---|---|---|---|
| E6 | Channel bed material richness | 0 | The channel bed material could not be observed during the survey due to high turbidity. |
| E7 | Channel bed siltation | 0 | Channel bed siltation could not be observed during the survey due to high turbidity. |
