# **GEO-ENVIRONMENTAL AUDIT**

## **PHASE 2 SITE INVESTIGATIONS**

## **PHASE 3 REMEDIATION STATEMENT**

**PROPOSED RESIDENTIAL DEVELOPMENT**  
**LAND ADJACENT 1 WILDHOUSE COURT**  
**WILDHOUSE LANE**  
**MILNROW**  
**ROCHDALE**  
**OL16 3UU**

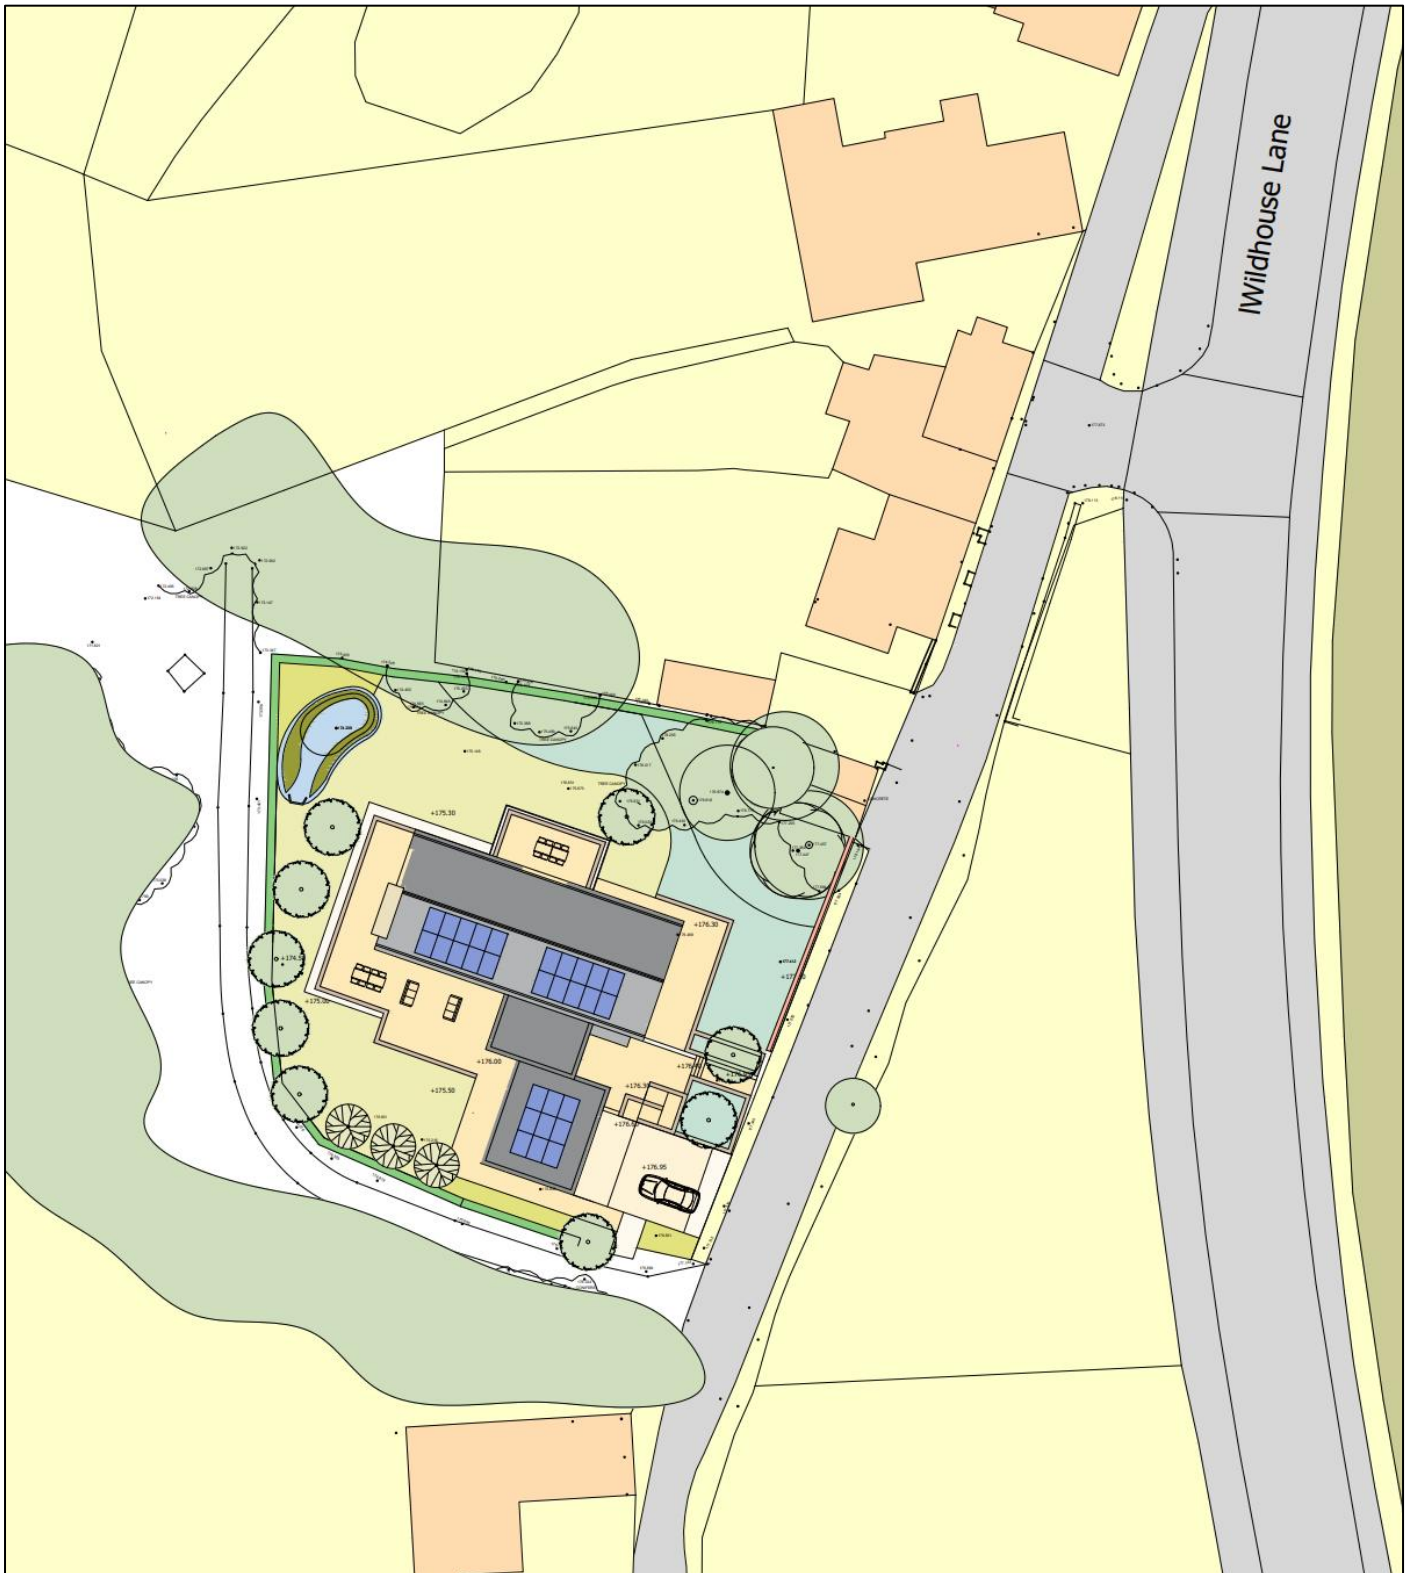
### 3.2. Proposed Development.

The proposal is for redevelopment of the site for residential purposes.

It will comprise 1No residential dwelling, soft landscaped garden area, and driveway.

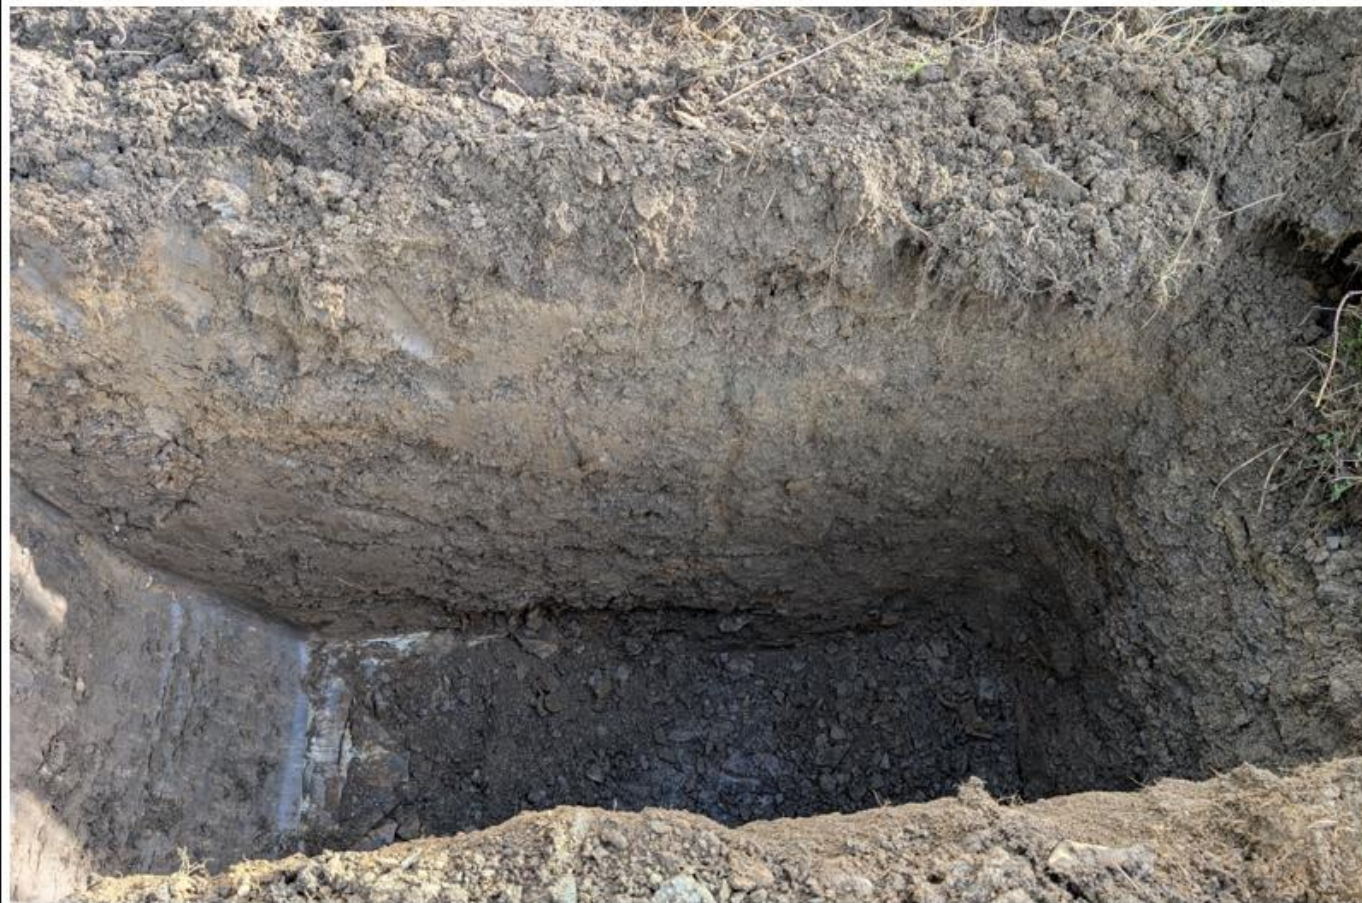
| Trial pit reference TH1 | | | | Sheet 1 of 1 |

| Trial pit reference TH1 | | | | Sheet 1 of 1 |
|---|---|---|---|---|
| | 177.05 | x - x - x | 0.10 | Brown clayey SILT (topsoil). (S1) |
| | 176.80 | X X<br>X X | (0.25)<br>0.35 | Stiff orange-brown, grey mottled silty gravelly CLAY. |
| | 176.25 | X o X o<br>o X o X<br>X o X o | (0.55)<br>0.90 | Stiff grey-brown very gravelly CLAY (WEATHERED BEDROCK). Gravel is mudstone/shale. |
| | 175.95 | X X<br>X X | (0.30)<br>1.20 | Grey-brown MUDSTONE (BEDROCK) |
