# **GEO-ENVIRONMENTAL AUDIT**

## **PHASE 1 PRELIMINARY RISK ASSESSMENT**

## **PHASE 2 SITE INVESTIGATIONS**

**PROPOSED RESIDENTIAL DEVELOPMENT  
LAND TO THE EAST OF RUDMAN STREET  
SHAWCLOUGH  
ROCHDALE  
OL12 6LJ**

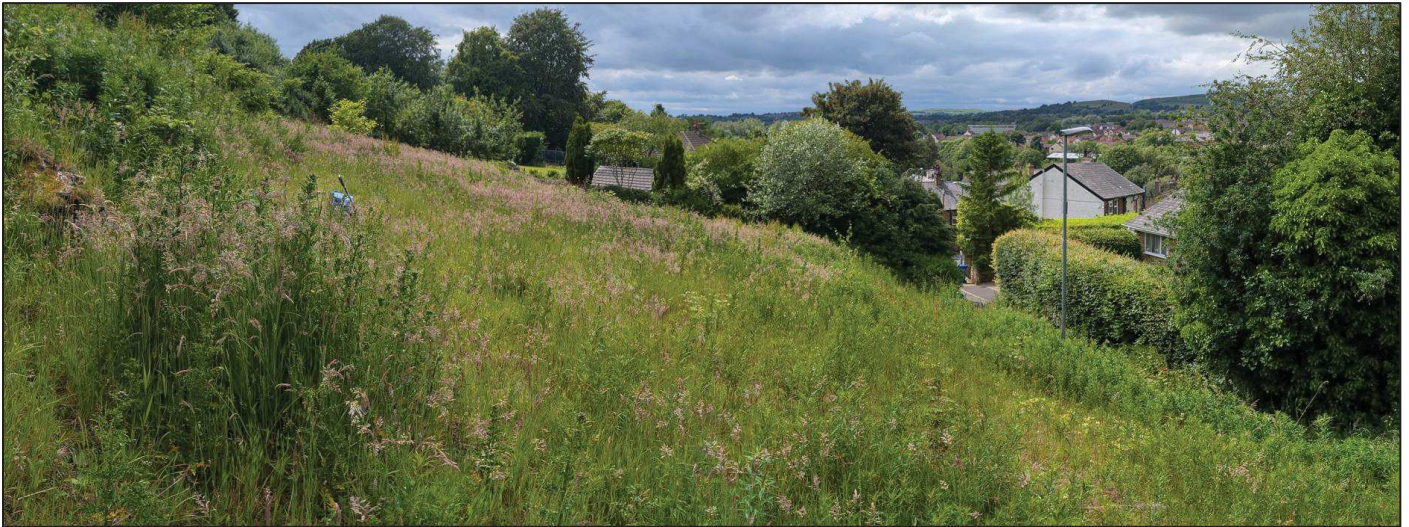
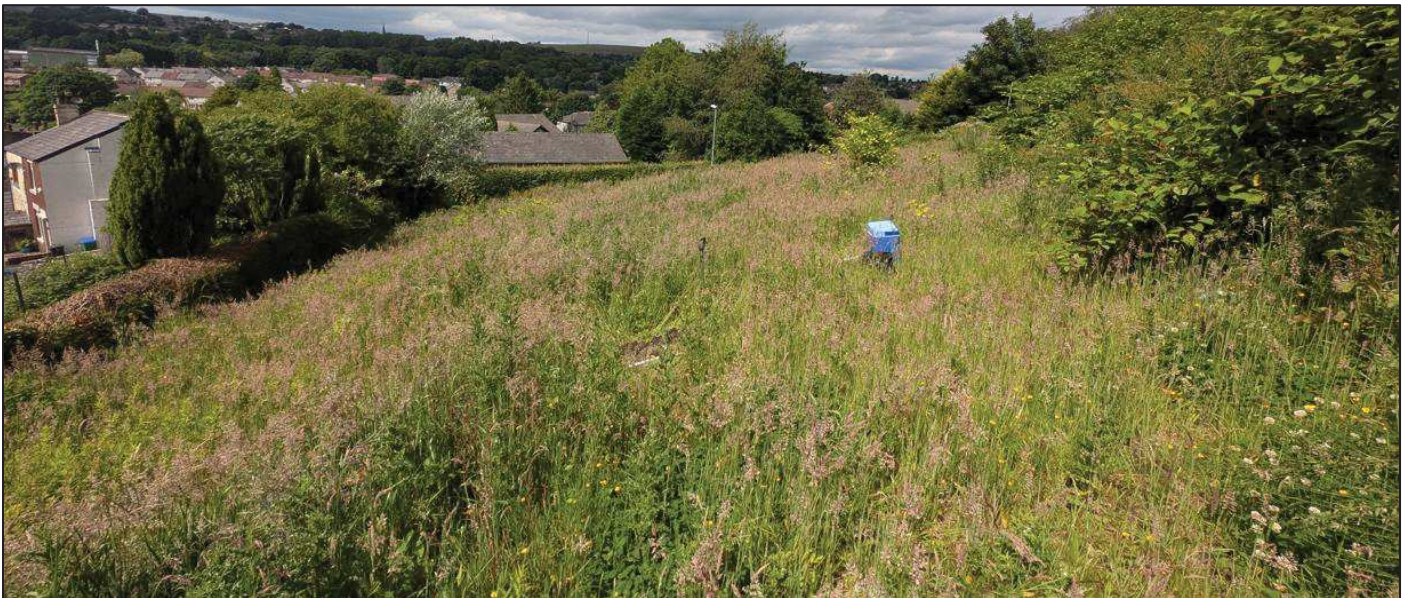
## 6. APPENDIX B: SITE WALKOVER PHOTOS.

| Details of existing structures: | <p>A site reconnaissance/investigation was undertaken in June 2026.</p> <p>The site was a vacant plot of land to the east side of Rudman Street.</p> <p>To the north side of the site was an old footpath, partially vegetated and partly covered with hardcore.</p> <p>The site was at higher level nominally 2-3m above the footpath, and was formed by an irregular nominally triangular plot, tailing off to a sharp point to the south.</p> <p>The southern tip of the site was inaccessible due to being heavily vegetated.</p> <p>The main body of the site had a slope towards No.4 Rudman Street to the west boundary.</p> <p>The site was covered with long grass, with some vegetation to the east/southeast boundary which included Japanese Knotweed.</p> |
| Areas of discoloured soil, polluted water, vegetation, and significant odours: | <p>None noted.</p> <p>Some small patches of Japanese Knotweed to the east boundary.</p> |
