# STRUCTURAL INSPECTION REPORT

Project Ref: Edge Gate Farm, Newhey

Date: 25 August 2022

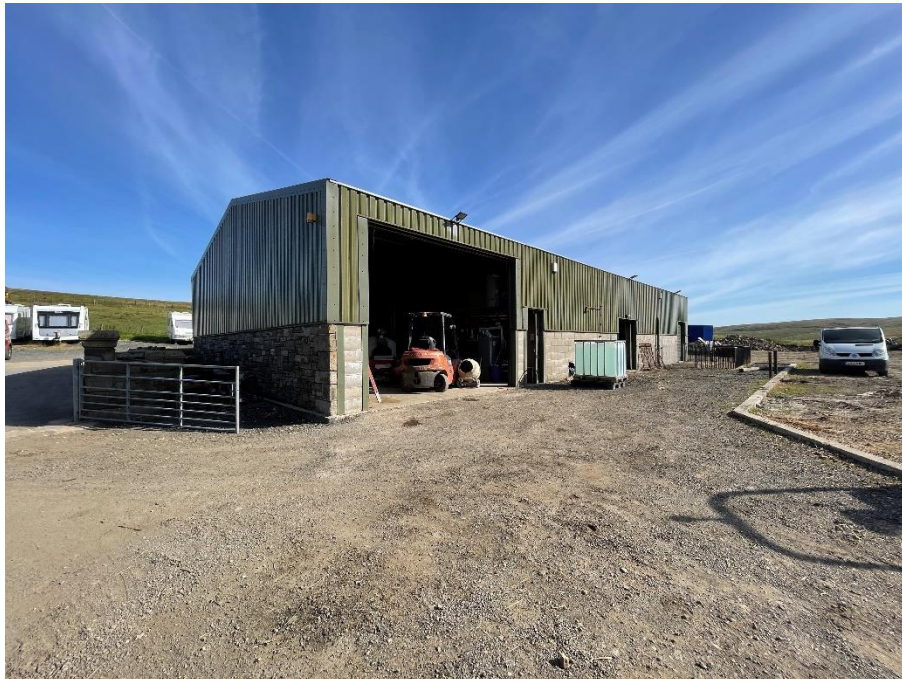
Photo 2 - Agricultural Building view from northwest

- 3.2 The building is not listed on the National Heritage List.
- 3.3 The building is a single storey agricultural building current being used as storage for the farm.

- 4.1.4 There are four doors located within the front elevation, one large roller shutter door to the left-hand side, one slightly smaller roller shutter to the right-hand side, a single personnel door to the right of the larger roller shutter door and a double door centrally located.
- 4.1.5 The lower half of the east side elevation is also constructed from block masonry. The ground levels adjacent to the building raise towards the rear elevation (see Photo 4).
- 4.1.6 The lower masonry wall to the northwest elevation is constructed in stone (see Photo 2)

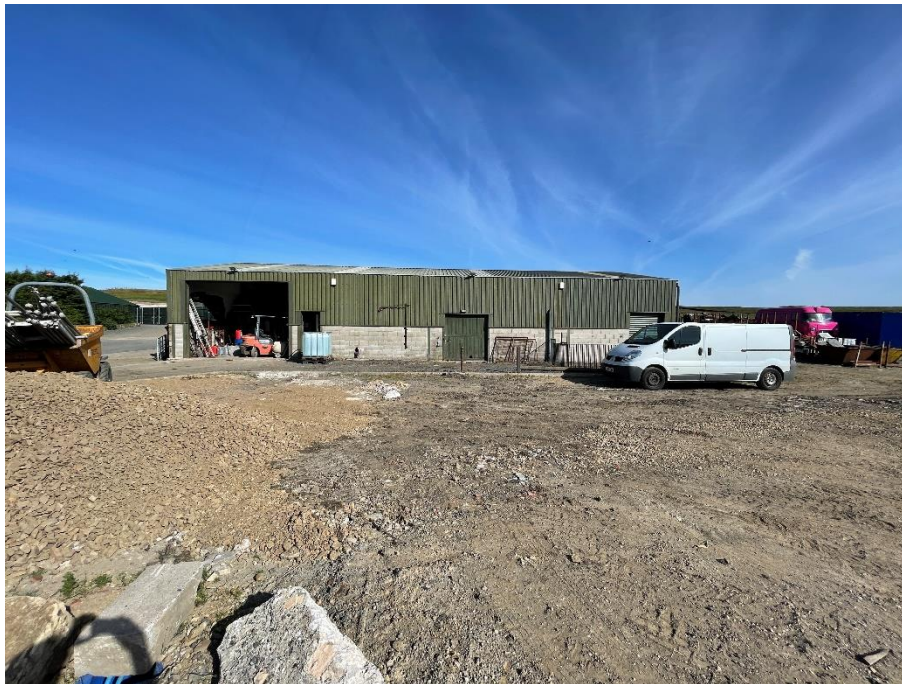
Photo 3 - Front Elevation

- 4.1.1 The building is constructed from a steel portal frame clad with steel roof cladding, the walls clad to upper half and the lower half constructed from masonry.
- 4.1.2 The building is rectangular on plan approximately 22m long by 12m wide and 4m high to the eaves. It has a duo-pitched roof.
- 4.1.3 The lower wall to the front elevation is constructed from block masonry (see Photo 3).

- Alterations to the mezzanine floor to include staircases
  - Additional area of mezzanine floor
  - Introduction of separating walls
- 6.4 The alterations to the external elevations can be made by altering the structural support to the cladding. This is a minor structural alteration.

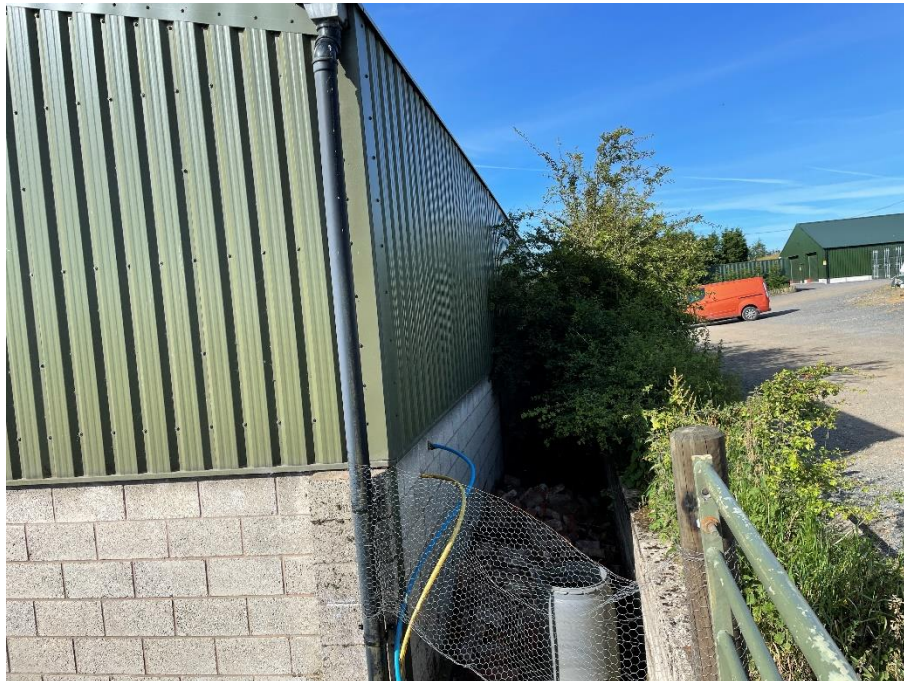
Photo 5 - Rear Elevation

- 4.1.7 The rear elevation is similar, the lower wall constructed in blockwork and the ground level is higher. There is a retaining wall spaced approximately 1.5m away from the face of the building which retains the higher ground (see Photo 5).

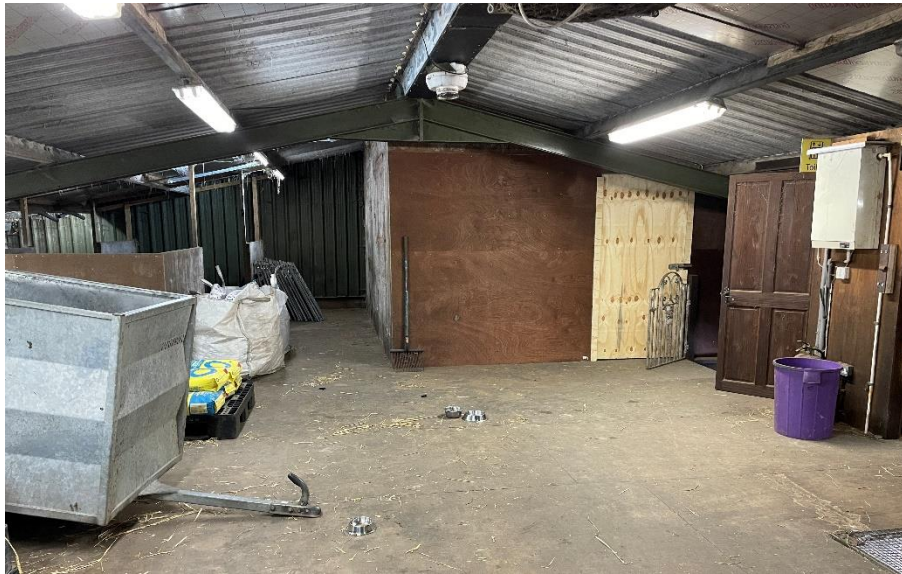
Photo 6 - Mezzanine Floor

- 4.2.1 We were able to inspect the building internally.
- 4.2.2 The building was being used therefore our inspection was limited to certain areas.
- 4.2.3 There was a timber mezzanine floor constructed to two thirds of the building, this was used as a storage area (see Photo 6).

- 6.5 The alterations to the mezzanine floor will require additional timber joists to form the openings within the mezzanine floor to cater for the new stair opening.

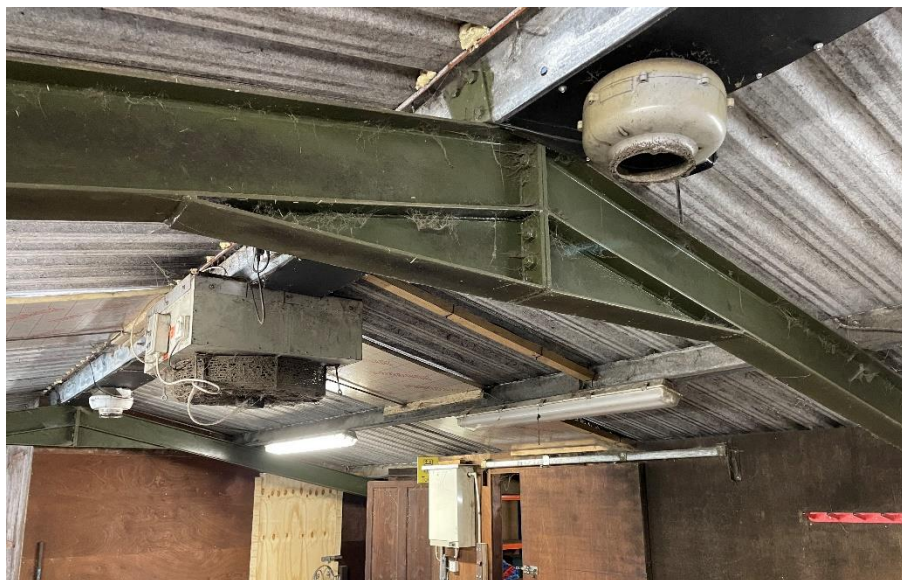
Photo 7 - Steel Portal Frame

- 4.2.4 The steel frame was exposed, this comprised of steel sections connected with moment resisting connections typical with this type of structure.

- 4.2.5 Steel purlins spanned between the steel portal frames, these purlins supported the metal sheet roof.
- 4.2.6 Steel cladding rails spanned between the steel portal frames which supported the metal side cladding.

- 5.3 We did not observe any structural defects with the property that would require intervention over and above what is listed within the Class Q guidance.
- 5.4 We were informed that the steel frame was supplied and erected by a reputable farming steel frame supplier Wareing buildings <https://www.wareingbuildings.co.uk/> over 20 years ago.
- 5.5 The building is located at an elevation of over 1000 feet above sea level and has stood the test of time, with weather cycles of extreme wind loads and heavy snow fall.
- 5.6 The inside of the building has been used for all these years as an agricultural storage which would apply greater loads than domestic loadings.
