## Phase 2 Intrusive Site Investigation

### **Concept Design Architects**

Edgegate Farm, Huddersfield Road, Milnrow, OL16 3TJ

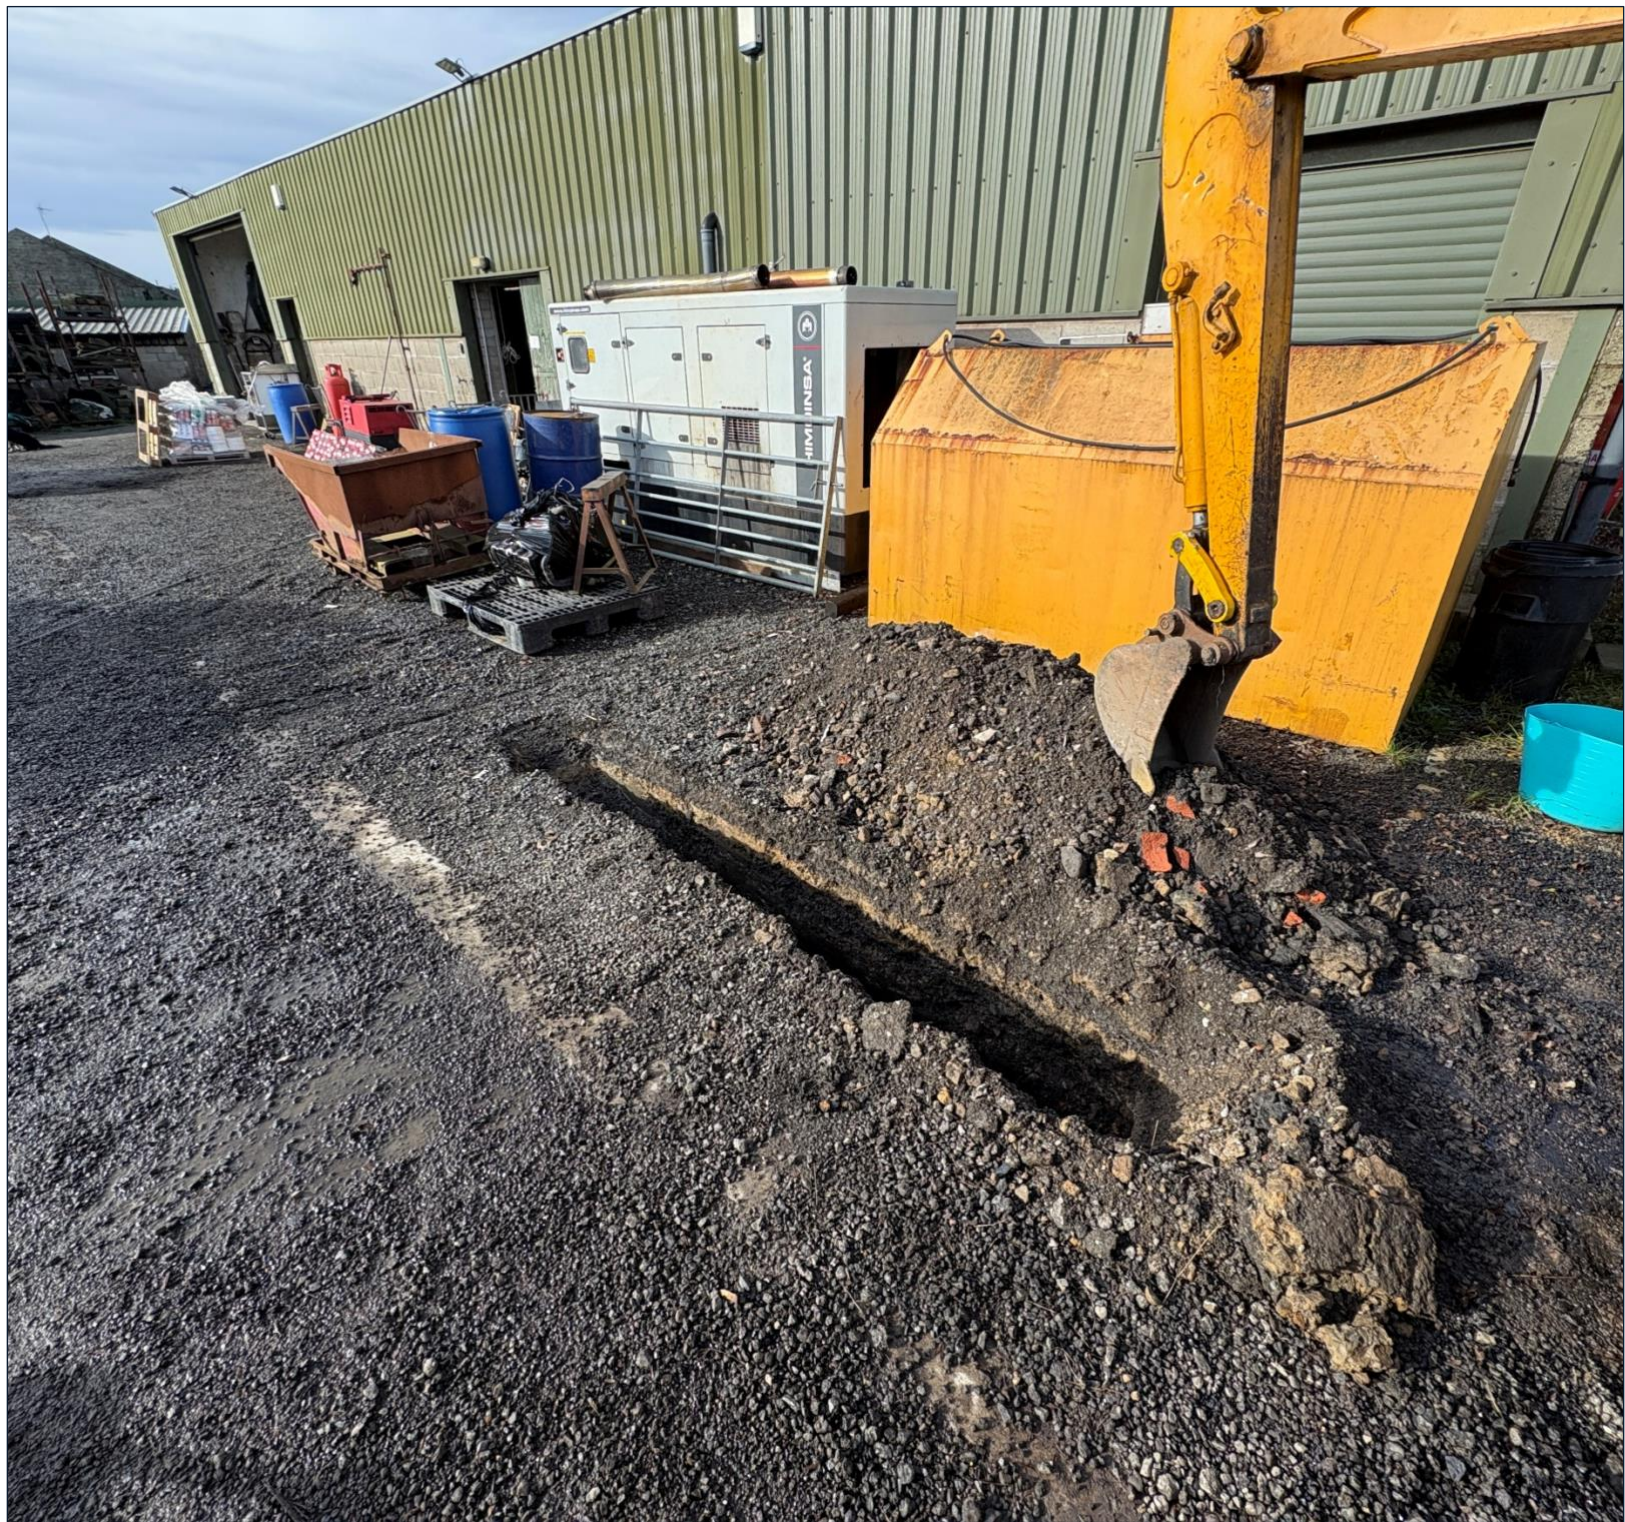
Ground conditions identified in trial pit TP01 comprised made ground including road planings overlying blackish brown gravelly sandy clay with frequent road planings, gravel, brick and concrete and patches of yellow gravelly sand to a depth of 0.20m, made ground including blackish brown gravelly sandy clay with frequent road planings, gravel, brick and concrete to a depth of 0.60m and made ground including blackish brown and medium brown gravelly sandy clay with frequent road planings, gravel, brick and concrete to the bottom of the trial pit at 1.00m.

Photo showing the location of trial pit TP01

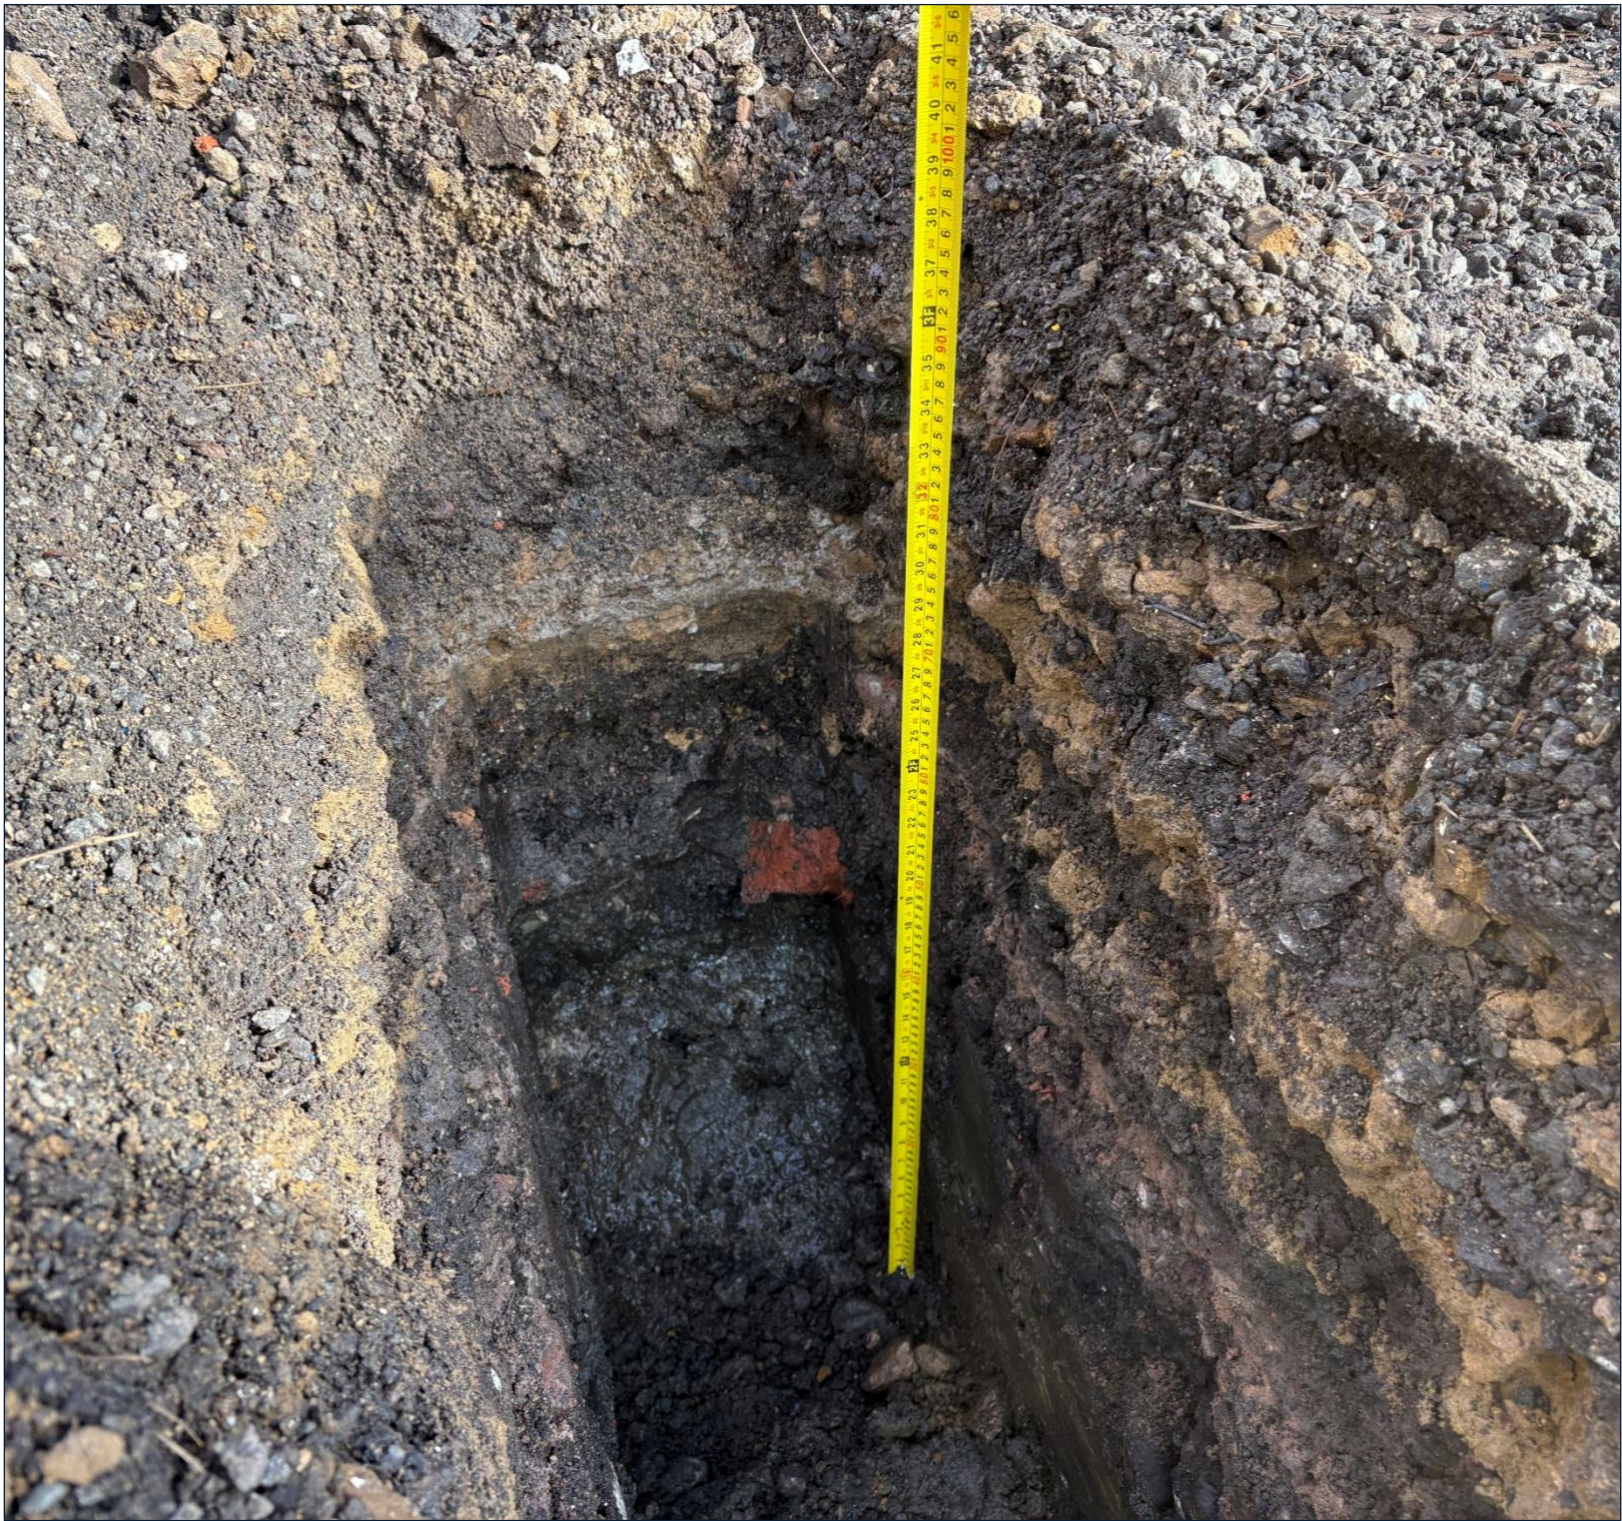
Photo showing the depth of trial pit TP01

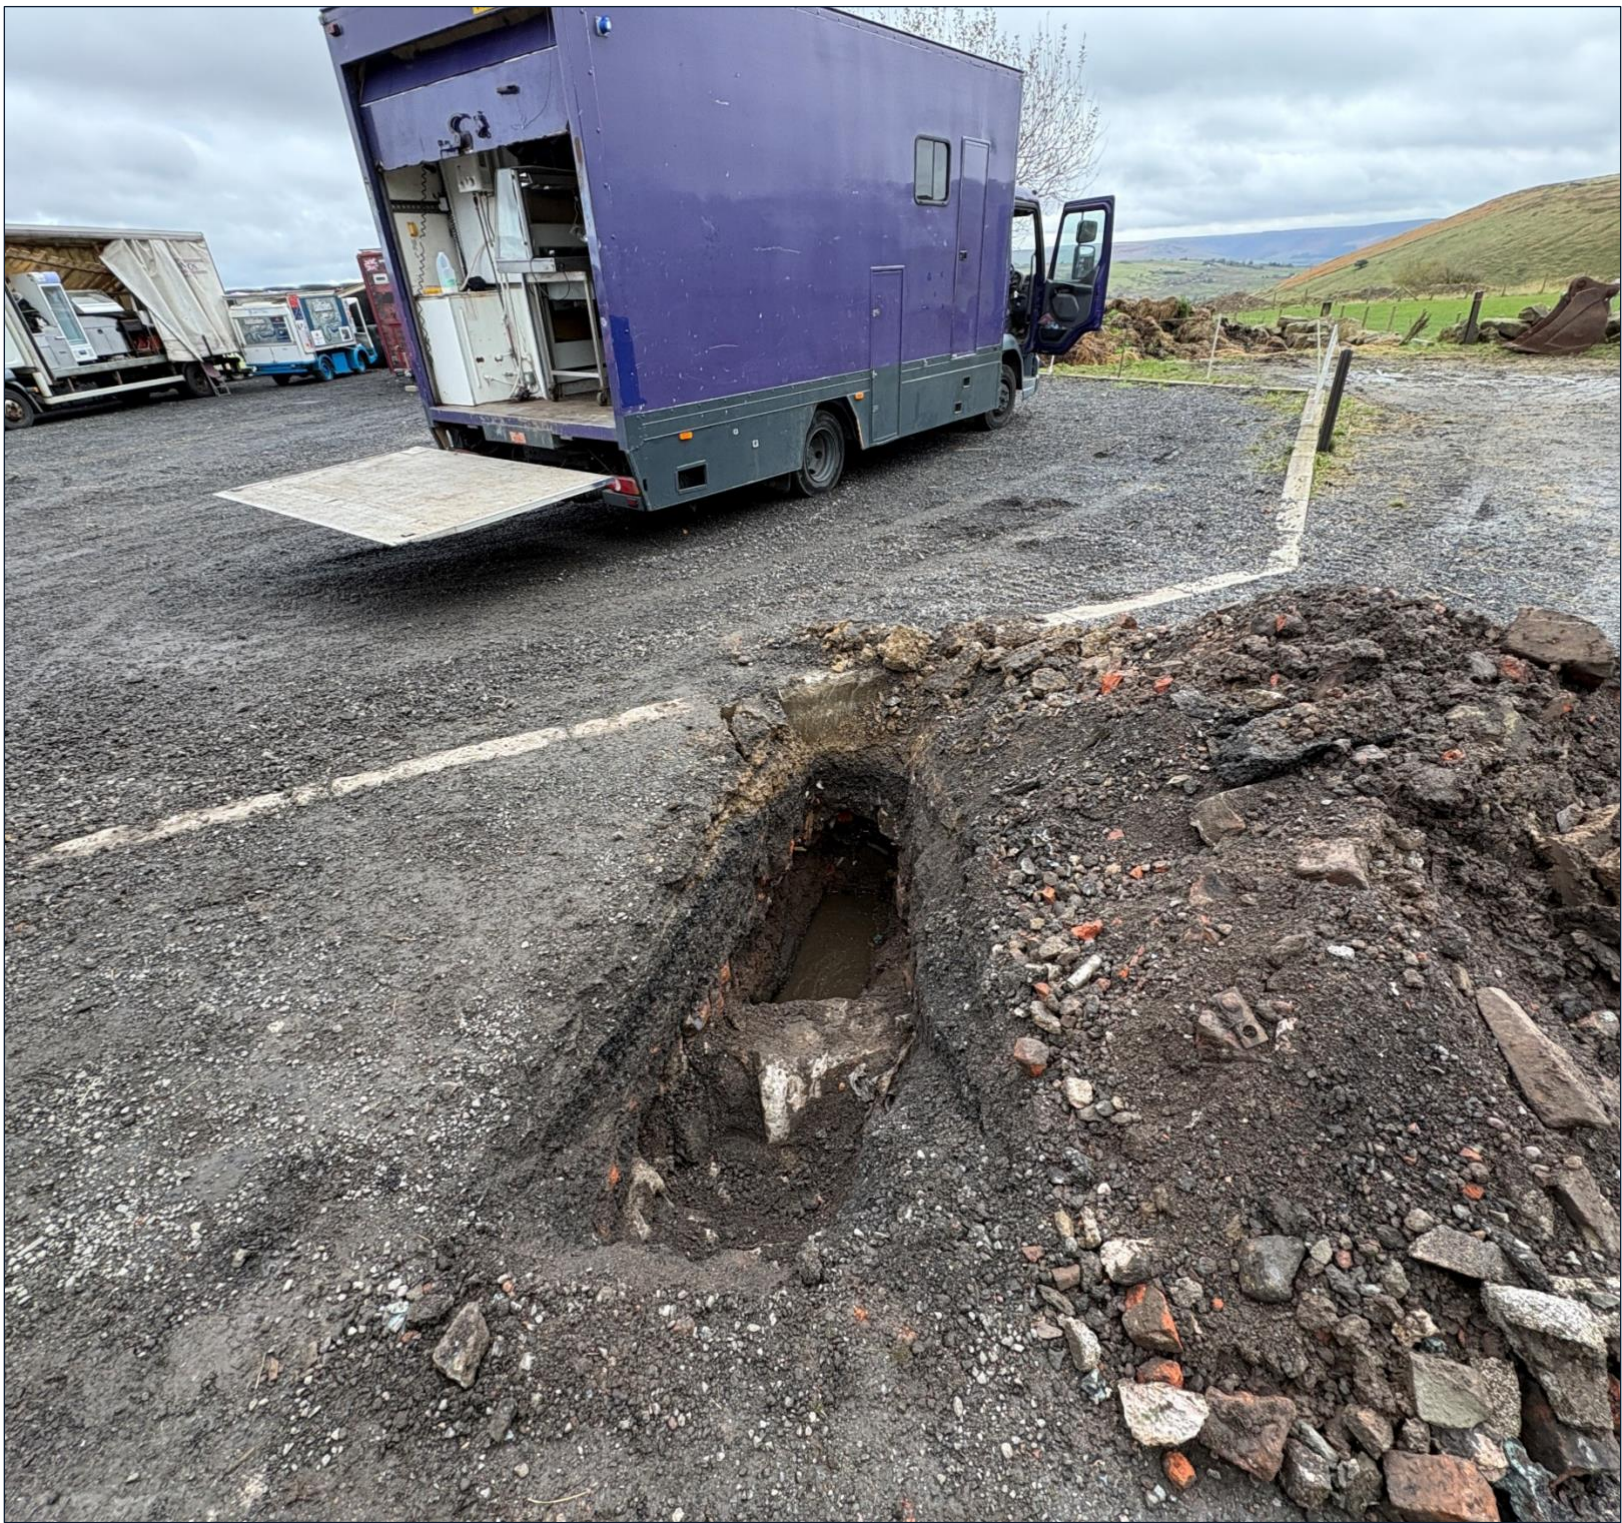
Ground conditions identified in trial pit TP02 comprised made ground including road planings overlying blackish brown gravelly sandy CLAY with frequent road planings, gravel, brick and concrete and patches of yellow gravelly sand to a depth of 0.30m, made ground including blackish brown gravelly sandy clay with frequent road planings, gravel, brick and concrete to a depth of 0.90m, made ground including blackish brown and medium brown gravelly sandy clay with frequent road planings, gravel, brick and concrete to a depth of 2.00m and blackish brown slightly sandy clay with gravel the bottom of the trial pit at 2.10m.

Photo showing the location of trial pit TP02

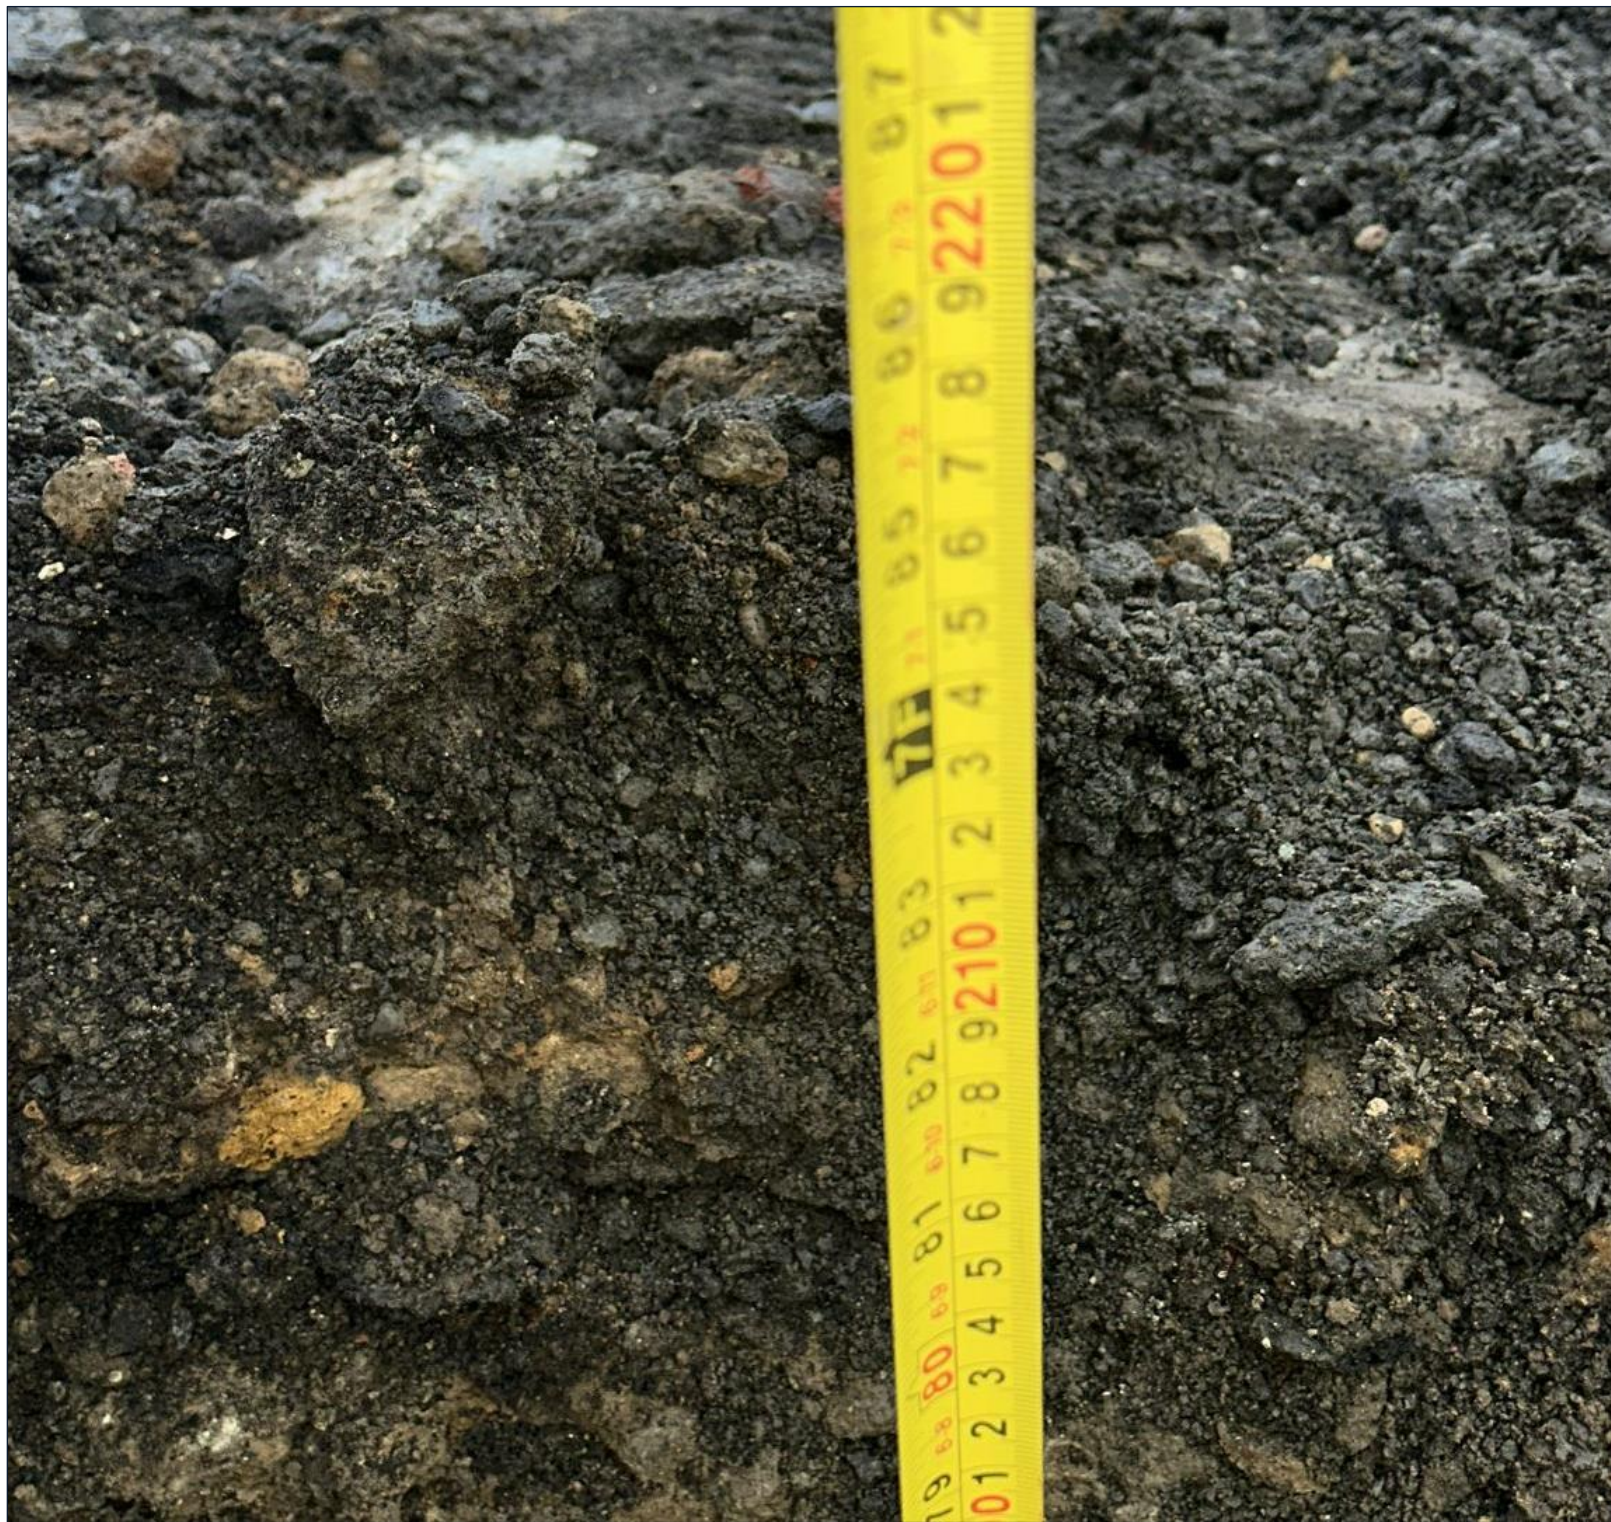
Surface water pooling was identified in trial pit TP02, due to heavy rainfall at time of sampling and underlying clay soils, however, no groundwater was identified.

Photo showing the depth of trial pit TP02

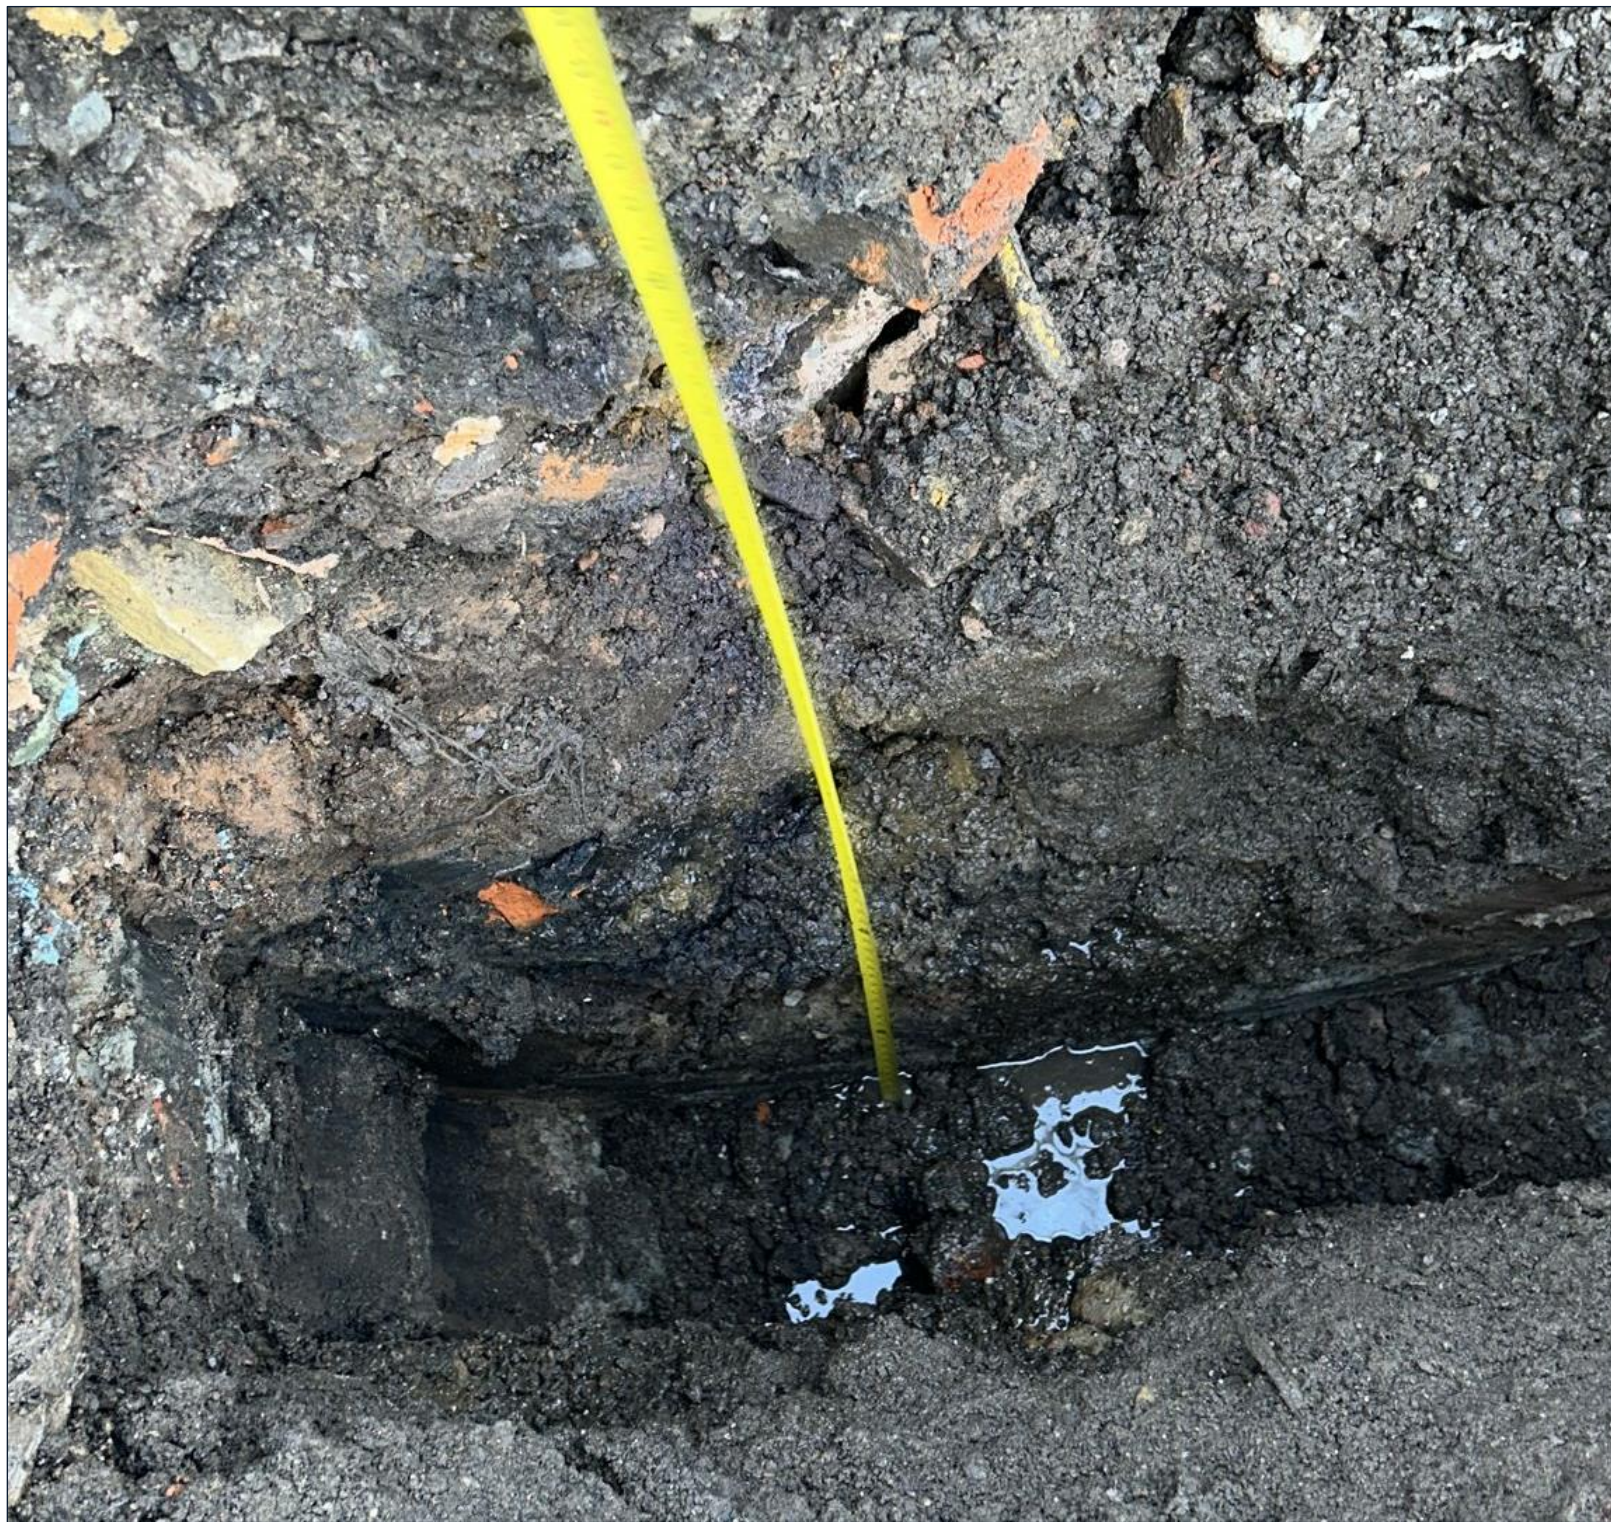
Photo showing the depth of trial pit TP02
