# Precautionary Working Method Statement (PWMS) *for bats*

**Site:** Littleborough Community Primary School,  
Calderbrook Road, Littleborough, OL15 9HW

**Ref:** 231665 / E5

**Client:** Rochdale Borough Council

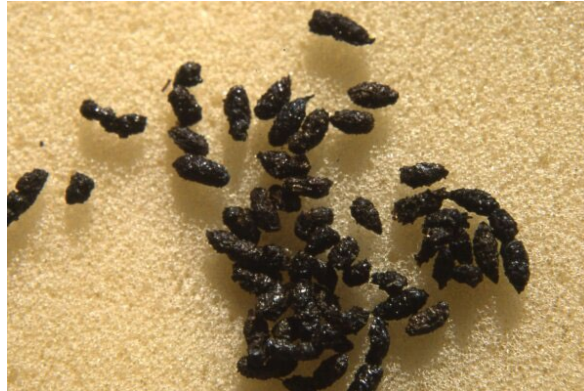
### **Bat Droppings**

- Small, dark pellets (like mouse droppings but crumbly)
- Often found below roost points (windowsills, floors, ledges)
- When crushed, they break apart easily and may show shiny insect fragments

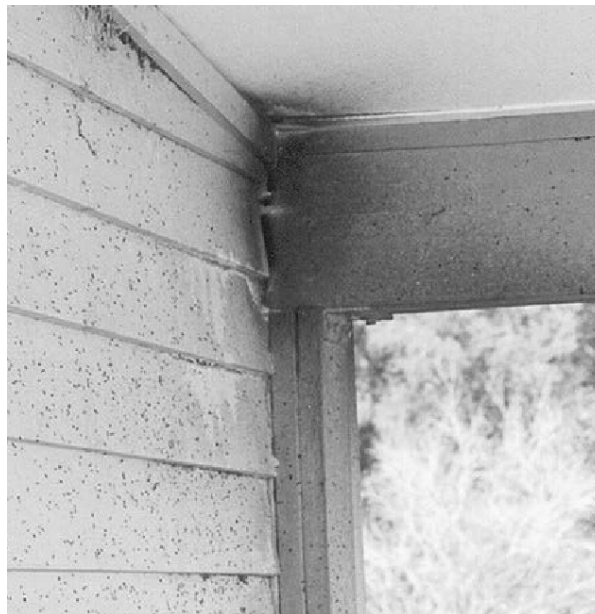
### **Staining / Grease Marks**

- Dark brown/black staining around small gaps or crevices
- Often around fascia boards, soffits, or tile gaps
- Caused by oils in bat fur as they repeatedly enter/exit

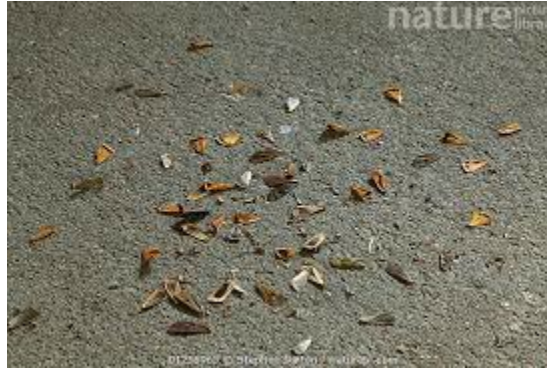
### **Feeding Remains**

- Piles of insect wings (often moth wings)
- Found beneath feeding perches or roost access points
- Looks like dry, papery fragments

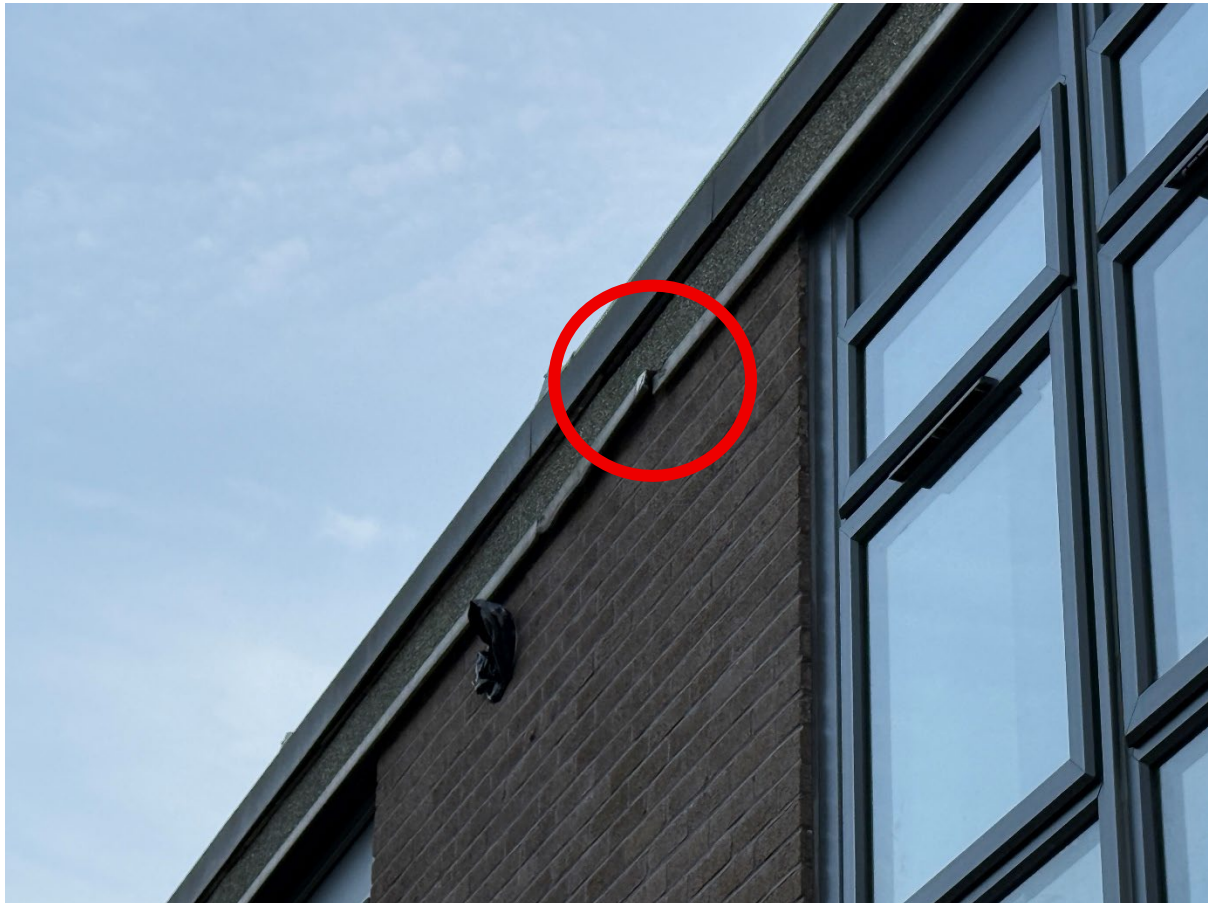
*Photograph below of confirmed bat roost on the east-elevation of the building.*

These features are to be retained and left undisturbed at all times. Any works affecting these areas will require further ecological input and may require licensing.

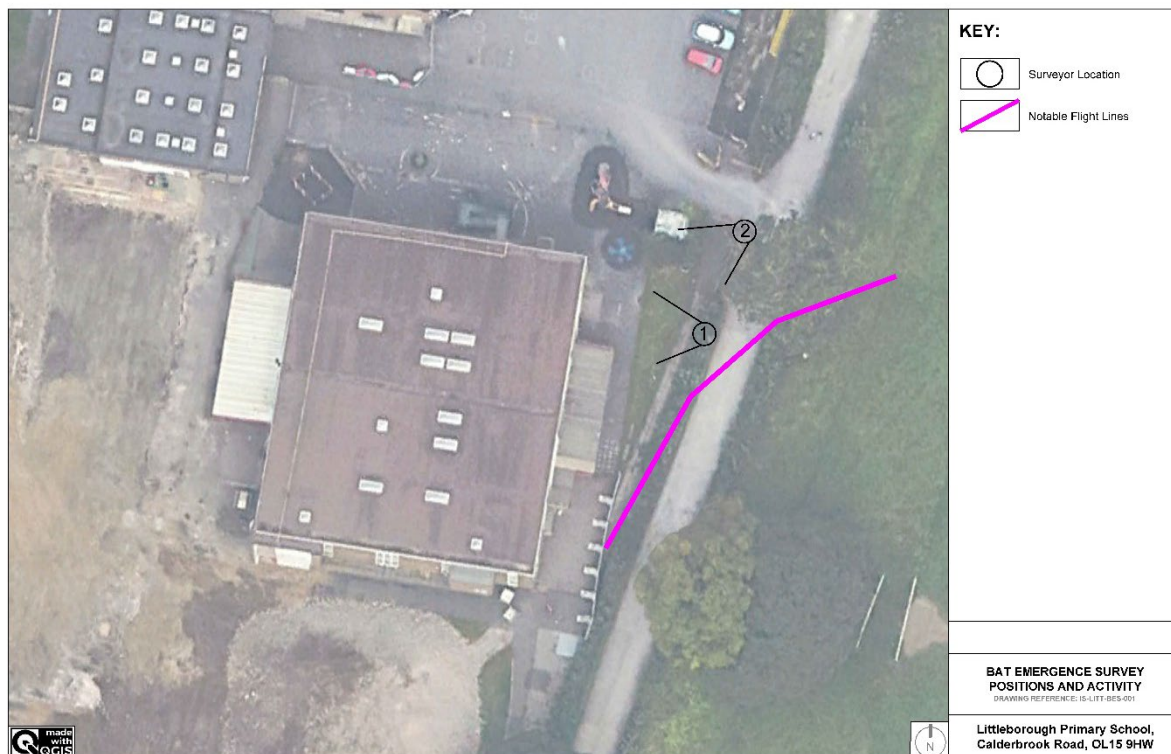
**Figure 1: Surveyor and infrared camera positions and locations (Survey 1)**
