# BIODIVERSITY METRIC REPORT

| Site: | Bowlee, Rochdale |
| References: | 83-001 |
| Date: | 12 August 2026 |

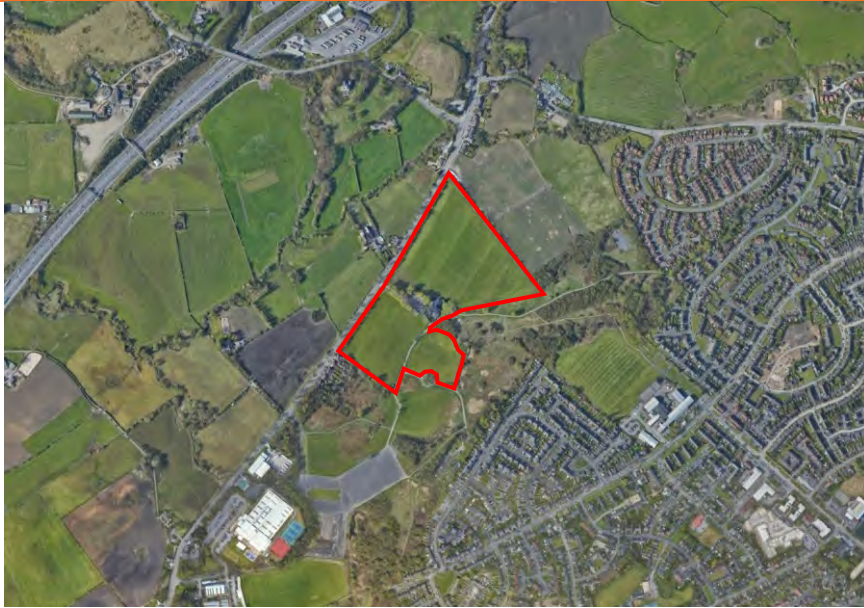
Figure 1 Approximate Site Location

The site is located on the outskirts of Middleton. Heywood Old Road runs adjacent to the western boundary of the site while Bowlee Community Park lies adjacent to the east of the site. Edgar Wood Academy is located to the north of the site and residential housing with a patchy area of woodland and scrub is located to the south of the site. Whittle Brook is located approximately 70 m west of the site at its nearest point, and the M62 is located approximately 550 m west of the site at its nearest point. Please refer to Figure 1 for the approximate site location.

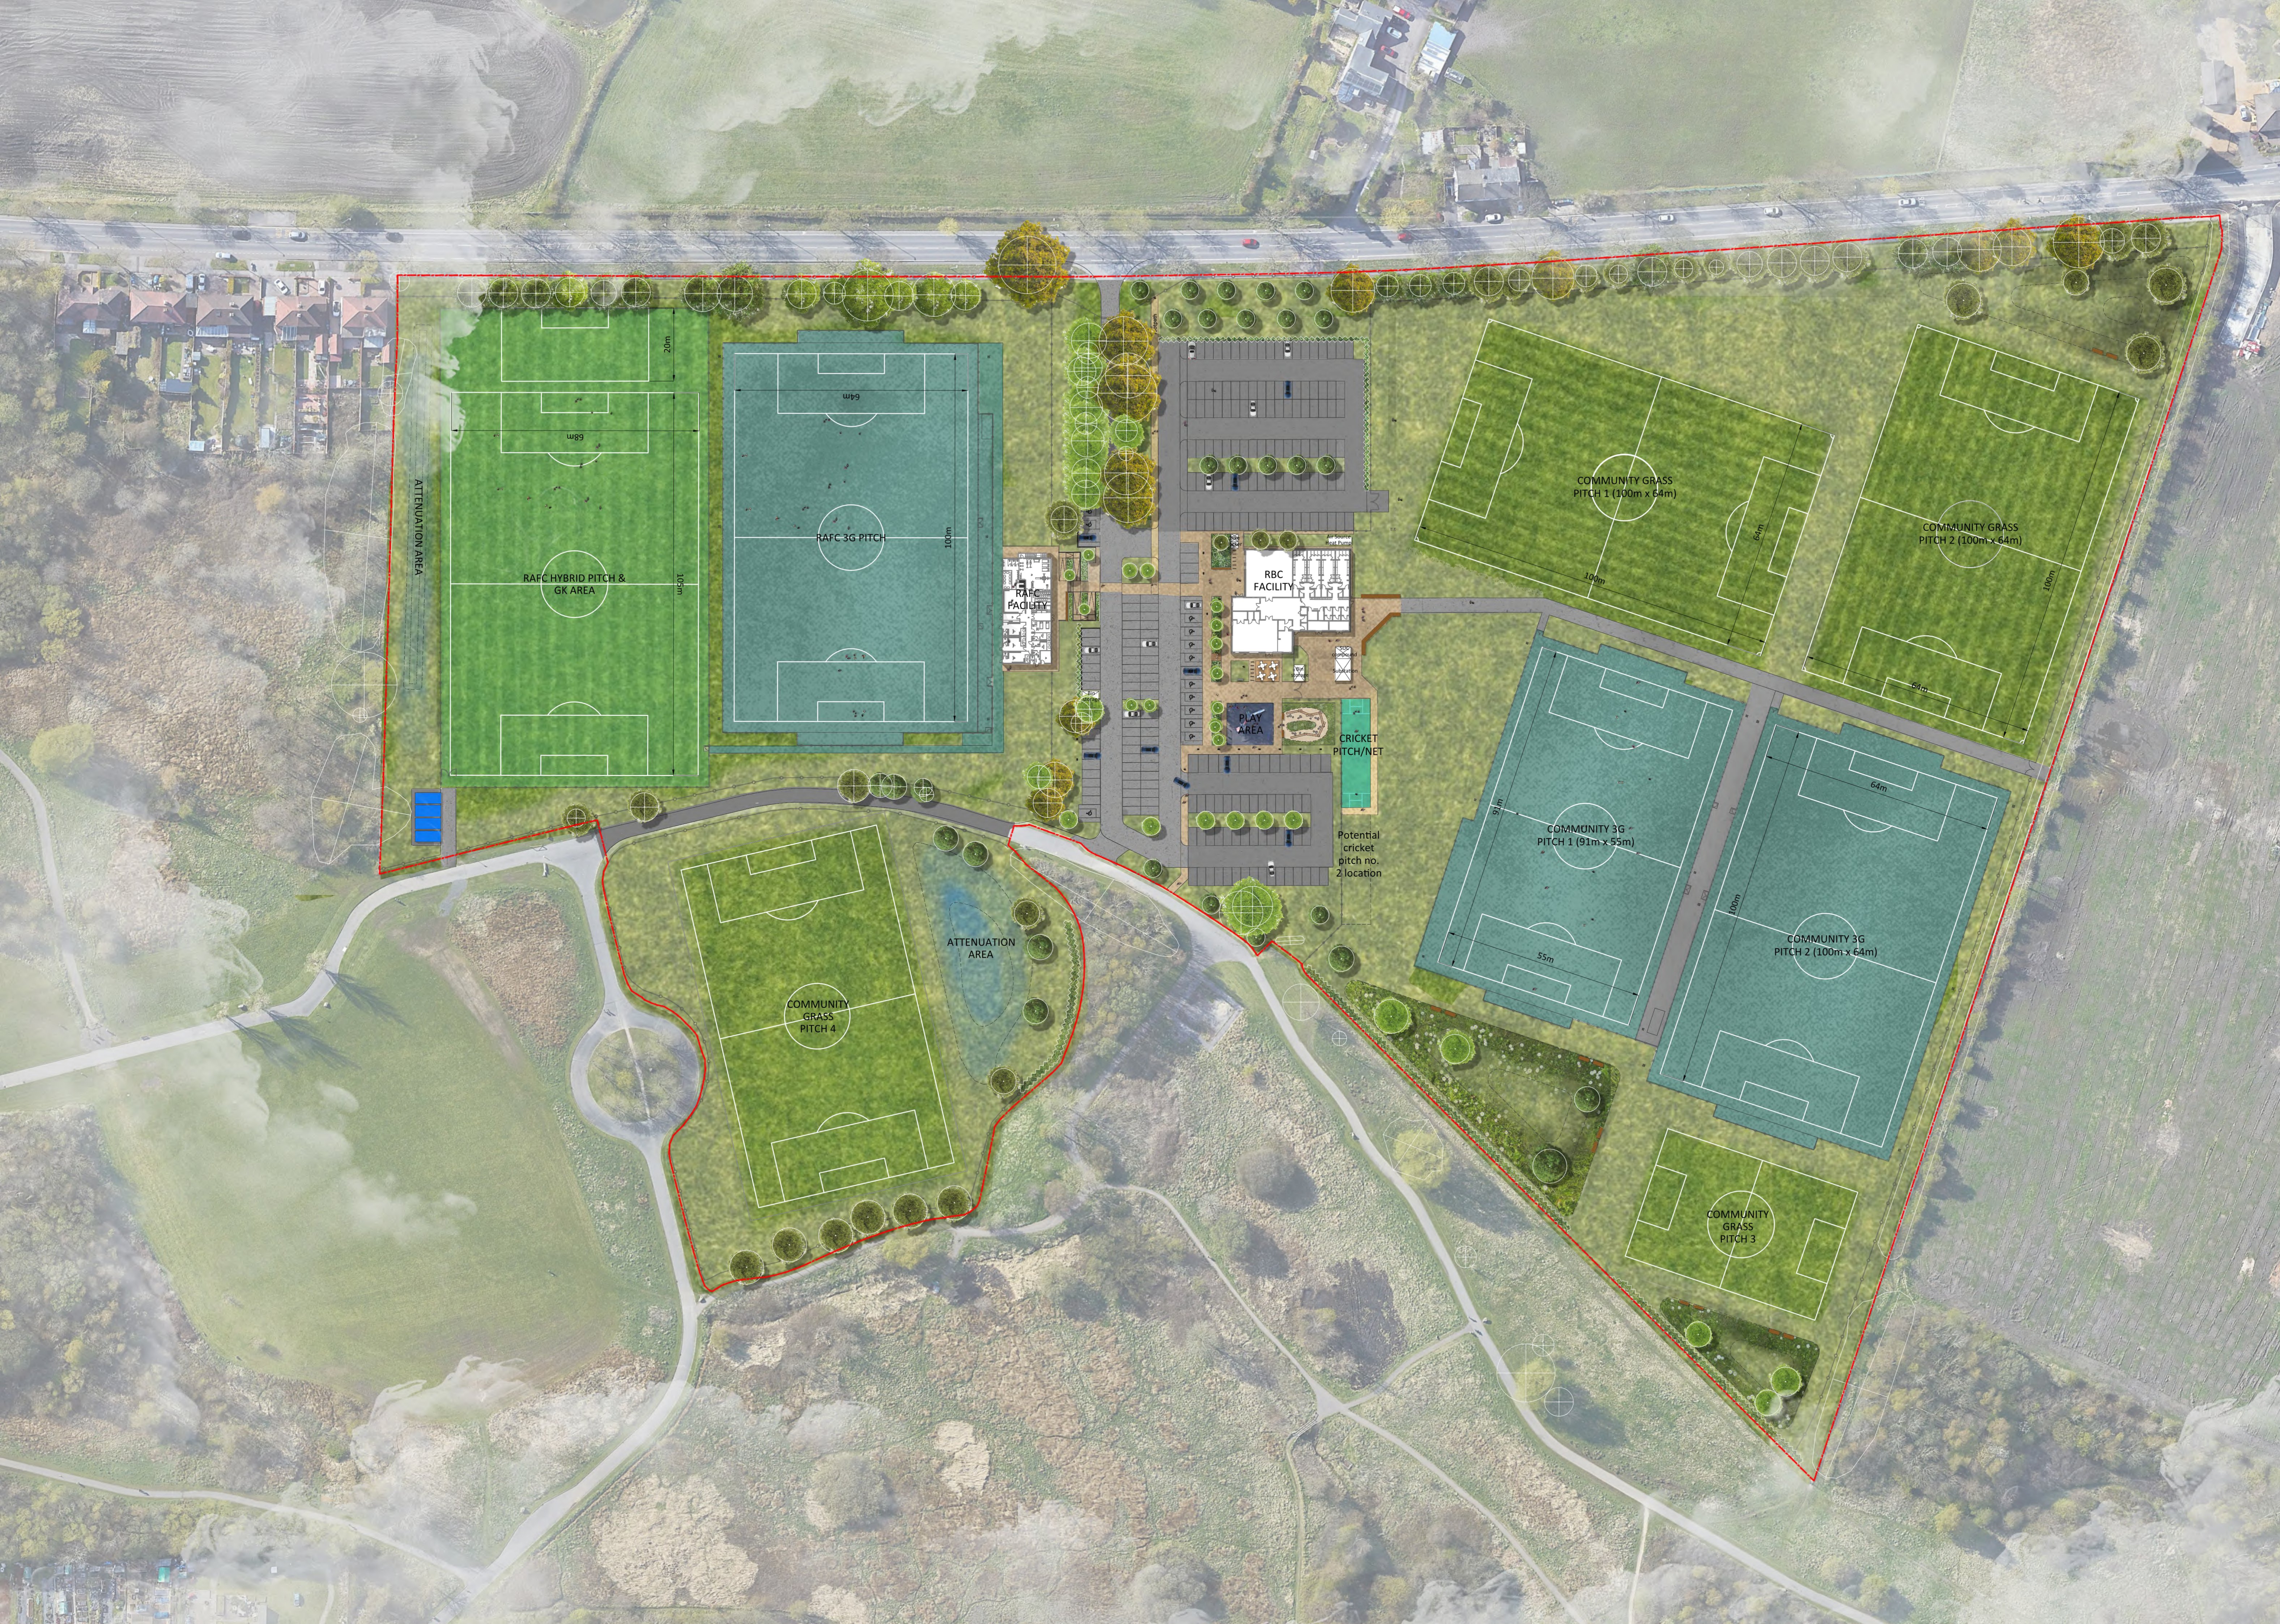
# Appendix III: Illustrative General Arrangement Plan

The General Arrangement Plan (Re-form Landscape Architecture, 2026, Drawing Reference: 1341-RFM-XX-00-DR-L-0101, Revision: P03) was used to measure habitat creation on site. The areas of proposed habitat were measured using QGIS from the PDF drawing. The RPAs of proposed trees were calculated using the metric's tree helper. All newly planted trees are assumed to be small (<30cm diameter at breast height (DBH) when planted) in line with the guidance.

Please see **Appendix III** for the General Arrangement Plan and **Appendix IV** for the Post Development Habitat Plans.

The General Arrangement Plan shows a total loss of 1.89 (-8.15%) habitat units, and a gain of 0.34 (10.64%) hedgerow units as a result of the development. The habitat trading rules of the metric have not been satisfied as habitats lost have not been compensated for by habitats of the same or higher distinctiveness.

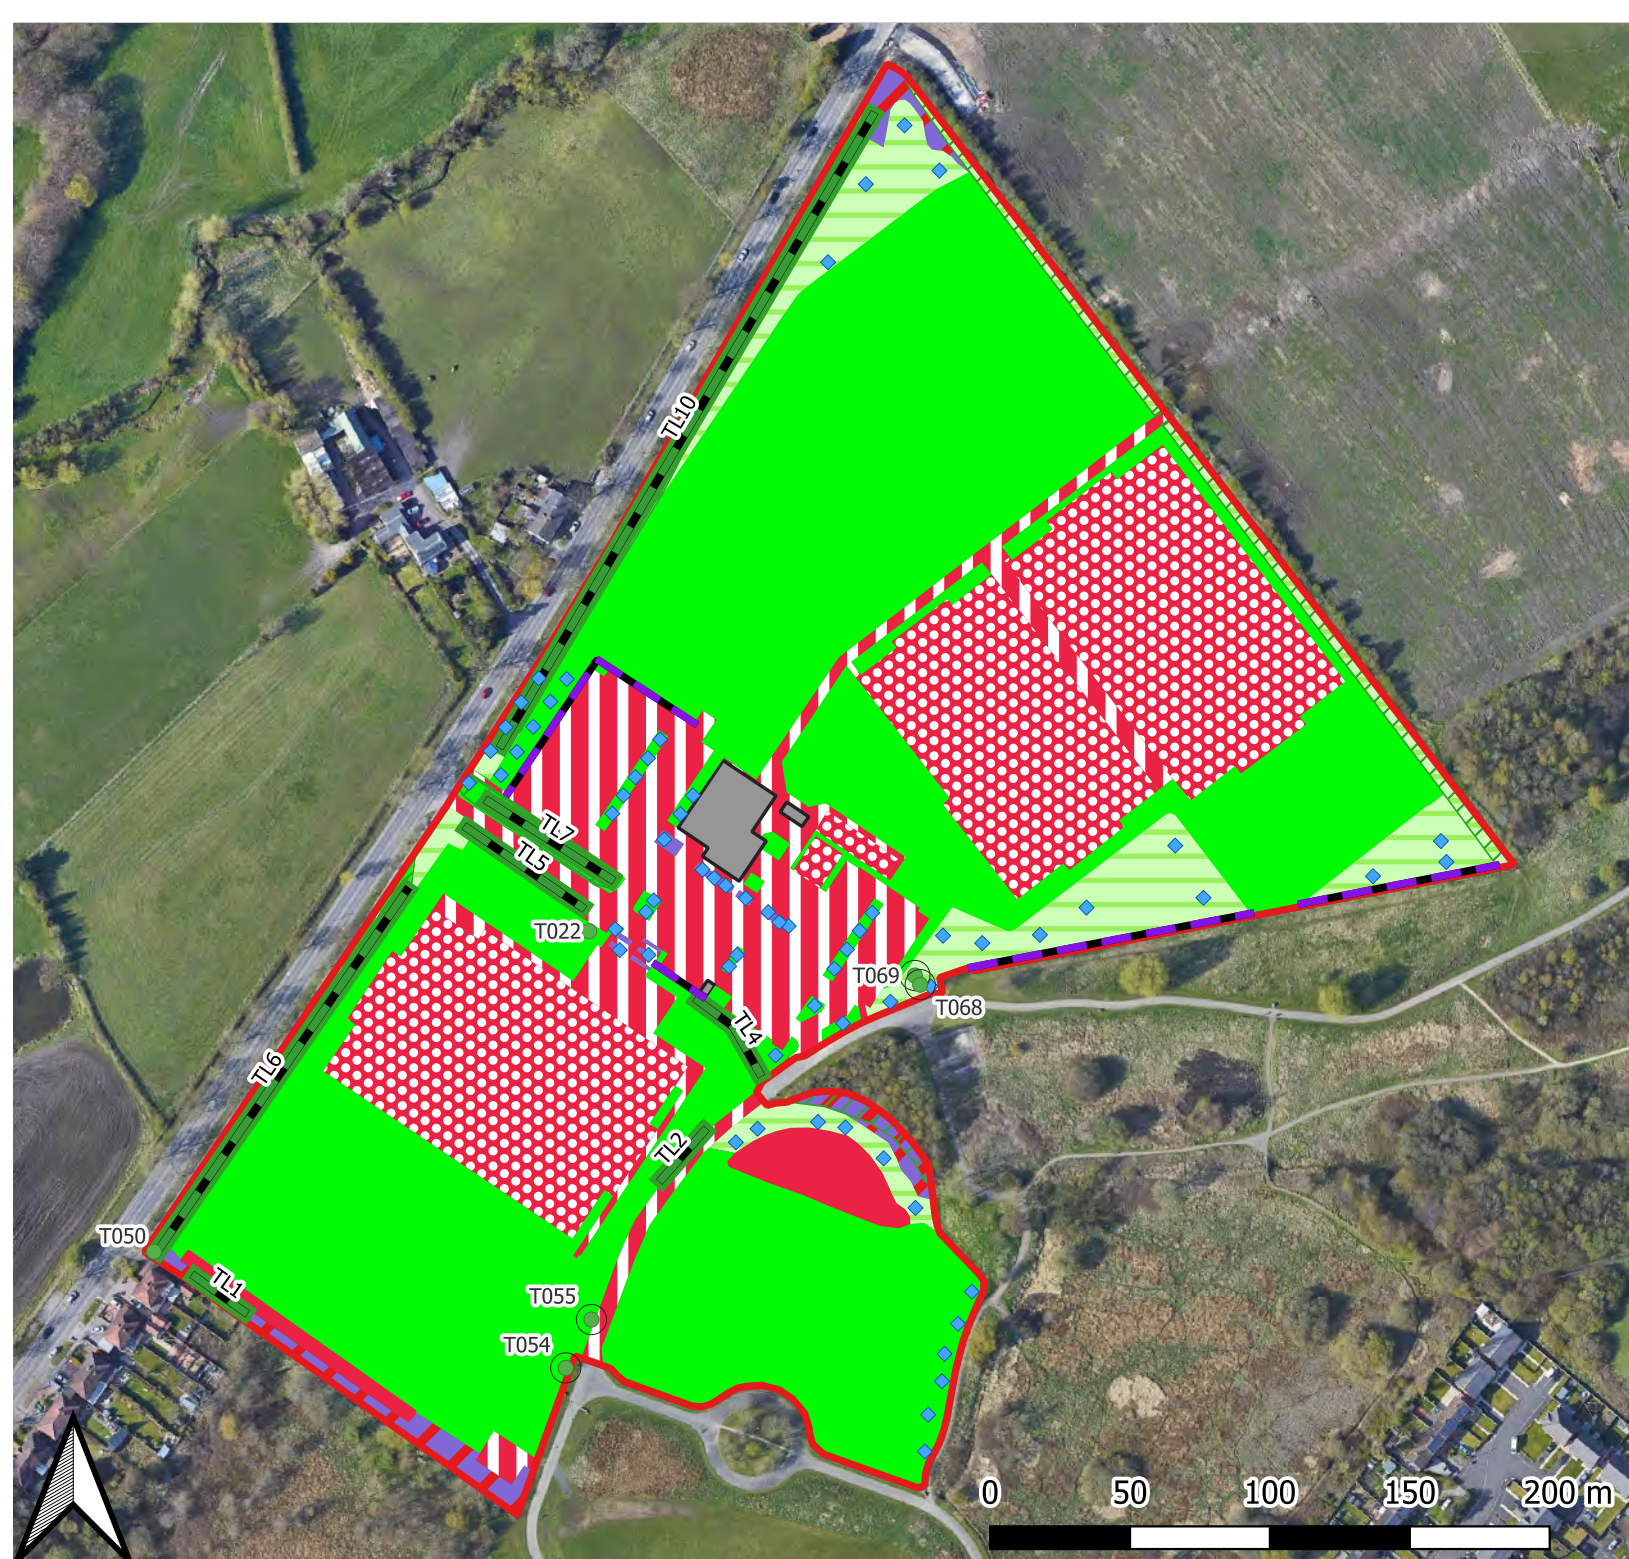
# Appendix IV: Post Development Plan

- Red line boundary
- Proposed small urban tree
- Retained medium rural tree
- Retained small rural tree
- Retained line of trees
- Proposed species-rich native hedgerow
- Artificial unvegetated, unsealed surface
- Buildings
- Developed land; sealed surface
- Introduced shrub
- Mixed scrub
- Modified grassland
- Moderate condition modified grassland
- Other neutral grassland
- Sustainable drainage system
- Retained habitats
