Phase II Geoenvironmental Site Assessment  
Land to the West of New Street, Littleborough

Reference: 15-075-R2-2

Date: June 2023

## **PHASE II GEOENVIRONMENTAL SITE ASSESSMENT**

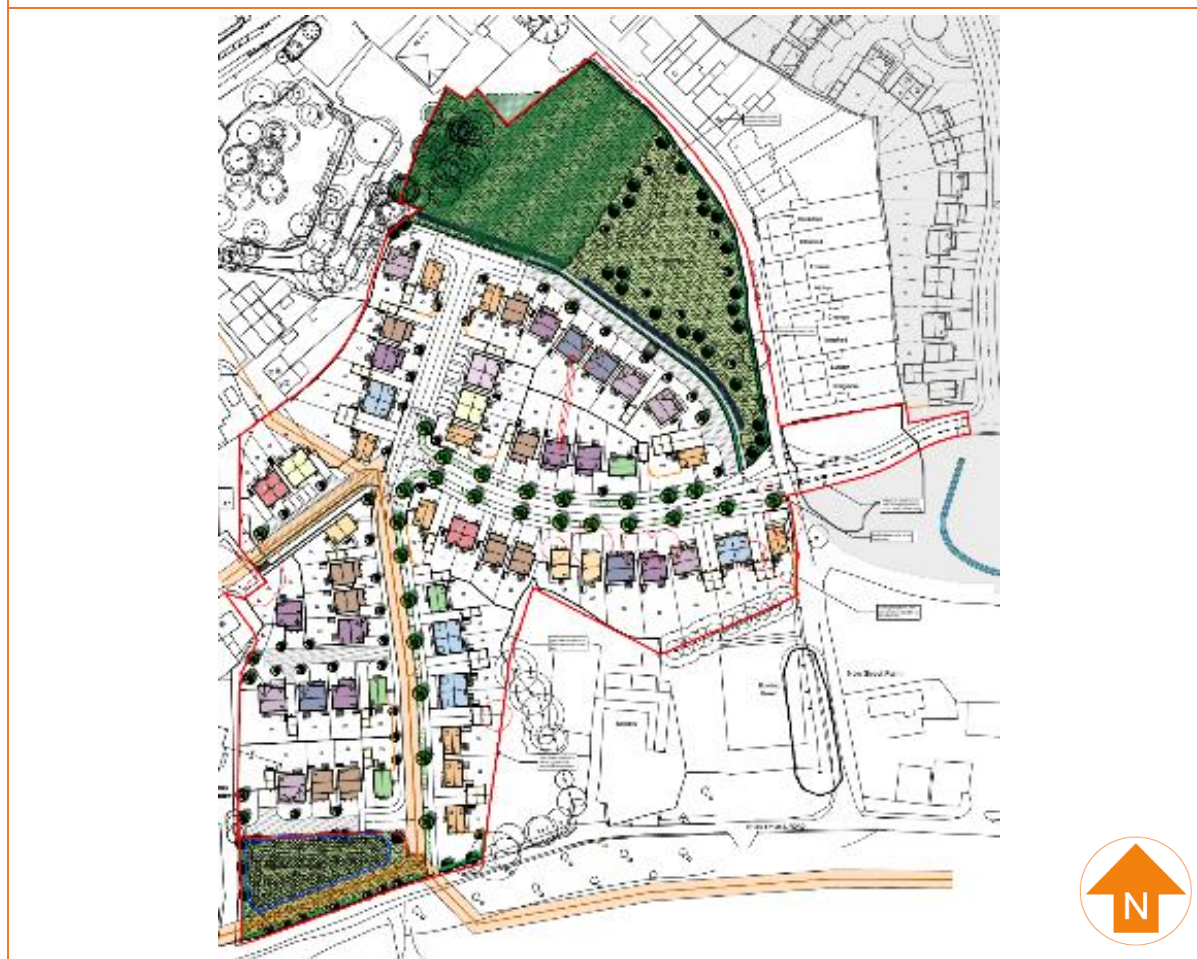
FIGURE 1.1 SNAPSHOT OF THE PROPOSED DEVELOPMENT

The Proposed Development Scheme is presented in Drawing 15-075-002 (Appendix III) and Figure 1.1 below.

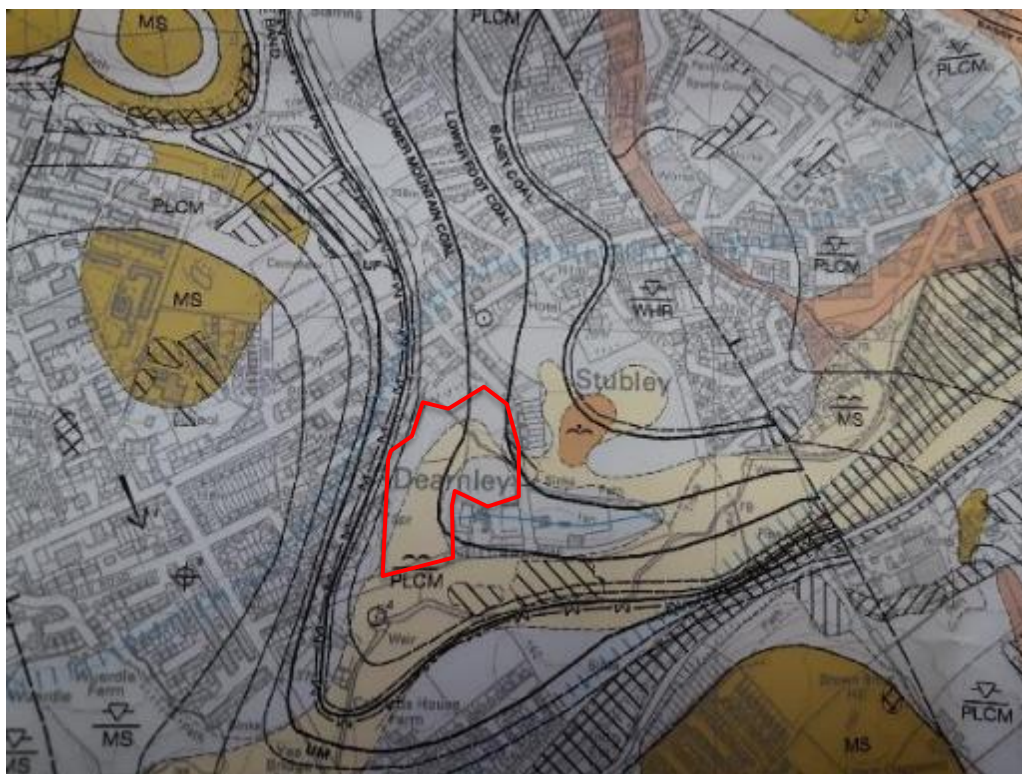
FIGURE 5.1 PHOTOGRAPH OF THE 1:10,000 PLAN FOR THE SITE

Figure 5.1 below is a photograph of the 1:10,000 plan for the site which shows the presence of coal seams outcropping within the site boundary.

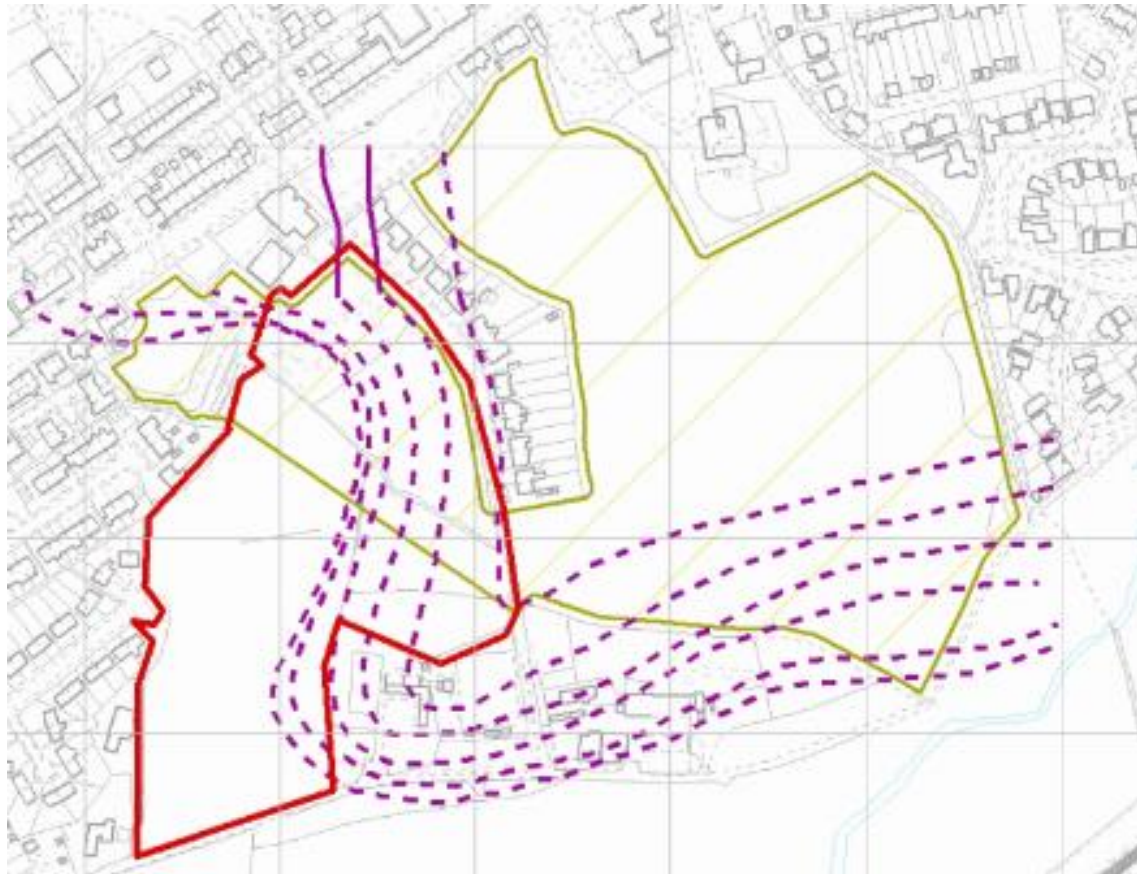
**FIGURE 5.2 COAL AUTHORITY PLAN FOR THE SITE**

The Coal Authority plan referenced: MR-LARGE-PLOT-51003006852001-1649344698727 shows six conjectured outcrops on Site. Two of the outcrops are recorded as proven at the northern boundary.

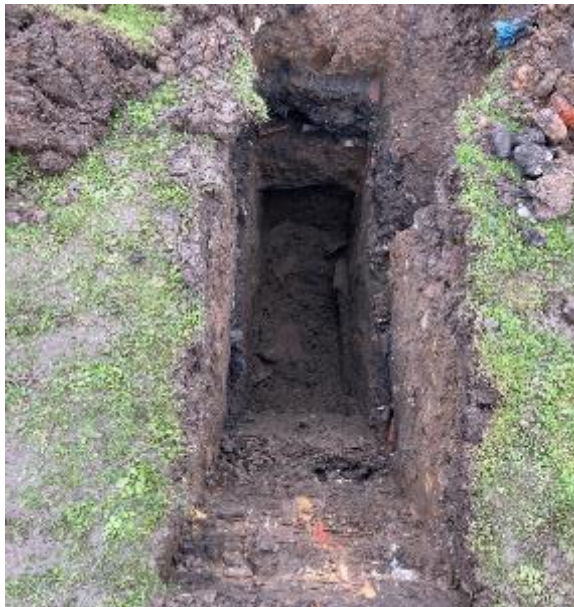
PLATE 8 TP107 EXCAVATION AND ARISING – MADE GROUND

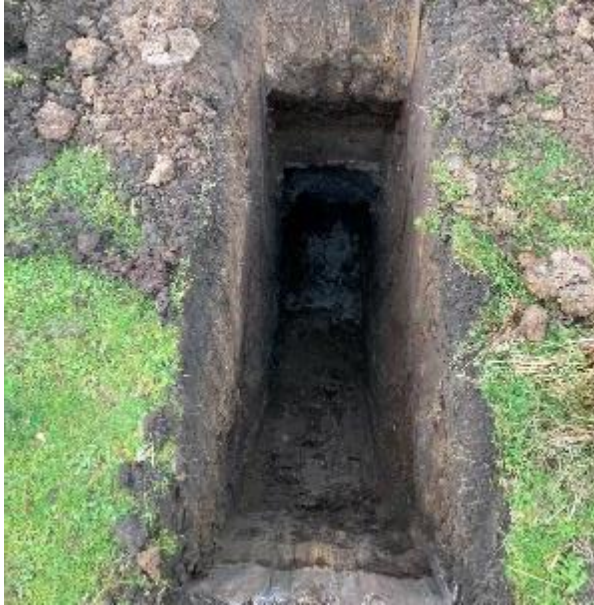
PLATE 9      TP115 EXCAVATION AND ARISINGS – NATURAL DRIFT WITH POCKETS OF PEAT

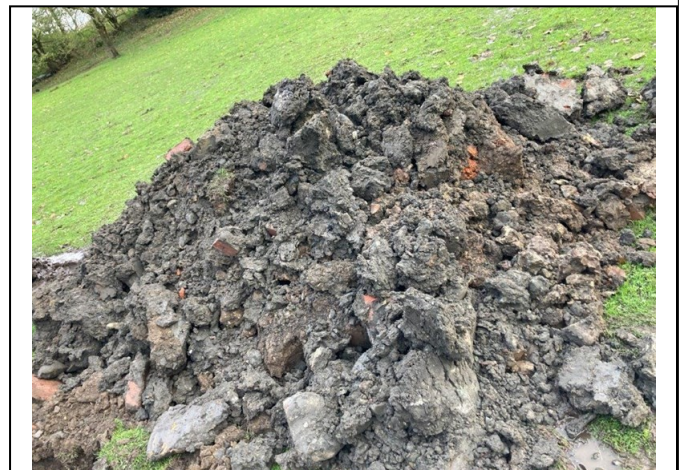
TP101 spoil

Remarks: 1. Terminated on concrete boulder at 2.80 m bgl. 2. Water strike encountered at 0.40 m bgl as slow ingress through Made Ground.

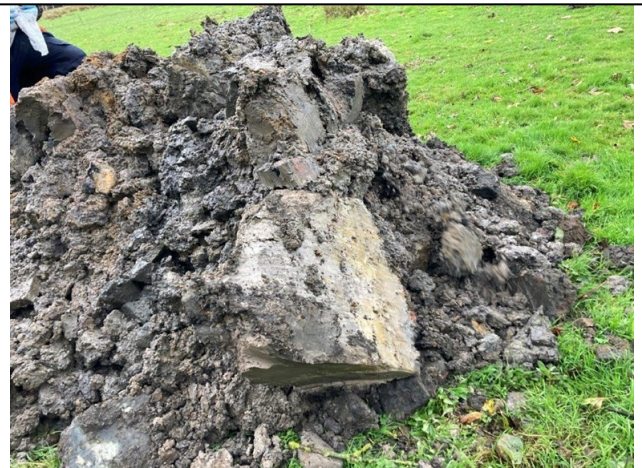
TP104 spoil

Remarks: 1. Complete. 2. Unstable at 1.20 m bgl due to granular Made Ground deposits. 3. Water strike encountered at 1.50 m bgl as slow ingress through granular Made Ground and at 2.00 m bgl as fast ingress through sandy CLAY.

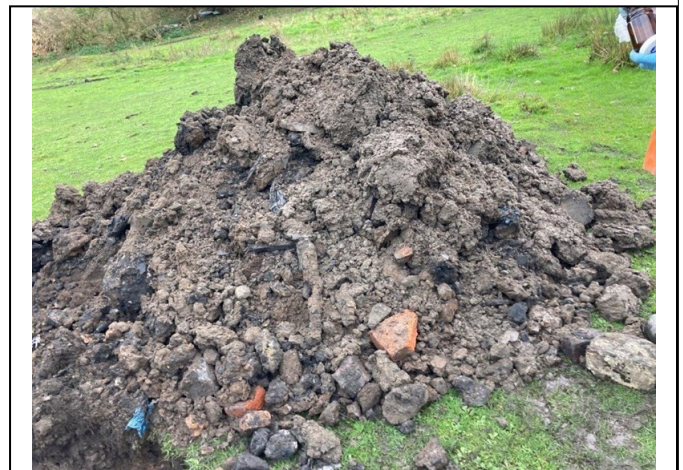
TP107 spoil

Remarks: 1. Complete. 2. Unstable at 1.20 m bgl due to saturated granular Made Ground deposits. 3. Water strike encountered at 2.00 m bgl as very slow ingress through granular Made Ground deposits.

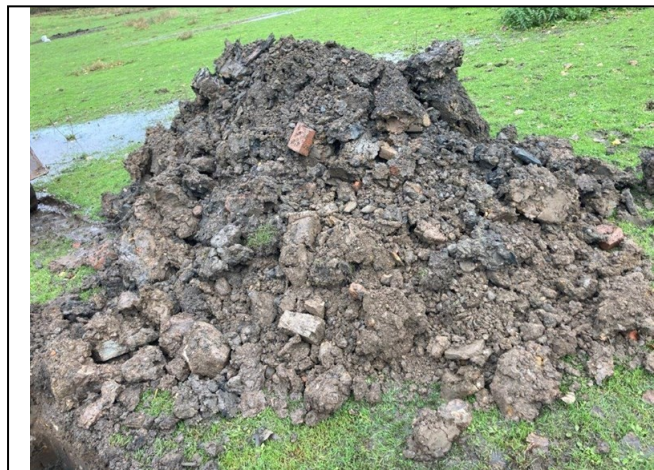
TP109 spoil

Remarks: 1. Terminated on concrete boulder at 2.00 m bgl.

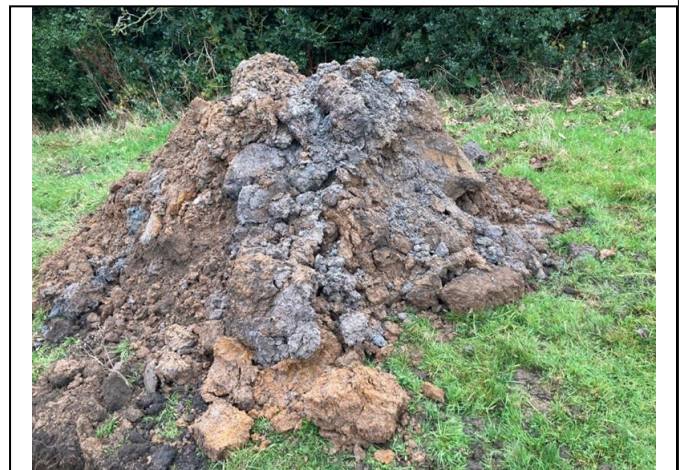
TP117 spoil

Remarks: 1. Complete. 2. Water strike encountered at 2.00 m bgl as slow ingress through sandy silty CLAY. 3. Unstable pit at 0.50 m bgl due to saturated sandy silty CLAY.

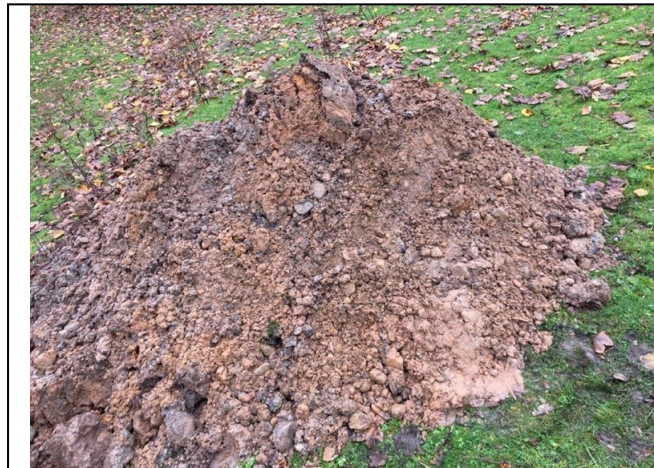
TP118 spoil

Remarks: 1. Terminated at 1.90 m bgl due to unstable pit associated with saturated granular deposits at 1.00 m bgl - running sands. 2. Water strike encountered at 1.00 m bgl through granular deposits.

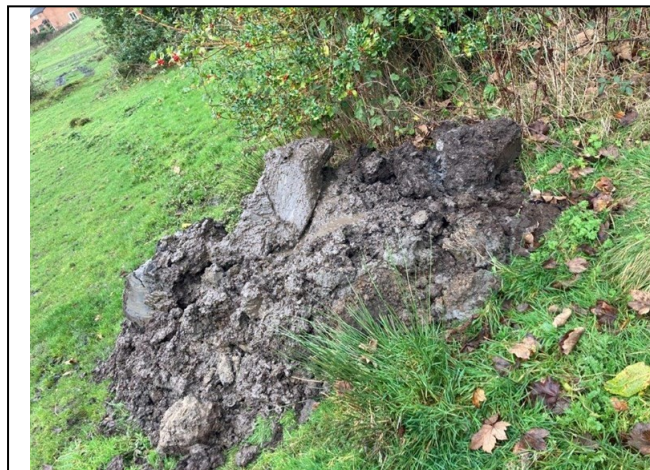
TP119 spoil

Remarks: 1. Terminated at 1.40 m bgl due to fast ingress of water flooding Trial Pit. 2. Water strike encountered at 0.20 m bgl through silty sandy CLAY. 3. Gravelly CLAY encountered at 1.00 m bgl - HSV test not viable.

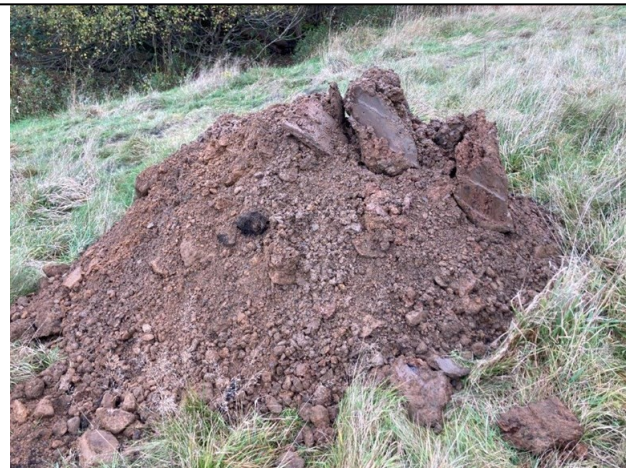
TP121 spoil

Remarks: 1. Complete. 2. Water strike encountered at 1.00 m bgl as medium ingress above CLAY - running sands.
