## **Phase I & II Geo-Environmental Assessment**

**EG Manchester Road**

**EPS Reference Number:** UK23.6426

## LAND AT EG MANCHESTER ROAD, SUDDEN

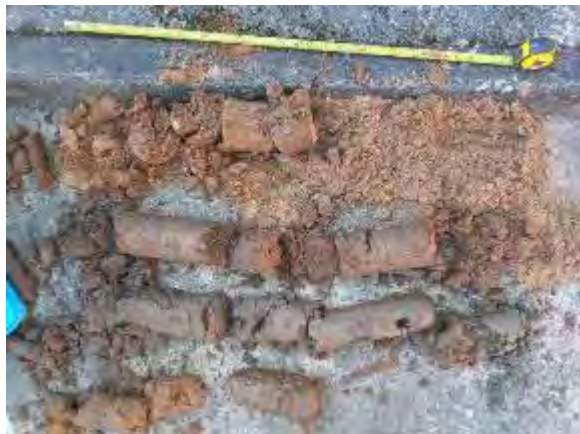
Photo 1: Photograph of material recovered from WS01.

Groundwater was encountered at 3.47m within WS01. All other locations were dry. However, it should be noted that the sand in WS07 and WS10 at 4.0m and 3.0m depth, respectively were observed wet.

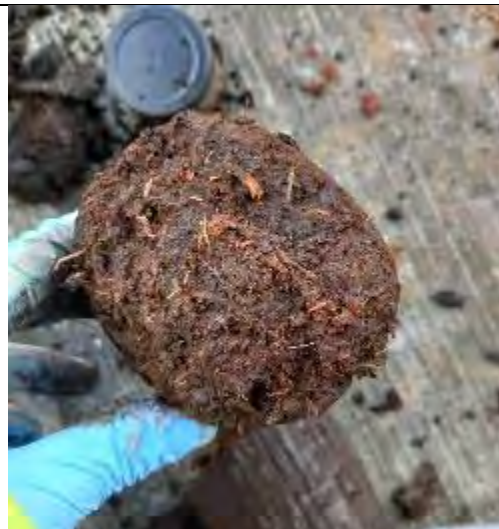
Photo 2: Photograph of peat recovered from WS03.

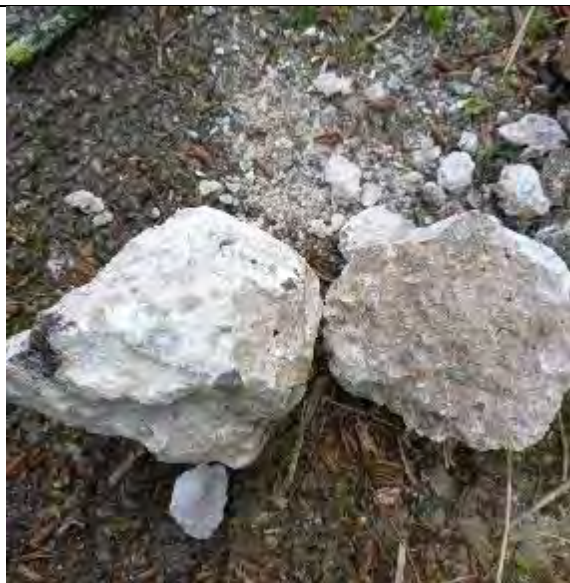
Photo 3: Photograph of concrete found at the base of borehole within WS03.

Underlying the Topsoil in the woodlands area and the concrete hardstanding within the areas of the PFS is the Made Ground. This is generally observed as a dark brown silty gravelly cobbly sand with fragments of brick, glass, metal and concrete down to 2.80m depth. Fragments of sandstone and red brick were observed within WS02. These large fragments of sandstone and concrete are assumed to be the cause of refusals within WS03, WS09 and WS11.

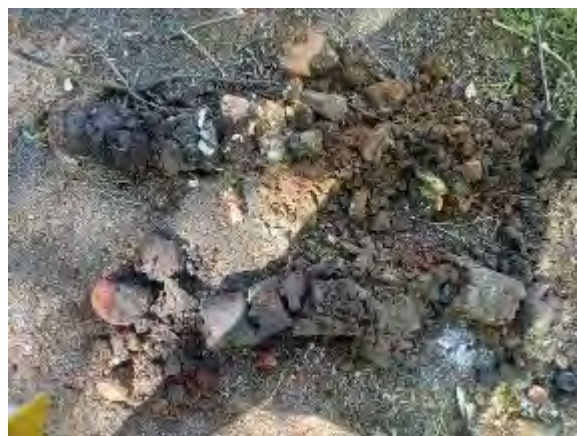
Photo 4: Photograph of Made Ground materials within WS06.

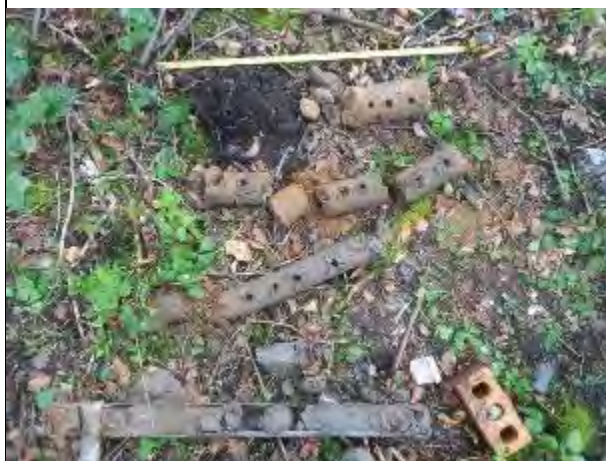
Photo 5: Photograph of clay soils recovered from WS07.

It should be noted that Glaciofluvial Deposits in WS07 was recovered as a firm grey mottled orange very silt sandy clay to 3.0m depth with interbeds of small sand lenses overlying the sands observed within other borehole locations.
