# **GEO-ENVIRONMENTAL AUDIT**

## **PHASE 1 PRELIMINARY RISK ASSESSMENT**

## **PHASE 2 SITE INVESTIGATIONS**

**PROPOSED RESIDENTIAL DEVELOPMENT**  
**FORMER STAR WORKS**  
**HEYWOOD**  
**ROCHDALE**  
**OL10 4QU**

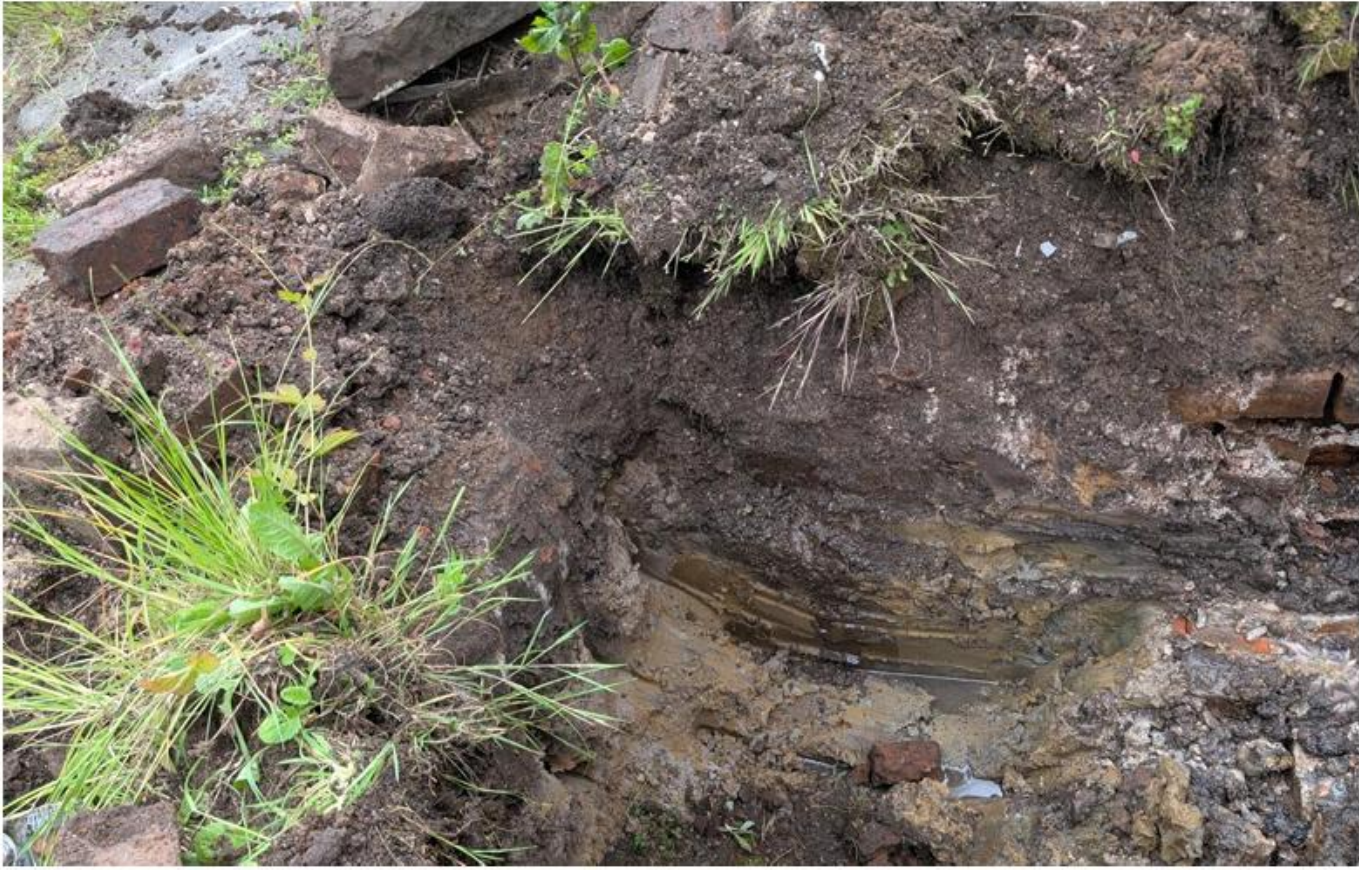
| TRIAL PIT LOG | | | | |
|---|---|---|---|---|
| | | X X<br>X X<br>X X | (0.70) | Loose dark brown gravelly sand MADE GROUND. Gravel is brick, stone, concrete, slate, mortar. Occasional cobble of brick. (S1) |

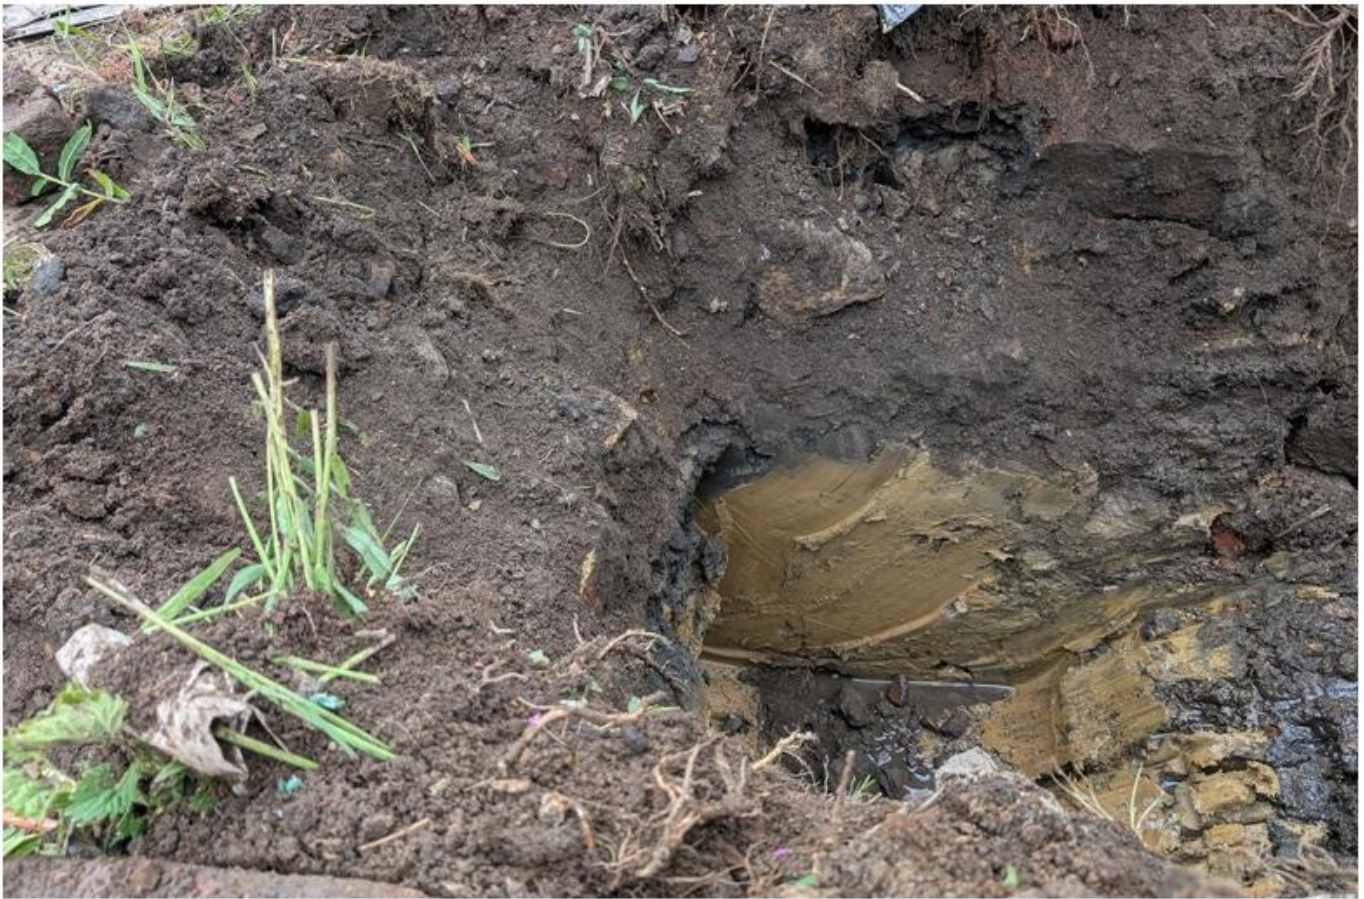
Trial pit reference TH2

| Water | Reduced Level (m) | Legend | Depth (m) | Description |
|---|---|---|---|---|
| | 121.25 | X X<br>X X | (0.35)<br>0.35 | Loose dark brown gravelly sand MADE GROUND. Gravel is brick, stone, concrete, slate, mortar. Occasional cobble of brick. (S2) |

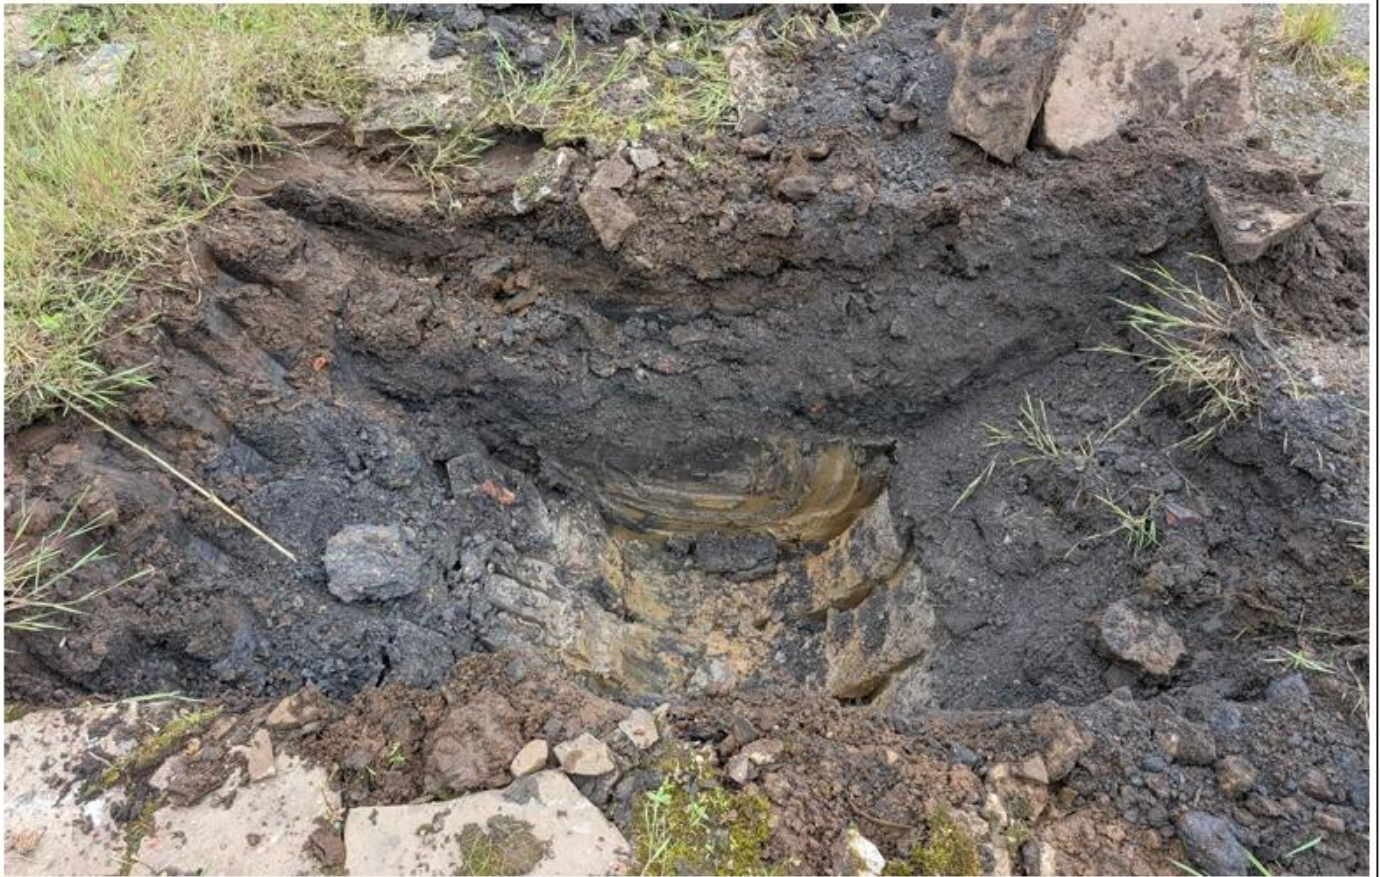
Trial pit reference TP3

| Water | Reduced Level (m) | Legend | Depth (m) | Description |
|---|---|---|---|---|
| | 121.50 | X o X o<br>o X o X | (0.40)<br>0.40 | Loose dark grey-black gravelly MADE GROUND. Gravel is ash. Hydrocarbon odour noted. (S3) |

In the area of TH3, nominally 400mm of ashy MADE GROUND with a hydrocarbon odour was noted.

However, the contamination is noted to the centre of the site within the current yard area, and is limited to around TH3. The contamination is also shallow, c400mm deep, and will need to be removed from site (removing the source material).

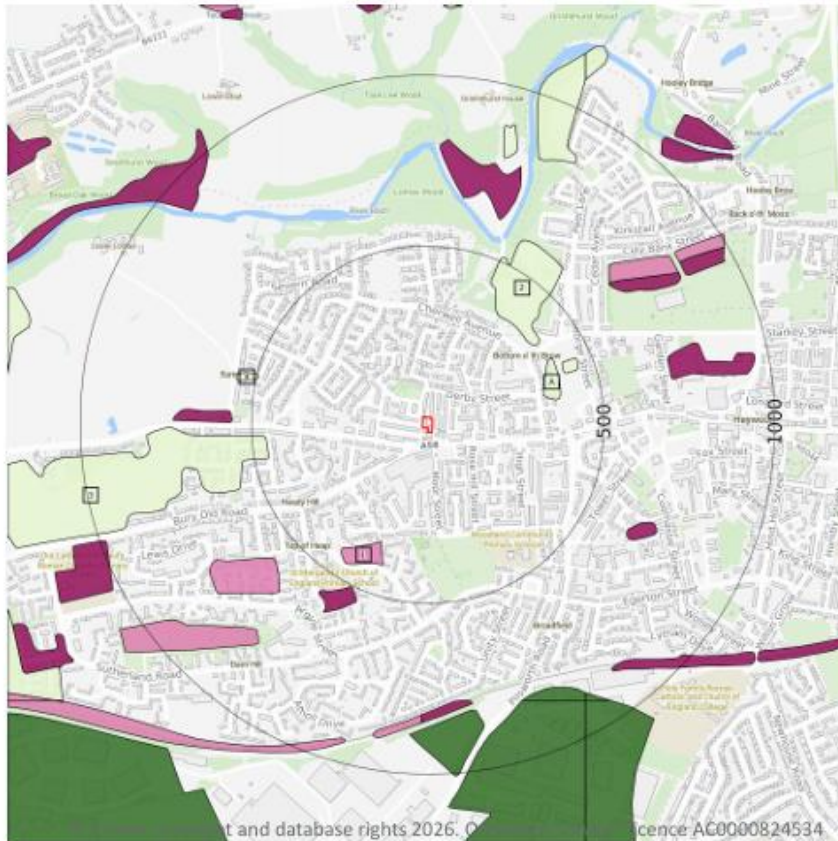
## Geology 1:10,000 scale - Artificial and made ground

Details of made, worked, infilled, disturbed and landscaped ground at 1:10,000 scale. Artificial ground can be associated with potentially contaminated material, unpredictable engineering conditions and instability.
