KE/CLC/45466-001 (Issue 4)

21 January 2026

## **Former Akzo Nobel Site, Hollingworth Road, Littleborough**

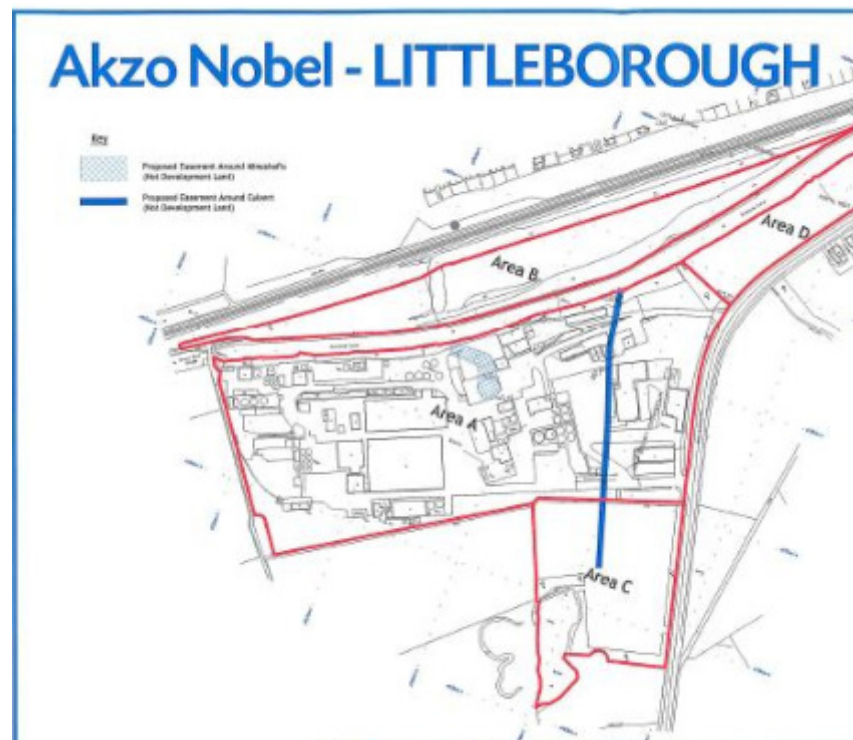
The site comprises Area A (proposed residential development) and Area C (a recreational 'Events Area') as indicated on the plan below.

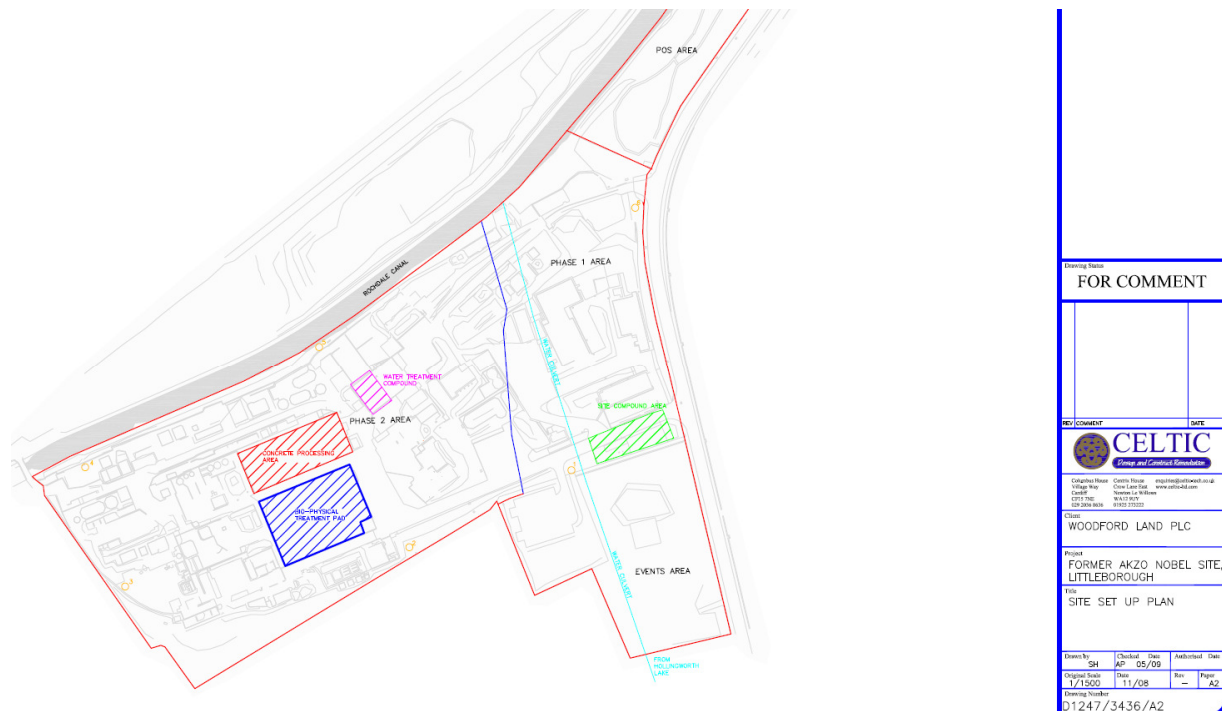
CELTIC's Site Set Up Plan included in their March 2009 report notes the area of the site proposed for housing west of the culvert is titled 'Phase 2' whilst the area east of the culvert and south of the proposed residential area is 'Phase 1':

It is now understood that the 2011 remediation works planned were to revert the Phase 1 area to a residential end use.
