MCI Developments (North West) Ltd

# Trub Farm Development - Rochdale

Existing Bridge - Structural Condition Survey

APRIL 2024

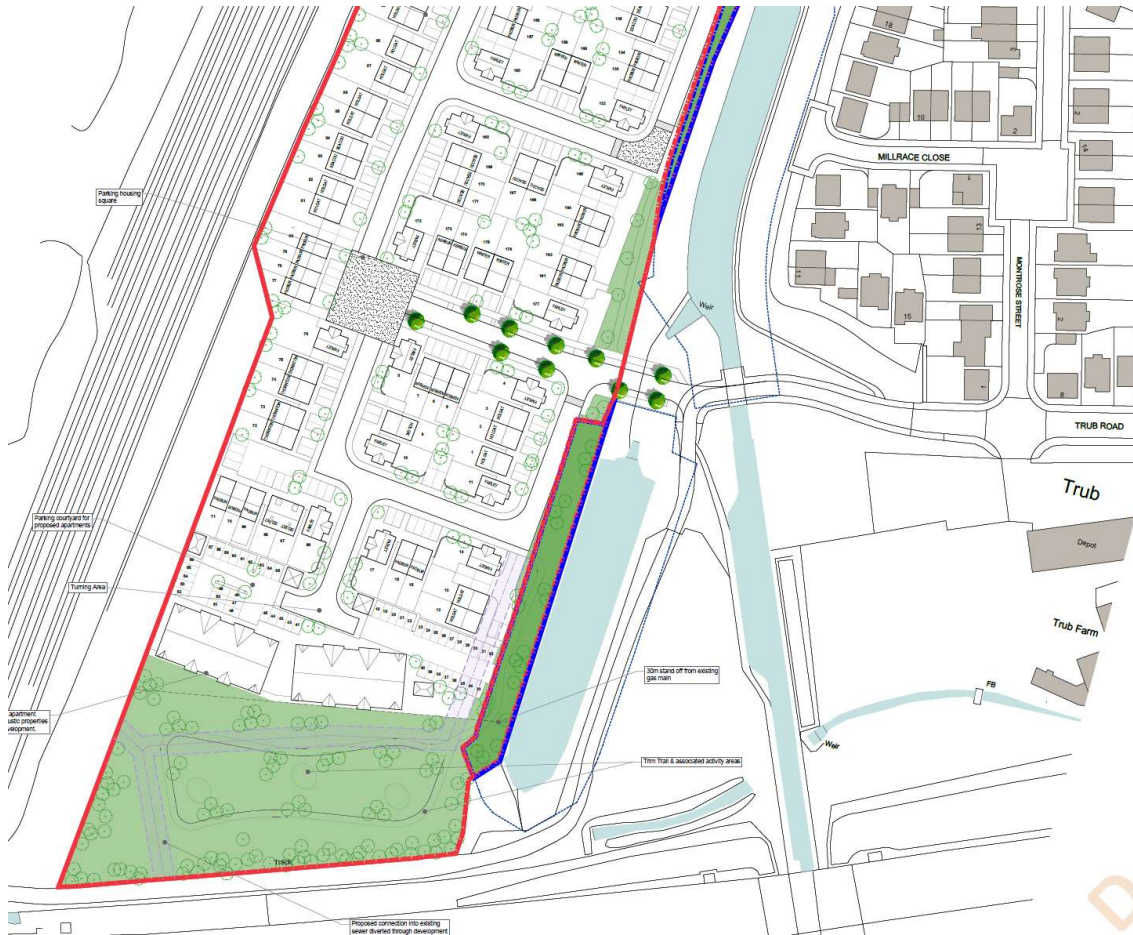
**Figure 2 – Extract from apd sketch layout**

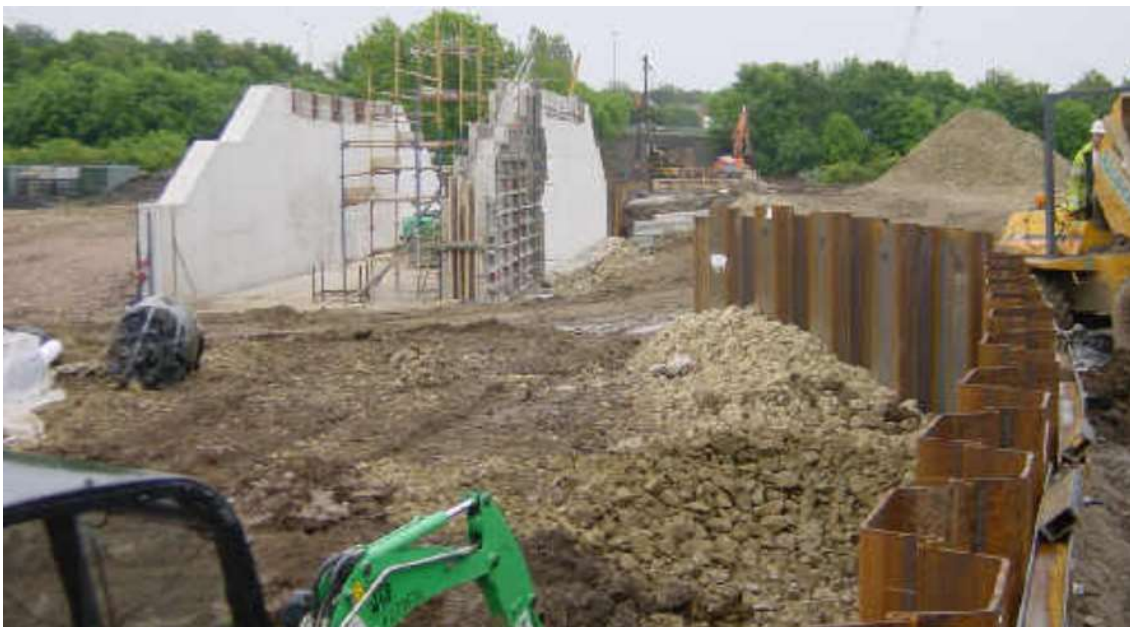
**Figure 9 – New Bridge Construction Looking South Towards the M62 Circa 2002<sup>2</sup>**

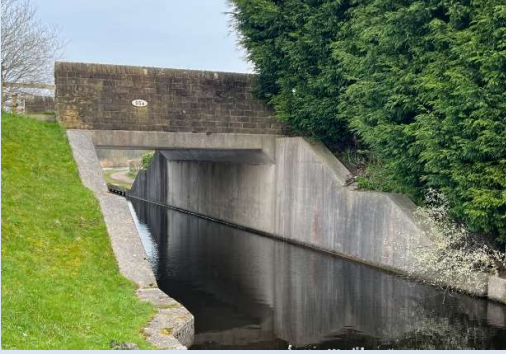
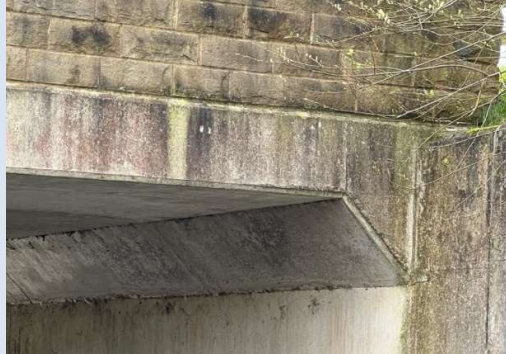
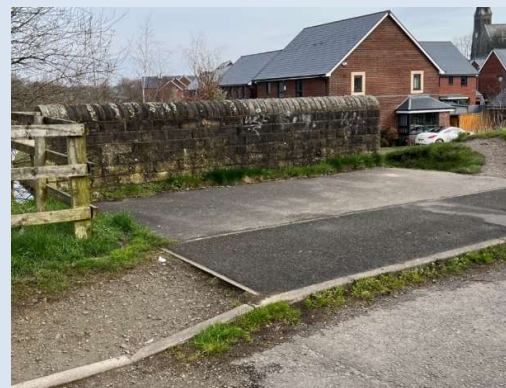
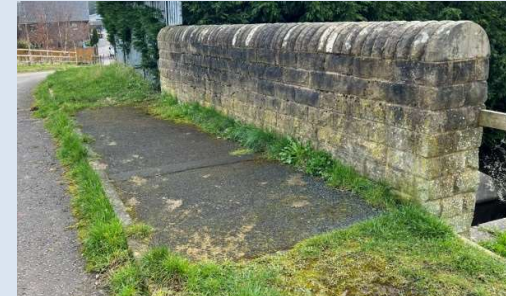
| Description and Discussion | Picture example |
|---|---|
| <p><b>Existing Trub Road Traffic Bridge.</b></p> <p>The existing bridge structure is formed of reinforced concrete construction and has a clear span between reinforced concrete abutments of approx. 5.5m.</p> <p>The concrete bridge deck itself is approx. 380mm deep and supported either end via continuous monolithic concrete haunching (approx. 400mm wide x 380mm deep) at its bearings with the abutments either side.</p> <p>The bridge deck is supported by approx. 380mm thick reinforced concrete abutments which double-up as retaining structures for Trub road and the banking either side of the Canal.</p> <p>The bridge abutments are approx. 2.2m in height measured from the top of the Canals 'wash walls', and it is conjectured that the wash walls are approx. 2.0m in height measured from the base of the canal (from review of Pennine Waterways historical construction photos) i.e. the abutments are thought to measure approx. 4.2m in height (measured from the base of the canal) at their highest point.</p> <p>Trub road and the public footpaths on either side are protected by 475mm thick x 1.3m tall solid brick parapet walls which protect the public and traffic from falling into the Canal below.</p> <p>The solid brick masonry parapets appeared plumb and stable with only minor thermal cracking noted along their elevations and some weathering of bed joints noted within the coping stones.</p> | |

Trub road and the public footpaths appeared flat and level where crossing the bridge structure with only minor defects noted i.e. minor spalling of the tarmac access and exit ramps was noted and grass/vegetation growth was prevalent along the junction of the road/kerbs and parapets/footpaths.

Footpath construction is thought to be approx. 300mm in thickness.

The distance between the inside faces of the masonry parapets measure approx. 10.8m with the Northern footpath approx. 4.85m wide, the road approx. 4.1m wide and the Southern footpath approx. 1.85m wide.

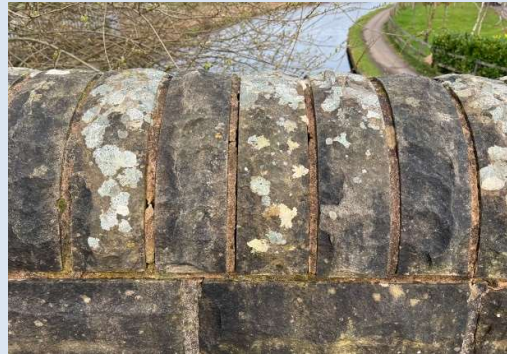
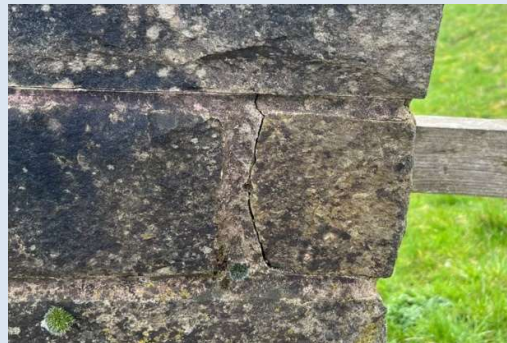
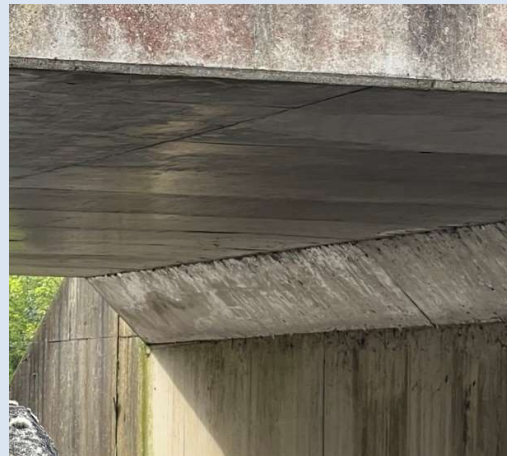
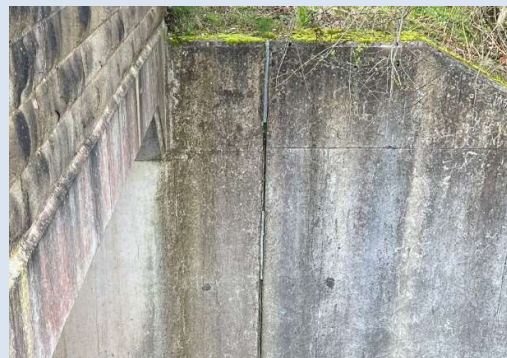
Visual inspection to the underside of the existing bridge deck and the inside faces of the bridge abutments was restricted to what could be observed from the banks either side of the canal.

Shutter joints were observed throughout the surfaces of both abutments and the bridge, suggesting construction was undertaken using in-situ concrete by use of formwork.

Concrete faces appear flat and plumb with only very minor defects noted that are not thought to affect the performance of the bridge i.e. moss growth and very shallow spalling at shutter joints/junctions which were likely caused when formwork was struck circa 2002.

Movement joints (approx. 25mm thick) were observed within both abutments at approx. 600m from the face of the bridge deck on

either side. The flexible sealant within all joints inspected was observed to be only partially filled and require repair.

Water level was measured at approx. 370mm below the top of the 'wash walls' at the time of inspection.

| Building | Conclusion & Recommendations |
|---|---|
| Existing Traffic Bridge and Abutments. | <p>The structural integrity of the bridge, its abutments and solid masonry parapets appear satisfactory under current loading conditions and in their existing condition.</p> <p>No major defects were observed at the date of inspection.</p> <p>Some maintenance works are recommended in order to mitigate future deterioration and to increase design life i.e. clear vegetation from the bridge deck/abutments, repoint weathered/missing bed joints, replace the flexible sealant within the MJ's etc.</p> <p>The bridge is to be assessed in accordance with the recommendations made on page 14 in order to determine its suitability to support the proposed Trub Farm development access road.</p> |

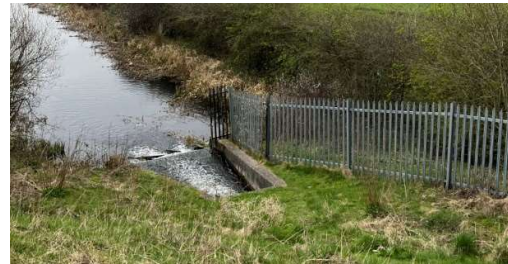
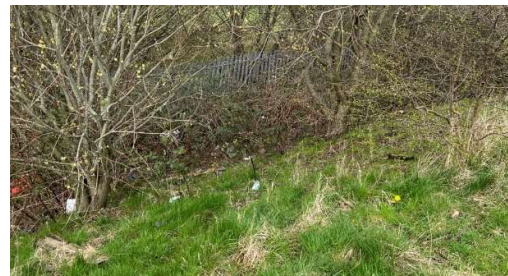
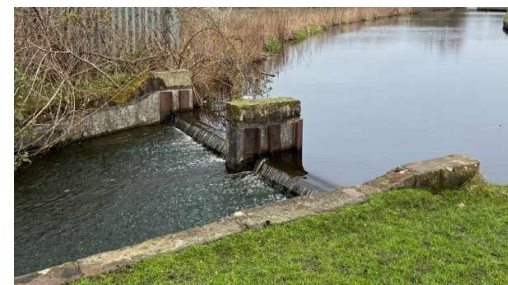
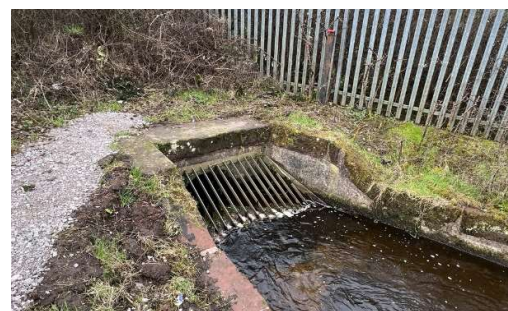
The existing culvert structure is completely obscured by the ground, grass, vegetation and trees.

Levels drop by approx. 1.5m from the bridge to the culvert and then approx. 1.5m from the culvert to the existing Trub Farm site.

The existing 'fish-pass' culvert follows the line of the original Canal channel with water flowing from the North in a Southerly direction from the Canal, over a concrete weir and through the culvert in the direction of the M62.

The Northern end of the culvert channel is circular, is approx. 800mm in diameter and protected by a metal grate. The crown of the circular culvert channel was measured at approx. 500mm below the top of the headwall.

The splayed reinforced concrete wingwalls are approx. 12m long with the distance between them varying between approx. 6m at its junction with the main Canal/weir and approx. 1.6m at the face of the reinforced concrete headwall/culvert.

The headwall and wingwalls are approx. 380mm thick.

Some cosmetic wear and vegetation growth was noted along the coping stones that top

the wingwalls and some rubbish/vegetation was observed as trapped within the grate.

The Water level was higher on the Canal side of the weir and the culvert appeared to be functioning well, with water flows satisfactory at the time of inspection.

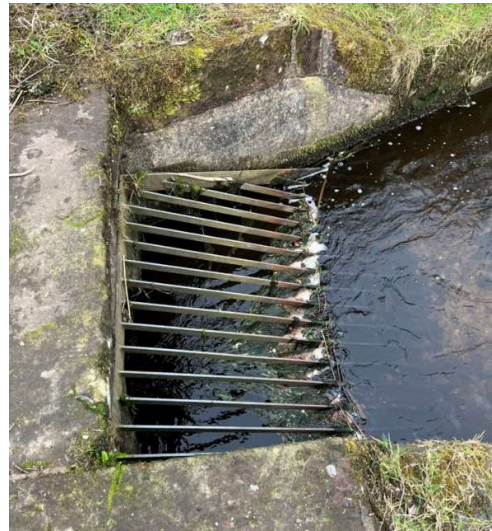
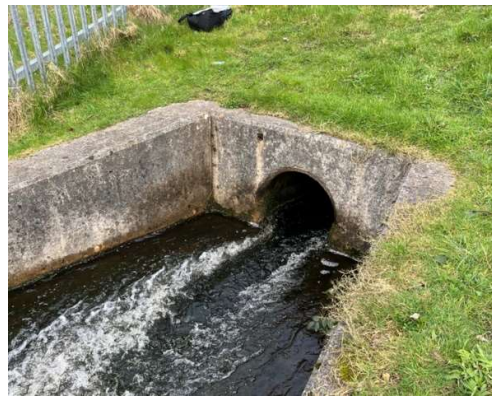
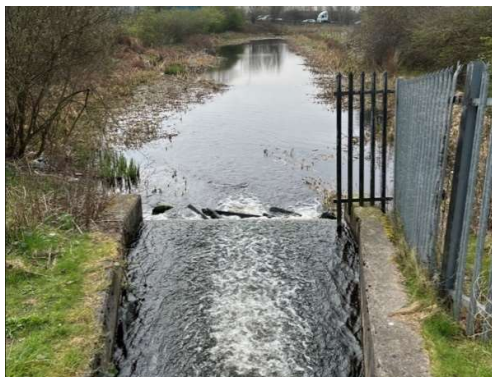
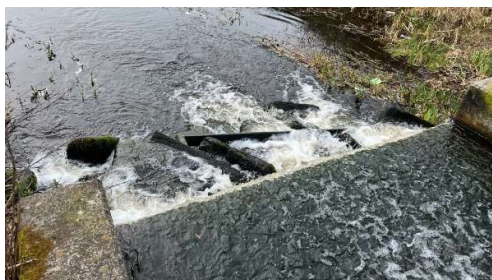
The Southern end of culvert channel is circular and is approx. 600mm in diameter but is open and not protected by a metal grate. The crown of the circular culvert channel was measured at approx. 250mm below the top of the headwall.

The splayed reinforced concrete wingwalls are approx. 5m long and vary in width between approx. 1.5m at the face of the reinforced concrete headwall/culvert and approx. 3m at the end of the wingwalls in the South.

The headwall and wingwalls are approx. 380mm thick.

No major defects were noted within the headwall or culvert structures however some areas were obscured by vegetation growth.

The base soffit level is higher than the water level within the old channel in the South.

Timber and concrete obstructions were observed at the foot of the base slab within the old channel but water flows were satisfactory at the time of inspection.

| Building | Conclusion & Recommendations |
|---|---|
| Existing Culvert and Associated Heawall/Wingwall Structures. | <p>The structural integrity of the headwalls and culvert appear satisfactory under current loading conditions and in their existing condition.</p> <p>The culvert itself was completely obscured by ground cover, vegetation and trees at the time of inspection and as such was restricted to visual inspection of the entrance and exit openings only.</p> <p>No major defects were observed at the date of inspection.</p> <p>Some maintenance works are recommended in order to mitigate future deterioration and to increase design life i.e. clear vegetation from the culvert headwalls/wingwalls, repoint weathered/missing bed joints, clear obstructions which could restrict water flow and/or cause further vegetation/rubbish build-up.</p> <p>The fish-pass culvert is to be assessed in accordance with the recommendations made on page 14 in order to determine its suitability to support the proposed Trub Farm development access road.</p> |
