Hopwood College

Milnrow Chapel

Proposed Concrete Repairs
Elevations Sheet 2 of 2

DATE CREATED:	May 2024	SCALE:	1:100 @ A1
CONTRACT No: P15715	DRAWING No: 211	REV: -

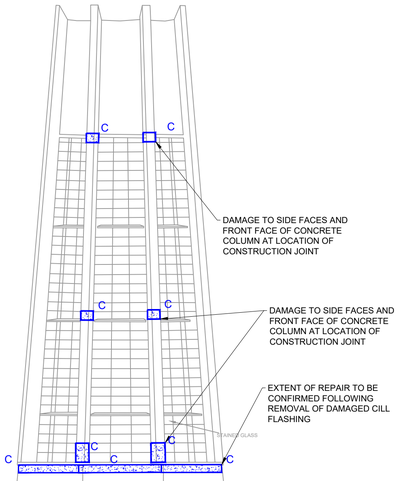
ELEVATION 4
SCALE - 1:100

- A — DENOTES AREA OF CORRODED STEEL (REFER TO REPAIR DETAIL A)
- B — DENOTES AREA OF LOOSE CONCRETE (REFER TO REPAIR DETAIL B)
- C — DENOTES AREA OF DAMP CONCRETE / CONCRETE WITH SURFACE DEGRADATION (REFER TO REPAIR DETAIL C)

EXTENT OF REPAIRS TO BE CONFIRMED. FINAL EXTENT OF WORKS TO BE CONFIRMED FOLLOWING CONCRETE CARBONATION & CHLORINATION TESTS, COVER METER TESTS, REMOVAL OF ROOF COVERING, HIGH LEVEL SURVEY.
