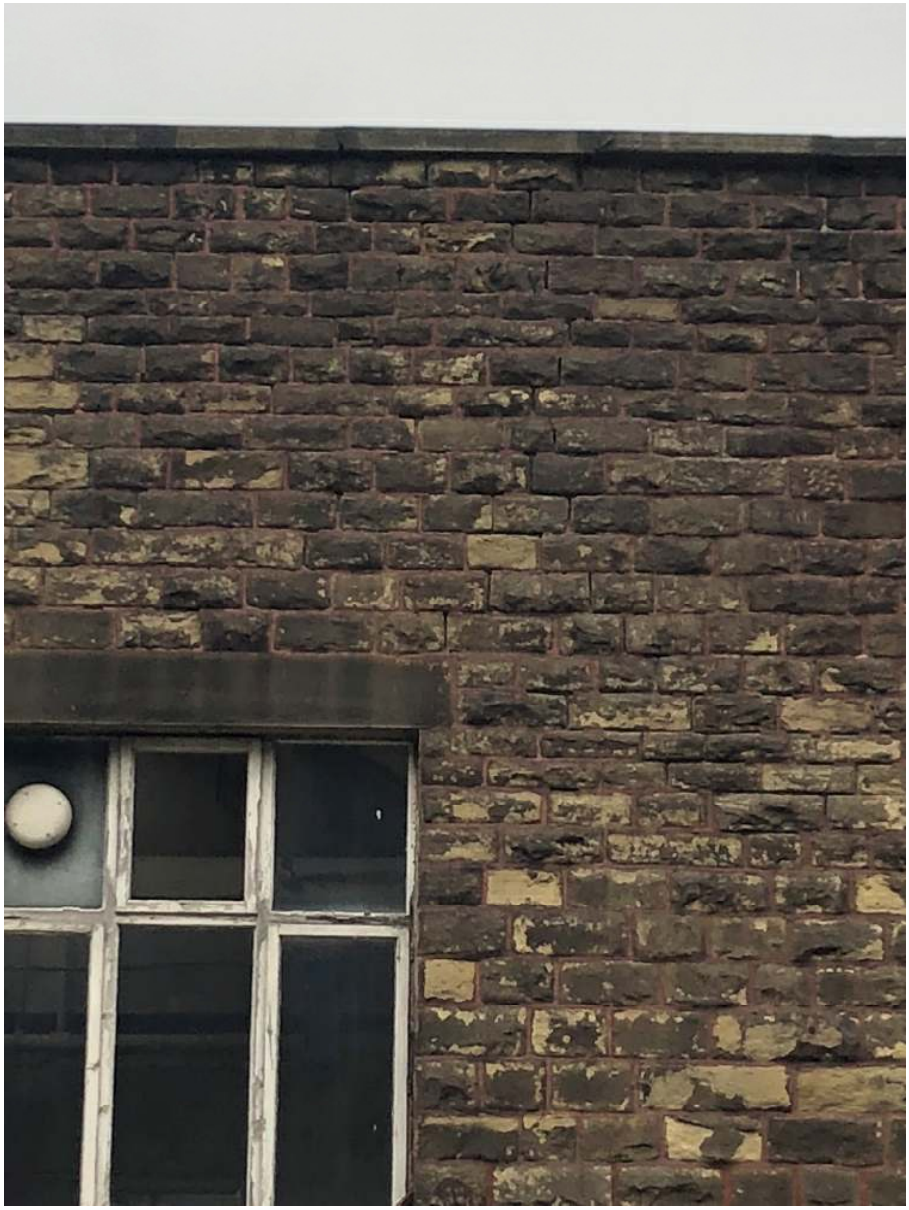
Photograph 7 – Lateral movement to parapet
