# Inspection Report

| Project Name: | Unicorn House |
| Job Purpose: | Sample condition survey |

**Street:** Unicorn House, Cheetham Street  
**Town or City:** Middleton  
**Post Code:** M24 4DG

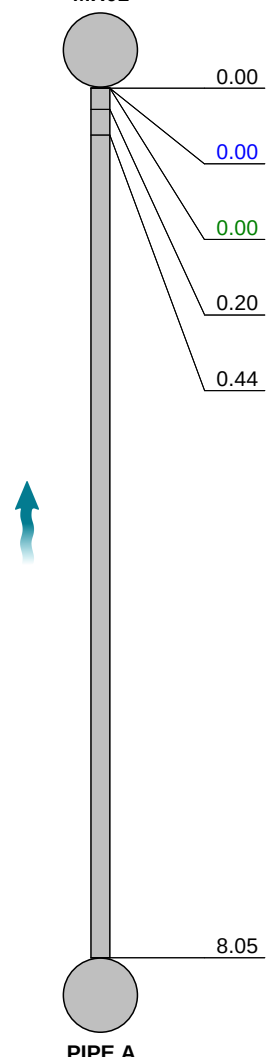
| Scale: | 1:70 | Position [m] | Code | Observation | MPEG | Photo | Grade |
|---|---|---|---|---|---|---|---|
| | | 0.00 | LR | Line deviates right: 45° | 00:00:00 | | |
| | | 0.20 | SC | Pipe size changes, new size(s), 100mm high | 00:00:04 | | |
| | | 0.44 | MCPVC | Pipe material changes to polyvinyl chloride at this point | 00:00:09 | | |

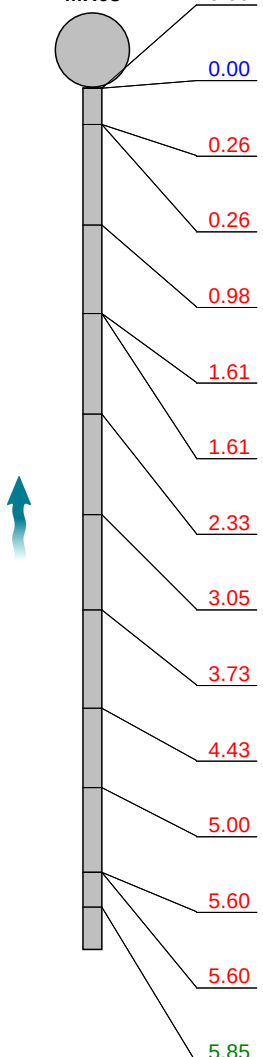
| Scale: | 1:54 | Position [m] | Code | Observation | MPEG | Photo | Grade |
|---|---|---|---|---|---|---|---|
| | | 0.26 | CCJ | Crack, circumferential at joint from 7 o'clock to 12 o'clock | 00:00:03 | MH02_32e4e53f-4387-4807-a5f | 2 / 2 |
| | | 1.61 | CCJ | Crack, circumferential at joint from 12 o'clock to 12 o'clock | 00:00:17 | MH02_e4946c1f-7ccc-4114-b3a | 2 / 2 |
| | | 5.60 | CCJ | Crack, circumferential at joint from 12 o'clock to 4 o'clock | 00:00:45 | MH02_d4f3ed90-e2f9-4c69-b5 | 2 / 2 |

| | | 11.43 | CC | Crack, circumferential from 12 o'clock to 12 o'clock | 00:01:33 | MH02_d53<br>0ed01-3a1<br>6-47c3-bc | 2 / 2 | | |

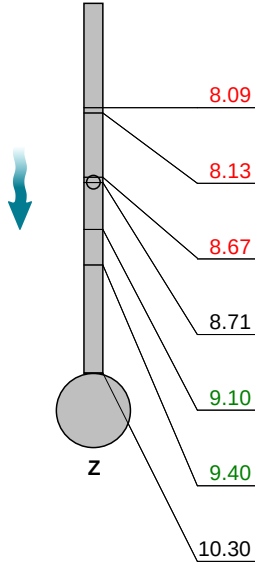
| Scale: | 1:63 | Position [m] | Code | Observation | MPEG | Photo | Grade | | |
|---|---|---|---|---|---|---|---|---|---|
| | | 8.09 | JDM | Joint displaced, medium | 00:01:10 | SVP02_8f<br>bf373b-25<br>dc-43e1-a | 1 / 3 | | |
| | | 8.13 | H | Hole in drain or sewer from 10 o'clock to 12 o'clock | 00:01:10 | SVP02_3c<br>0ea611-f6<br>95-43ce-8 | 4 | | |
| | | 8.67 | FLJ | Fracture, longitudinal at joint at 3 o'clock | 00:01:22 | SVP02_e7<br>3e7fc4-fdc<br>4-44e0-b5 | 3 / 2 | | |
