Hopwood College

Milnrow Chapel

Proposed Concrete Repairs  
Elevations Sheet 2 of 2

| CONTRACT No: | P15715 | DRAWING No: | 211 |

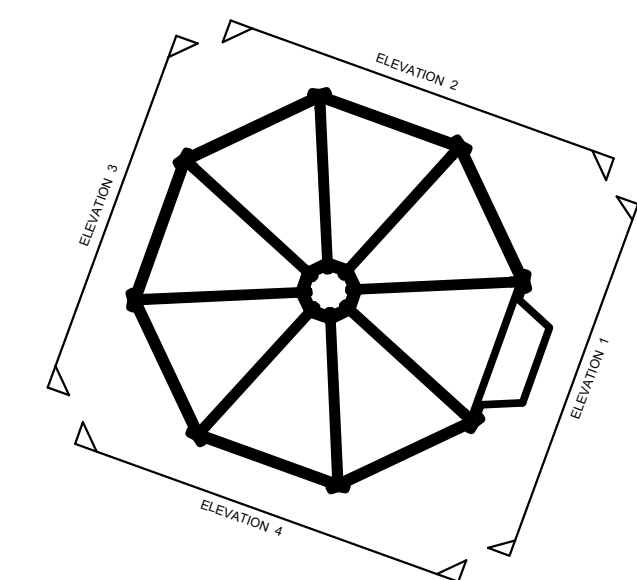
- A DENOTES AREA OF CORRODED STEEL (REFER TO REPAIR DETAIL A)
- B DENOTES AREA OF LOOSE CONCRETE (REFER TO REPAIR DETAIL B)
- C DENOTES AREA OF DAMP CONCRETE / CONCRETE WITH SURFACE DEGRADATION (REFER TO REPAIR DETAIL C)

EXTENT OF REPAIRS TO BE  
CONFIRMED. FINAL EXTENT OF  
WORKS TO BE CONFIRMED  
FOLLOWING REMOVAL OF ROOF  
COVERING, HIGH LEVEL SURVEY.
