Timber repairs to dormer windows

Touchstones Art Gallery, Rochdale

Roof Zone 1  
Roofplan - West Dormer Window Repairs

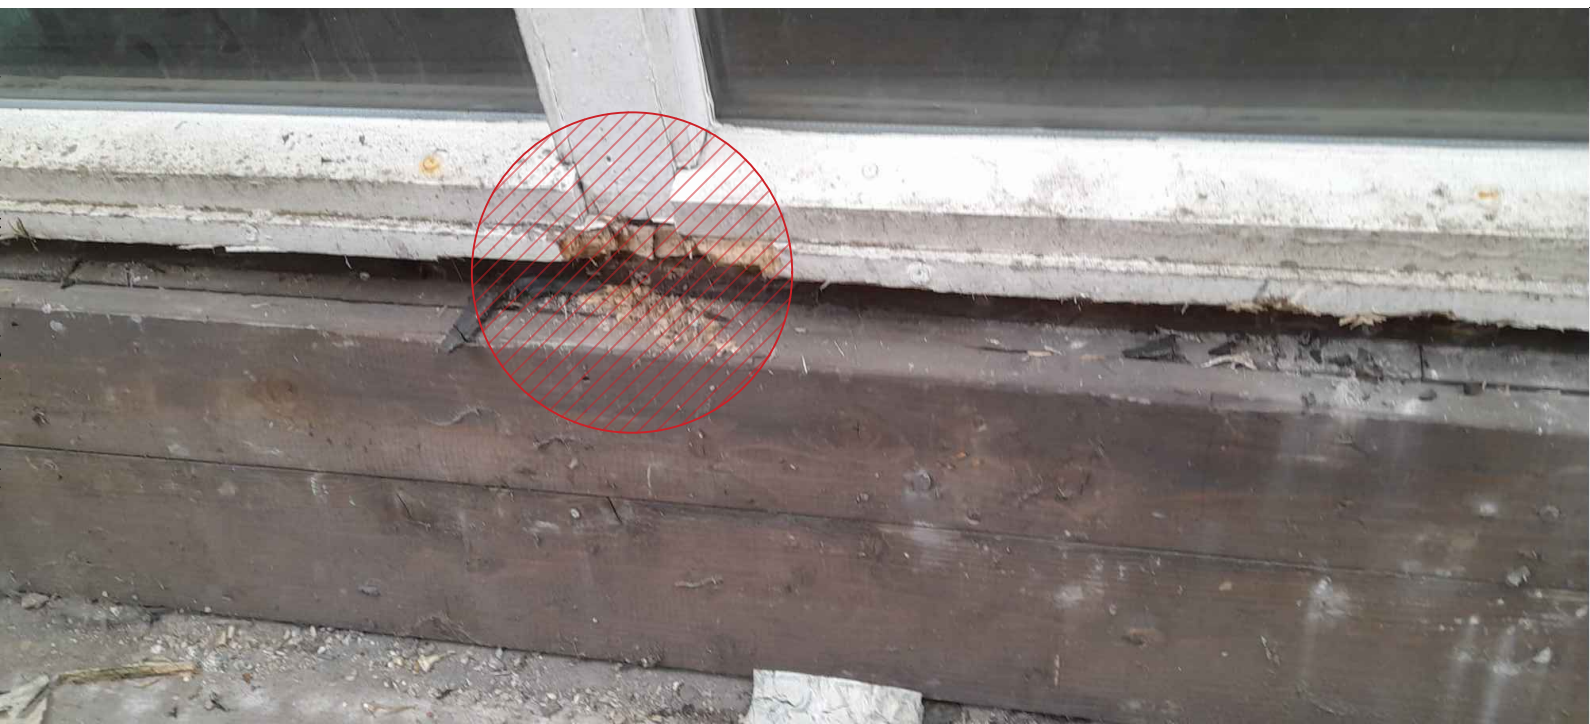
05 West Dormer Elevation  
1:nts @ A1

Allow for splice repairs at bottom of post as NBS C51.

Rot to cill. Allow to renew full length of cill as NBS G20.

Rot to cill. Allow to replace as NBS G20 to match existing.

Replace beading as NBS G20 to match existing profile throughout the length of the dormers.
