**Broadfield Park Slopes ('The Slopes'), Rochdale**

Design & Access Statement Appendix: Volume II

For Rochdale Development Agency

**RE: BROADFIELD PARK SLOPES, ROCHDALE – SURFACE WATER SAMPLING**

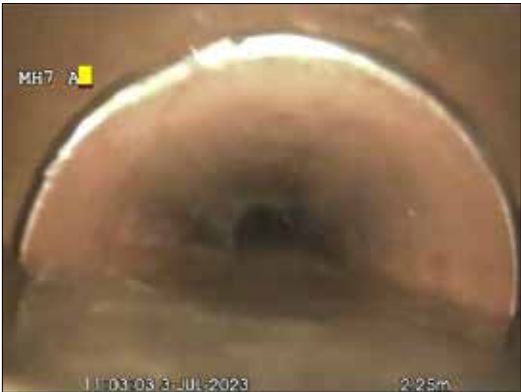
Photo: 3\_4a, 00:00:00  
2.3m, Open joint medium

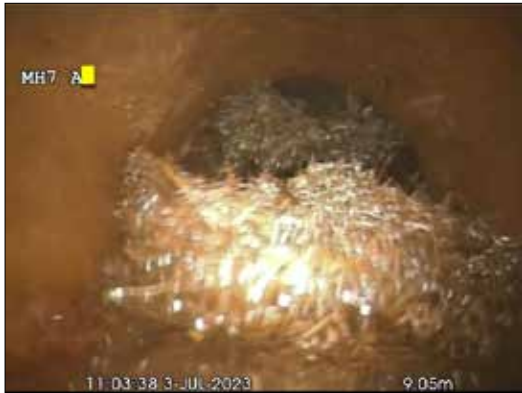
Photo: 23\_8a, 00:00:00  
9.1m, Obstruction, 95 % height/diameter loss

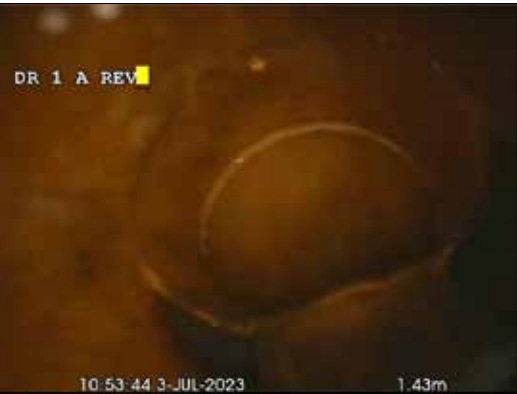
Photo: 5\_7a, 00:00:00  
1.5m, Joint displaced. Large

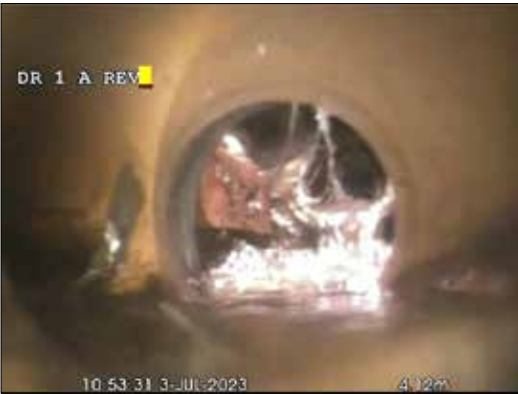
Photo: 5\_9a, 00:00:00  
4.1m, Junction at 09 o'clock, dia 100 mm

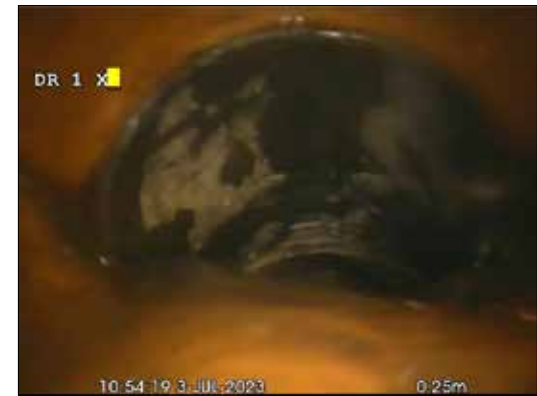
Photo: 54\_4a, 00:00:00  
0.1m, General Condition photograph

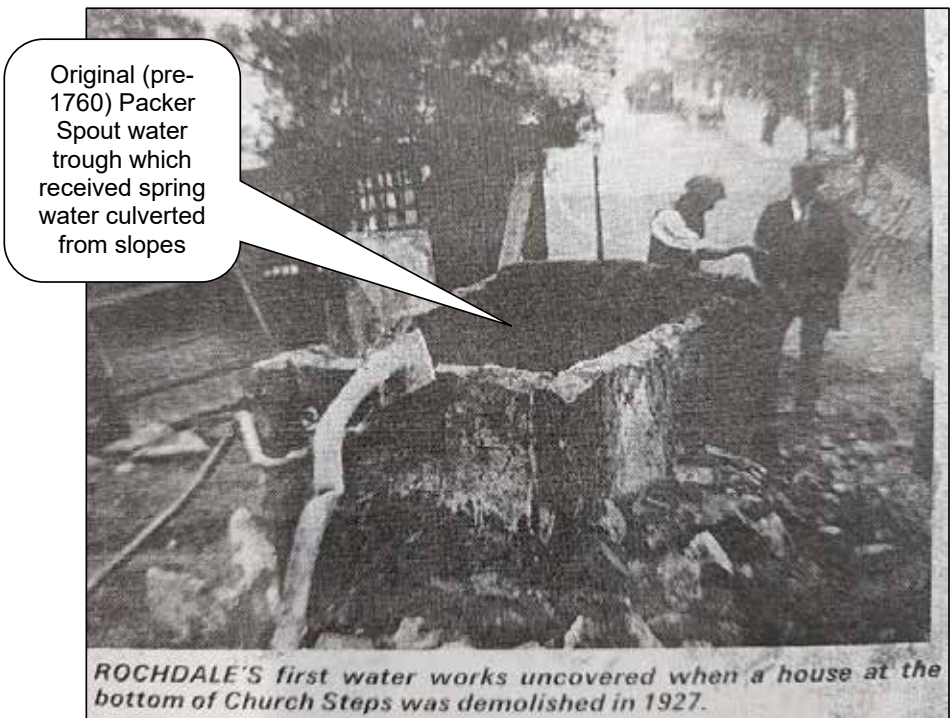
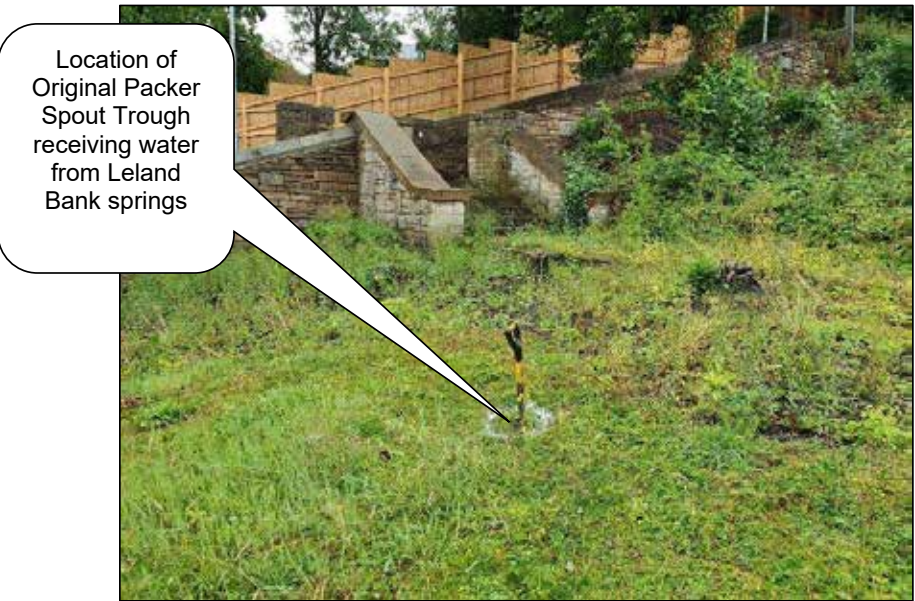
Fig. 2.4.  
Original Packer Spout Trough Removed in 1927 when Leyland House was Demolished

The original water trough was removed in 1927 when Leyland House was demolished, and the site is next to the Church Steps is now grassed over (Fig. 2.4).

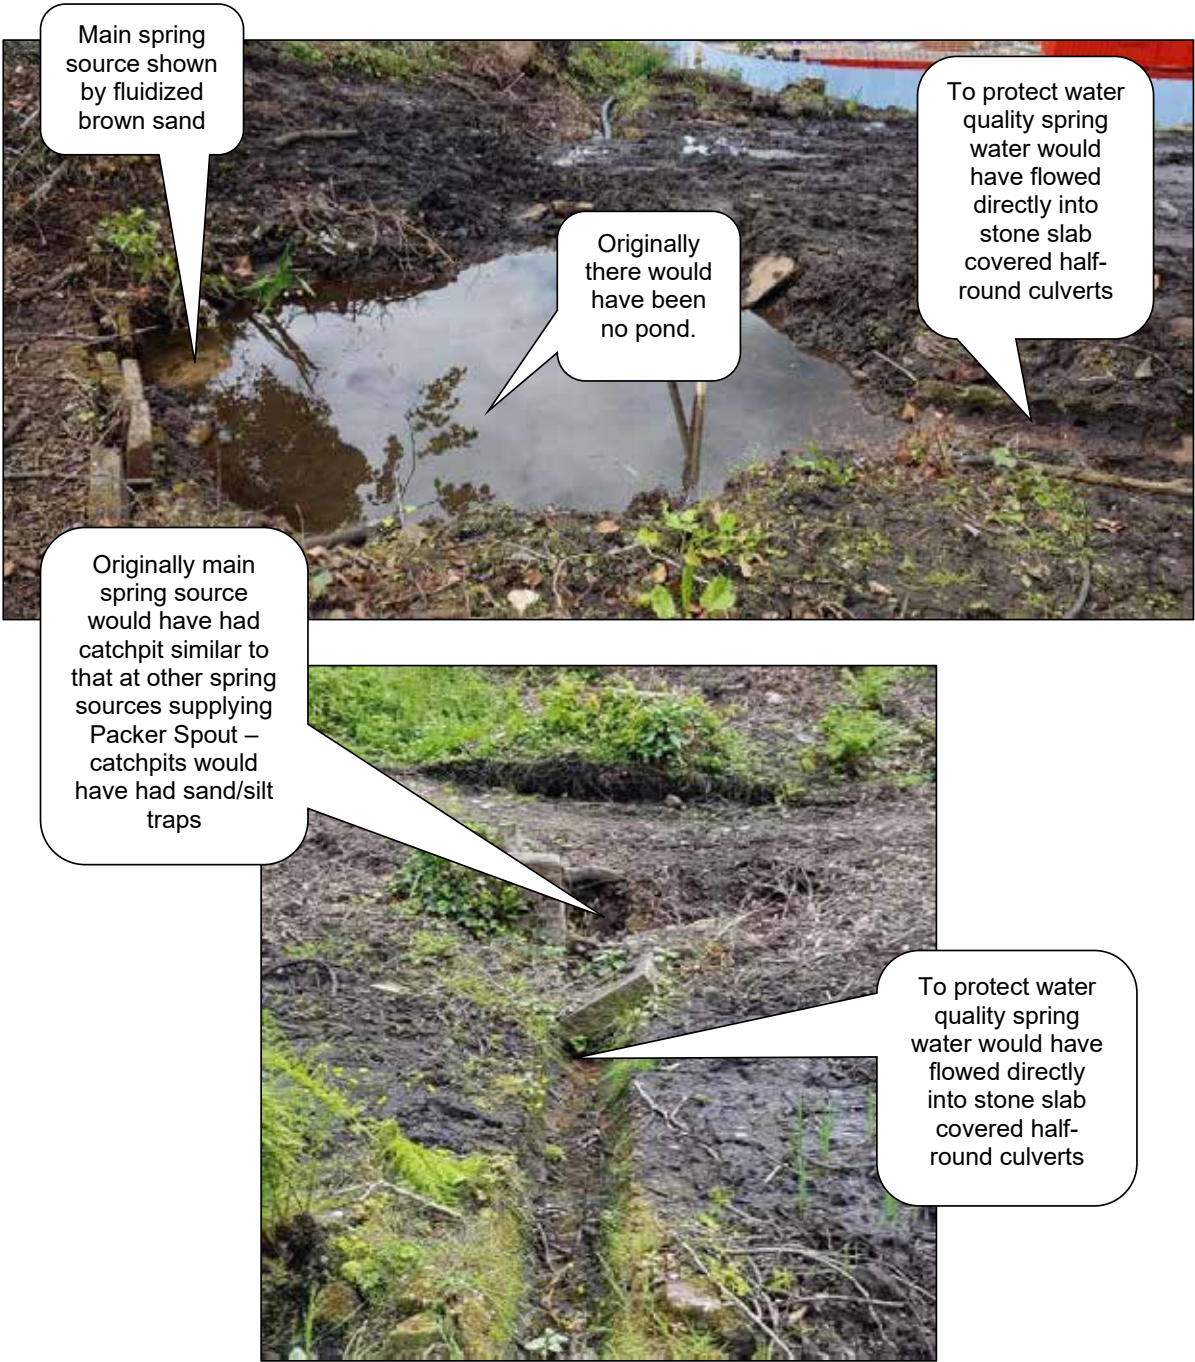
Fig. 2.5.  
Main Spring Source Originally would Have had Covered Catchpit (i.e. No Pond)

Originally the main spring source, 75 m to the SW of the Leylands House trough, would have had catchpit similar to those at other spring sources supplying Packer Spout. The visible remnants of those catchpits indicate the presence of circular chambers which would have acted as sand/silt traps (Fig. 2.5).

To protect the spring water quality (and to prevent culvert blockages) there would have been no pond (Fig. 2.5) and the spring water would have flowed directly into the half-round culverts covered by stone slabs, as recreated in Fig. 2.6.

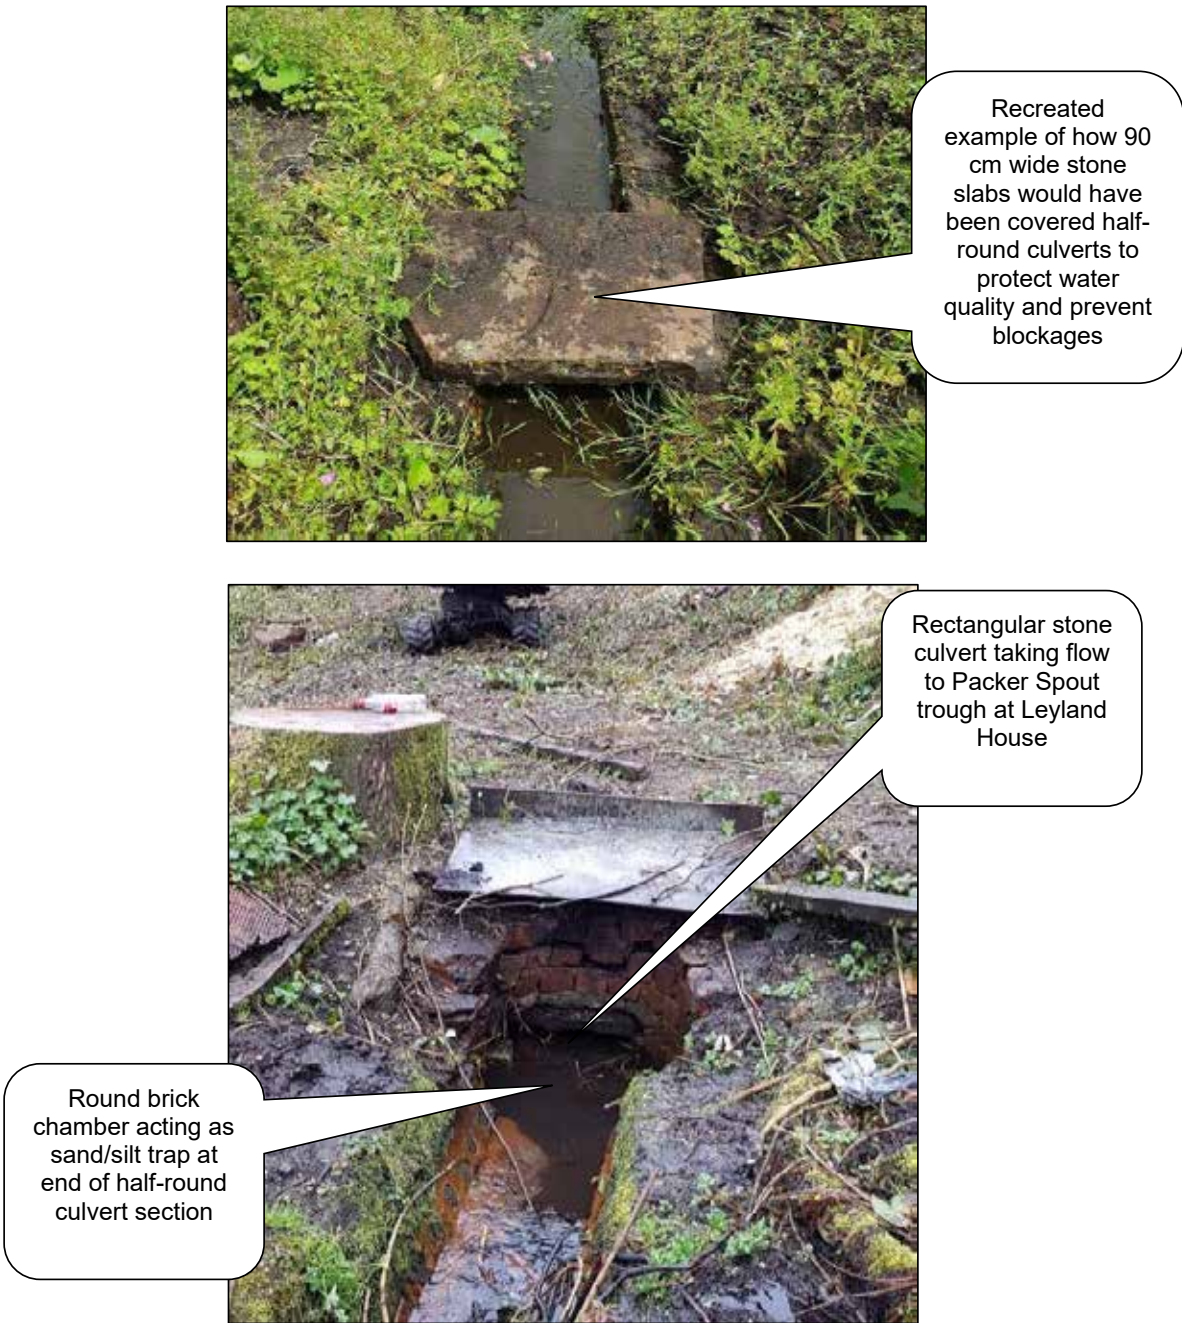
Fig. 2.6.  
Example of How Half Round Culvert Section Would Have Been Covered by Stone Slabs & Round Brick Chamber Sand/Silt Trap Prior to Rectangular Stone Culvert Leading to Trough at Leyland House

At the end of the half-round culvert section was a round brick chamber, which would have provided another sand/silt trap before the water flowed down a rectangular stone culvert to the water trough at Leylands House (Fig. 2.6).

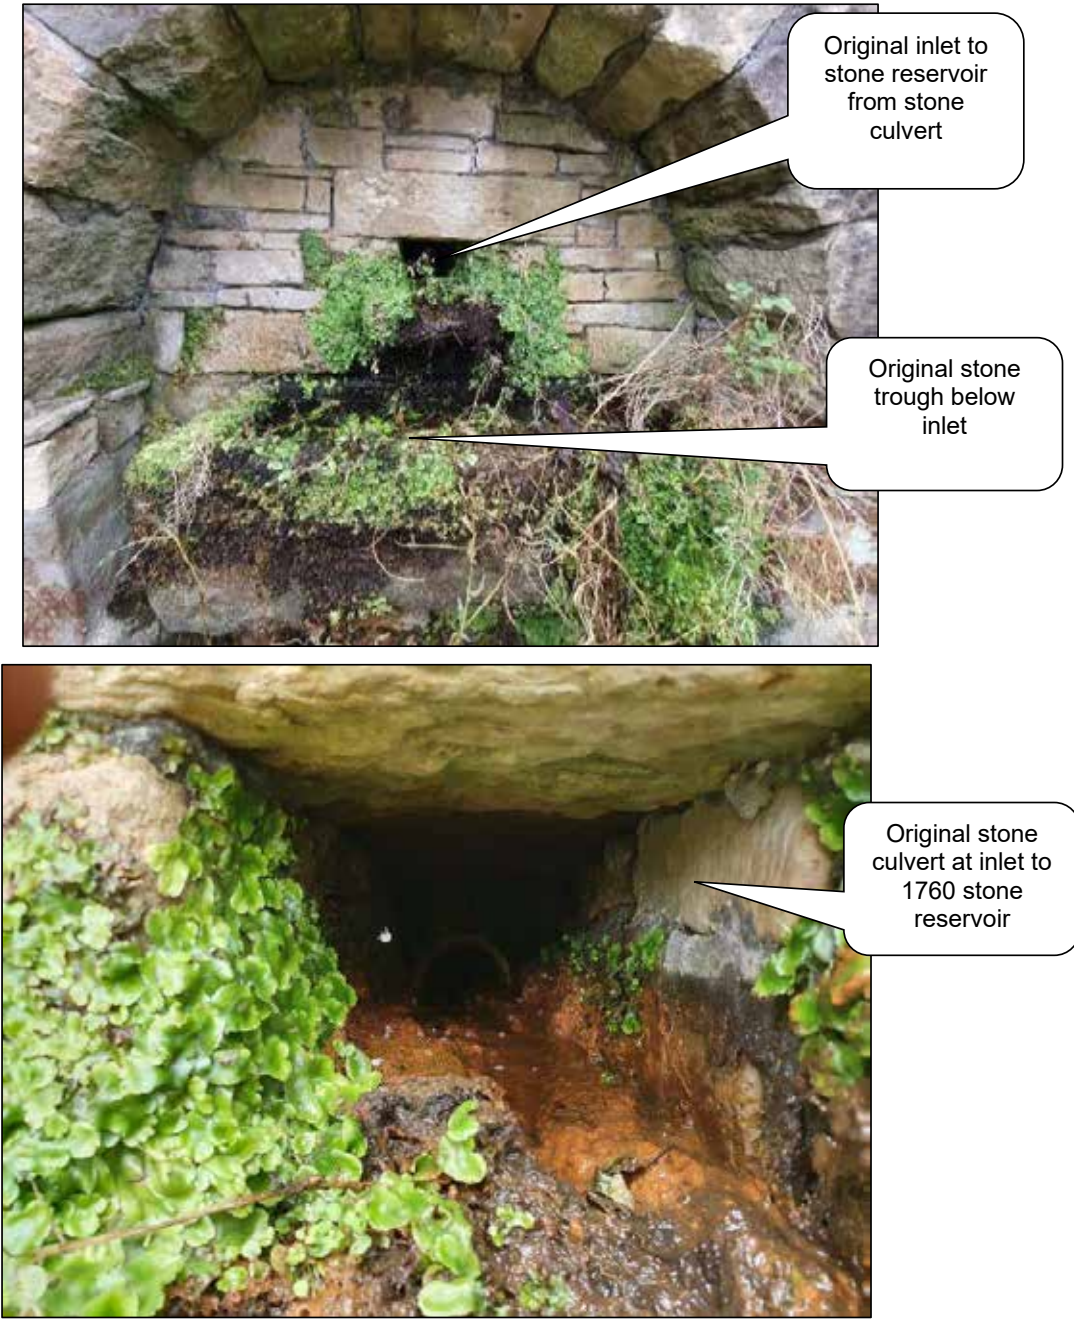
Fig. 3.3.  
Details of Original Water Inlet to 1760 Stone Reservoir

The draining of the Packer Spout reservoir in June & July 2022 did not reveal any water outlet pipes near the base of the reservoir

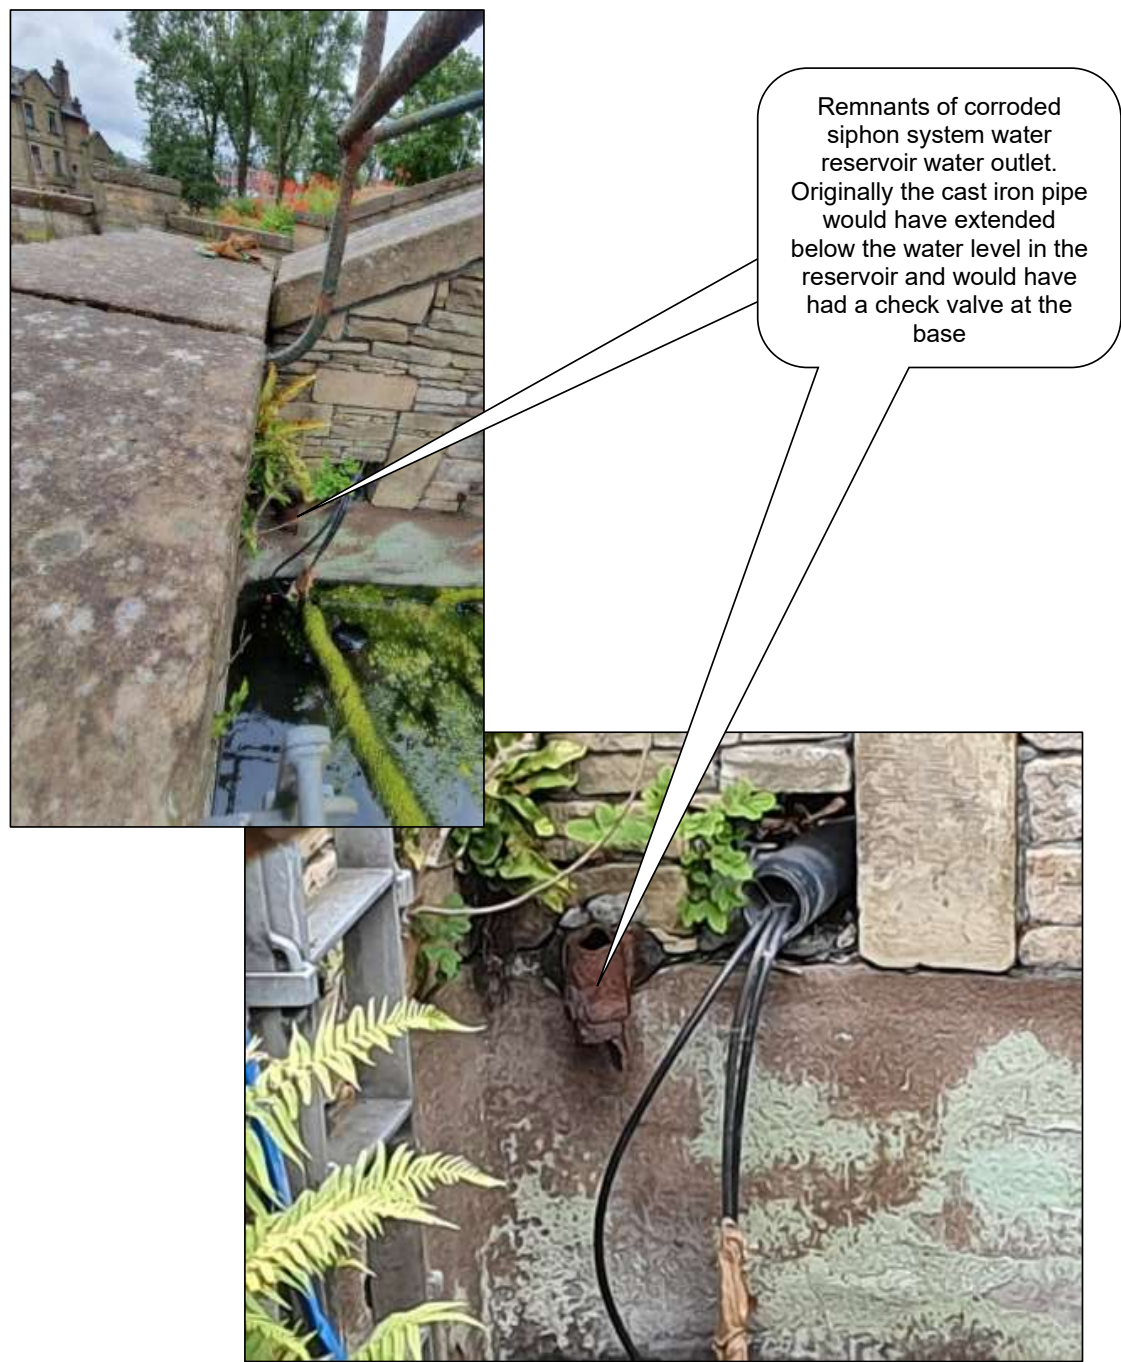
Fig. 3.4.  
Details of Probable Original Siphon Water Outlet System for 1760 Stone Reservoir

Most of the siphon pipe system has now been lost due to corrosion. The inlet to the syphon pipe in the reservoir would have had a check valve, and stop valves at the highest point of the siphon pipe and at the outlet would have enabled the priming of the siphon.

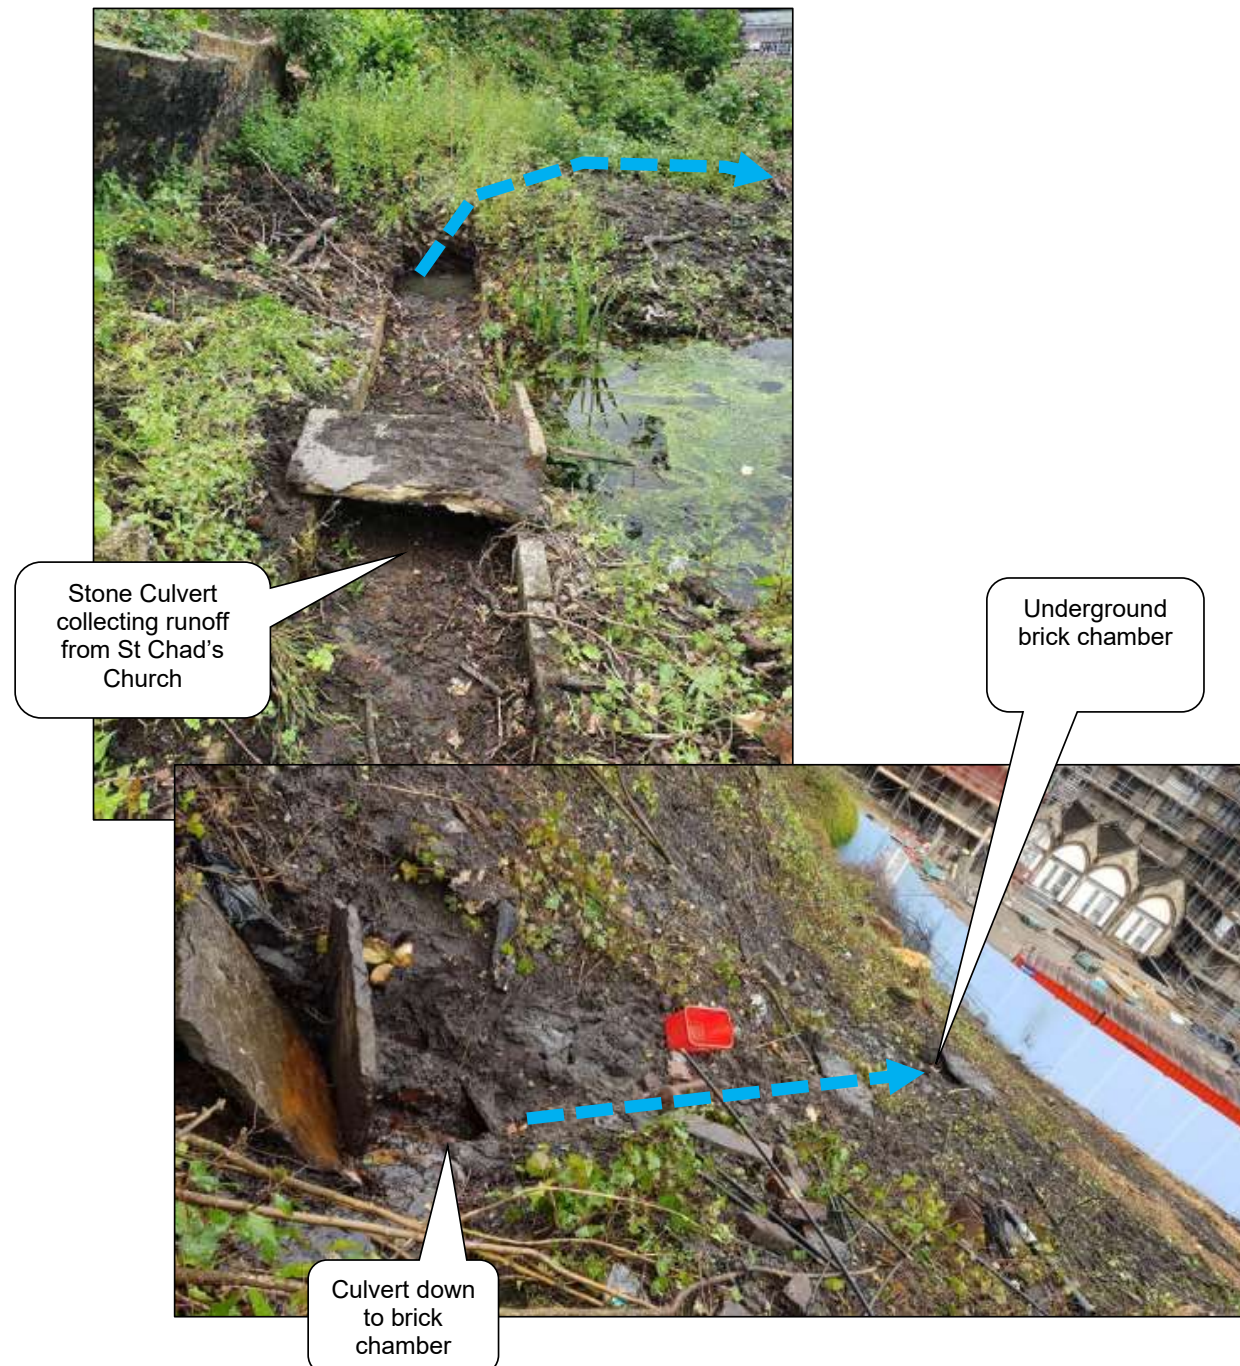
Fig. 4.4.  
Details of Stone Culvert Leading from St Chad's Church to  
Underground Brick Chamber

The stone culvert from St Chad's Church to the underground brick chamber still exists, however it has been covered with soil for part of its length and is blocked (Fig. 4.4).

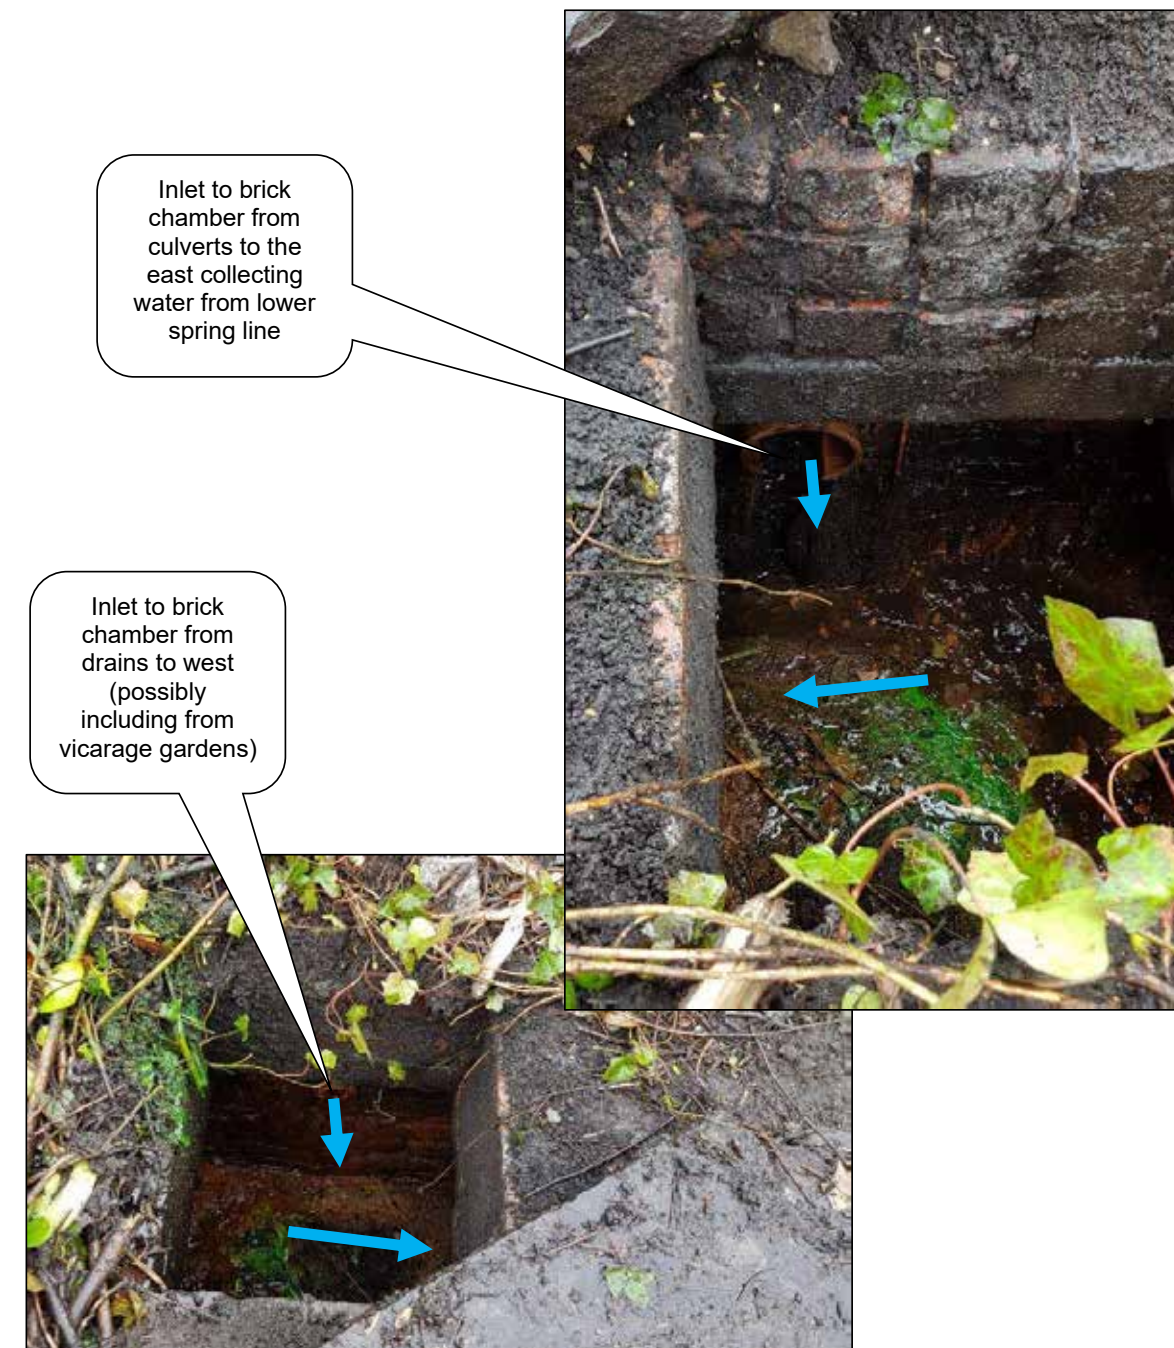
Fig. 4.5.  
Details of Underground Brick Chamber with Drain Inlets to the West & East

The underground brick chamber still exists (Fig. 4.5), however the culverts which supplied spring water from the west and the east have become blocked (Fig. 4.6). As a result of this the lower spring line in St Chad's Garden is no longer drained and is a permanent bog.

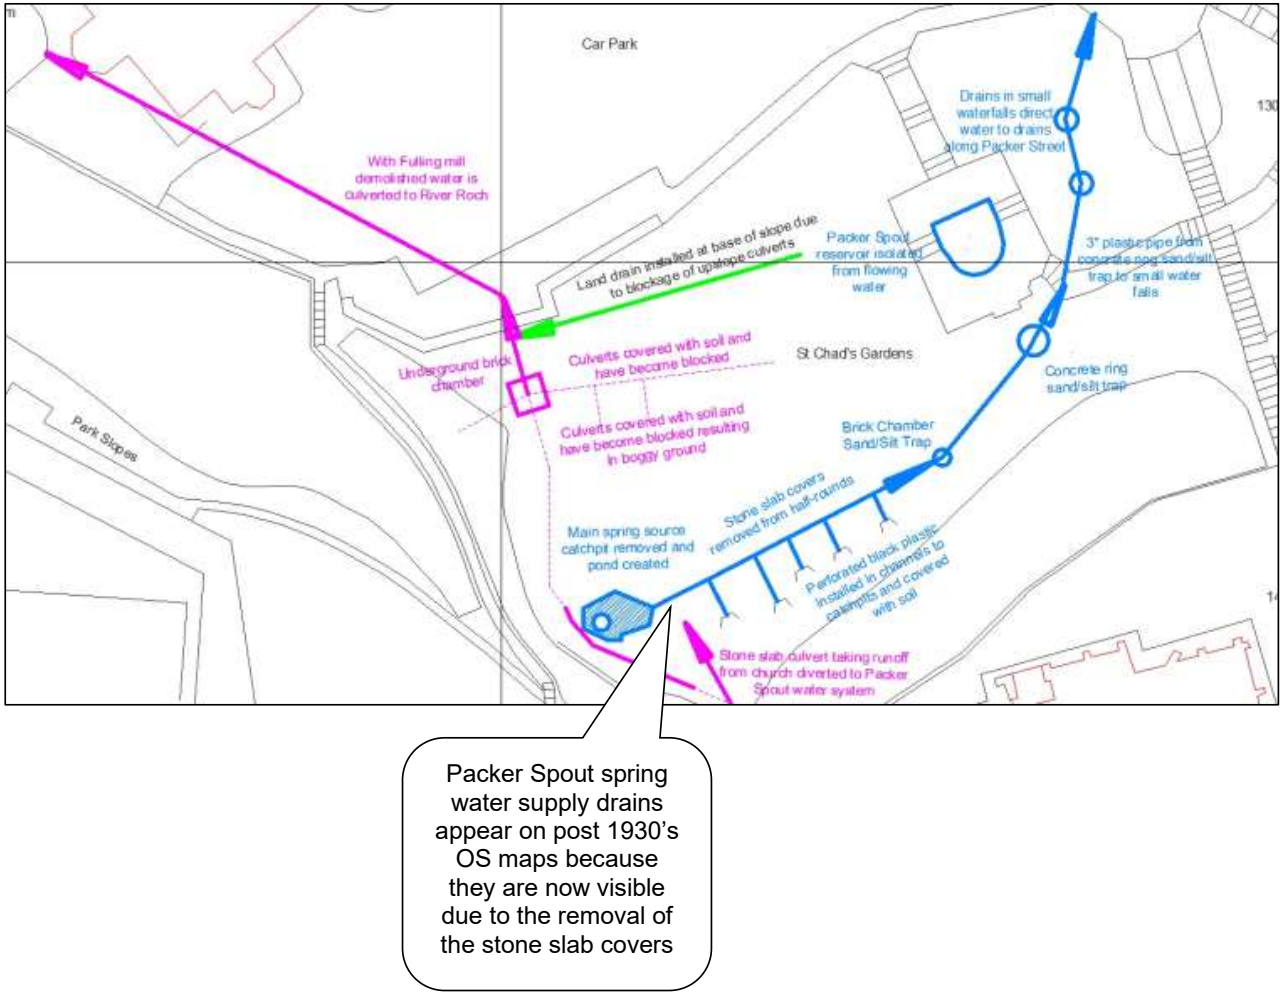
Figure 6.2  
Summary of Changes to Slopes Water Supply Systems and Drainage Following  
Demolition of Central Corn Mill in 1934

The changes to the two water supply systems are summarised in the plan in Fig. 6.2. Unfortunately, this redevelopment resulted in significant damage to the slopes drainage.

Packer Spout spring  
water supply drains  
appear on post 1930's  
OS maps because  
they are now visible  
due to the removal of  
the stone slab covers

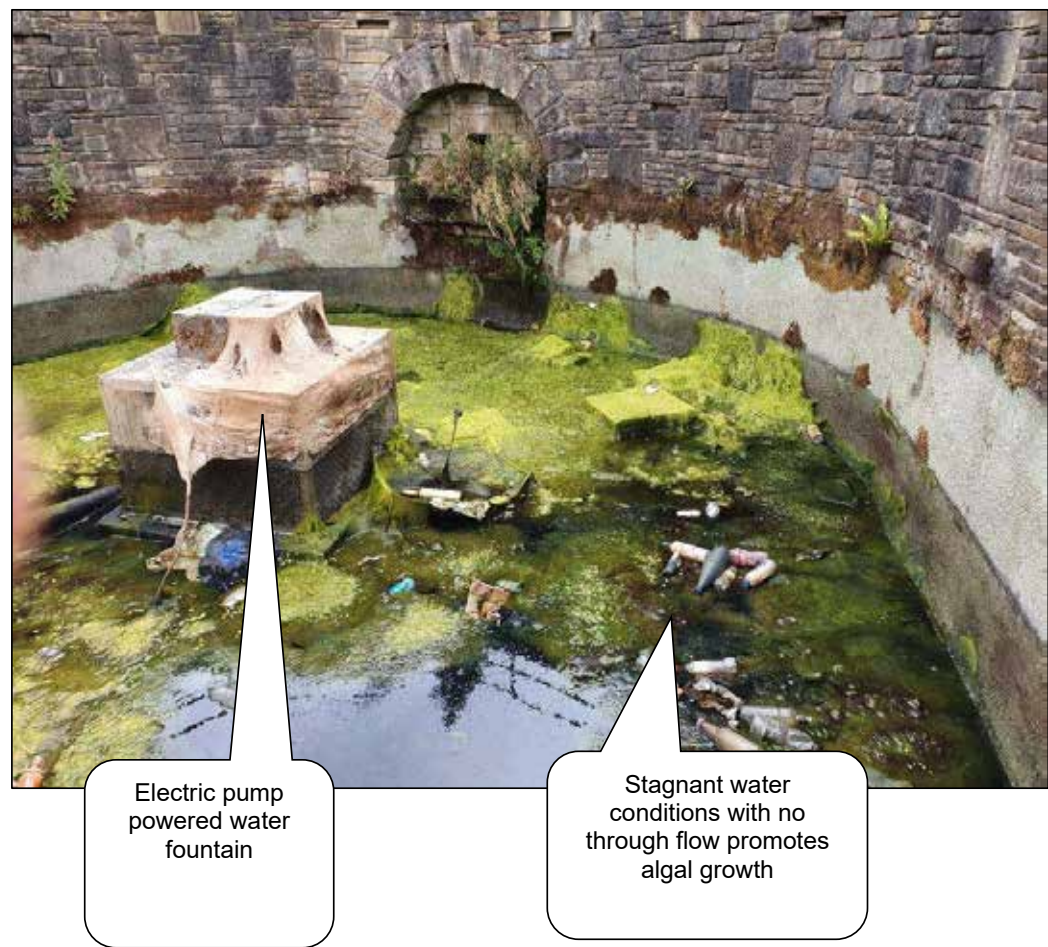
Water flow was diverted away from, and to the east of the Packer Spout reservoir (via a concrete ring chamber silt trap) enroute to cascades using 10 cm diameter plastic pipe which is easily blocked (Figs. 6.5, 6.6 & 6.7). The drain holes at base of upper cascade take water to Packer Street Drains, however dye tracing has indicated that the water is also leaking to old culverts near RTH basement.

Fig. 6.5  
Packer Spout Reservoir No Longer Has Water Flowing Into It – Spring Water  
Diverted to the East to the Water Falls/Cascades

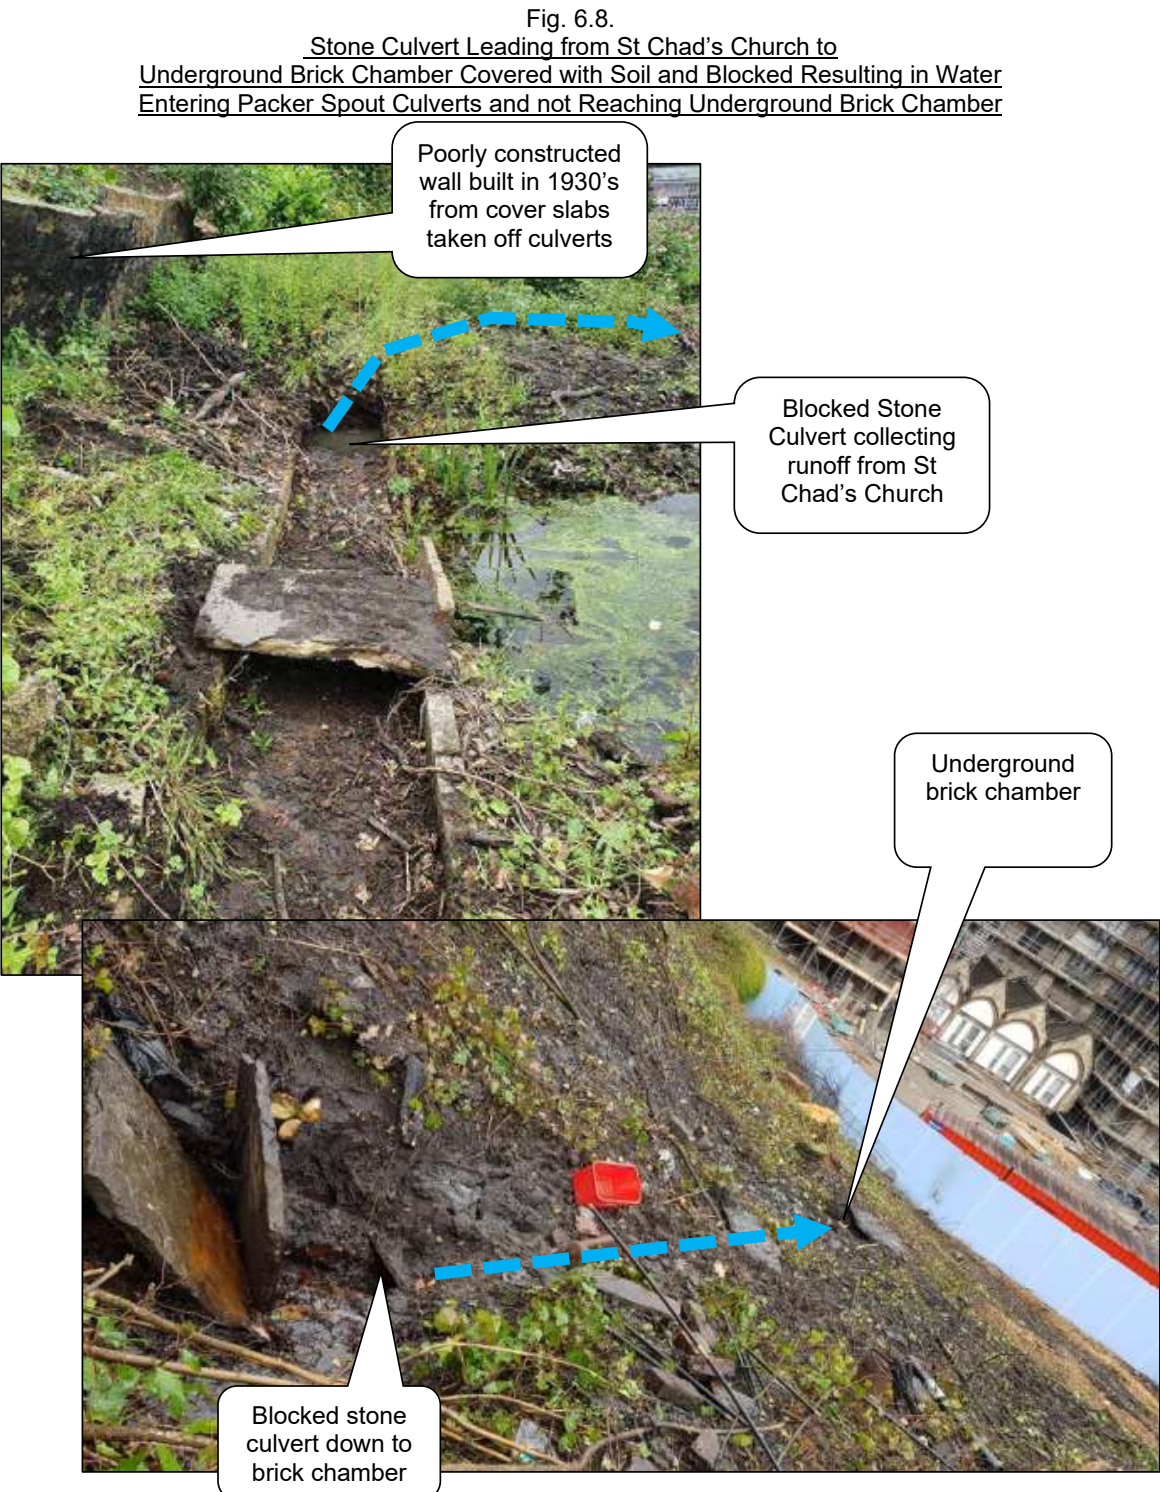
The downslope and lateral culverts collecting water from the lower spring line and channelling it to the underground brick chamber were also covered with soil and consequently blocked, resulting in permanently boggy ground along (Fig. 6.9).

Fig. 6.9.  
Culverts Collecting Water from Lower Spring Line and Channelling it to Underground  
Brick Chamber Covered with Soil and Blocked

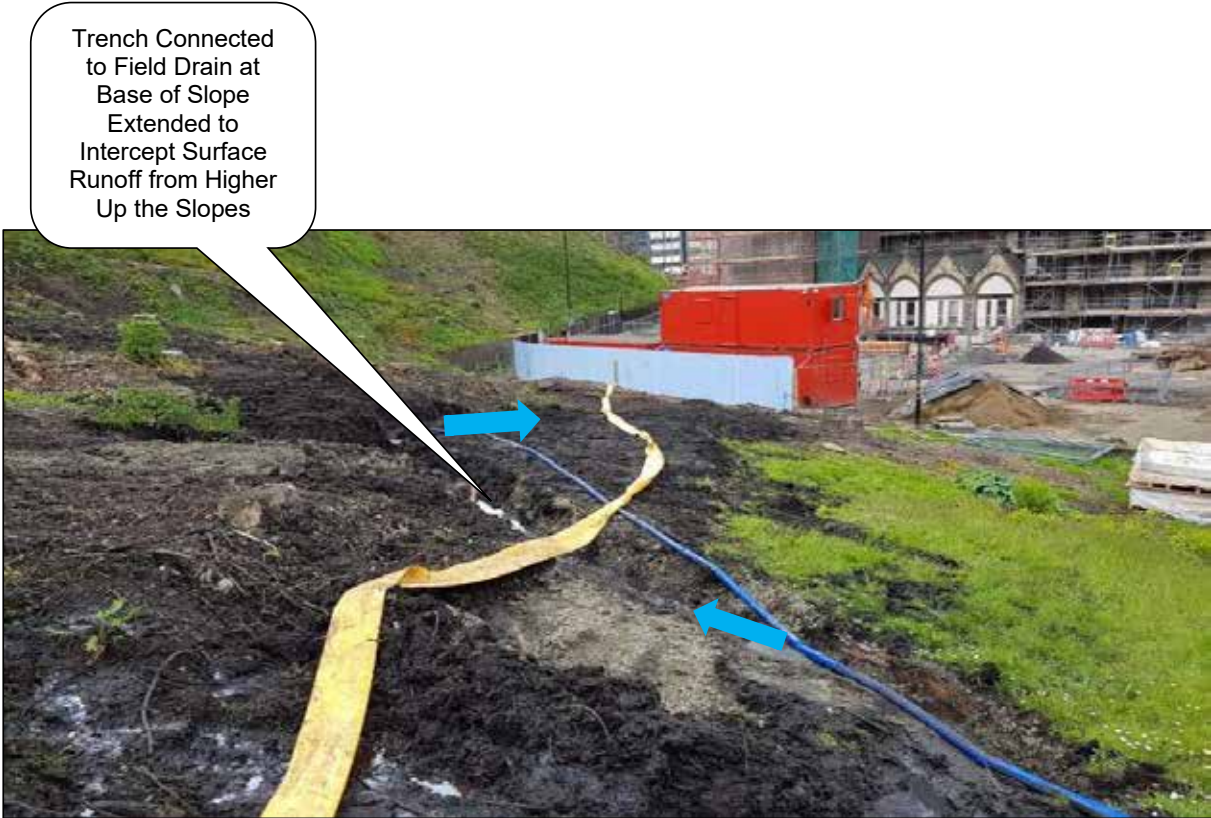
Fig. 8.2  
Trench Connected to Field Drain at Base of Slope Extended to Intercept Surface  
Runoff from Higher Up the Slopes (Due to e.g., storms and blocked pipes)

Trench Connected to Field Drain at Base of Slope Extended to Intercept Surface Runoff from Higher Up the Slopes

The trench connected to the field drain at the base of the slope was extended to the east to intercept surface runoff from higher up the slopes which may occur due to, for example, storms and blocked pipes leading to the cascades (Fig. 8.2).

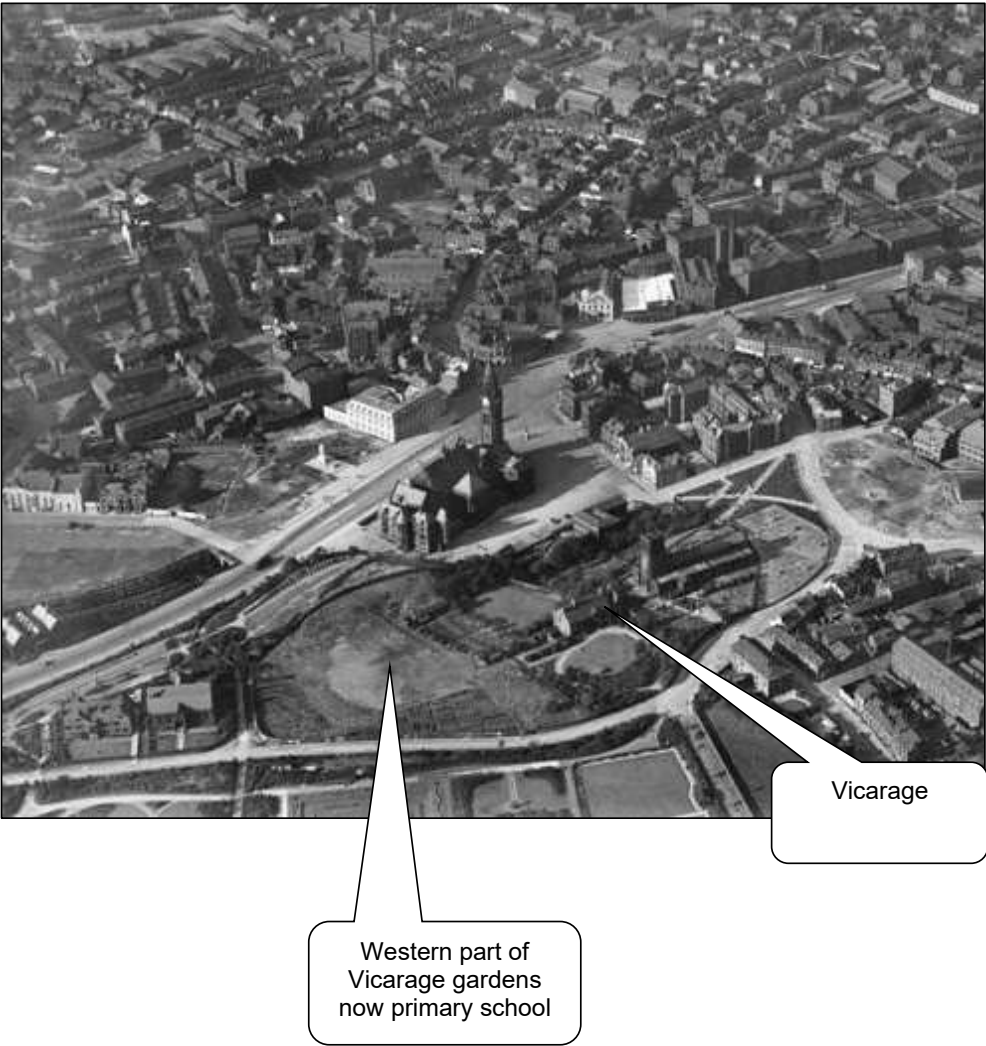
The 1926 aerial photo (Fig. 11.1) shows the area of the catchments prior to the building of the school on the western side of the vicarage gardens.

Fig. 11.1  
1926 Aerial Photo Showing Catchment 1 in Vicarage Gardens Before Building of  
Primary School

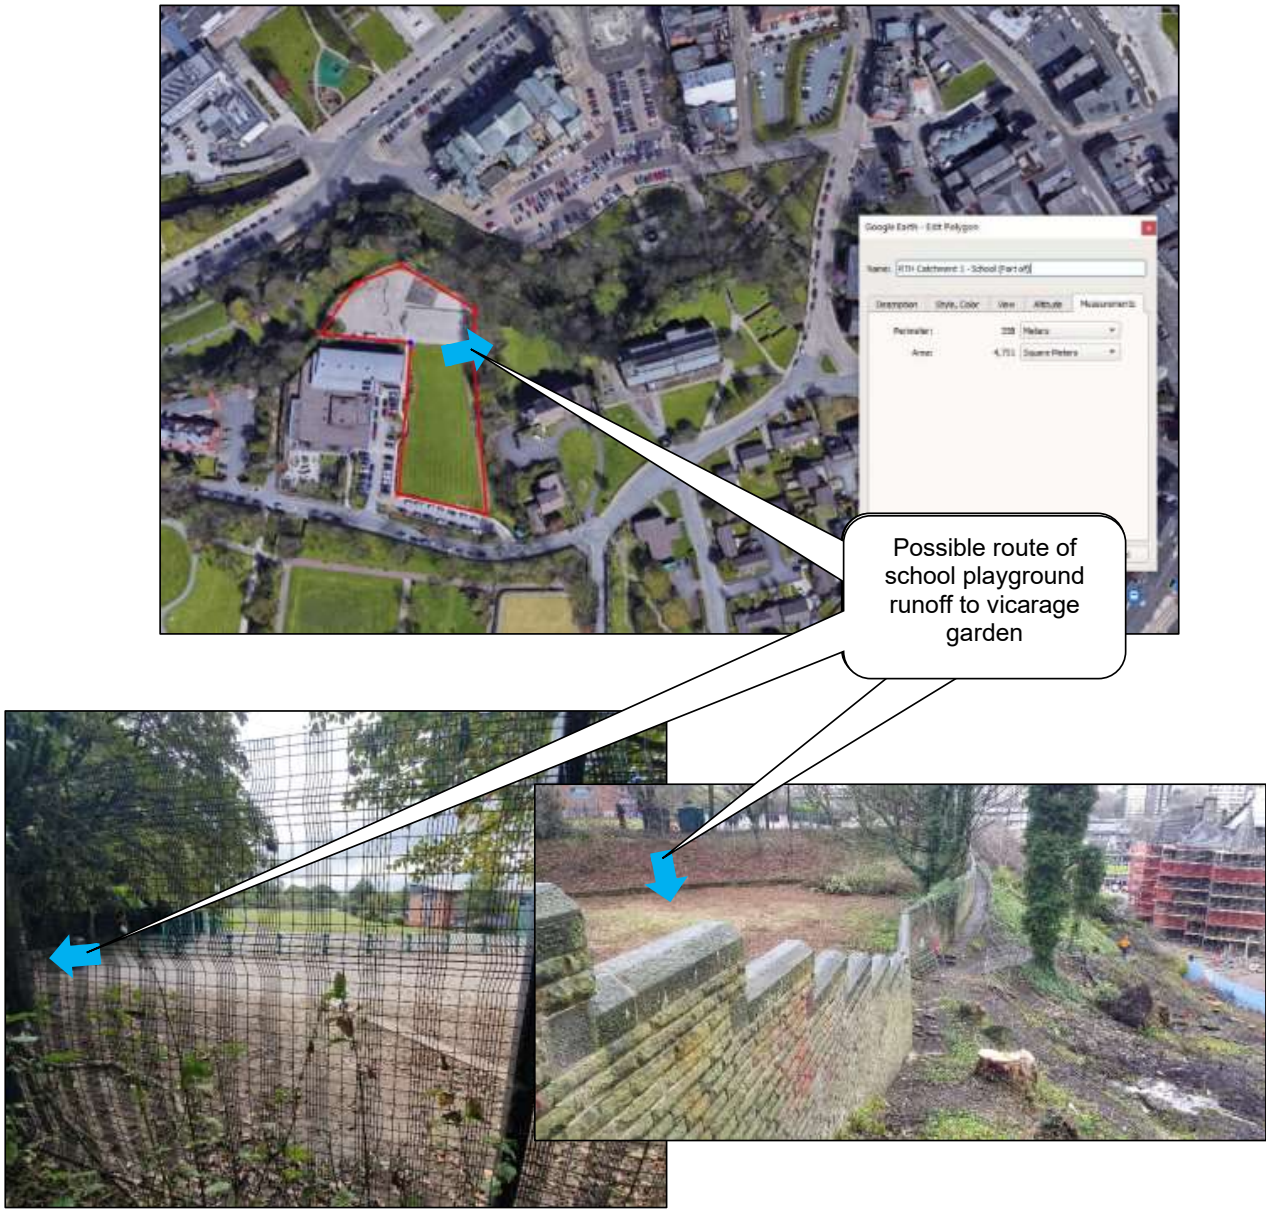
It is possible that the runoff from the school playgrounds could follow the route of the original site drainage into the remaining part of the vicarage gardens (Fig. 11.2).

Fig. 11.2  
Catchment 1 - Grassed & Hard Standing Playground Areas Could Still Possibly Drain  
to Vicarage Garden as per Original Drainage Before Construction of School

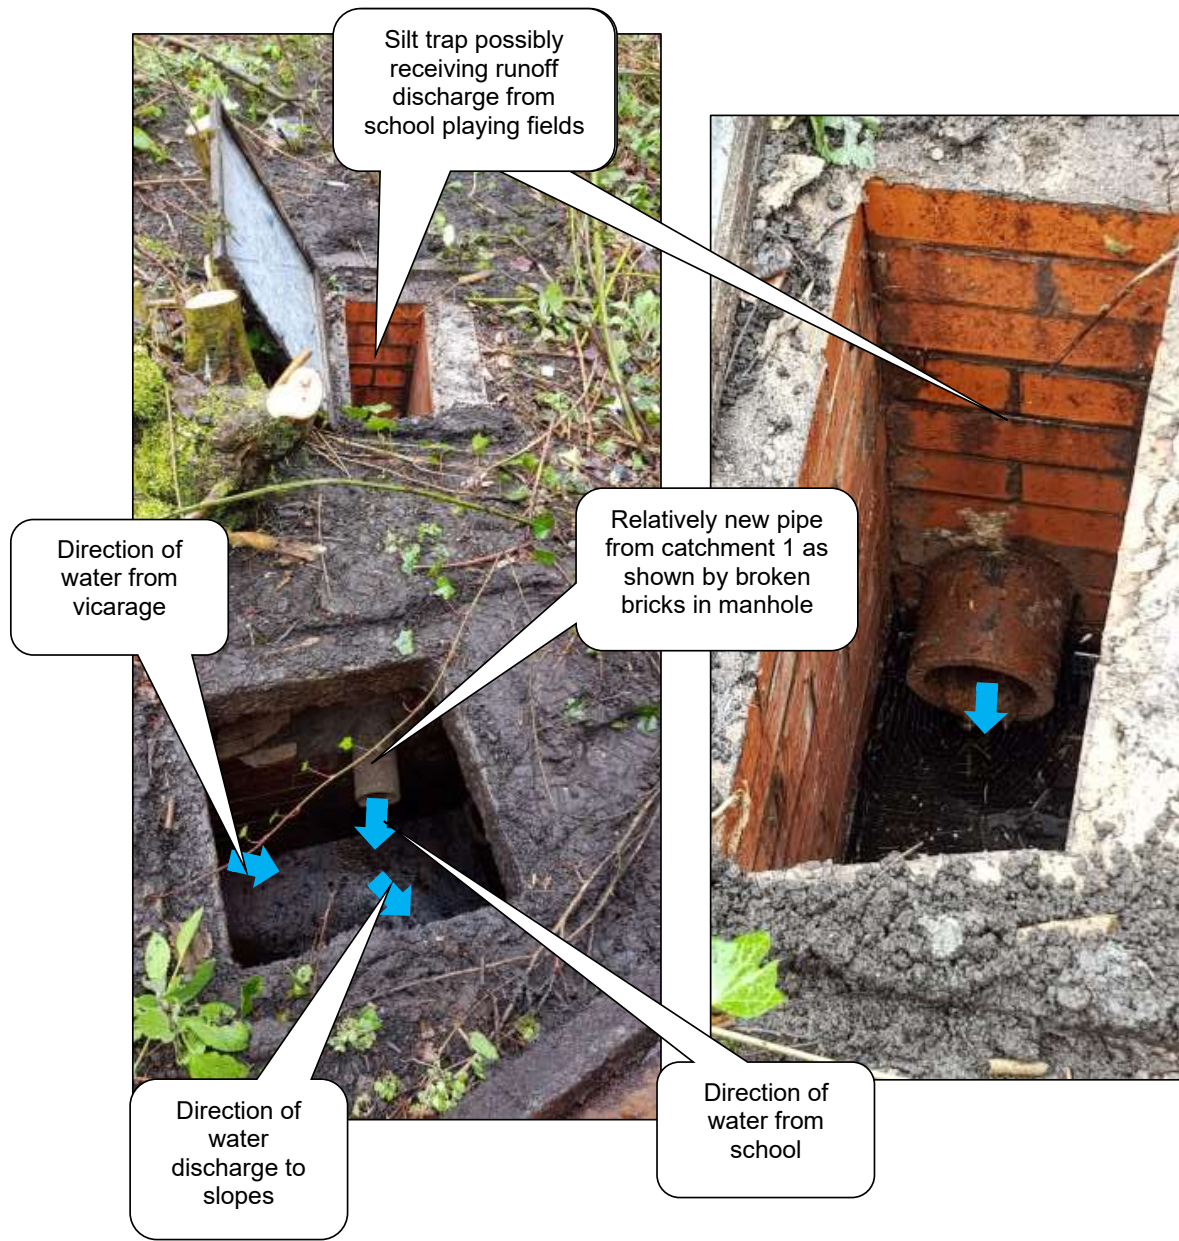
The silt trap manhole in the vicarage garden next to garden gate receives runoff from the direction of Catchment 1 (School playing fields) and so could potentially be receiving runoff from Catchment 1 (Figs. 11.3).

Fig. 11.3  
Manhole Next to Garden Gate Receiving Runoff from Direction of Catchment 1  
(School Playing Fields)
