**Broadfield Park Slopes ('The Slopes'), Rochdale**

Design & Access Statement Appendix: Volume II

For Rochdale Development Agency

**RE: BROADFIELD PARK SLOPES, ROCHDALE – SURFACE WATER SAMPLING**

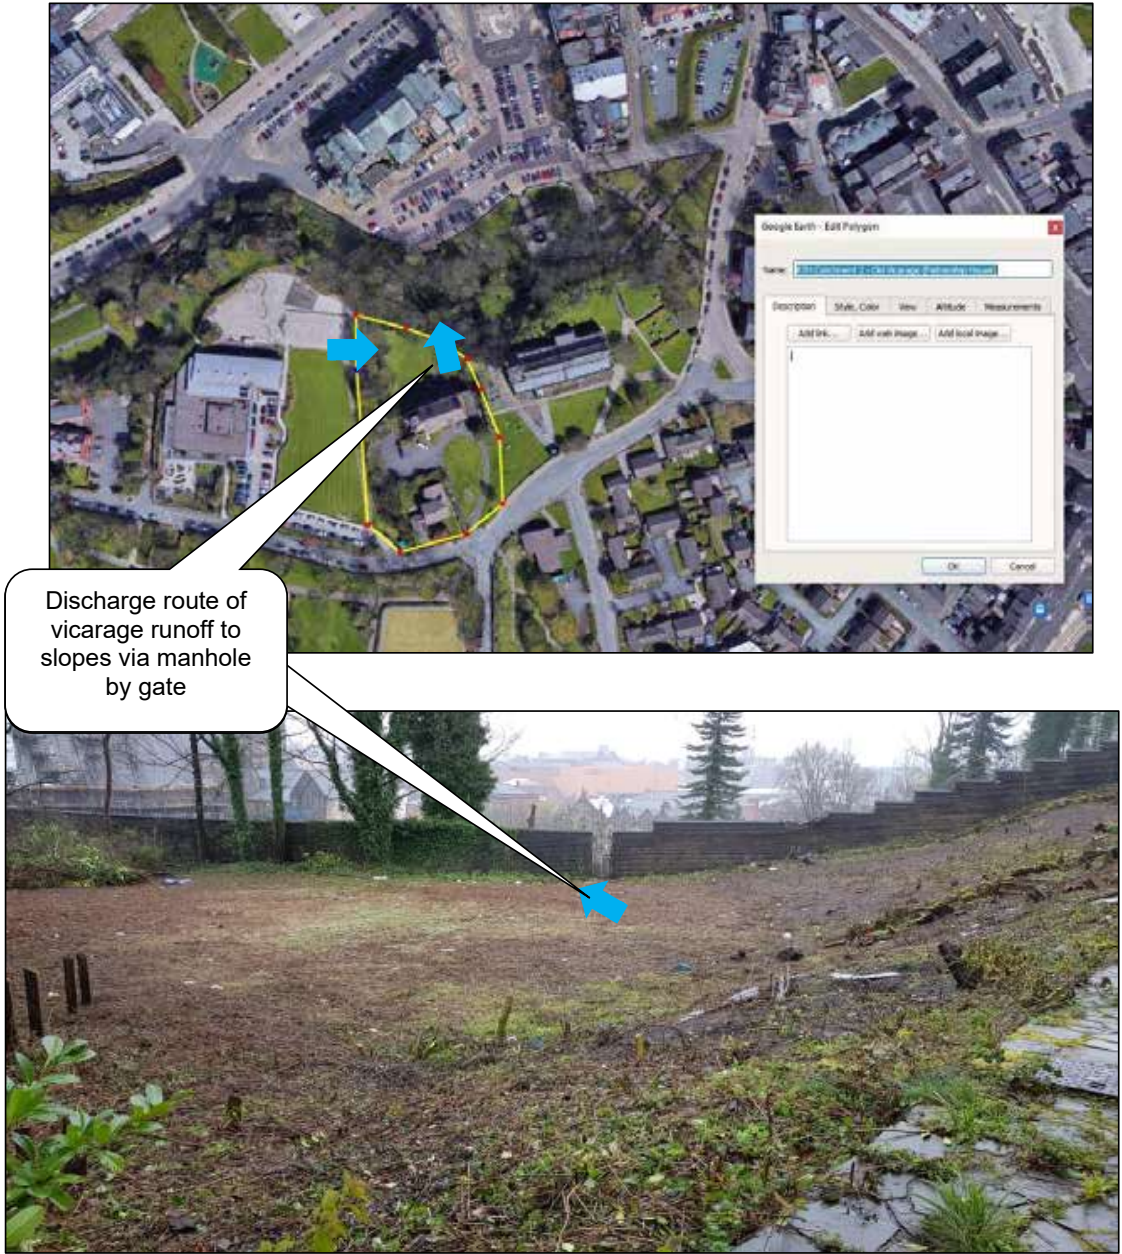
Fig. 6.3

Catchment 2 is the remaining part of the old vicarage with a surface area of 5,723 m<sup>2</sup> (Fig. 12.1).

Catchment 2 – Old Vicarage Discharging Runoff (& Probably Foul Water) to Slopes  
Via Manhole by Gate

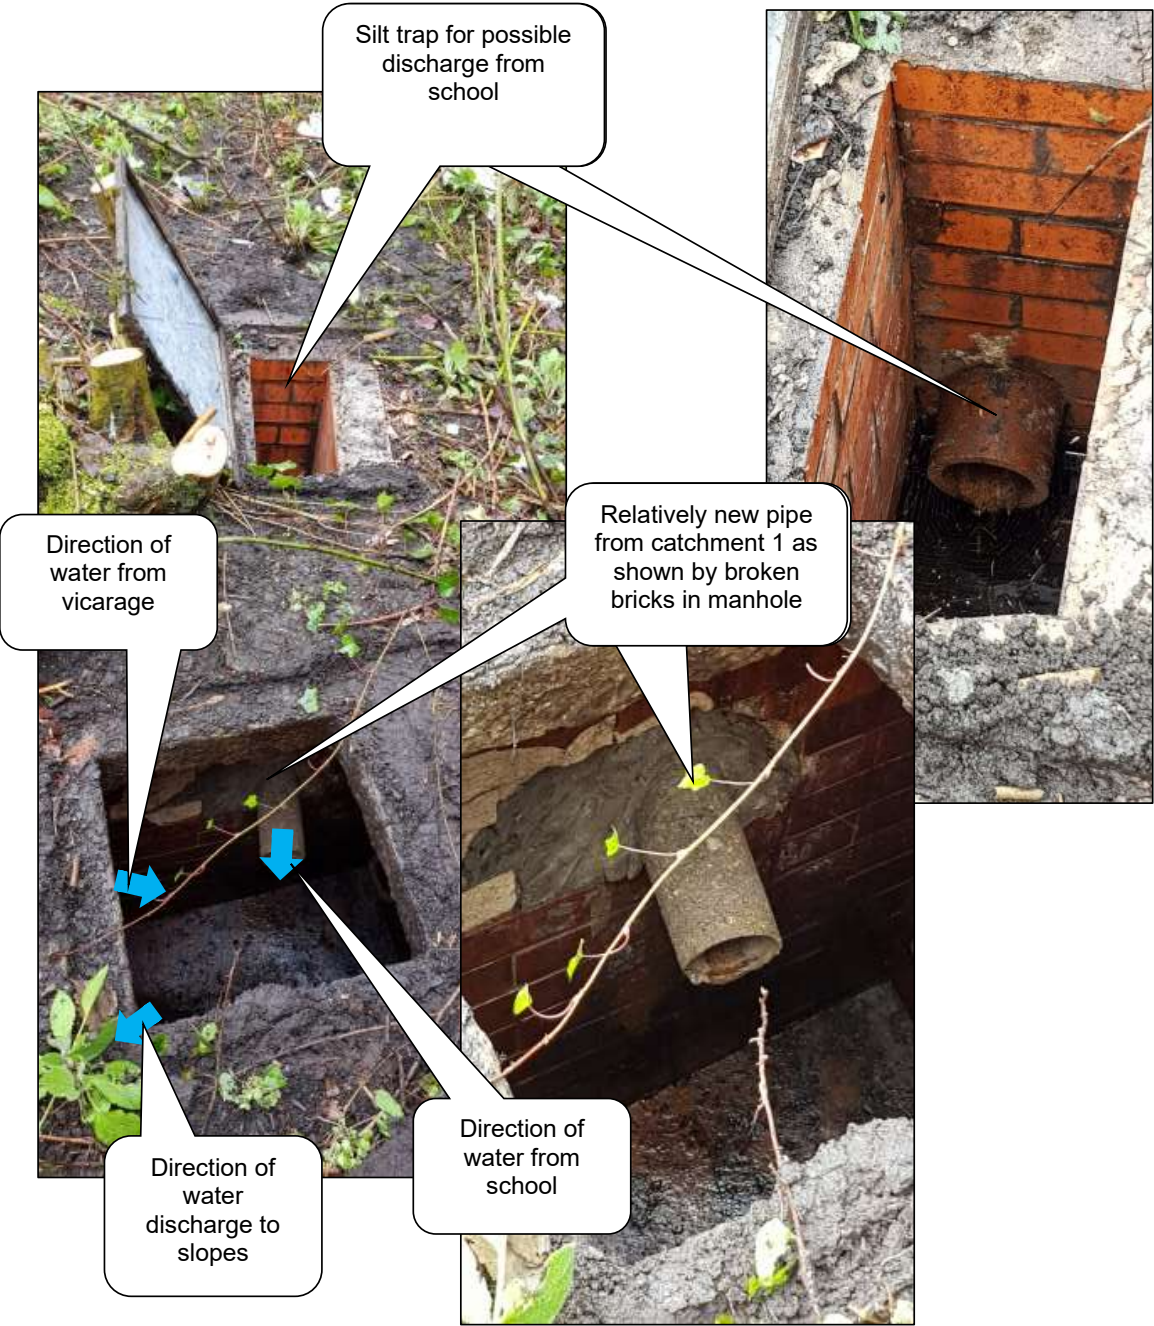
Fig. 12.2

The manhole in the vicarage garden next to garden gate (which leads to the slopes) receives runoff from the direction of Catchment 1 (School playing fields) and Catchment 2 (Vicarage) and discharges it to the Slopes (Fig. 12.2).

Manhole Next to Garden Gate Receiving Runoff from Catchment 1 (School playing fields) and Catchment 2 (Vicarage) and then Discharging to the Slopes

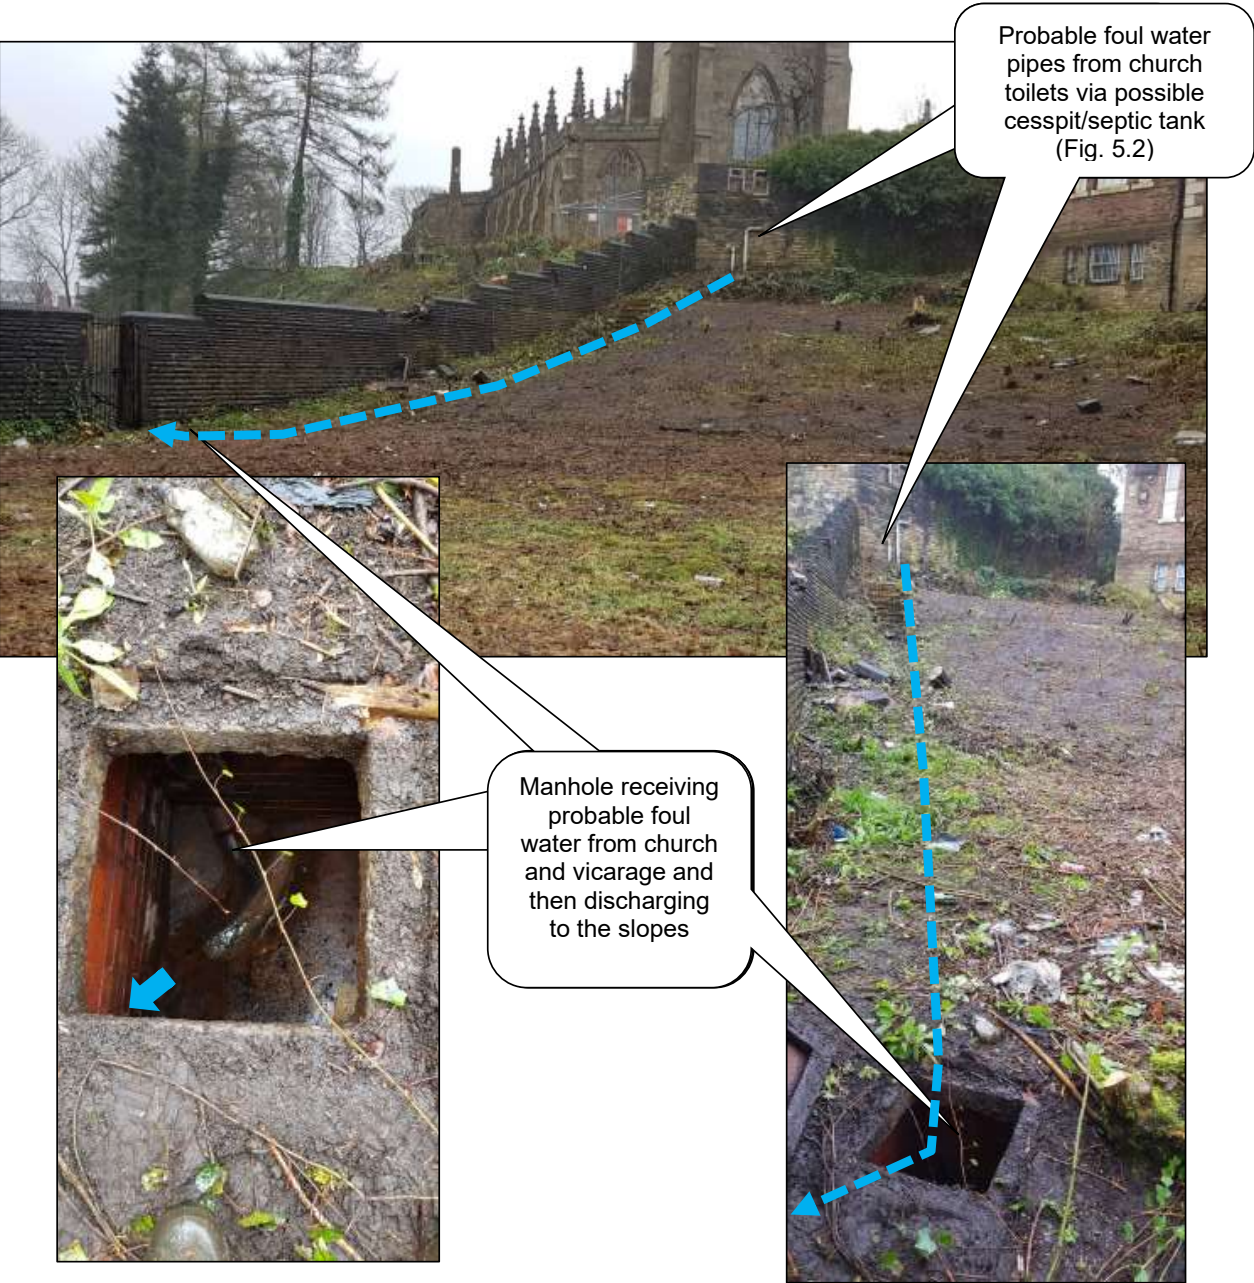
The walkover investigations of drainage from the church and the old vicarage to the slopes revealed that it is highly probable that foul water from the church and the vicarage is being discharged to the slopes via the manhole adjacent to the gate in the wall. Fig. 12.3 shows the probable route of foul water from church to the slopes via a manhole in the vicarage gardens. The church website confirms that the church has toilet facilities (Fig. 12.4). The location of a possible septic tank or cesspit in church yard to the west of the church is also shown in Fig. 12.4.

Probable Route of Foul Water from Church to the Slopes Via Vicarage Gardens

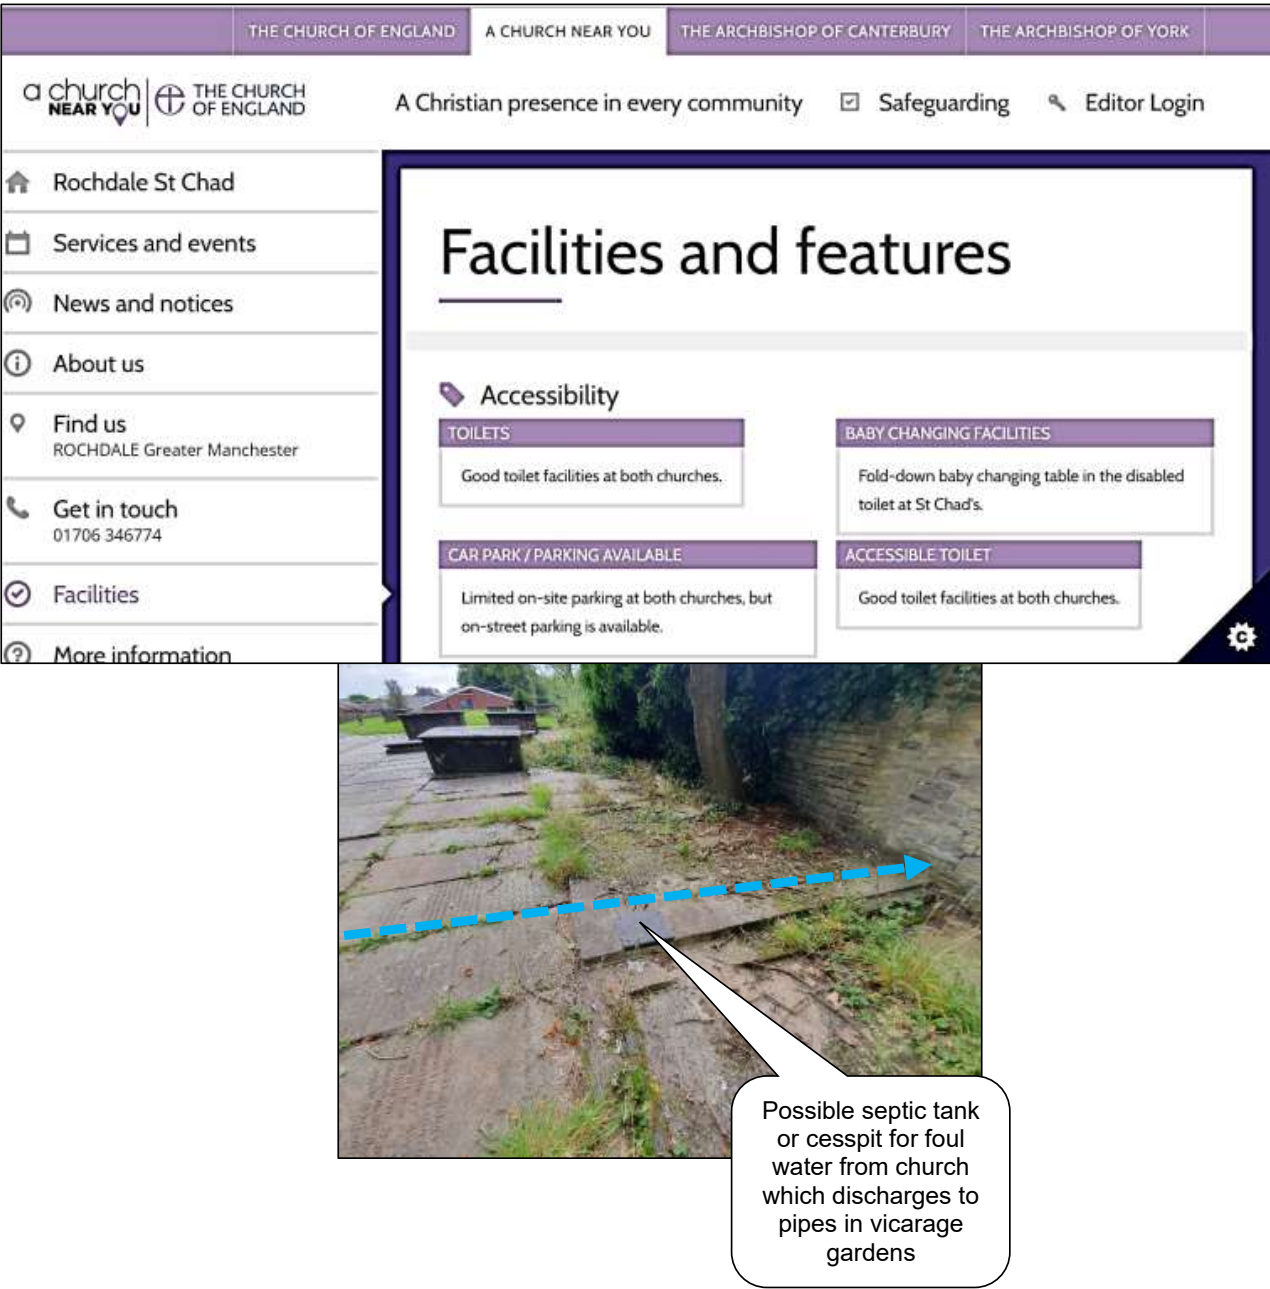
Fig. 12.4

Confirmation St Chad's Church has Toilets and Possible Septic Tank or Cesspit in Church Yard to the West of the Church

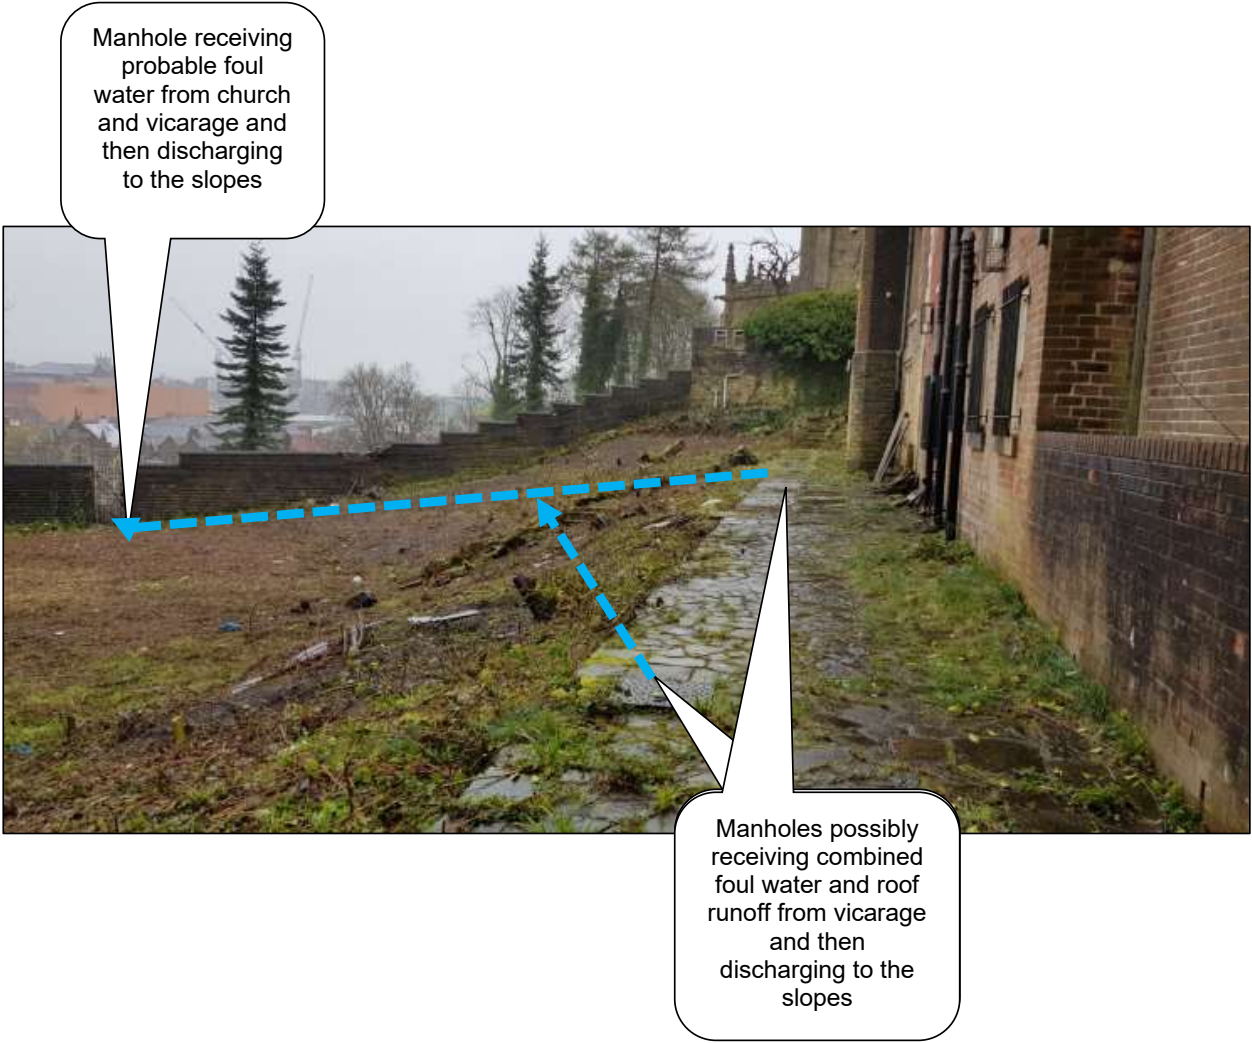
Fig. 12.5

It is possible that the 2 manholes in the terrace immediately to the north of the old vicarage are receiving combined foul water and roof runoff from vicarage and then discharging to the slopes via the same manhole receiving the foul water from the church (Fig. 12.5).

Manholes Possibly Receiving Combined Foul Water and Roof Runoff from Vicarage and then Discharging to the Slopes

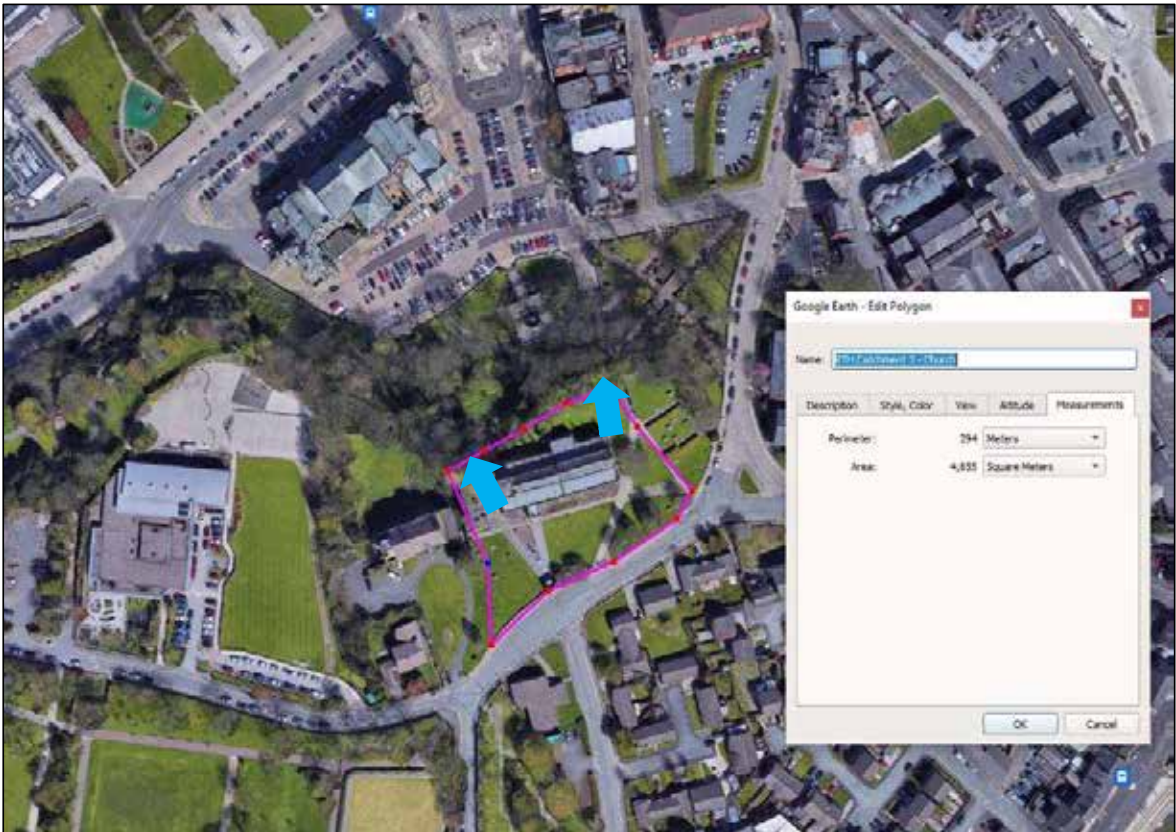
Runoff from the church roof and paved church yard is discharged both to the west and east of the of the church (Figs 13.1 & 13.2).

Fig. 13.1  
Catchment 3 – Church Discharging Runoff to Slopes to the West and East  
of St Chad’s Church

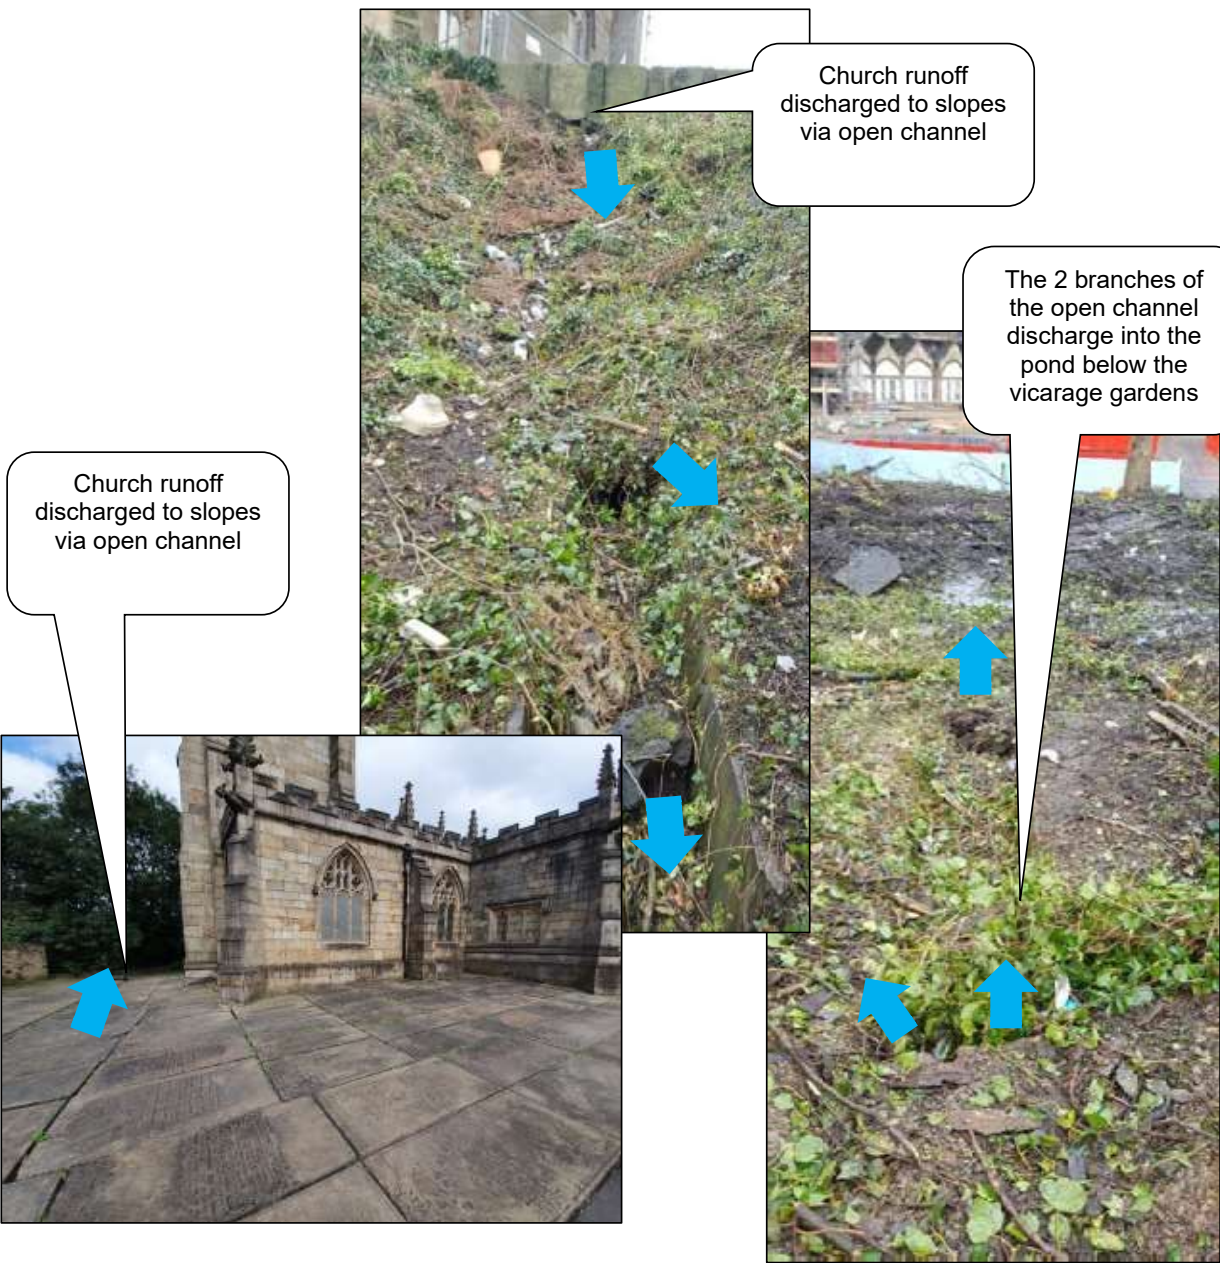
On the western side of the church, an open channel discharges runoff into the pond and open channel of the Packer Spout water supply (Fig. 13.2).

Fig. 13.2  
West Side of Church Discharging Runoff to Slopes Via Open Channel to Packer  
Spout Water Supply – Open Channel Splits into Two Channels Halfway Down Slope

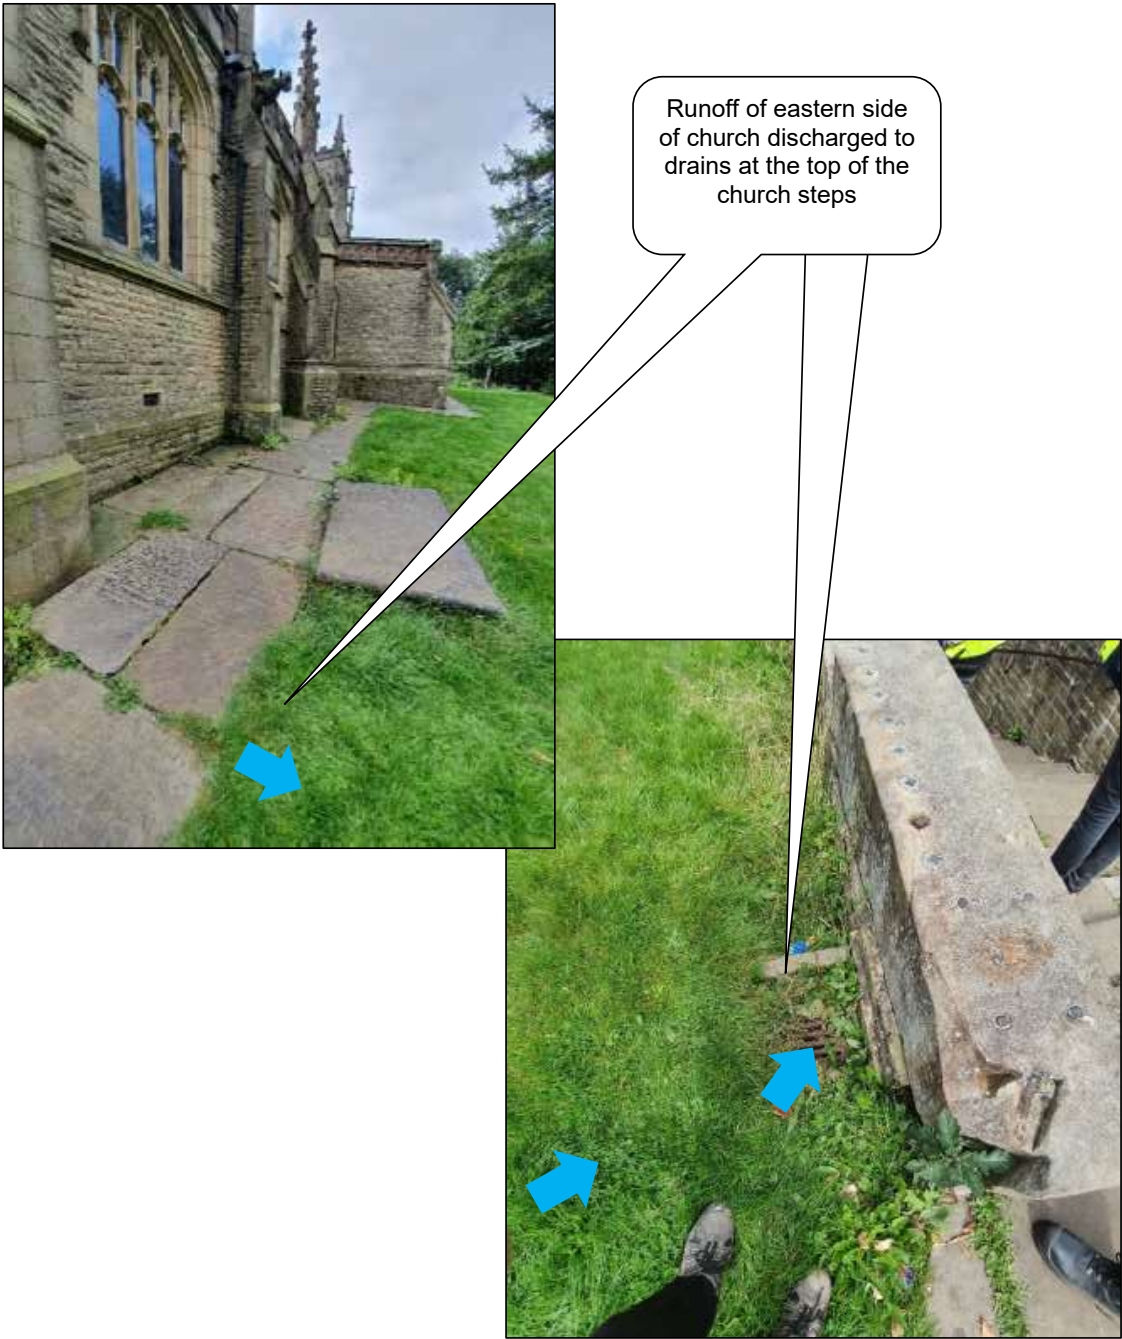
On the eastern side of the church, the runoff is directed into the drains at the top of the church steps (Fig. 13.3).

Fig. 13.3  
Church Discharging Runoff to Slopes Via Open Channel to Pond Below Vicarage  
Gardens – Open Channel Splits into Two Channels Halfway Down Slope

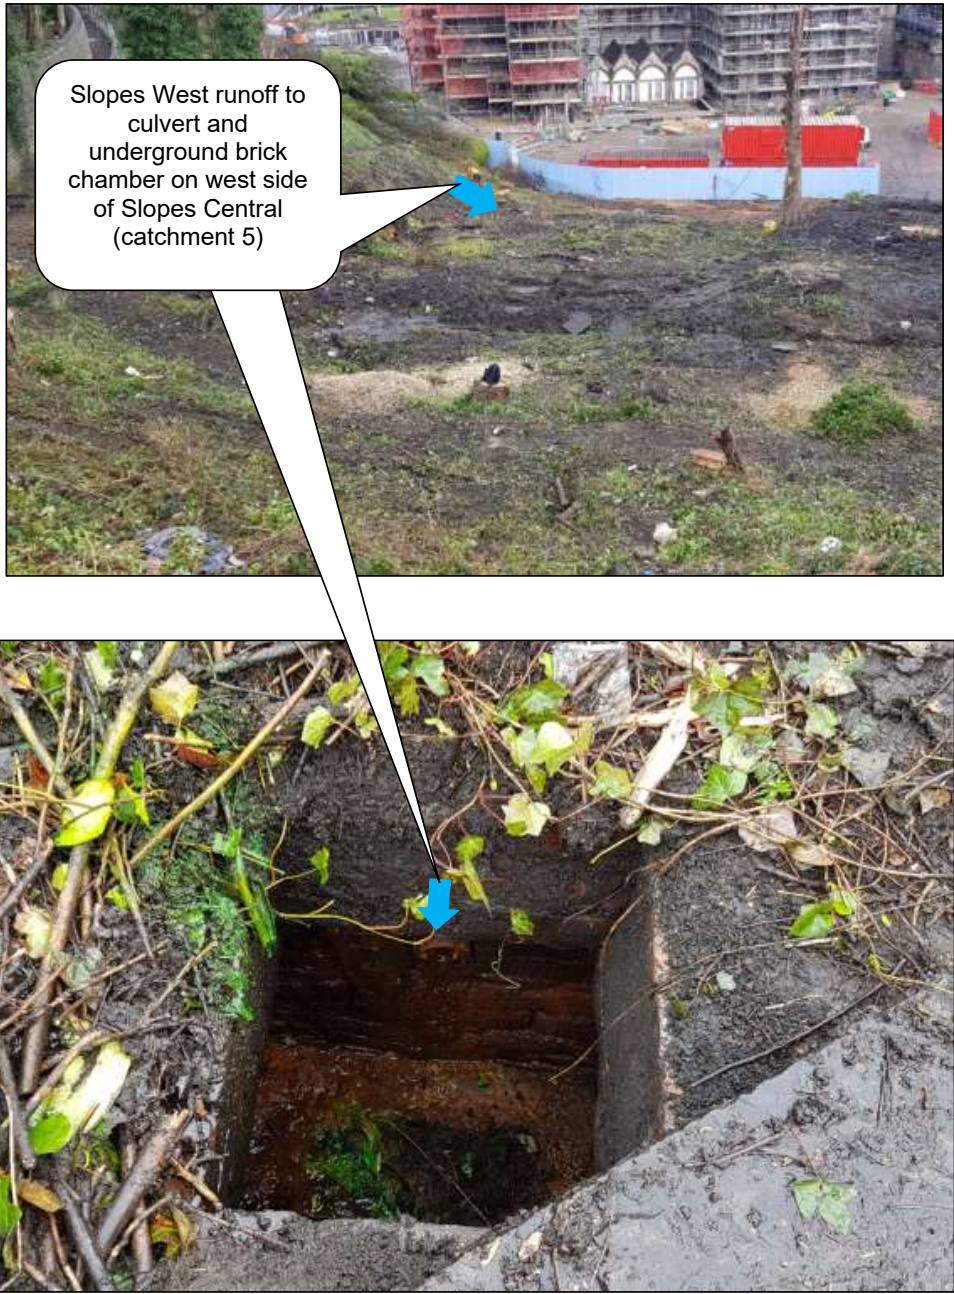
Part of the Slopes West runoff is drained to the culvert and underground brick chamber on west side of Slopes Central (catchment 5) (Fig. 14.2).

Fig. 14.2  
Catchment 4 – Slopes West runoff to culvert and underground brick chamber on west side of Slopes Central (catchment 5)

Any new planting on the slopes should not disturb the existing drainage.

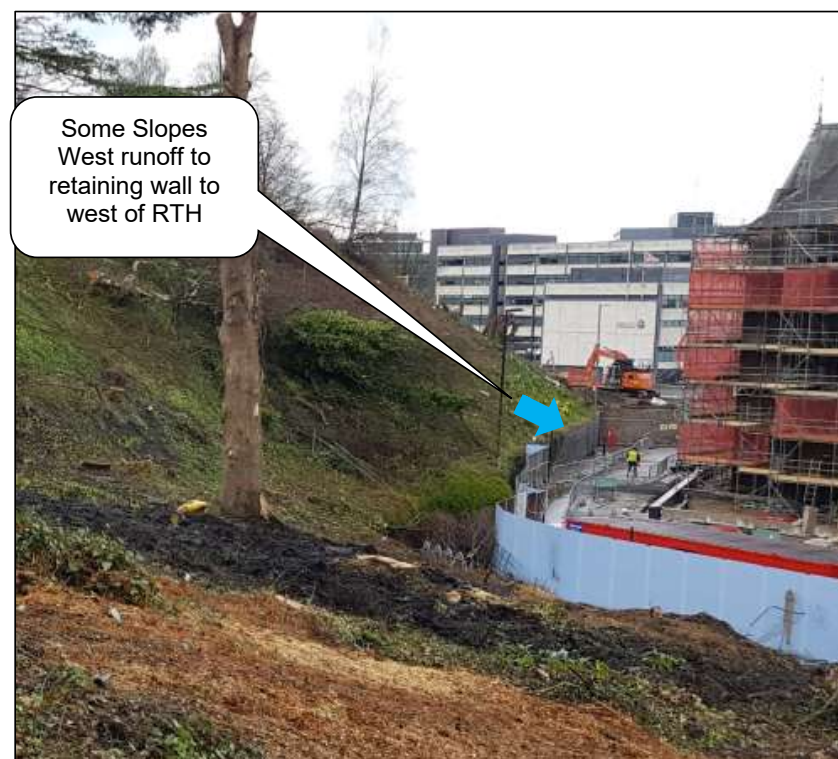
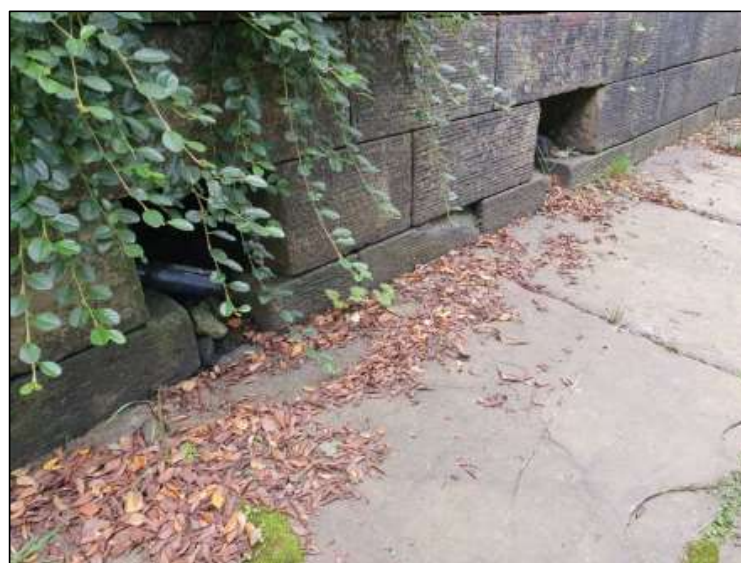
Fig. 14.3

Some Slopes West runoff to flows to behind the retaining wall to west of RTH where seep holes release build-ups of water (Fig. 14.3).

Catchment 4 – Some Slopes West runoff to retaining wall to west of RTH

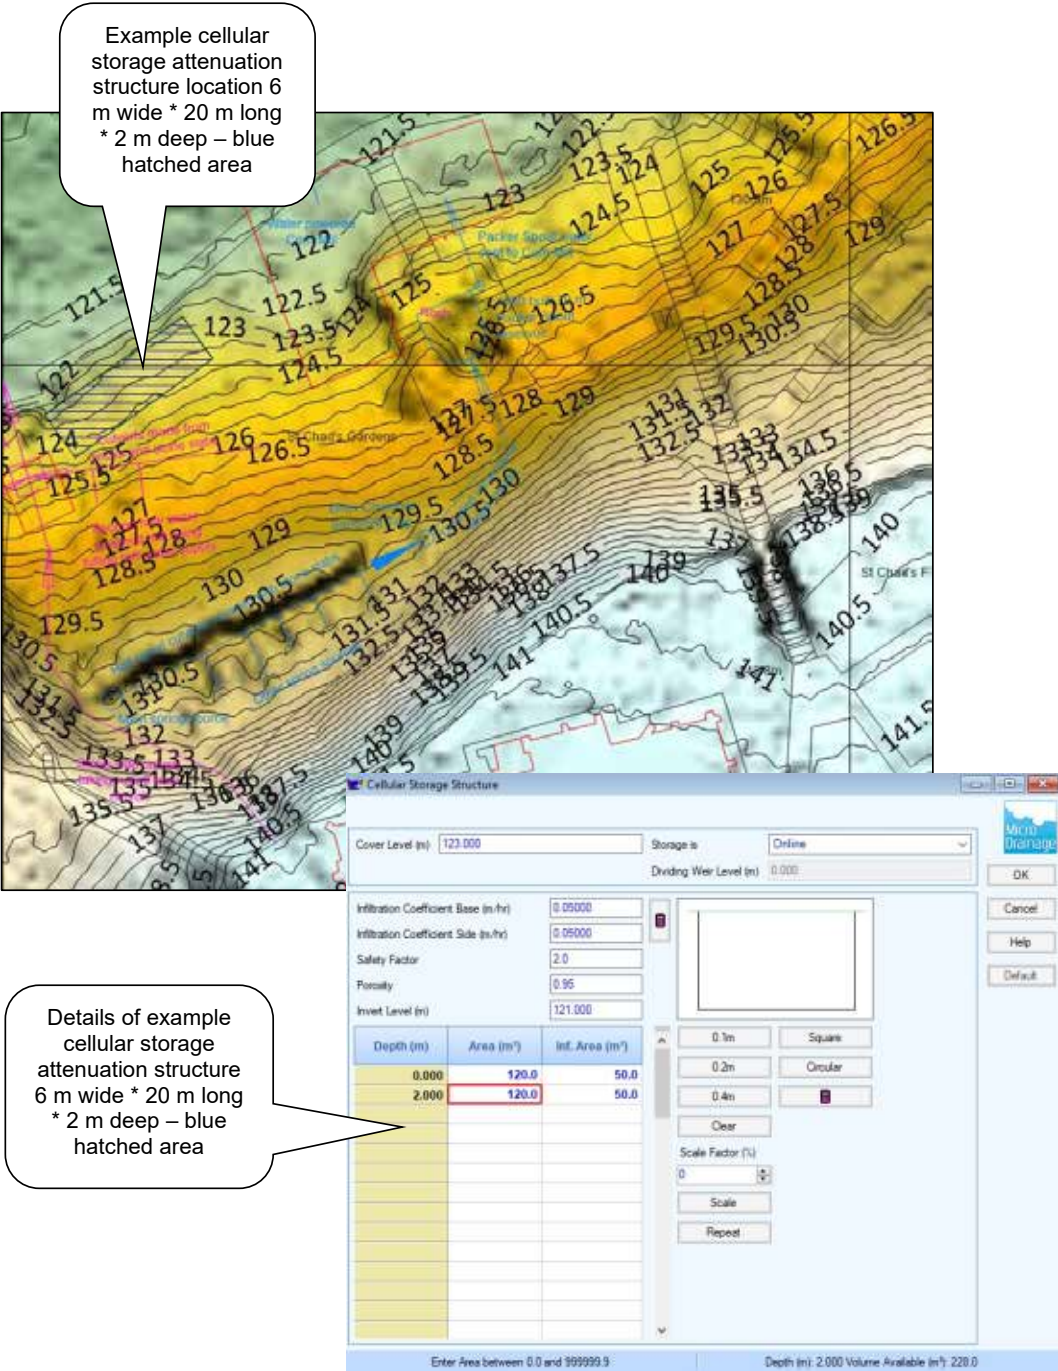
An example flood attenuation structure design for a cellular storage structure at the base of the western side of the central slopes catchment is presented in Fig 15.2.

Figure 15.2  
Example Cellular Storage Attenuation Structure Location & Dimensions

The cellular storage structure (6 m wide \* 20 m long \* 2 m deep) was been designed on the basis of receiving 100 year storm flow (+40% for climate change) from a catchment area of 0.33 hectares. The maximum allowable discharge rate from the cellular storage was set at 5 l/s. The design calculations are shown in Fig. 15.3 confirming that the cellular storage would retain the storm flows (status OK).

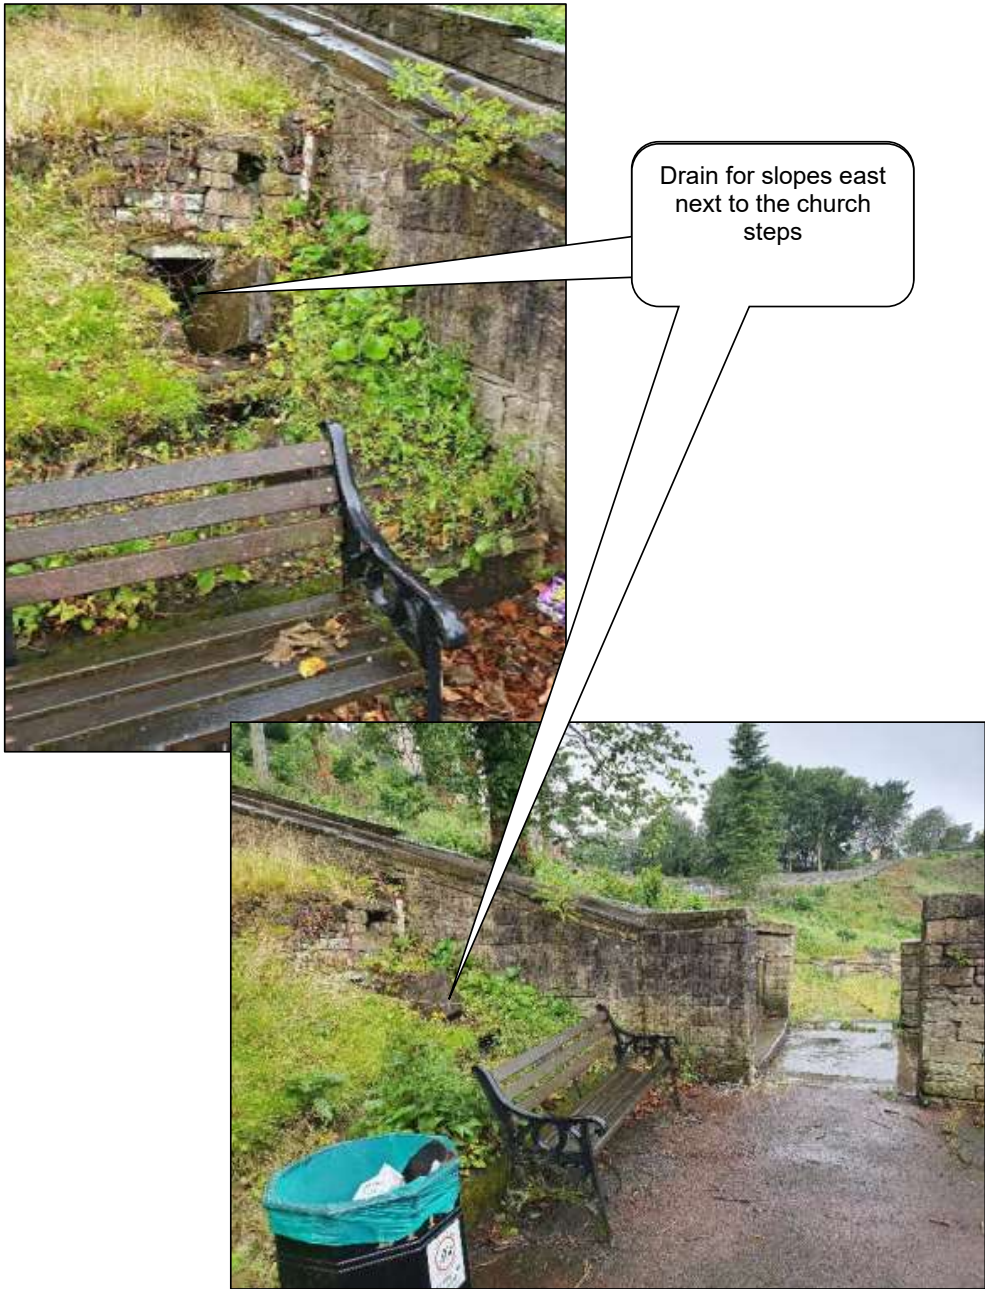
A significant drain for the surface runoff from the slopes east catchment is next to the base of the church steps (Fig. 16.1).

Fig. 16.2  
Significant Drain for Catchment 6 – Slopes East Next to Church Steps

| Catchment No. | Catchment Name | Problems | Remedy |
|---|---|---|---|
| 6 | Slopes East | Unknown extent and condition of drains on these very steep slopes | Investigate condition of significant drain for the surface runoff next to the base of the church steps |

As previously mentioned for the other slopes catchments, it should be determined if storm runoff flow attenuation is required based on the relative flow capacity of the new RTH drainage compared with the slopes storm runoff rates.
