## **SYKE HOUSE BARN**

## **Archaeological Building Recording**

**North Star Archaeology**

**February 2024**

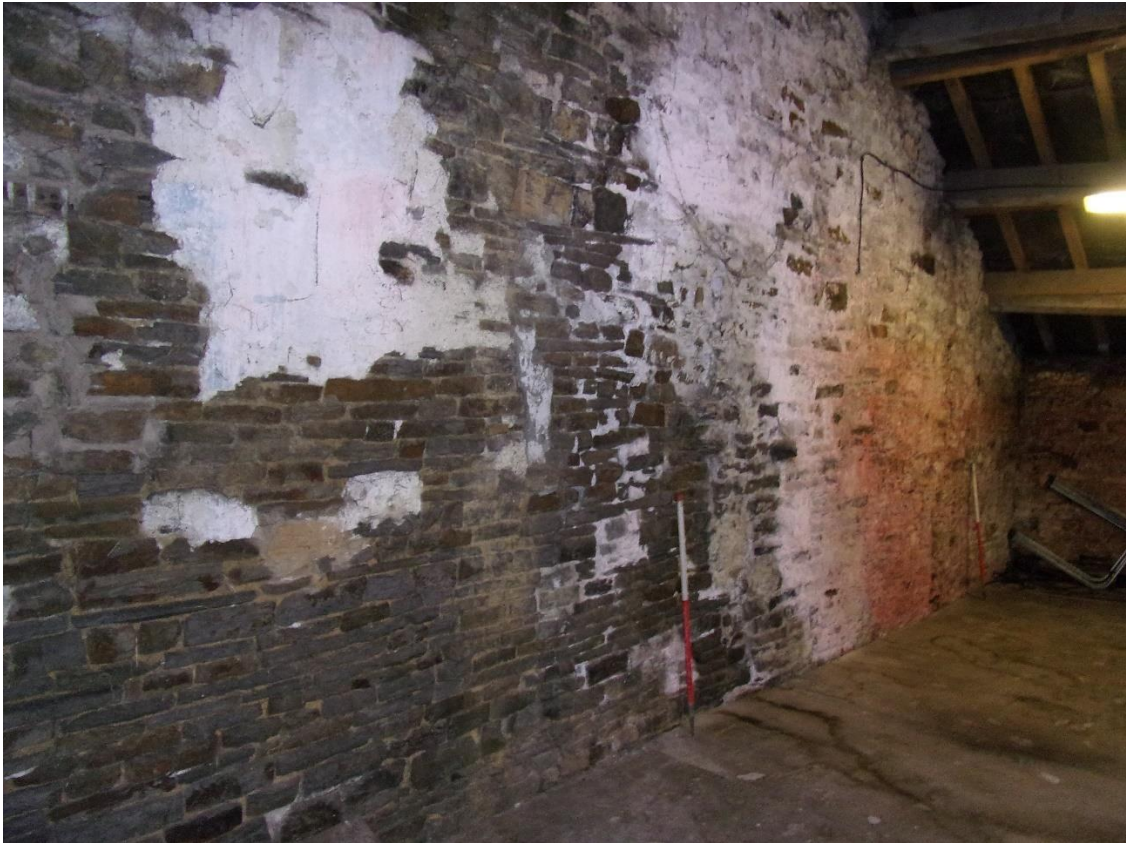
*Plate 73 Partition wall between Rooms 13 and 14, facing northwest*

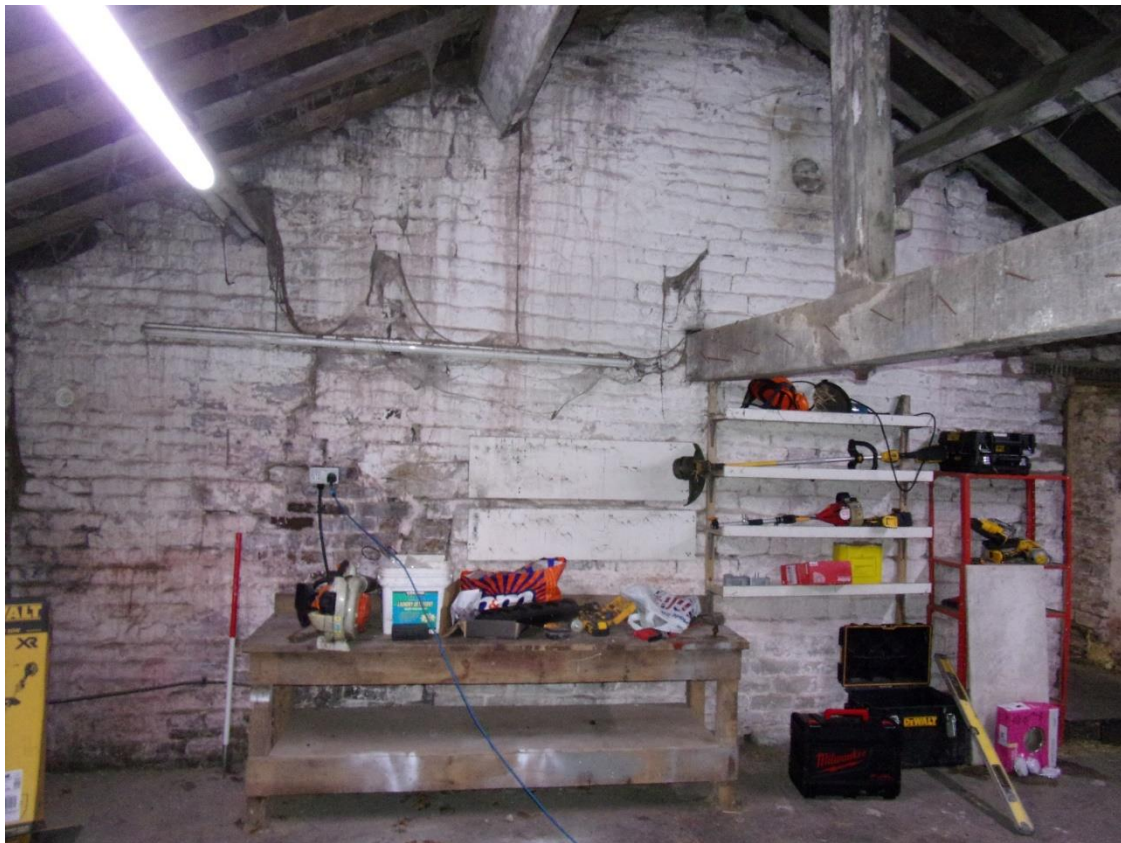
*Plate 75 East elevation in Room 14, facing southeast*

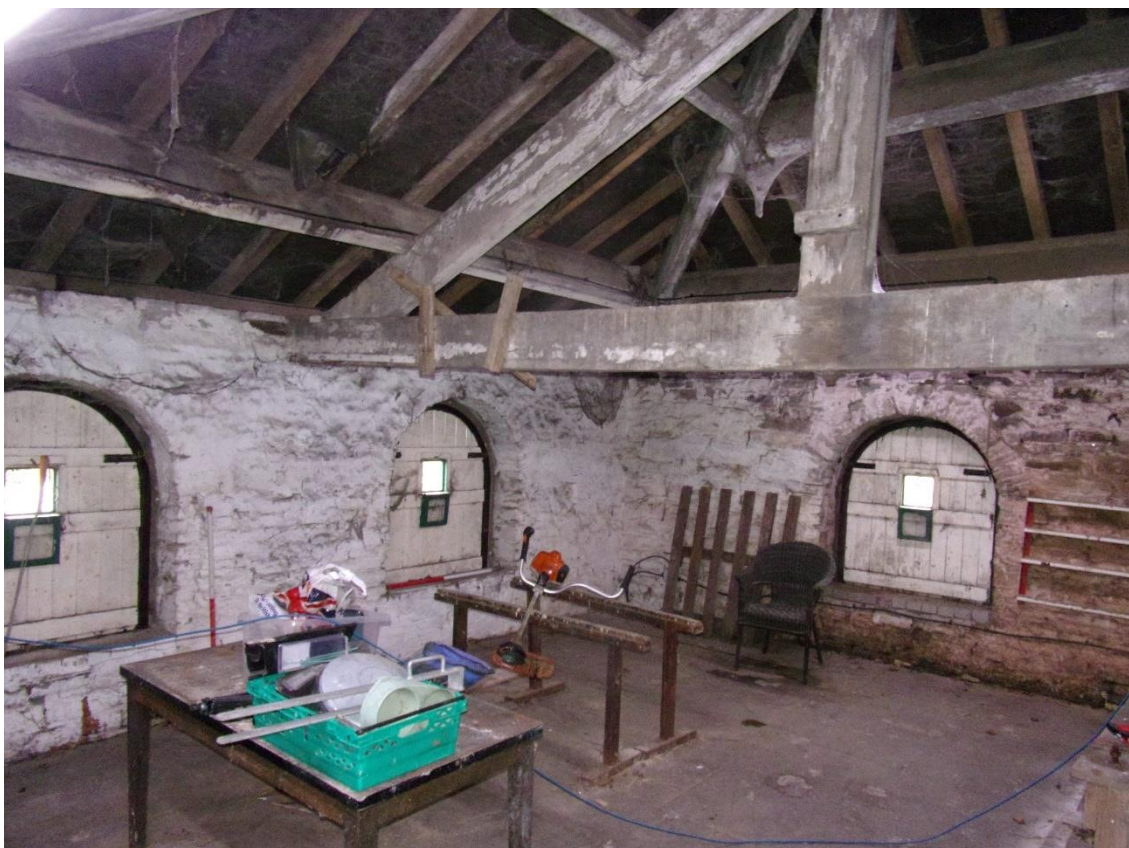
*Plate 78 Room 14 facing southwest*

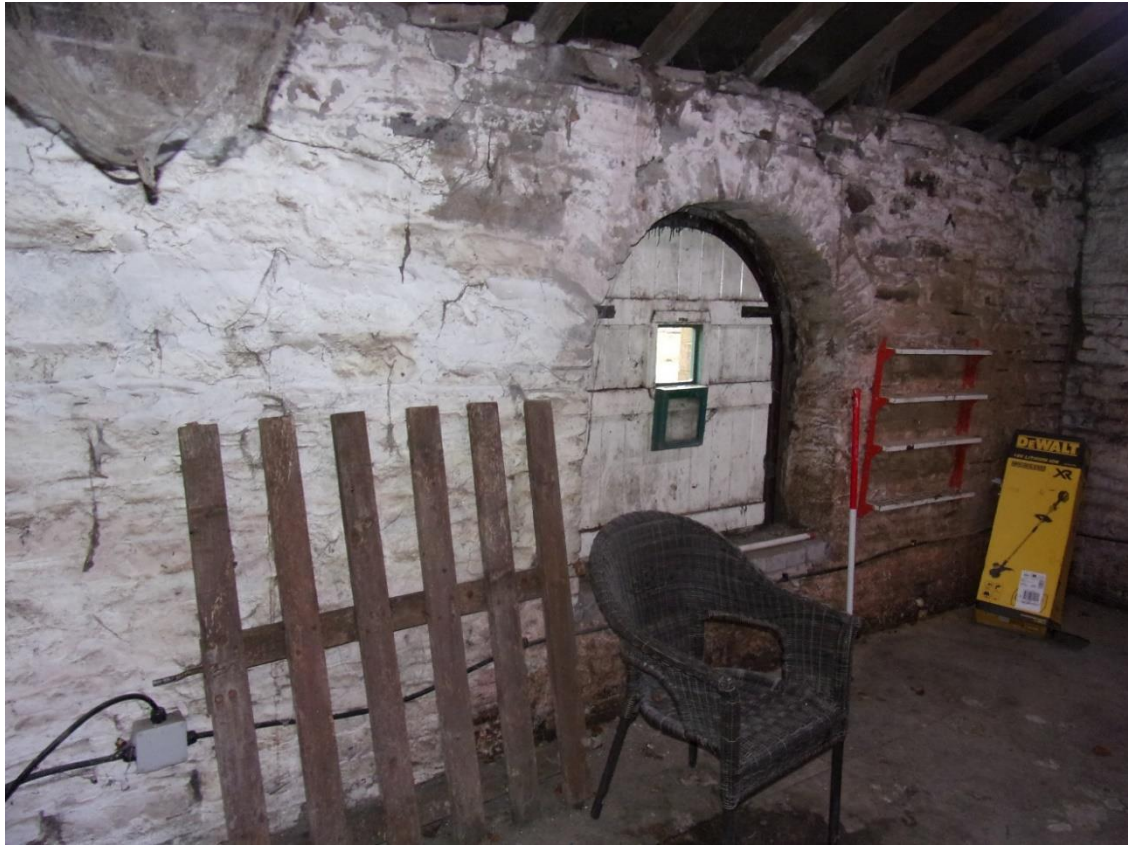
*Plate 79 North elevation of Room 14, facing northeast*

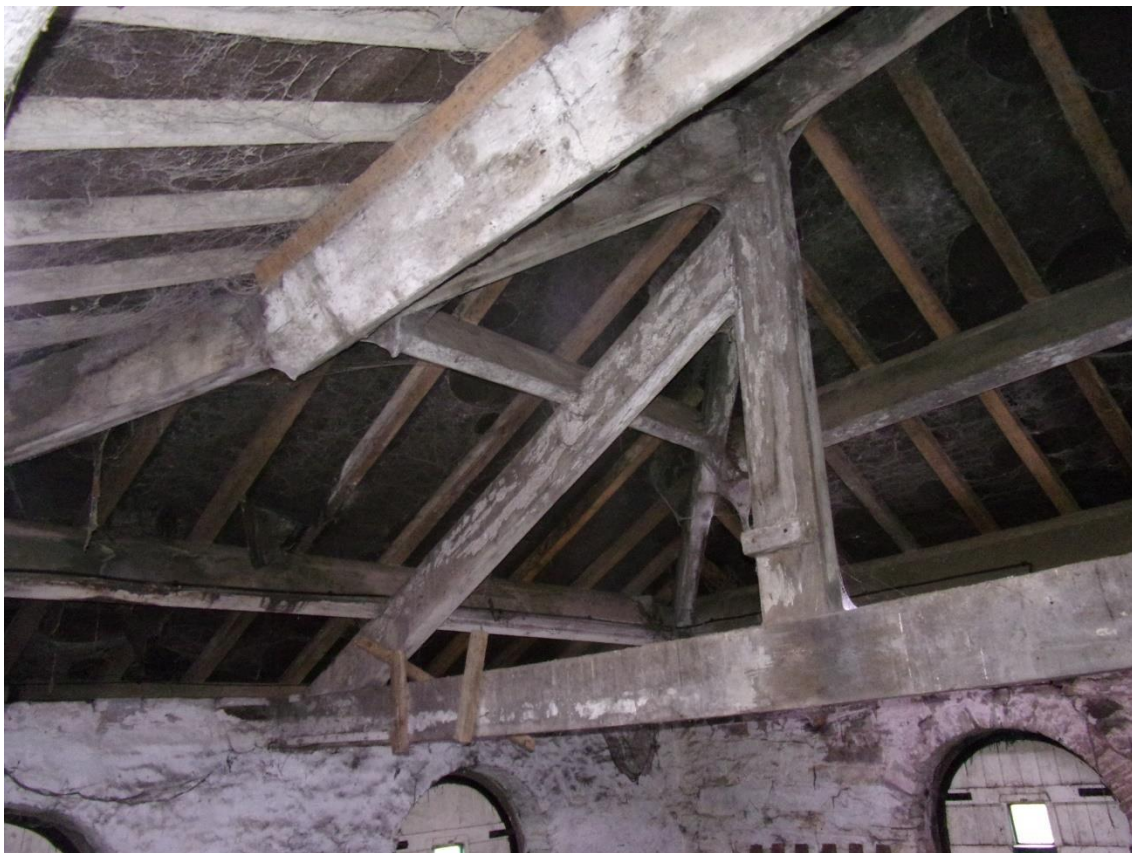
*Plate 80 Roof structure of the west stables*
