Elevation DD

Rochdale Borough Council  
SMP - St Mary's CE Primary School  
Elevation DD - Demolition & Repairs  
SMP-SEV-XX-XX-DR-A-03013

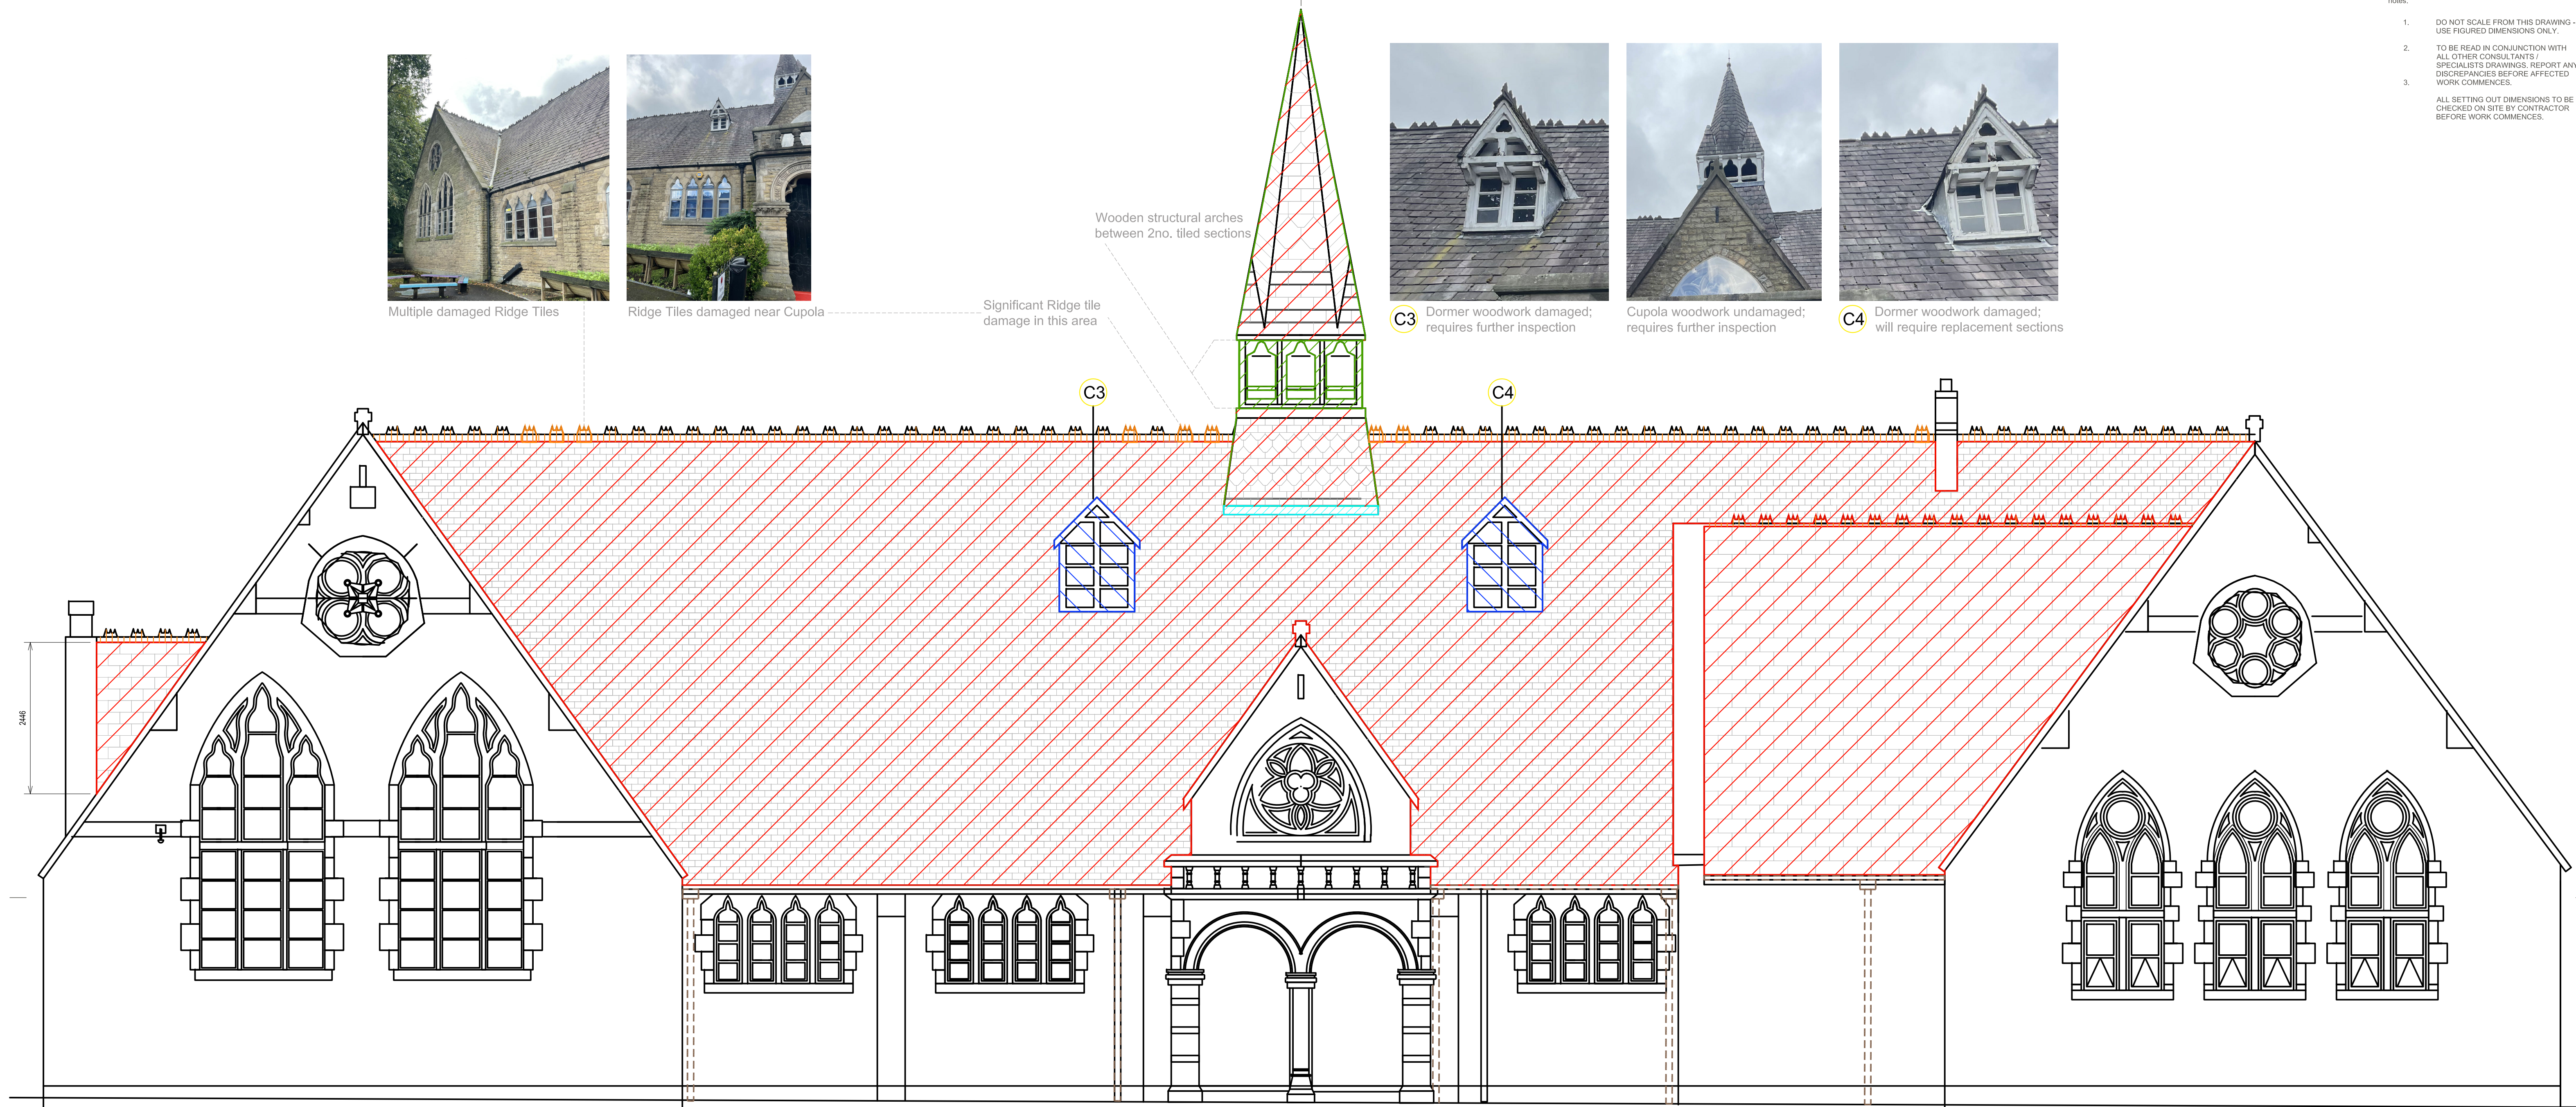
C4 Dormer woodwork damaged; will require replacement sections

- Dormer Window: 09 no.  
Splice in new timbers where appropriate. Access to be provided for detailed inspection and methodology agreed. Carefully sand down and repaint in appropriate materials as per the specification. Roofing section per detail F-F in drawing SMP-SEV-XX-XX-DR-A-03105 (Typical Dormer Window)

- Decorative Ridge Tiles: 105 Lm  
Ridge tiles to be removed and set aside with salvaged tiles for re-use. Replace damaged tiles as per the existing style. Ridge ventilation provided with new linear vent. Ridge venting per detail F-F in drawing SMP-SEV-XX-XX-DR-A-03105 (Typical Dormer Window)
