| PROJECT | SMP - St Mary's CE Primary School |
| TITLE | Elevation CC - Demolition & Repairs |
| NUMBER | SMP-SEV-XX-XX-DR-A-03012 |

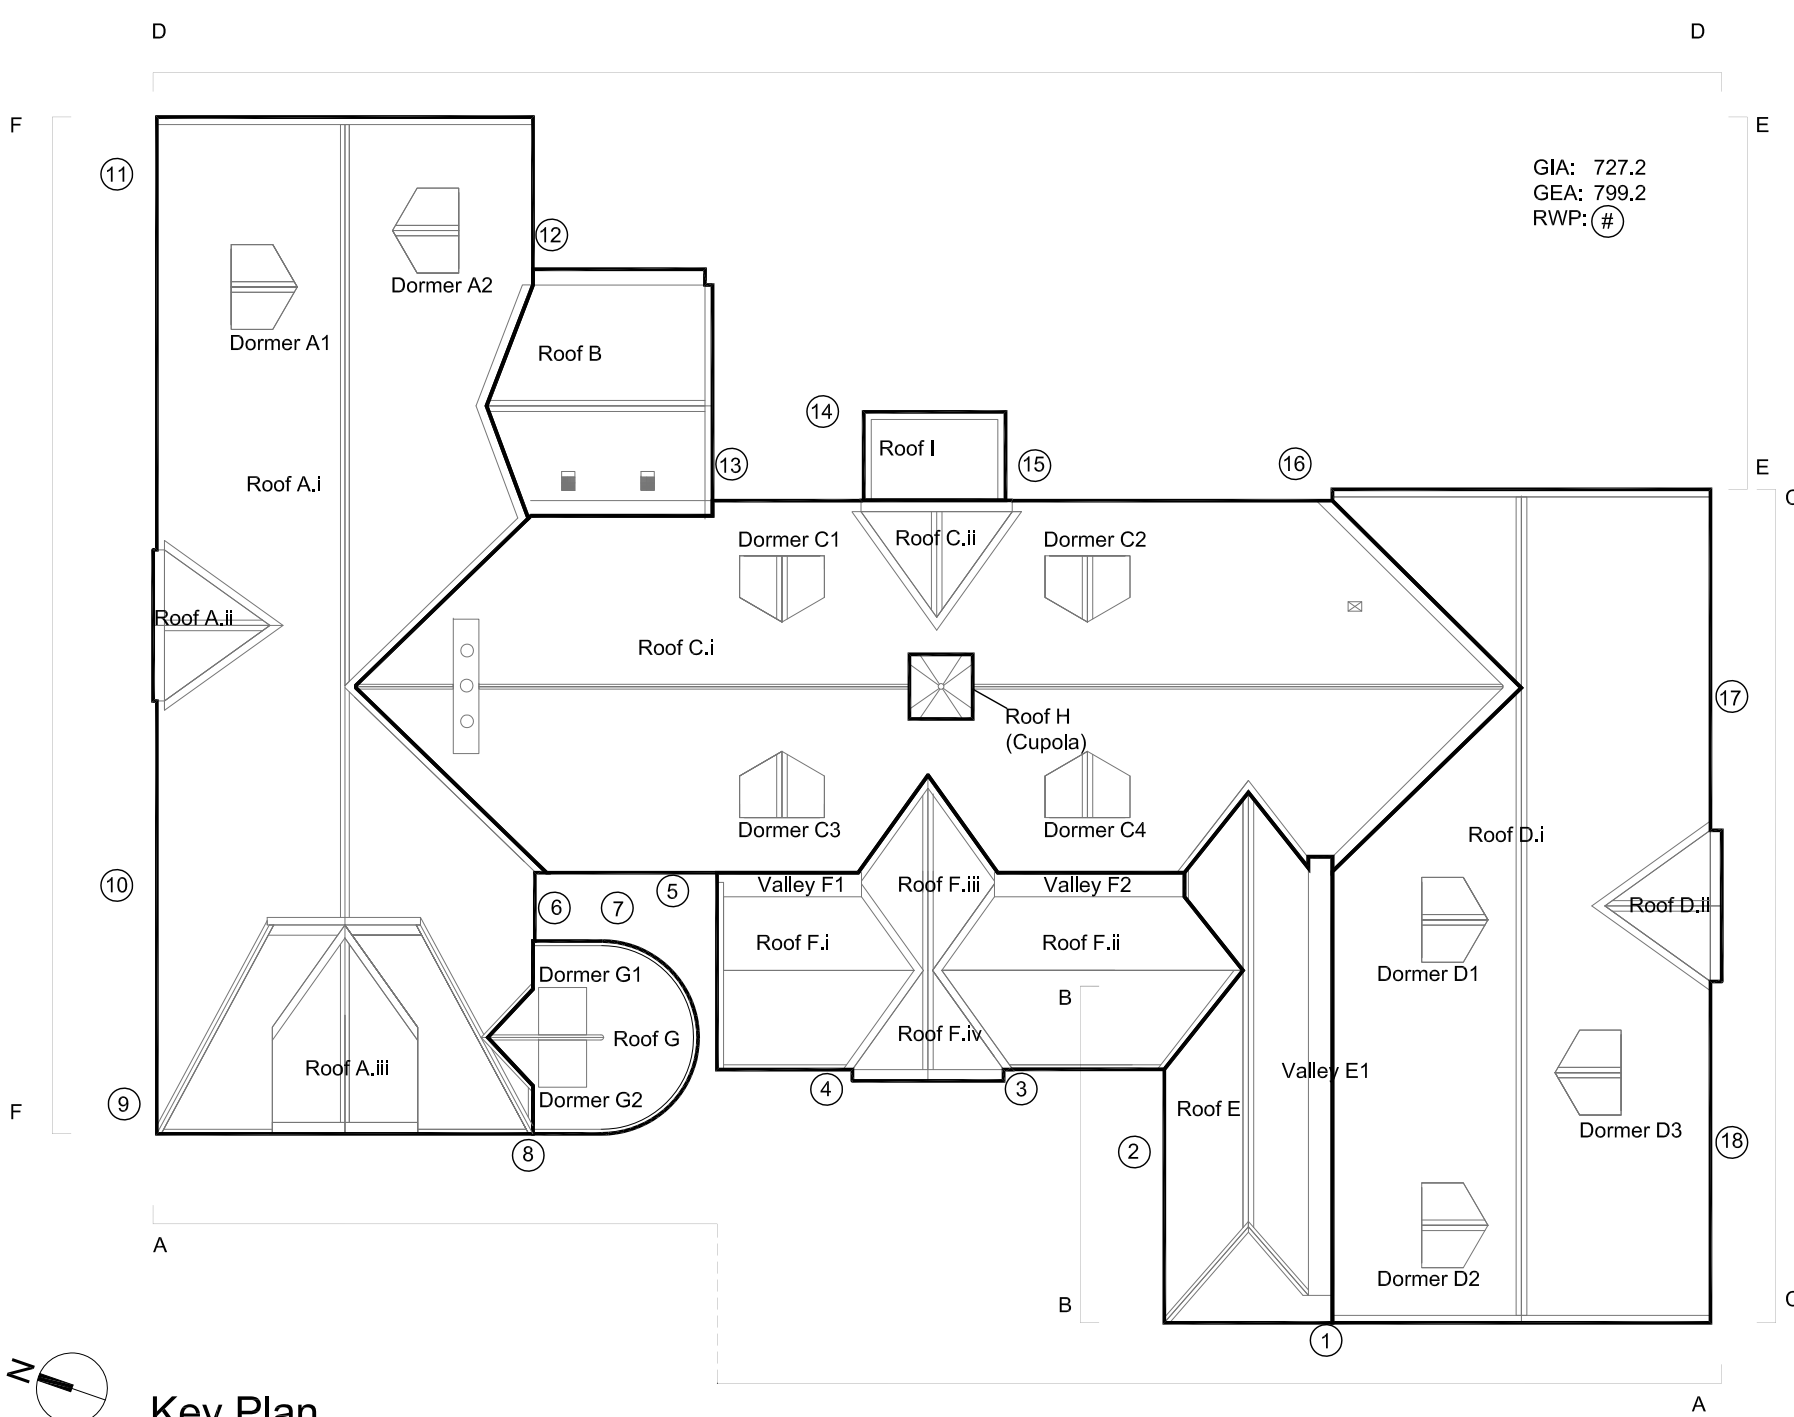
Elevation CC

D3 Dormer damaged; requires replacement sections spliced into remaining framework

Rusted metal clamping at base of stone capping

Mould at ground level - investigate if moisture trapped by adjacent Nursery rubberised hard-standing

- Roof Slate Restoration: 762sqm / 8220sqft  
Strip existing slate roof coverings and set aside salvaged slates for re-use. Strip existing battens, felt, lead-lined gutters and gutter structure then safely dispose of any defective material. Re-felt & batten existing roof slope. As per detail A-A in drawing SMP-SEV-XX-XX-DR-A-03100 (Typical Roof Build-Up)

- Dormer Window: 09 no.  
Splice in new timbers where appropriate. Access to be provided for detailed inspection and methodology agreed. Carefully sand down and repaint in appropriate materials as per the specification. Roofing section per detail F-F in drawing SMP-SEV-XX-XX-DR-A-03105 (Typical Dormer Window)

- Rainwater Goods: 18 no.  
Down-pipe to be removed and replaced with cast-iron rainwater goods allowing for increased diameter (6 inch) to mitigate increased rainfall. Existing cast-iron hoppers to be retained & refurbished where possible. Guttering per detail B-B in drawing SMP-SEV-XX-XX-DR-A-03100 (Typical External Gutter)

- Lead Flashing: 75 Lm  
Replace with new terne-coated stainless steel (TCSS) flashing where appropriate. Access to be provided for detailed inspection and methodology agreed.

- Decorative Ridge Tiles: 105 Lm  
Ridge tiles to be removed and set aside with salvaged tiles for re-use. Replace damaged tiles as per the existing style. Ridge ventilation provided with new linear vent. Ridge venting per detail F-F in drawing SMP-SEV-XX-XX-DR-A-03105 (Typical Dormer Window)

- Flat Ridge Tiles: 50 Lm  
Ridge tiles to be removed and set aside with salvaged tiles for re-use. Replace damaged tiles like-for-like.
- Bat Slate: [Dashed Hatch Approx. Location, Solid Hatch Exact Location]  
Integrated Bat access slate: metal vent to allow access for bats into roof void, with sufficient gap cut into roof structure underneath. Fitted within a hole cut to slate which is placed over the vent to reduce visual impact. 1no. Bat Slate located in area of observed bat emergence (west wing of the building, facing north, adjacent to Dormer D2) and then 3no. supplementary 'enhancement slates' along remaining wings (north, east, south).
